## Peer Review

Document number: H-1019

Review of Comprehensive Heritage Study Proposed

Cumberland Heritage List

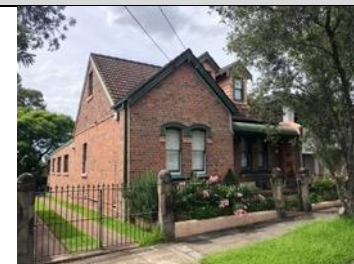
<p>HS54</p>

Item	Name	Address	Listing	Comments	Recommendations	Photographic Evidence
HS54	Late Victorian Cottage	3 Beatrice Street	Local	<p>The Late Victorian Cottage is a two storey dwelling that is in a good condition and has a moderate degree of integrity.</p> <p>It is representative of domestic Late Victorian architecture with a transverse gable and a projecting gable end that features two narrow timber double hung windows, and two additional timber double hung windows to the recessed façade. A privacy wall is constructed to the external edge of the verandah and includes moulded detailing to the top.</p> <p>Two dormer windows have been added to the roof, which are timber clad and have double hung windows.</p> <p>The heritage inventory sheet notes the modifications that detract from its aesthetic significance, such as the low stone fence with palisade infill and gate, which are not original to the site and are inscribed with 'Larcombe Villa'.</p> <p>Condition: Good</p> <p>Integrity: Moderate</p>	The exterior of the Late Victorian Cottage <b>should be considered for individual listing.</b>

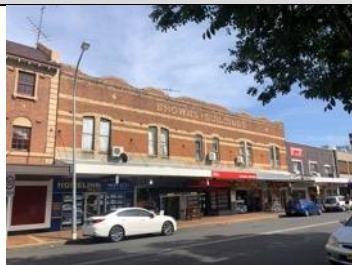
<p>HS58</p>

Item	Name	Address	Listing	Comments	Recommendations	Photographic Evidence
HS58	Brown's Buildings – historic main street facade	4-10 John Street	Local	<p>The façade of Brown's Buildings is a prominent feature on the street, displaying Federation commercial architecture across a row of five shopfronts.</p> <p>The ground floor has been considerably altered, although the upper level retains the original form and features.</p> <p>It presents as a red brick façade with blonde brick details, including contrasting string courses and "Brown's Buildings" inlaid in brick. The scalloped parapet is finished with blonde brick.</p> <p>There are five pairs of windows, two of which retain original double hung timber windows with fanlights, the remaining three have been replaced with aluminium frames. The original form of the façade and window openings has been retained.</p> <p>There are three intrusive air conditioning units and a satellite dish, and cement render below the windows of Nos. 4-6.</p> <p>Condition: Good</p> <p>Integrity: Moderate</p>	The Brown's Buildings – historic main street facade <b>should be considered for heritage listing.</b>

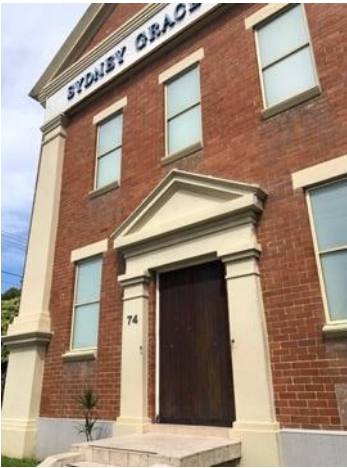
<p>HS59(1)</p>

Item	Name	Address	Listing	Comments	Recommendations	Photographic Evidence
HS59	Lidcombe's Former Masonic Temple	72-74 Joseph Street	Local	<p>Lidcombe's Former Masonic Temple is of aesthetic and historic significance, and is in a good condition with moderate integrity.</p> <p>The front façade incorporates rendered lintels, sills and columns, evoking stylistic tendencies of classical temples. The parapeted gable of the front façade contributes to its dominance and scale.</p> <p>The front elevation is of primary significance, with the side elevation, fronting Raymond Street, being a secondary view with lesser significance.</p> <p>Alterations have been made to the southern (side) elevation, including an external fire stair, infilled doorway and glass tiles to window openings.</p> <p>A single storey addition is located to the north, and another to the west (rear). A separate, free-standing building is also located to the north and within the boundaries of the site. It should be noted that this building is of recent construction and does not contribute to the significance of the site.</p> <p>Condition: Good</p> <p>Integrity: Moderate</p>	<p>The exterior of the former Masonic Temple <b>should be considered for individual listing</b>.</p> <p>Recommendations 12 and 13 relating to future development and planning should also be included, in the event that the existing adjacent building and additions are demolished and replaced.</p>

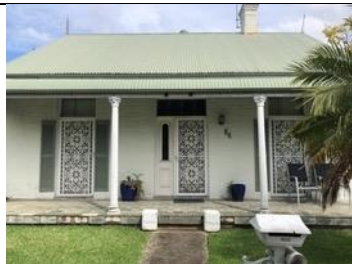
<p>HS60</p>

<p>HS59(3)</p>
HS60	'Clara Villa' – Victorian Cottage	84 Joseph Street	Local	<p>The 'Clara Villa' dwelling is a good, intact example of a Victorian Cottage.</p> <p>It has a transverse gable roof and bullnose verandah with corrugated sheeting. There are three doors to the front façade, with a transom above each. The centre door retains stained glass transom and sidelight.</p> <p>The front façade is the primary elevation, although the side, fronting Victoria Street, is visible and is a secondary view.</p> <p>There is an early addition to the rear, which has been extended with a covered verandah.</p> <p>Condition: Good</p> <p>Integrity: high</p>	<p>The exterior of the 'Clara Villa' Victorian Cottage <b>should be considered for individual listing.</b></p>

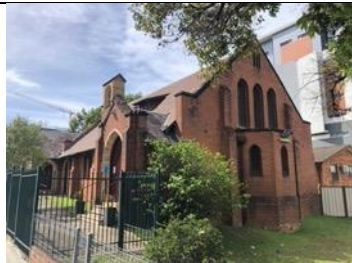
<p>HS66</p>

<p>HS64</p>
HS66	Lidcombe Anglican Church and St Stephen's Church Hall	Corner Mark and Taylor Streets	Local	<p>The Lidcombe Anglican Church and St Stephen's Church Hall present two distinct phases of development on the site. The Church, constructed in 1916, is the prominent element on the site and carries a higher degree of significance.</p> <p>It maintains original features, including slate roofing, bell tower and bell, stained glass windows and stone coping to the parapeted gables, and stone frames to window and door arches.</p> <p>The Church Hall contributes to the setting and the site history, although does not carry the same degree of heritage significance as the Church.</p>	The Lidcombe Anglican Church and St Stephen's Church Hall <b>should be considered for a group listing.</b>

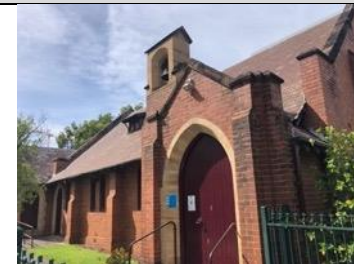
<p>HS66(2)</p>

Item	Name	Address	Listing	Comments	Recommendations	Photographic Evidence
				<p>Constructed in 1966, the red brick draws a visual cohesiveness across the site although the form and design does not draw upon that of the Church. It is more reflective of modern design, and includes a hit and miss brick panel to the centre, with the stone and marble foundation stones set below.</p> <p>An additional building is located within the site boundaries, to the south of the Church, used as the Rectory. It was constructed at a later date and does not considerably influence the heritage significance of the site.</p> <p>Condition: Good</p> <p>Integrity: High</p>

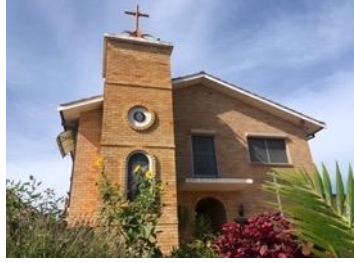
<p>HS67(3)</p>

Item	Name	Address	Listing	Comments	Recommendations	Photographic Evidence
HS67	St Andrew's Ukrainian War Memorial Church	27-29 Mary Street	Local	<p>The St Andrew's Ukrainian War Memorial Church is a prominent church building with modern design features and influences of Byzantine Ukrainian architecture.</p> <p>It features a rendered arched portico around the curved front façade, with large stained glass windows to the front and a circular domed cupola with stained glass windows, clad in copper roof sheeting.</p> <p>The site also includes other buildings (parish hall, presbytery, convent and chapel, apartments), each of which are blonde brick like the main church, set to the side and rear and at a lower ridge height than the Church. Statues of religious figures are placed in front of the buildings. Generally, these buildings contribute to the setting and the use of the site, although are not the prominent element of significance.</p> <p>Condition: Good</p> <p>Integrity: High</p>	The St Andrew's Ukrainian War Memorial Church <b>should be considered for listing.</b>

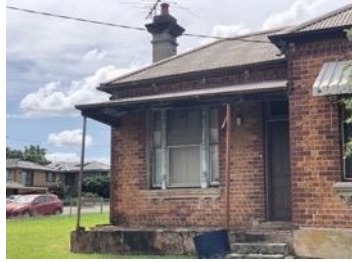
<p>HS69(2)</p>

<p>HS67(4)</p>
HS69	Victorian Cottage	33 Nottinghill Road	Local	<p>The Victorian Cottage is in a deteriorated condition, with cracking to walls, verandah base and stone window sills; unstable verandah awning, an intrusive fibro-clad addition to the rear, peeling paint to window frames and possible rising damp/salt damage. Steel bracing has previously been installed, evident on the side (northern) elevation.</p> <p>This condition is noted in the inventory sheet, which is detracting from its aesthetic significance.</p> <p>Conservation works would be required to bring the building back to a good condition, although the building does retain original features and is reflective of the earlier subdivision pattern.</p> <p>Condition: Poor</p> <p>Integrity: High</p>	<p>The Victorian Cottage <b>should be considered for listing and a defined heritage/boundary curtilage be identified that best describes its setting.</b></p> <p>As noted in the inventory sheet, conservation works are required to rectify the current deterioration. The condition, however, should not dissuade heritage listing, as it is possible to return the building back to a good condition with appropriate conservation works.</p>

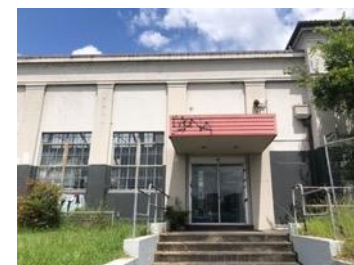
<p>HS71(1)</p>

Item	Name	Address	Listing	Comments	Recommendations	Photographic Evidence
HS71	Former Jantzen Swimwear Factory	32 Parramatta Road	Local	<p>The Former Jantzen Swimwear Factory is a good example of both Art Deco and Post-War, modernist industrial architecture, with two distinct phases of construction evident in one façade.</p> <p>There are two main entrances on the front façade, which are separated by a protruding tower in the centre, demarcating the line between the original factory and the addition. Both entrances are enunciated with a stairway and cantilevered awning. Some windows to the earlier portion have been altered with aluminium frames and a glazed door replaces the original.</p> <p>Areas of deterioration, such as broken window panes, peeling paint, old signage and overgrown garden beds, detract from the aesthetic significance of the site.</p> <p>Despite the deterioration and alterations, the original design intent, forms and features remain. It would be possible to rectify the deterioration without significantly compromising the integrity and aesthetic features.</p> <p>The space now appears to be used for storage.</p> <p>Condition: Fair</p> <p>Integrity: Moderate</p>	The Former Jantzen Swimwear Factory <b>should be considered for listing.</b>

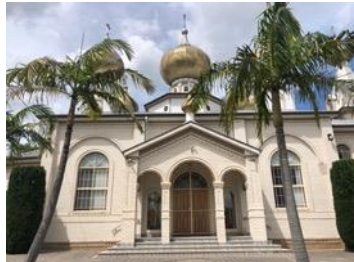
<p>HS75(1)</p>

Item	Name	Address	Listing	Comments	Recommendations	Photographic Evidence
HS75	Russian Old Rite Orthodox Christian Church	56-60 Vaughan Street	Local	<p>The Russian Old Rite Orthodox Christian Church has landmark qualities owing to its scale and design.</p> <p>The metal tile clad onion domes that sit atop towers contrast to the white brick of the building, creating a striking frontage and dominant form.</p> <p>There is a secondary building to the side of the site, which is a single storey structure with minimal architectural detailing in comparison to the Church. Other buildings are located to the rear of the Church, although these are not visible from the public domain.</p> <p>While the Church was constructed ca. 1991-2001, it is significant for its connections to the Russian migrant community and its aesthetic contributions to Lidcombe.</p> <p>Heritage listing a site that is less than 30 years old will contribute towards its retention for future generations without alterations that would otherwise detract from the site.</p> <p>Condition: Good</p> <p>Integrity: High</p>	<p>The Russian Old Rite Orthodox Christian Church <b>should be considered for listing.</b></p>

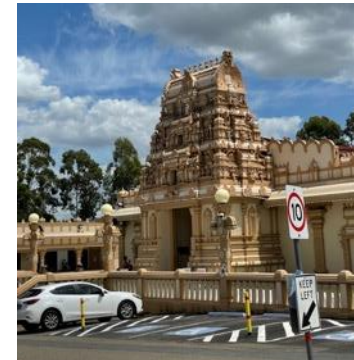
<p>HS77(1)</p>

Item	Name	Address	Listing	Comments	Recommendations	Photographic Evidence
HS77	Sydney Murugan Temple	217 Great Western Highway	Local	<p>The Sydney Murugan Temple is a rare example of the type, which displays traditional architecture of Hindu temples.</p> <p>The Temple was constructed in 1994, which indicates the increasing Tamil population in the area. Heritage listing a site that is less than 30 years old will contribute towards its retention for future generations without alterations that would otherwise detract from the site.</p> <p>It derives cultural significance through its association with the story of diversity and immigration in Australia.</p> <p>It is a landmark building, with a monumental entrance that towers higher than the remaining complex.</p> <p>Condition: Good</p> <p>Integrity: High</p>	The Sydney Murugan Temple <b>should be considered for listing.</b>

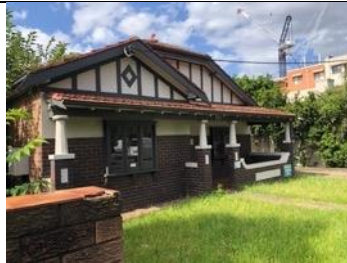
<p>HS79</p>

<p>HS78</p>
HS79	Federation Bungalow	291 Merrylands Road	Local	<p>The Federation Bungalow is a good example of its type. It appears to be in a good condition with a moderate degree of integrity externally.</p> <p>It features a double fronted gable and jerkin head façade with timber battens and diamond motif to the gable ends, with terracotta finials to the terracotta tiled roof. There are two window openings, which retain timber window frames to each of the three casement</p>	The exterior of the Federation Bungalow <b>should be considered for listing.</b>

Item	Name	Address	Listing	Comments	Recommendations	Photographic Evidence
				windows and coloured fanlight glazing above each window.		
				The site is now used for commercial purposes and has a carpark at the rear.		
				Condition: Good		
				Integrity: Moderate

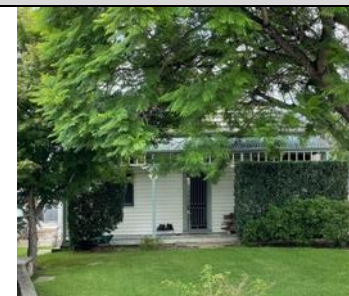
<p>HS84</p>

Item	Name	Address	Listing	Comments	Recommendations	Photographic Evidence
HS84	Late Victorian Cottage	64 Jersey Road	Local	<p>The Late Victorian Cottage is a good example of its type. It appears to be in a good condition and has a high degree of integrity externally.</p> <p>The ca. 1890s weatherboard clad, single storey dwelling has a hipped roof with corrugated sheeting to the bullnose verandah. The timber posts and valance to the verandah are sympathetic to the original. A timber panelled door is visible behind the aluminium security door, and windows to the front are timber framed with aluminium flyscreens.</p> <p>The inventory sheet notes that the "roof has been re-sheeted with decramastic pressed metal." The finish is visually similar to terracotta tiles, although it is possible that the roof is decramastic pressed metal.</p> <p>Condition: Good</p> <p>Integrity: High</p>	The exterior of the Late Victorian Cottage <b>should be considered for listing.</b>

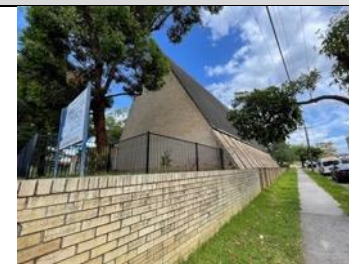
<p>HS87</p>

Item	Name	Address	Listing	Comments	Recommendations	Photographic Evidence
HS87	St Pauls Anglican Church and Hall	16-18 Pritchard Street East	Local	<p>The St Pauls Anglican Church and Hall reflect two distinct eras of construction, with the hall dating from 1919 and the Church from 1960. Both are good examples of ecclesiastical architecture of their respective eras (Federation and modern architecture). Both buildings appear to be in a good condition and have a high degree of integrity externally.</p> <p>The Federation style Church Hall displays the earlier phase of construction on the site and is connected to the early establishment of the Church of England in Wentworthville. It retains original elements, such as multi-pane timber windows and timber panelled doors.</p> <p>The Church indicates the growth of the congregation in the 1950s and 1960s. It displays mid-century modern architectural characteristics and includes a later single storey extension.</p> <p>Condition: Good</p> <p>Integrity: High</p>	The exterior of the St Pauls Anglican Church and Hall <b>should be considered for a group listing.</b>
