REPORT: **Arboricultural Impact Assessment**

Billbergia Group Pty Ltd

Lot 101, DP 791908
1 King Street
Concord West NSW 2138

22nd of January, 2024

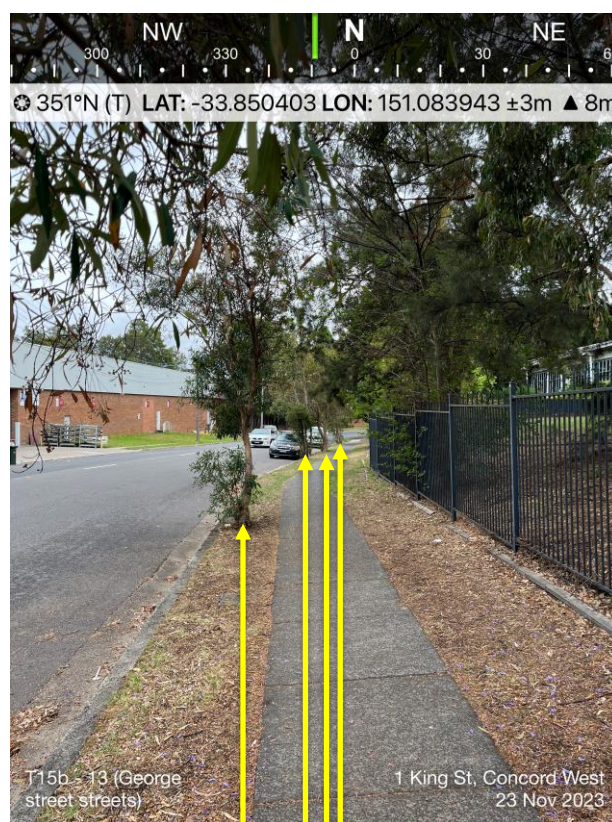
Plate 4: Trees 13 to 15b (from right to left).

15a	George Street.	<i>Tristaniopsis laurina</i> Water Gum	3	7	5/5/10 18	2.0 1.6	Immature, poor condition, with 10% dehydration.	3d Z10	Low	Remove and replenish.
15b	George Street.	<i>Tristaniopsis laurina</i> Water Gum	5	6	8/10 14	2.0 1.5	Immature, good condition but poor development.	2a Z10	Low	Remove and replenish.
16	Western boundary.	<i>Jacaranda mimosifolia</i> Jacaranda	8	11	16/22 26	3.2 1.9	Immature, good condition, with a lean and an unbalanced canopy.	2a Z10	Moderate	Remove and replenish.
17	Western boundary.	<i>Casuarina glauca</i> Swamp She-Oak	10	15	45 50	5.4 2.5	Immature, good condition but poor development, with minor exudation.	2a Z10	Moderate	Remove and replenish.

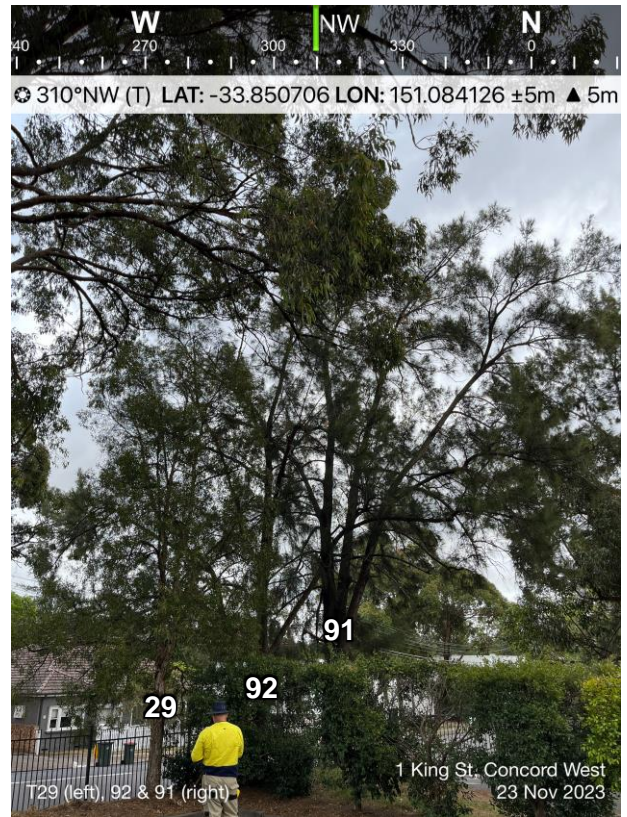
Plate 6: Trees 29, 91 and 92.

29	Carpark.	<i>Melaleuca quinquenervia</i> Broad-Leaved Paperbark	6	9	22 24	2.6 1.8	Immature, good condition.	2a Z10	Low-Moderate	Remove and replenish.
30	George Street.	<i>Casuarina glauca</i> Swamp She-Oak	8	15	32 35	3.8 2.1	Immature, in decline, with 35-40% dehydration.	4a Z4	Very Low	Remove (Exempt, dead/dying).
31	George Street.	<i>Casuarina glauca</i> Swamp She-Oak	12	17	40 50	4.8 2.5	Mature, good condition but poor development, with an inclusion at 4m height, a minor branch failure, sparse foliage, and termite damage.	2d Z10	Moderate	Remove and replenish.
32	George Street.	<i>Casuarina glauca</i> Swamp She-Oak	12	17	40 50	4.8 2.5	Mature, good condition but poor development.	2a Z10	Moderate	Remove and replenish.
33	Western boundary.	<i>Eucalyptus microcorys</i> Tallowwood	14	23	64 80	7.7 3.0	Semi-mature, good condition but poor development, with twin leaders.	2d Z10	High	Remove and replenish.

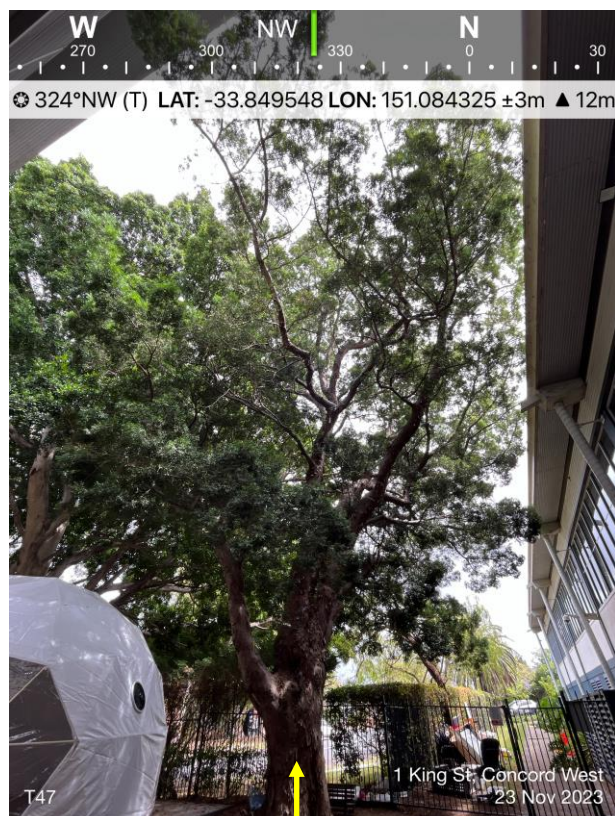
Plate 9: Tree 47.

46	Adjacent George Street.	<u>Ficus microcarpa</u> var. 'hillii' Hill's Weeping Fig	24	25	51 60	6.1 2.7	Mature, good condition, previously pruned at 30cm and 50cm height.	3a A2	High	Retain and protect.
47	Adjacent George Street.	<u>Podocarpus elatus</u> Plum Pine	NS 18 EW 15	18	86 85	10.3 3.1	Mature, good condition but poor development, with a lean and an unbalanced canopy to the north-east, and decay to the east at 50cm height.	3a A2	High	Retain and protect.
48	Western boundary.	<u>Celtis spp.</u> Hackberry	6	8	10/10/13 25	2.3 1.9	Immature, good condition but poor development, with damaged roots.	2a Z3	Very Low	Remove (Exempt plant species).
49	Tree removed prior to this report.									
50	Western boundary.	<u>Celtis spp.</u> Hackberry	6	7	10 (x 5)/13 25	3.1 1.9	Immature, good condition, with a lean to the north-west.	2a Z3	Very Low	Remove (Exempt plant species).
51	Western boundary.	<u>Cupressocyparis leylandii</u> Leighton Green	5	12	18 22	2.2 1.8	Semi-mature, moderate condition, with an unbalanced canopy to the west.	3d Z10	Low	Remove and replenish.
