Subject: 345 Appin Road, Appin Planning Proposal – Riparian Assessment

Thank you for the opportunity to prepare this riparian assessment of the watercourses at 345 Appin Road, Appin (the subject site) to support the planning proposal for the North Appin (Part) Precinct.

Attachment B – Riparian Assessment Matrix

345 Appin Road, Appin Riparian Assessment

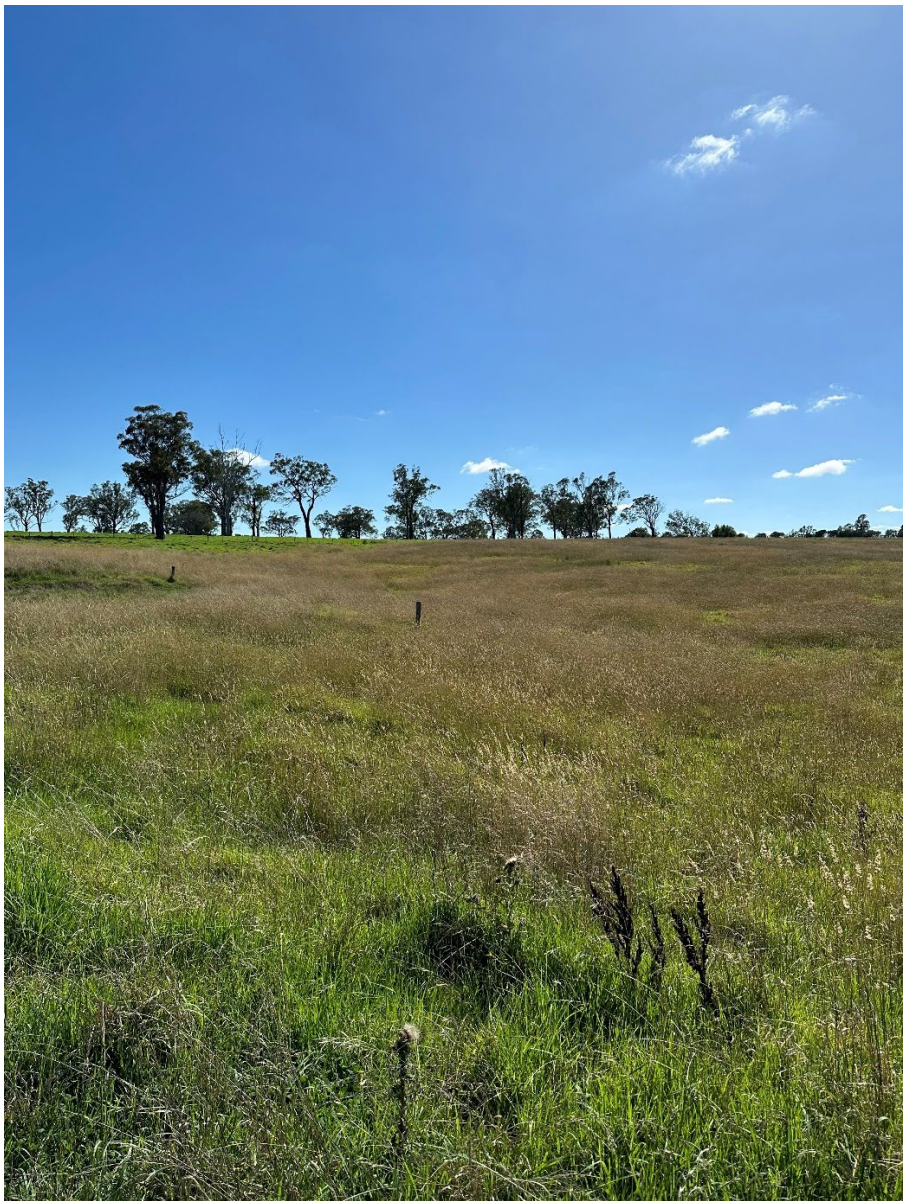
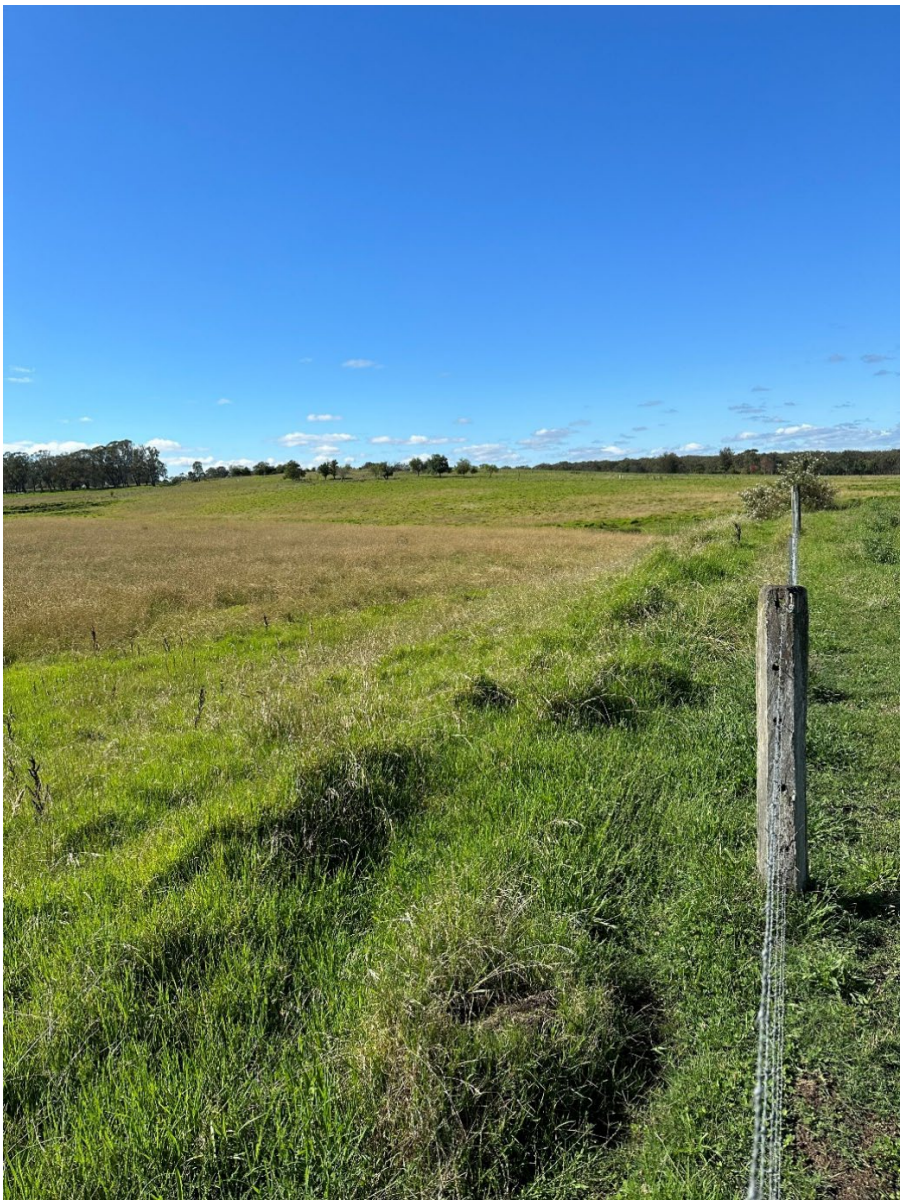
Location 1 (Looking Upstream)

Description	The photos of watercourse 1A show an open clearing with tall pasture grass (no trees). Local depression in terrain with no defined creek bed or banks. No riparian function evident.
Watercourse order	1 st order
Does the watercourse have a defined bed or bank?	No
Watercourse Features (NRAR Waterfront Land Tool – Appendix 6)	None

Result: Controlled activity approval not required–No watercourse

- There is no bed or bank
- There are no watercourse features

Outcome: Watercourse 1A is proposed to be removed in the proposed development and will be replaced by traditional road drainage networks

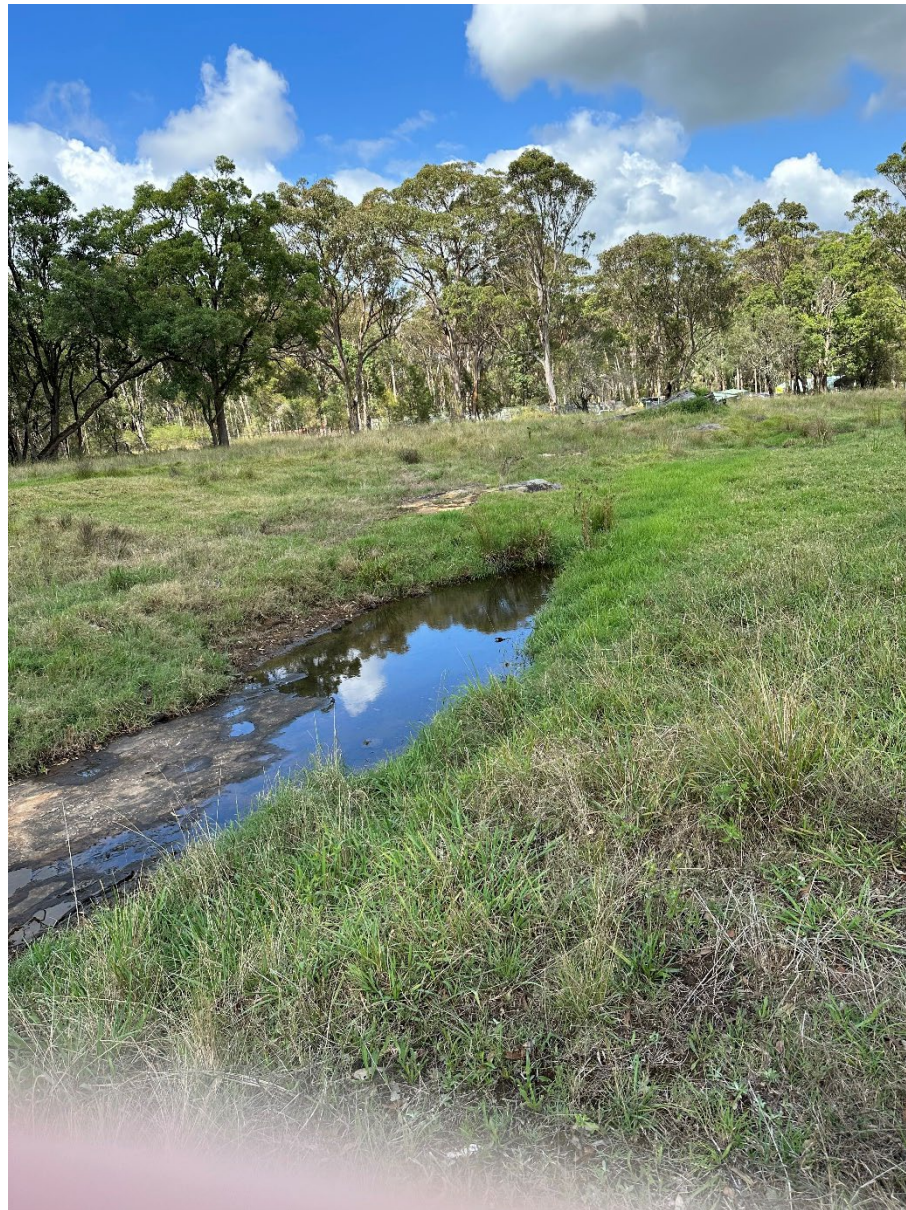
Location 24 (Looking downstream)

Description	The photos of watercourse 2B show signs of a watercourse with evidence of erosion in the creek bed and pools of stagnant water. It should be noted that rainfall occurred in the days prior to the site visit. There is minimal riparian vegetation in the creek bed.
Watercourse order	2 nd order
Does the watercourse have a defined bed or bank?	No
Watercourse Features (NRAR Waterfront Land Tool – Appendix 6)	Yes – Pools and erosion
High bank of the watercourse (NRAR Waterfront Land Tool – Appendix 8)	Type 4 – Laterally Unconfined Discontinuous
Are the proposed works located within 40 metres of the high bank?	Yes

Outcome: Watercourse 2B is proposed to be realigned in the proposed development and will be replaced by a linear open space alongside Brian Road which will include an overland flowpath. Given the limited ecological value in the location of the existing watercourse, this realignment is considered to be a suitable outcome.
