# **Flood Impact Assessment Report**

**21-23 Victoria Avenue, Castle Hill**

**Prepared for Blueprint Australia Planning Development Management / 29 July 2022**

191928 CAAB

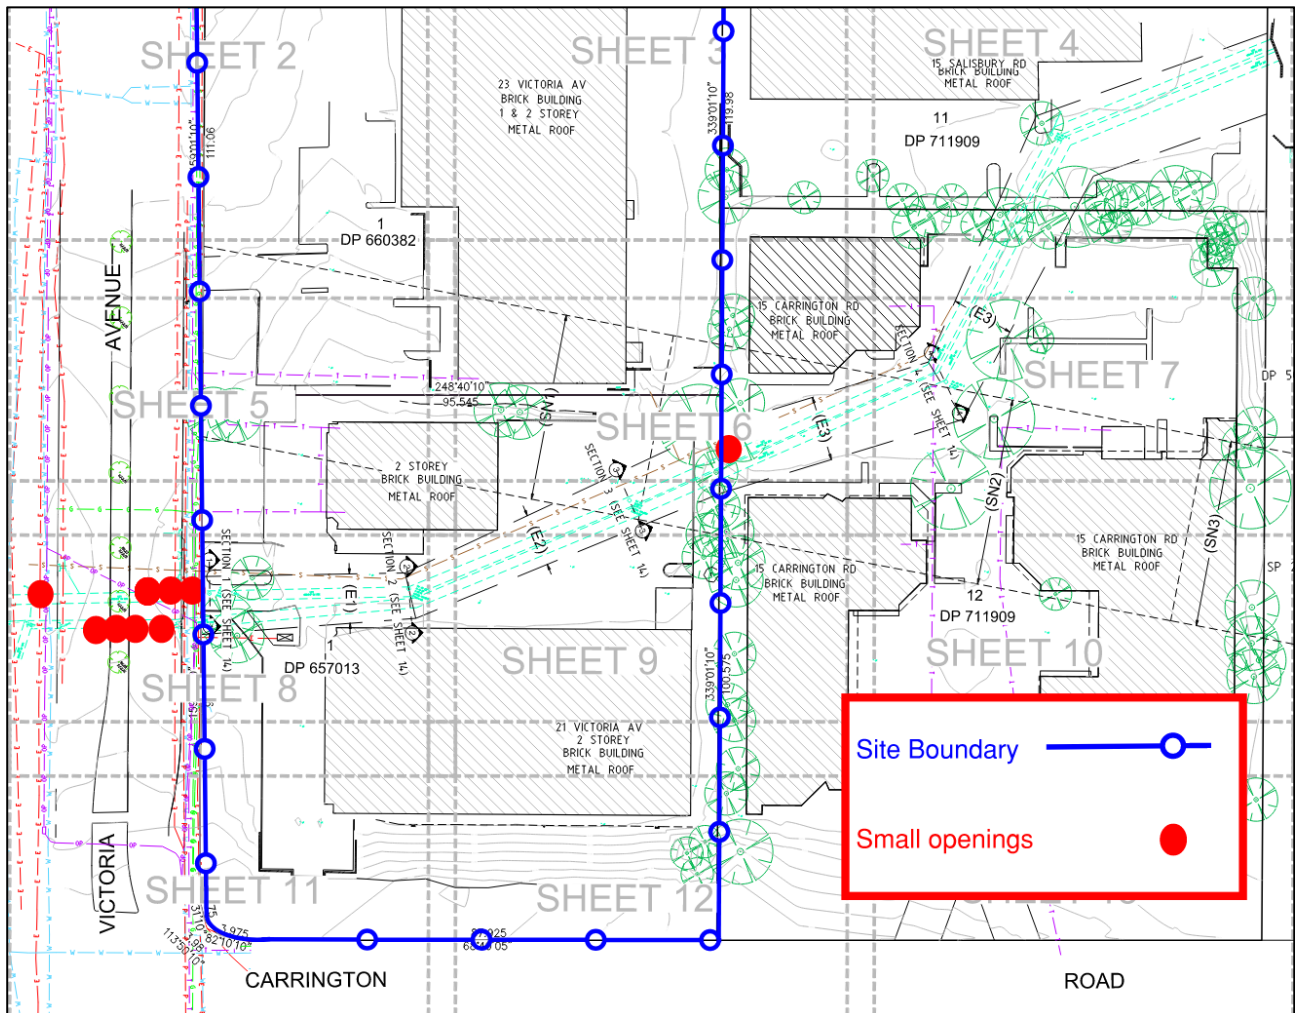
Figure 4. Open connections with 100-300 mm diameter

There are several connections that appear to be open with 100 to 300 mm diameter on the stormwater pipe, however these are also located outside the development site boundary, refer to figure 4.

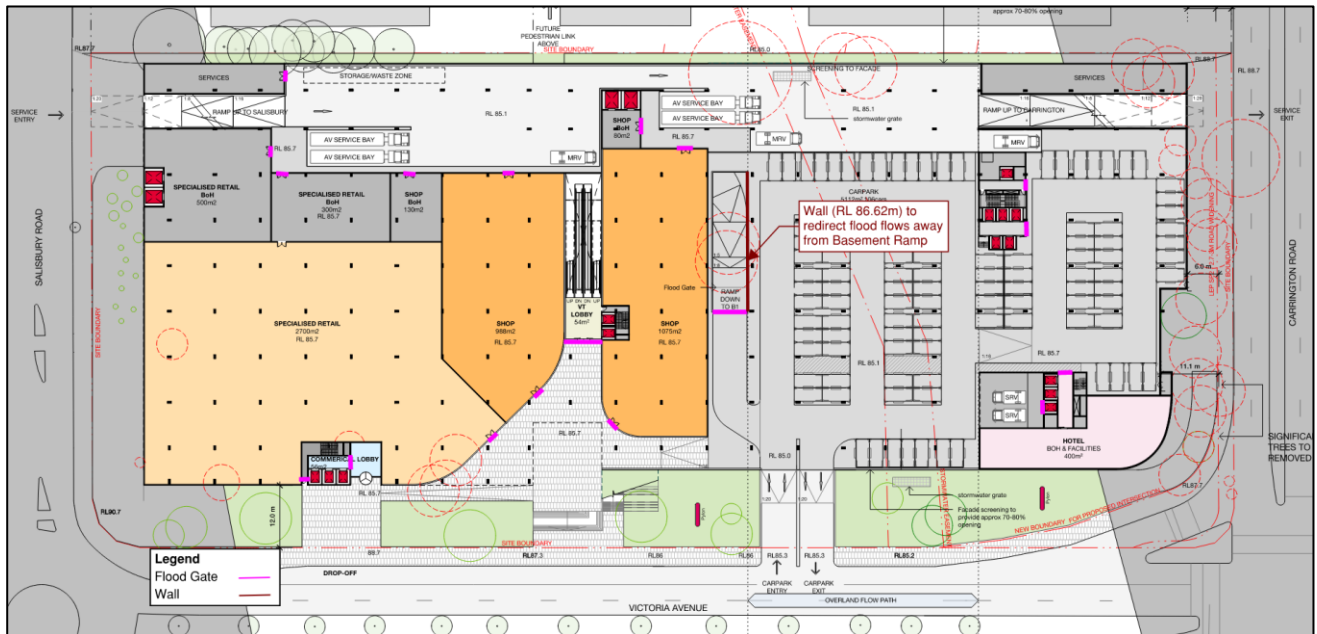
Figure 1 – Proposed Flood Barrier Locations (Lower Ground Level)

Flood gates will be provided to ensure retail areas in lower ground level and the lower ground lower basement openings are protected during large flood events up to the PMF. The flood gates are only expected to be triggered for storm events greater and the 0.2% AEP (1 in 500 Year ARI) when flood levels overtop the lower ground car park entrance at RL 85.30m. Location of proposed flood gates are shown in Figure 1.

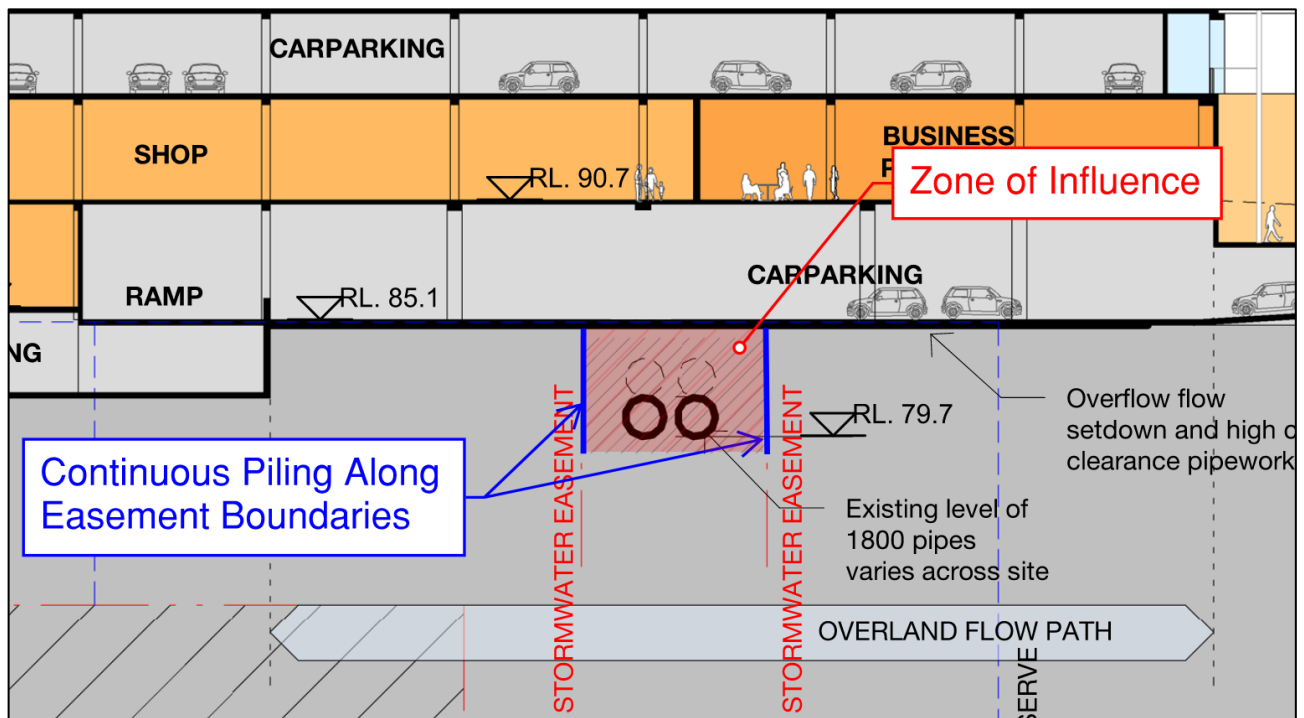
Figure 2 – Zone of Influence over the Easement – Typical section

- All load bearing structural elements will be located outside the existing stormwater easement to make pipe replacement works possible under post-development conditions.
- Foundation structures will also be out of the easement corridor and the zone of influence.
- continuous piling will be provided along the northern and southern easement boundaries within the proposed building to reduce the zone of influence.
- Concrete slabs will be designed over the easement across the car park with expansion joints that correspond to the easement extents to improve pavement removability in the event of future excavation. This will enable the slabs to be removed if required without interfering with adjacent slabs.
- Figure 1 shows indicative location of the columns at Lower Ground level. Figure 2 also shows typical location of the columns with relation to zone of influence for the easement.

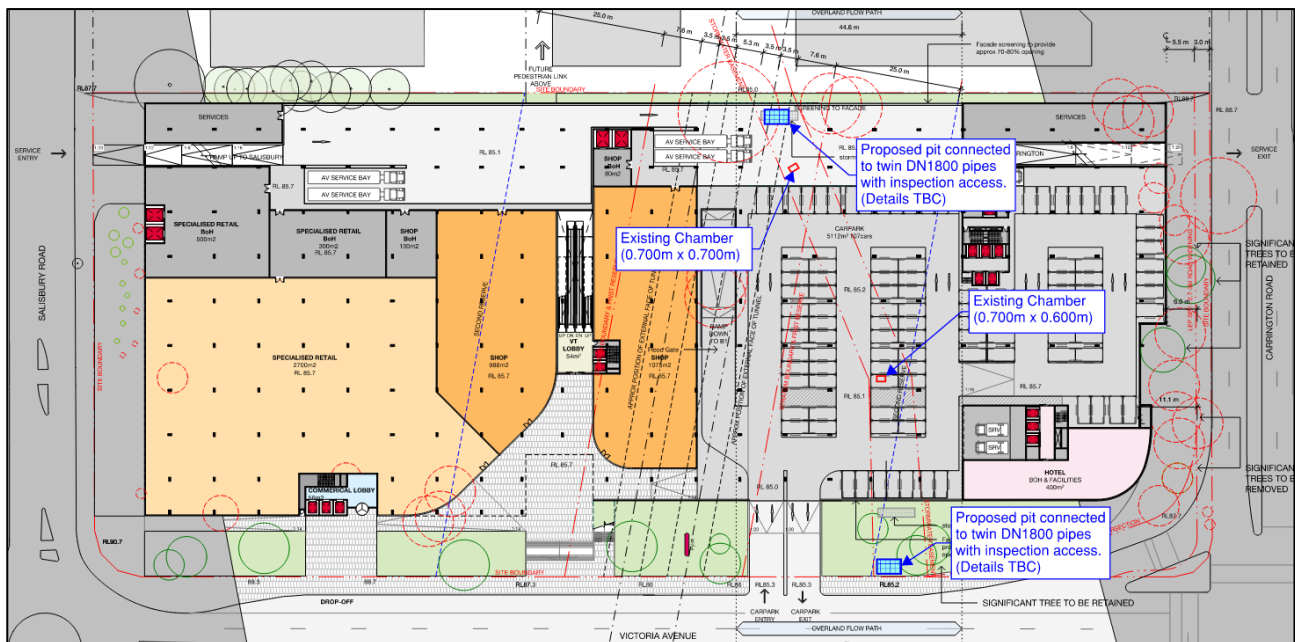
Figure 3 – Proposed and Existing Access Pits within the Site

- The existing access chambers to DN1800 pipes will be retained. The sealed cover access lids over the existing access chambers within the development boundary will be replaced with grated lids to allow better visual monitoring and access.
- Two additional access chambers to the twin DN1800 pipes with grated lids will be provided at locations as shown in Figure 3 to further facilitate access to the twin DN1800 pipes.

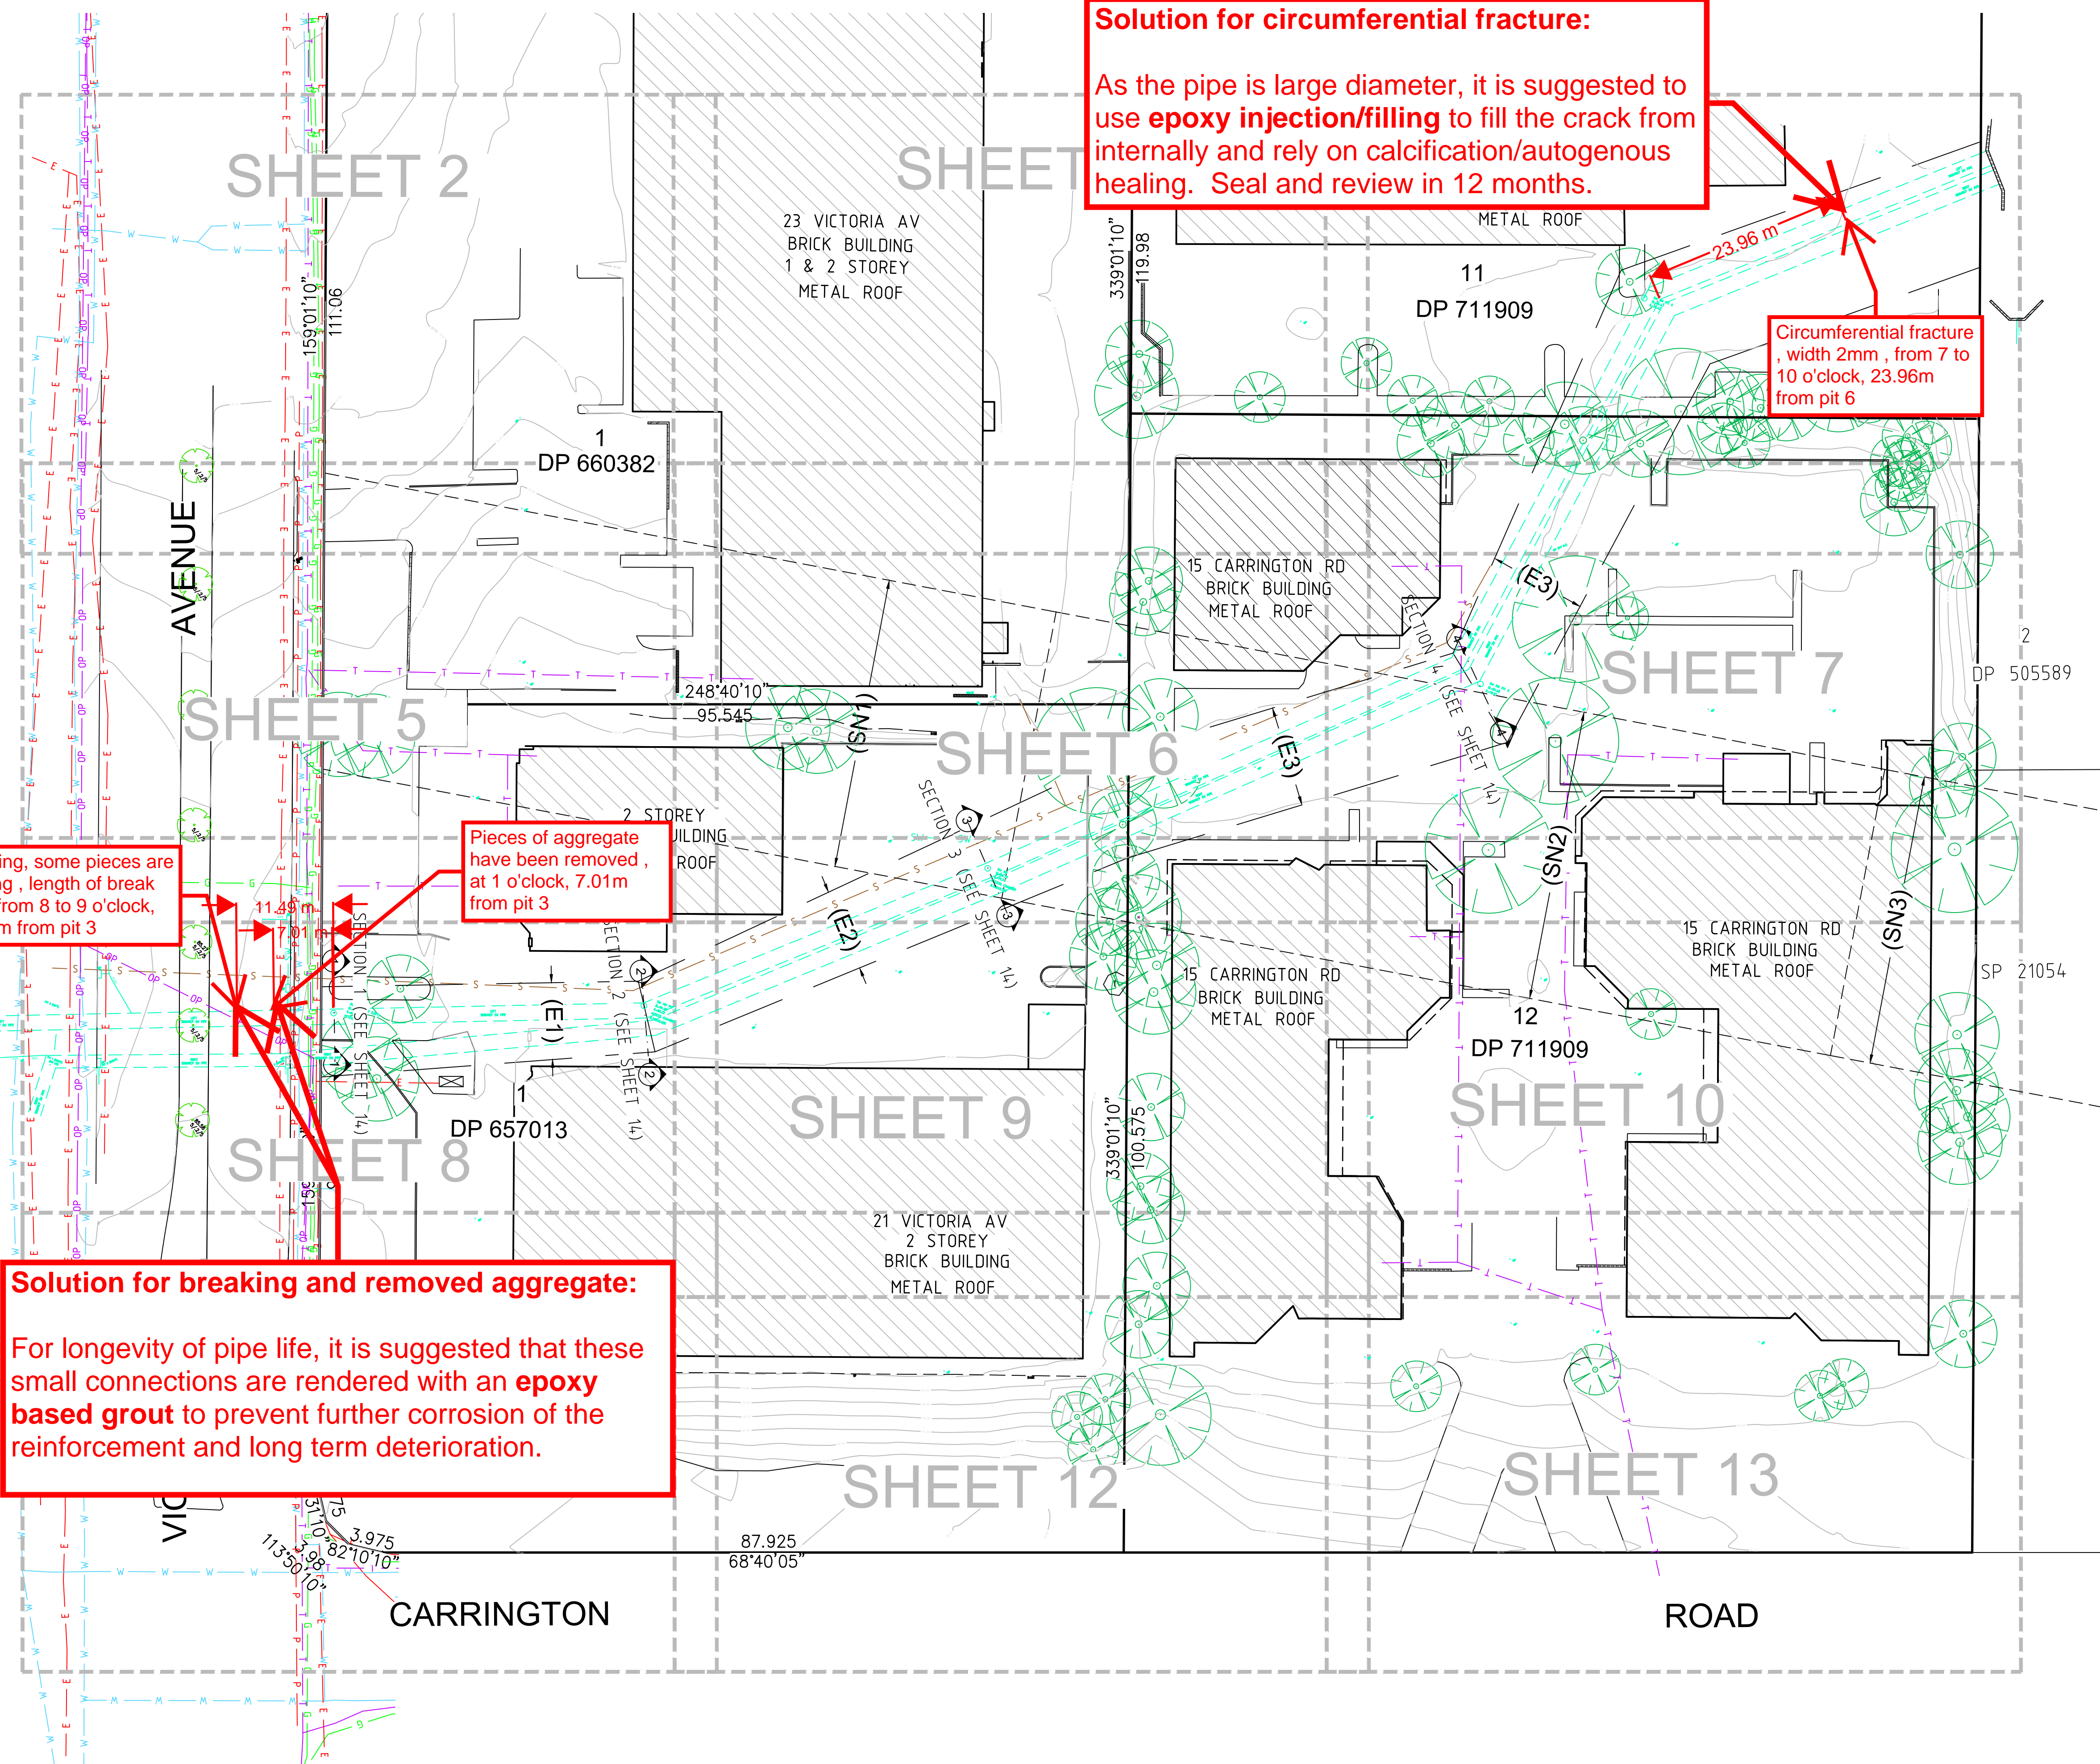
Circumferential fracture, width 2mm, from 7 to 10 o'clock, 23.96m from pit 6

**Solution for circumferential fracture:**  
As the pipe is large diameter, it is suggested to use **epoxy injection/filling** to fill the crack from internally and rely on calcification/autogenous healing. Seal and review in 12 months.

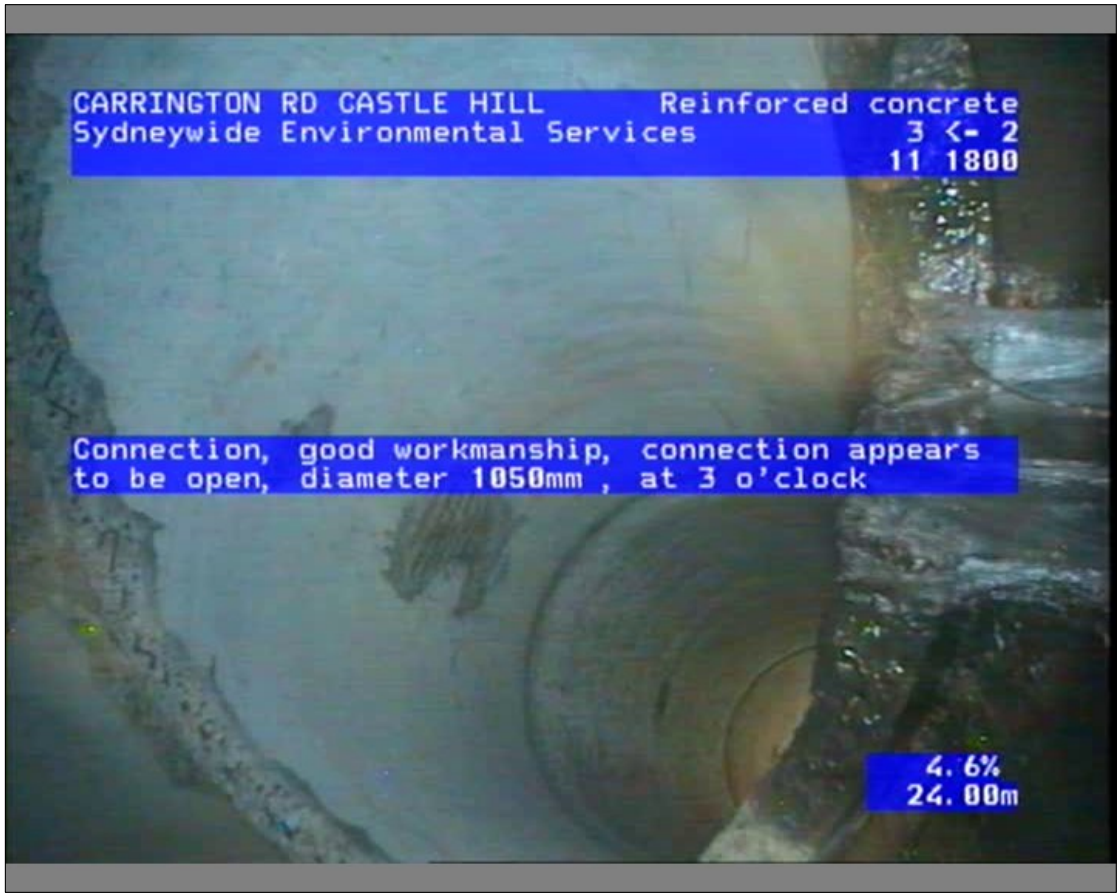
**Note:** An open connection with 1050 mm diameter has been identified that needs further investigation. This pipe was not in the map provided in the CCTV report and can only be seen in the CCTV video file. Refer to figure 5.

Photo: 095129\_18022022\_A.JPG, Media No.: LTS LOCKLEY\_0, 00:03:11 24m, Connection, good workmanship, connection appears to be open, diameter 1050mm, at 3 o'clock

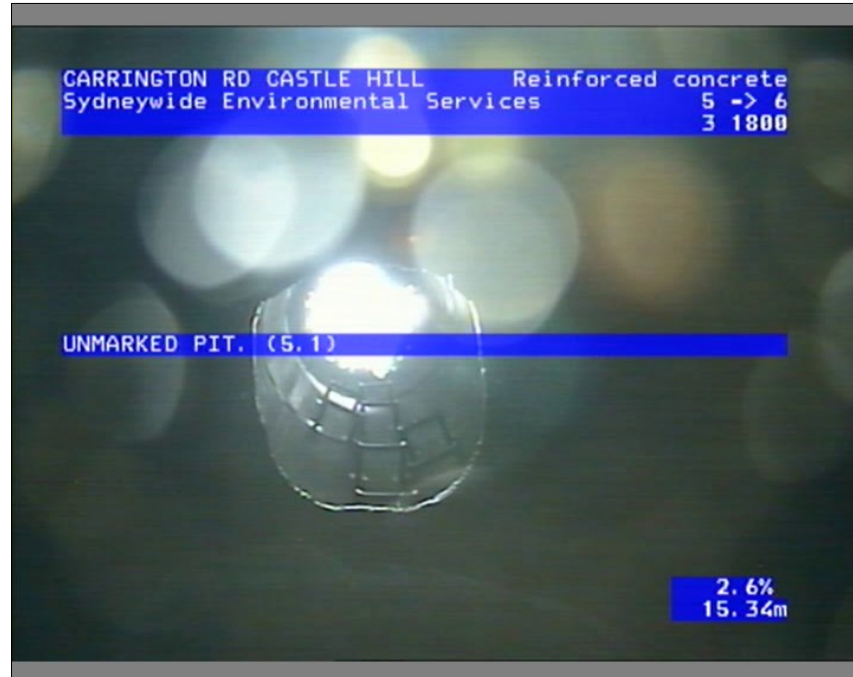
Photo: 081416\_18022022\_A.JPG, Media No.: LTS LOCKLEY,\_0, 00:01:12  
15.34m, UNMARKED PIT. (5.1) / UNMARKED PIT. (5.1)

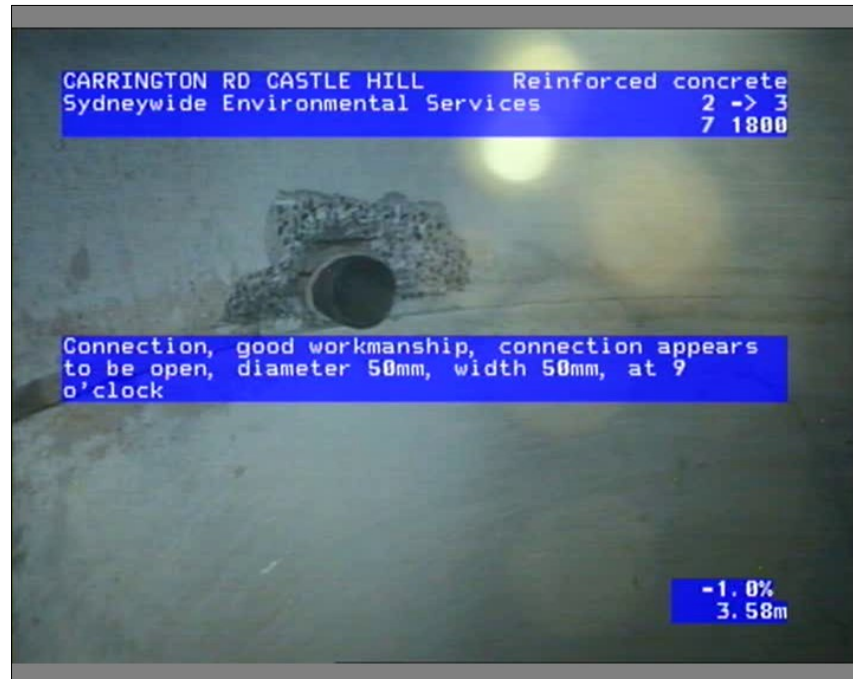
Photo: 085944\_18022022\_A.JPG, Media No.: LTS LOCKLEY,\_0, 00:00:25  
3.58m, Connection, good workmanship, connection appears to be open, diameter 50mm, width 50mm, at 9 o'clock

For all the marked up small connections, it is suggested that they are rendered with an **epoxy-based grout** to prevent further corrosion of the reinforcement and long-term deterioration.

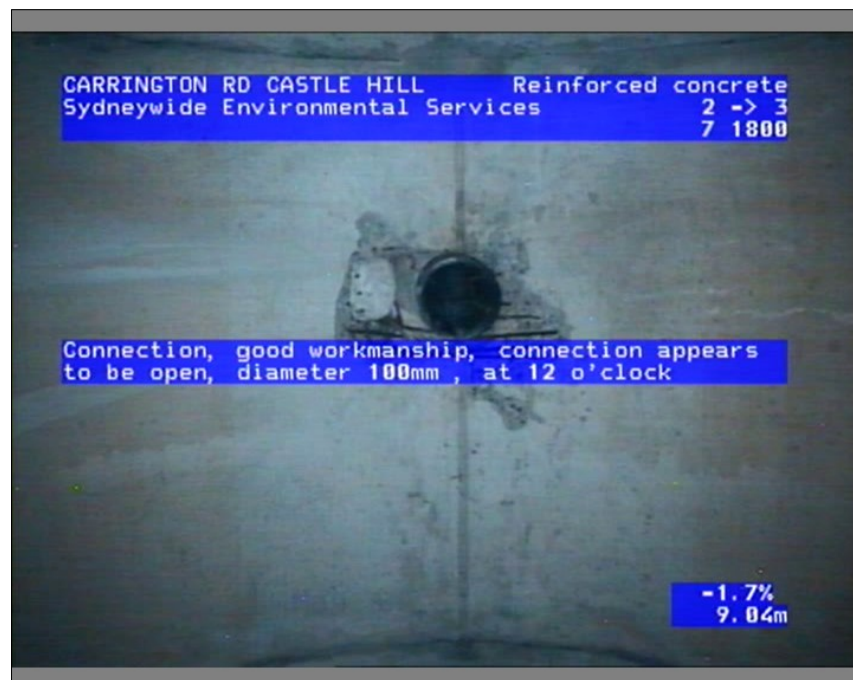
Photo: 090020\_18022022\_A.JPG, Media No.: LTS LOCKLEY,\_0, 00:00:53  
9.01m, Connection, good workmanship, connection appears to be open, diameter 100mm, at 12 o'clock

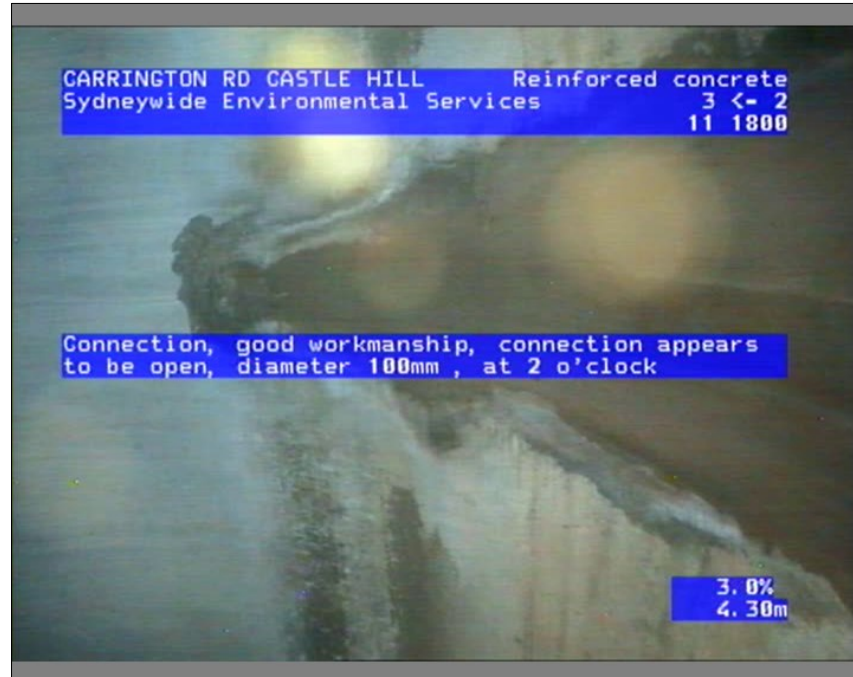
Photo: 094745\_18022022\_A.JPG, Media No.: LTS LOCKLEY,\_0, 00:00:38  
4.3m, Connection, good workmanship, connection appears to be open, diameter 100mm , at 2 o'clock

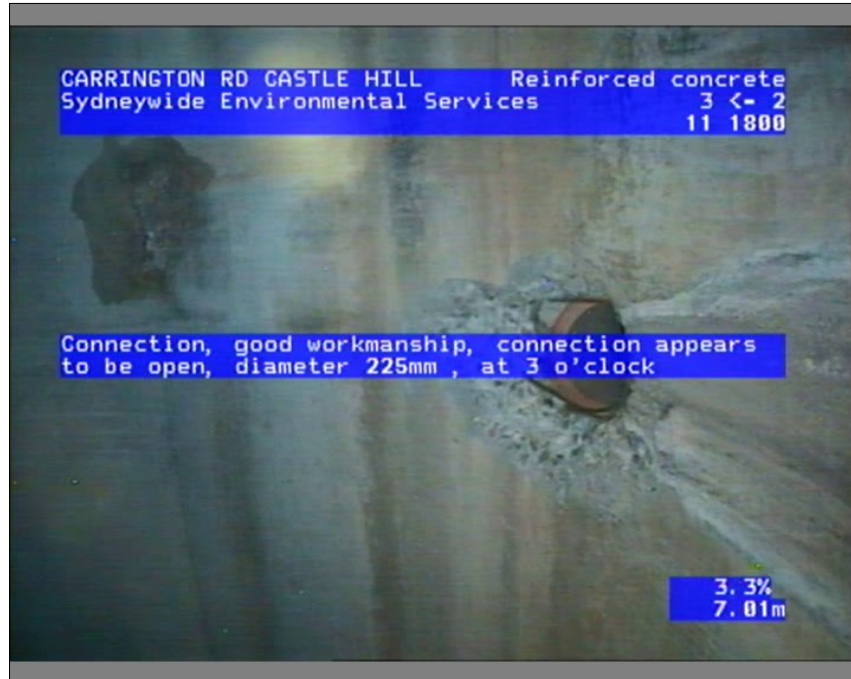
Photo: 094830\_18022022\_A.JPG, Media No.: LTS LOCKLEY,\_0, 00:01:05  
7.01m, Connection, good workmanship, connection appears to be open, diameter 225mm , at 3 o'clock

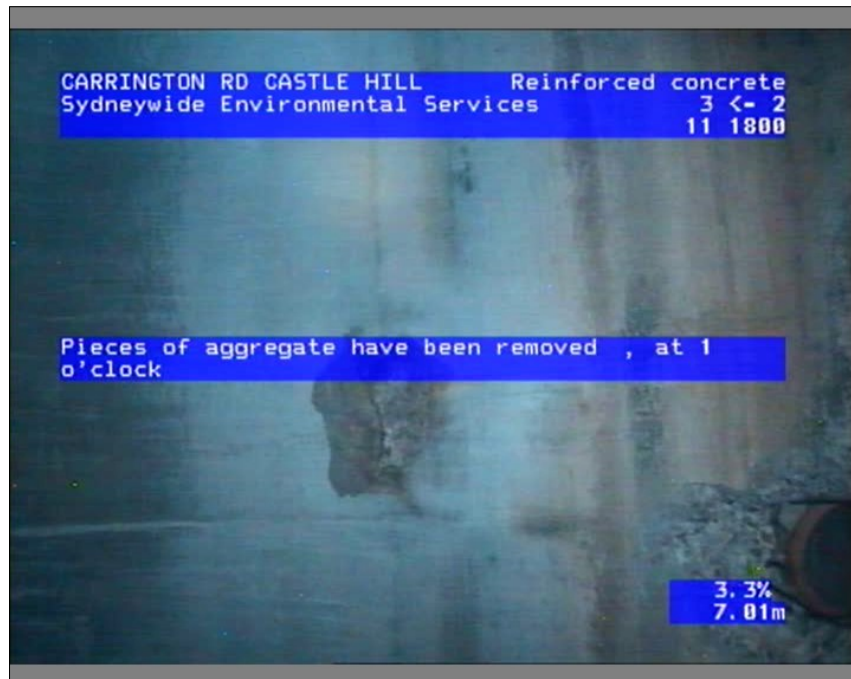
Photo: 094859\_18022022\_A.JPG, Media No.: LTS LOCKLEY,\_0, 00:01:15  
7.01m, Pieces of aggregate have been removed , at 1 o'clock

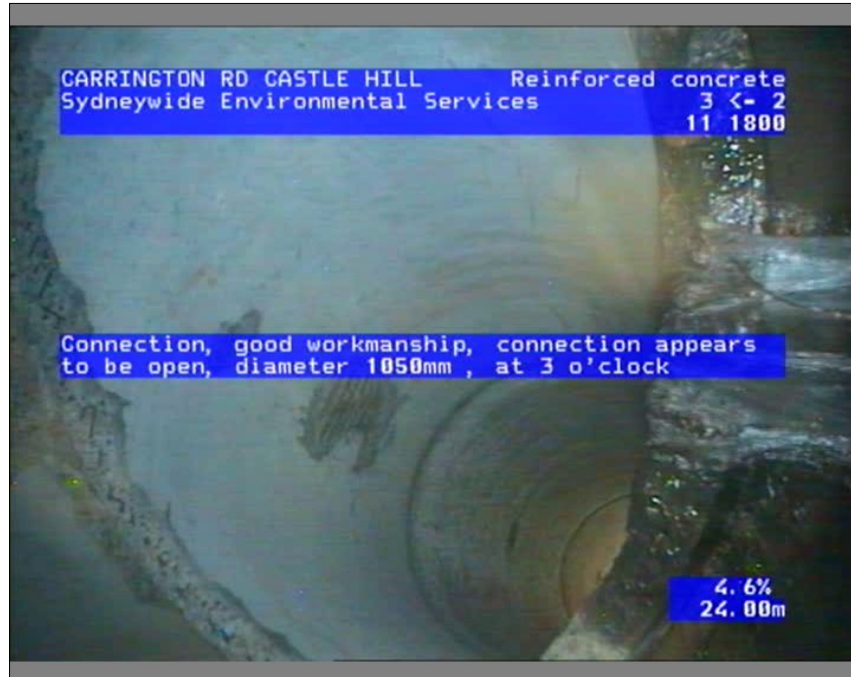
Photo: 095129\_18022022\_A.JPG, Media No.: LTS LOCKLEY,\_0, 00:03:11  
 24m, Connection, good workmanship, connection appears to be open, diameter 1050mm , at 3 o'clock

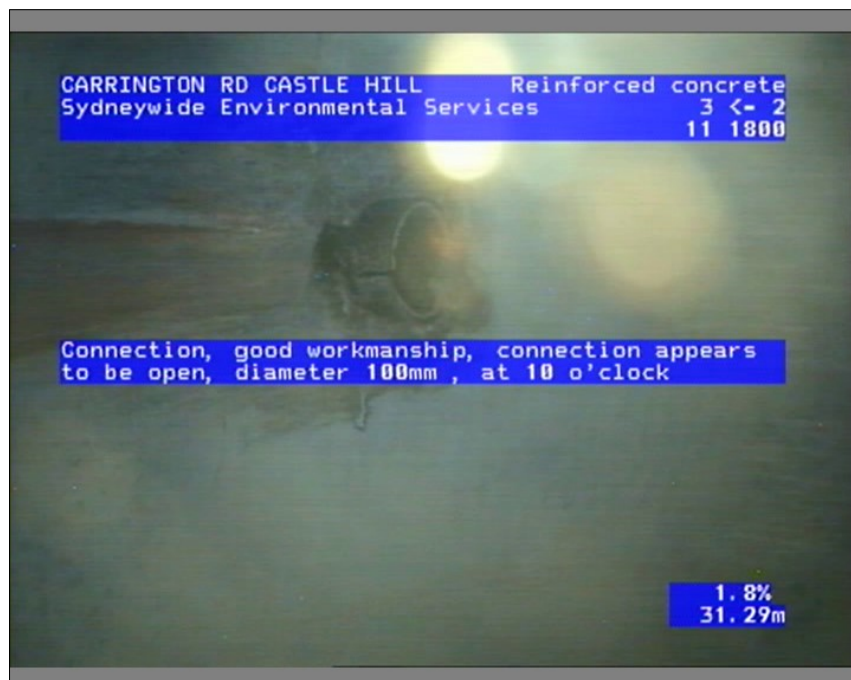
Photo: 095214\_18022022\_A.JPG, Media No.: LTS LOCKLEY,\_0, 00:03:49  
 31.29m, Connection, good workmanship, connection appears to be open, diameter 100mm , at 10 o'clock
