PRELIMINARY SITE INVESTIGATION

PROPOSED REZONING AND DWELLING ENTITLEMENT

Lot 1 DP 818394
Clothiers Creek Road
Bogangar NSW

HMC2023.627.02

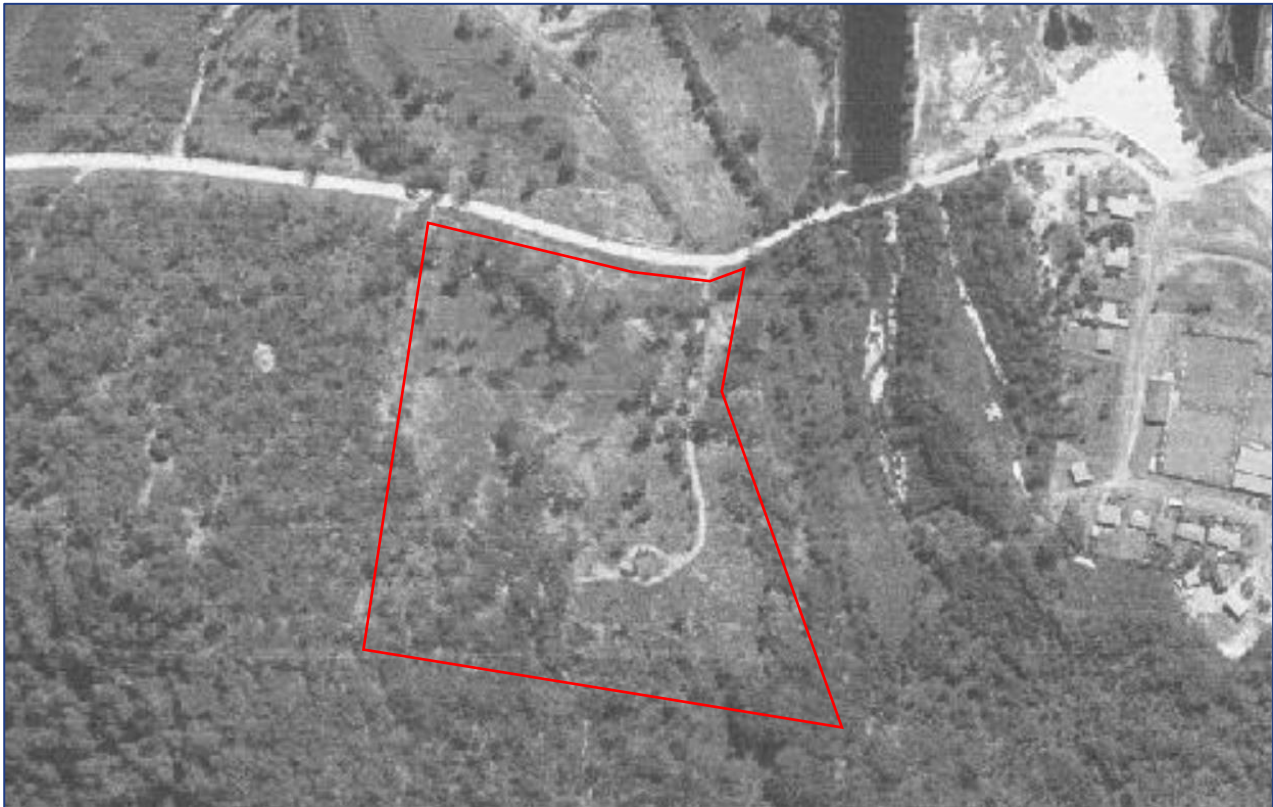
Figure 9 - Historical Aerial 1978 (NSW Spatial Services Historical Imagery <https://portal.spatial.nsw.gov.au>)

1978		Similar to 1971. Potentially a small structure is visible at the end of the existing vehicle track. No other structures or land uses are noted.	
1986		Significant vegetation re-growth is visible across the site. The existing vehicle track is now barely visible. No other changes are noted.

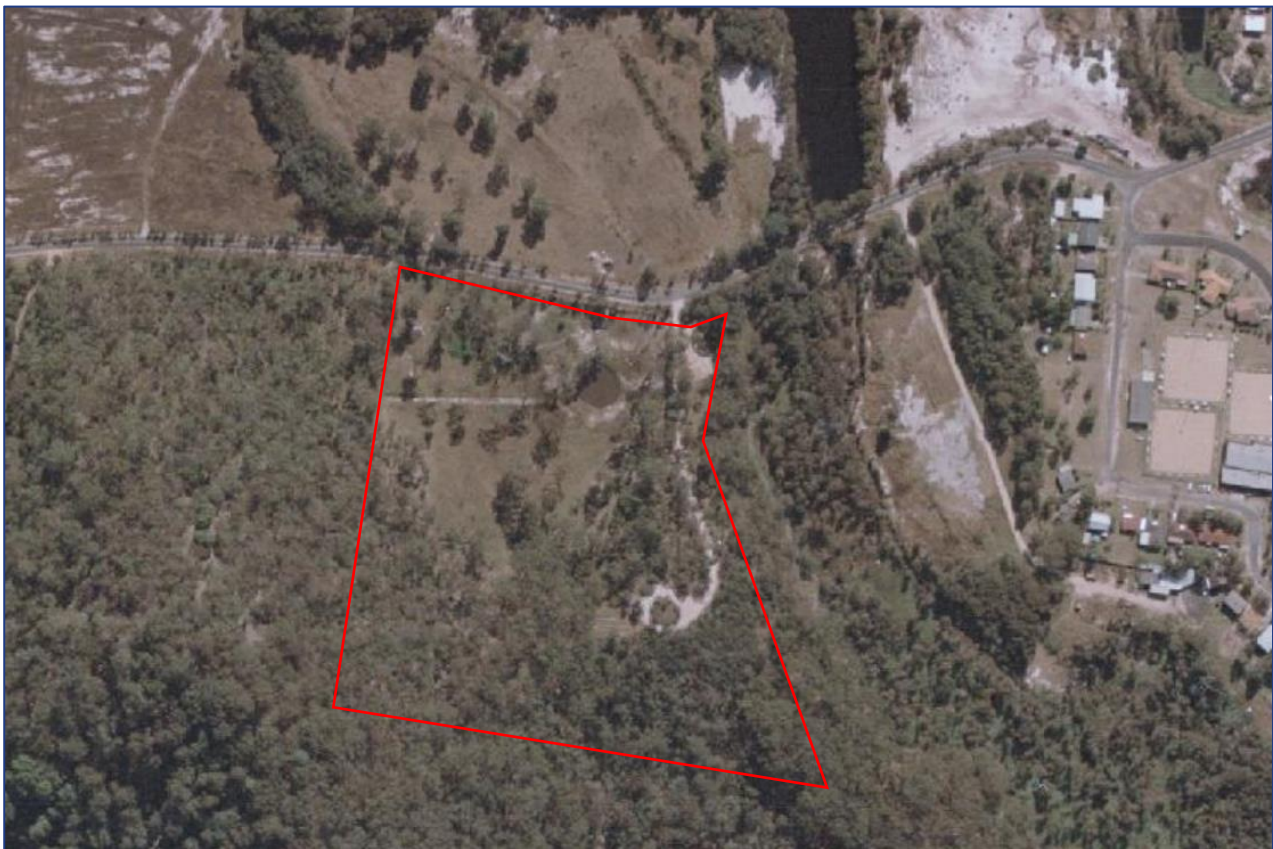
Figure 11 - Historical Aerial 1990 (NSW Spatial Services Historical Imagery <https://portal.spatial.nsw.gov.au>)

1990		The existing dam is now visible on the northern portion of the site. Some vegetation clearing has occurred along the vehicle track	
1996		Similar to 1990. No significant changes noted.	
2009-2023	Google Earth	Increased vegetation has occurred over the property in subsequent years. There are no visible land uses or structures on the heavily vegetated site in the aerials over this period, including any agricultural uses.
