30 August 2024

**Re: Riparian Assessment, 27 North Marshall Mount Road, Marshall Mount, 2530**

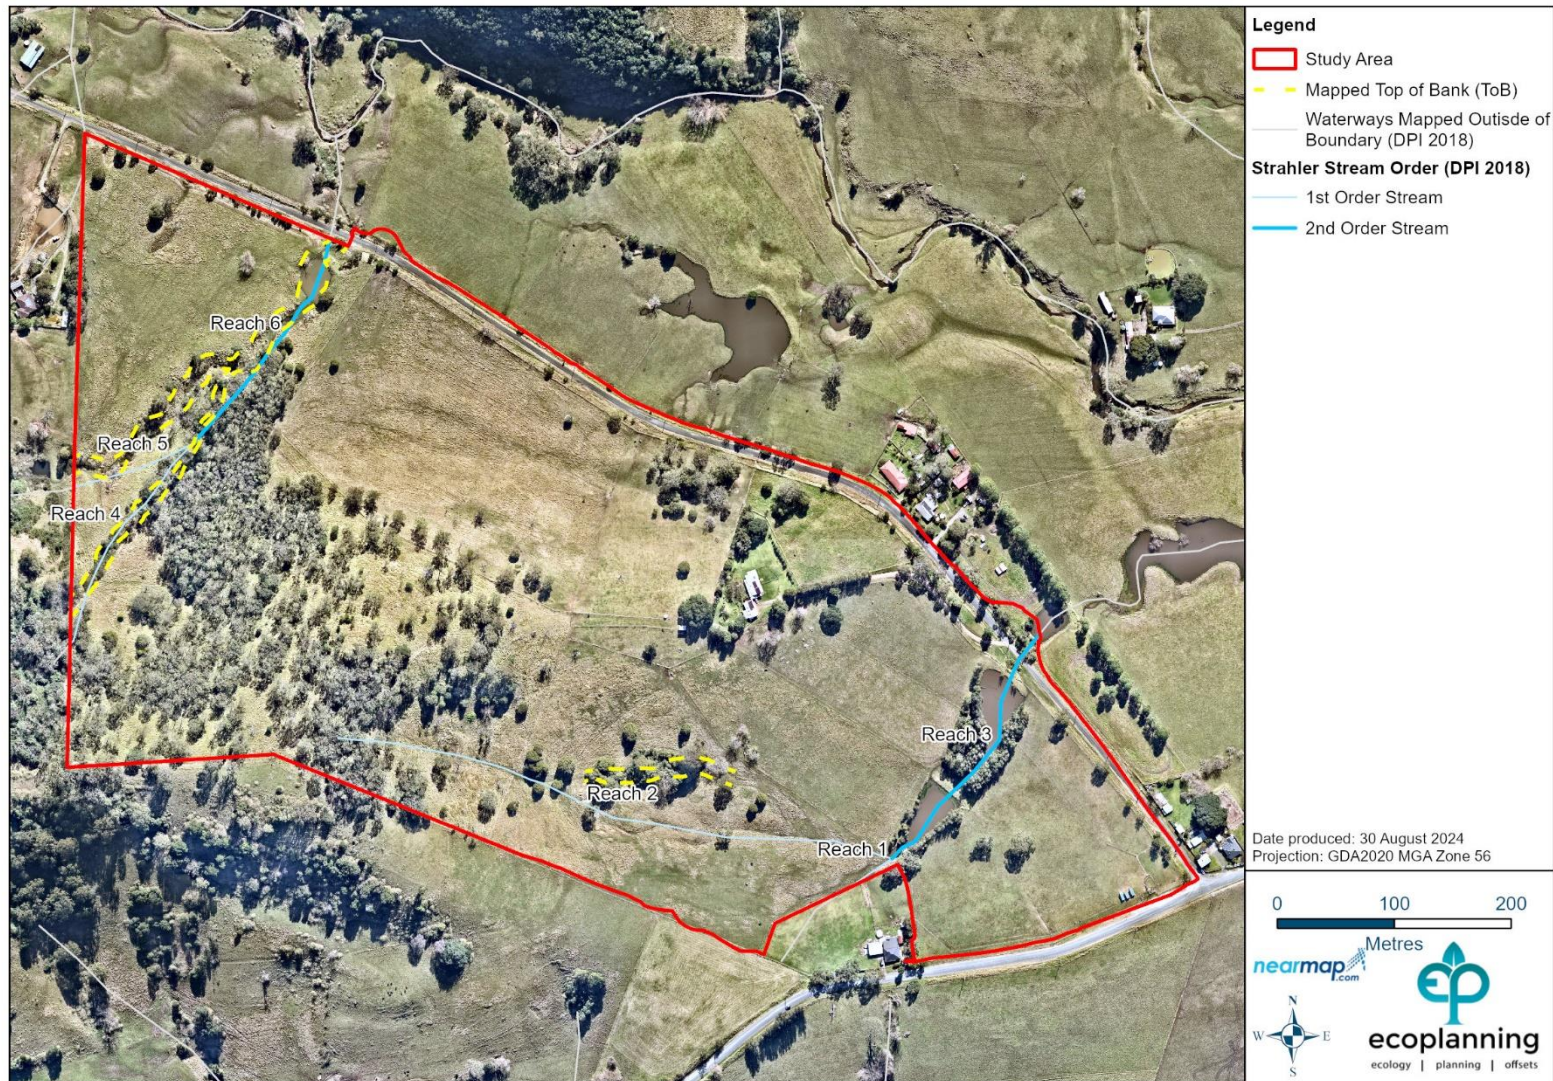
Figure 15: Top of Bank (ToB) mapping

Top of Bank mapping was done for all mapped watercourses, within the study area, where a discernible bed and bank was evident. It is also noted that for some of the mapped watercourses, and for some areas within a watercourse, it was not possible to identify clear bed and bank structures.

Bed and bank was confirmed in Reach 6, with the reach terminating in a dam on North Marshall Mount Road (**Figure 14**). The results of the ToB mapping within the study area are displayed in **Figure 15**.

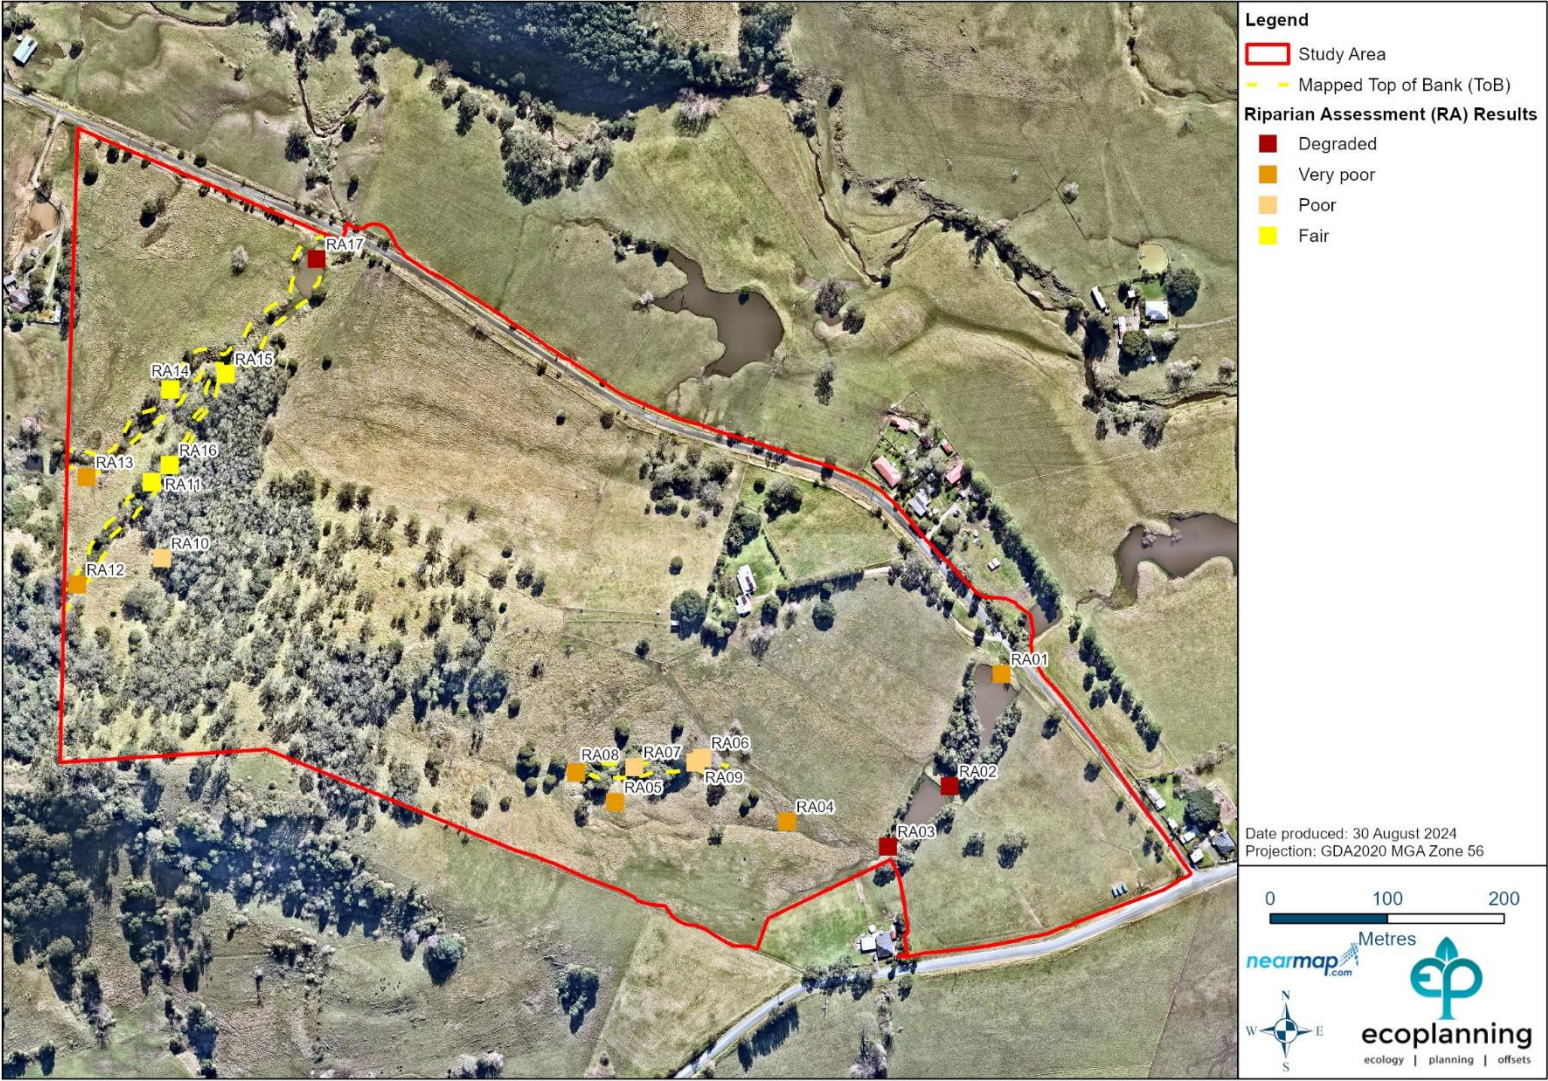
Figure 16: Rapid Riparian Assessment (RRA) results

Site Code	Site Score (%)	Category	Reach
RA 1	41	Very Poor	Reach 3
RA 2	39	Degraded	Reach 3
RA 3	39	Degraded	Reach 3
RA 4	43	Very Poor	Reach 2
RA 5	49	Very Poor	Reach 2
RA 6	50	Poor	Reach 2
RA 7	55	Poor	Reach 2
RA 8	44	Very Poor	Reach 2
RA 9	53	Poor	Reach 2
RA 10	52	Poor	Reach 4
RA 11	64	Fair	Reach 4
RA 12	44	Very Poor	Reach 4
RA 13	44	Very Poor	Reach 5
RA 14	61	Fair	Reach 5
RA 15	60	Fair	Reach 4
RA 16	66	Fair	Reach 4
RA 17	39	Degraded	Reach 6

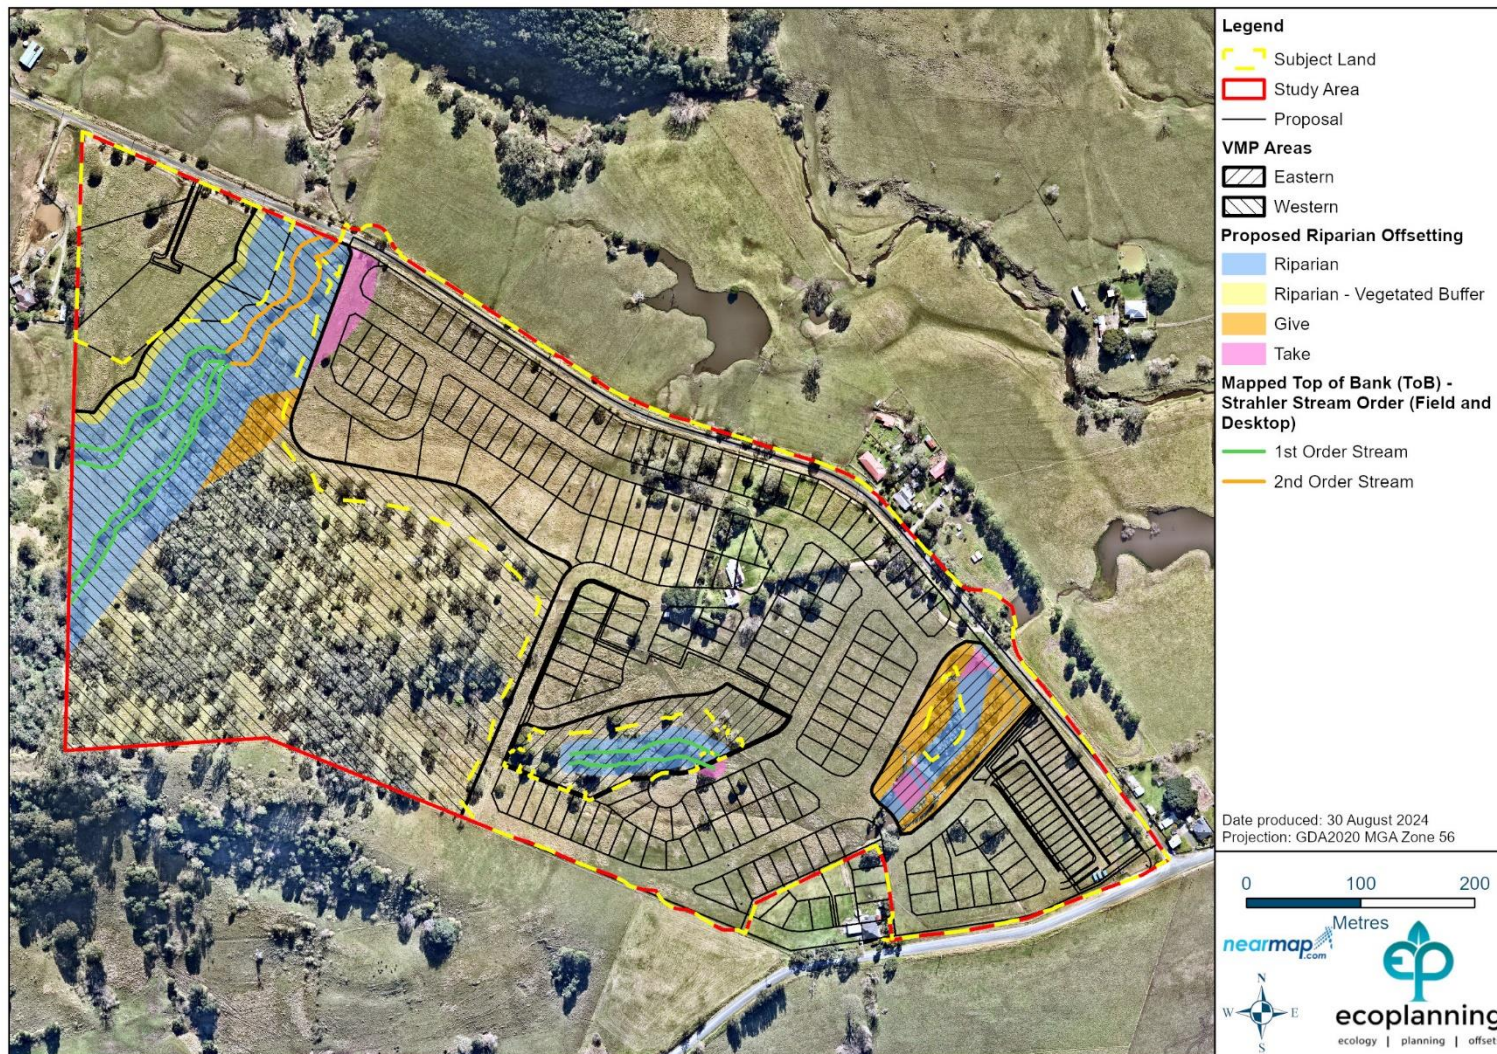
Figure 17: Top of Bank mapping and proposed riparian buffer offsetting

Riparian buffer type	Area of riparian buffer (ha)
Riparian buffer	4.31
Riparian buffer – vegetated buffer	0.26
Riparian buffer – give (additional riparian buffer)	0.89
<b>Total riparian buffer</b>	<b>5.46</b>
Riparian buffer – take (removal of riparian buffer)	0.38

Reach ID	Strahler Stream Order	RCMS category	Notes
5	Strahler order 1	1 - Environmental corridor	<p>Reach 5 has been assessed as being in Fair to Very Poor condition (RA13, RA14). ToB has been mapped along the drainage line, which placed the stream further west than previously mapped.</p> <p>A variation is sought to have the total width requirement of each side of this watercourse to be 30 metres. This is suitable as the connectivity of this reach to other significant habitat features is restricted by the condition of Reach 6 (and other reaches offsite [downstream]). The total combined corridor for Reaches 4 and 5 will be over 100 metres wide, achieving the intent of Chapter E23.</p> <p>A riparian buffer consistent with WDCP 2009; 2022 was applied. Much of the buffer lies within land zoned C2 - Environmental Conservation. Some of the buffer spills into land zoned C4 - Environmental Living, however it is proposed that this buffer not be impacted by development (<b>Figure 17</b>).</p>

6	Strahler order 2	1 - Environmental corridor	<p>The Riparian Assessment identified Reach 6 as being in Degraded condition (RA17). ToB was identified and mapped and a bed and bank is present.</p> <p>A riparian buffer was applied to the current ToB mapping consistent with WDCP 2009; 2022. Whilst much of buffer lies within land zoned C2 - Environmental Conservation some lies within the proposed residential footprint. This area is proposed to be offset to the south within the same broad riparian corridor (<b>Figure 17</b>).</p>
