# Construction Impact Assessment

Lourdes Retirement Village  
95 Stanhope Road, Killara

**Compiled by**  
George Palmer  
Botanics, Tree Wise People Pty Ltd

**Dated**  
April 2011.

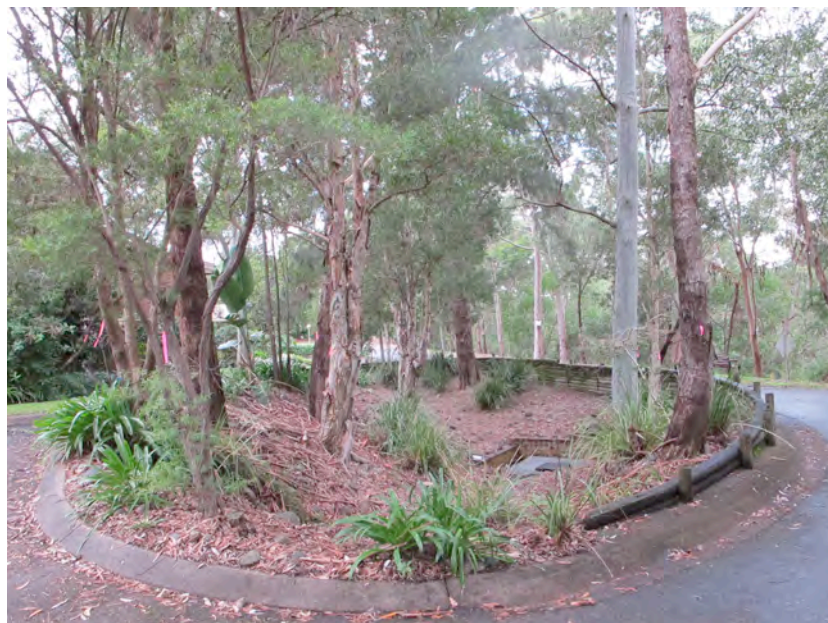
**Figure 1** Shows one of the storm water retention basins and some of the existing planting.

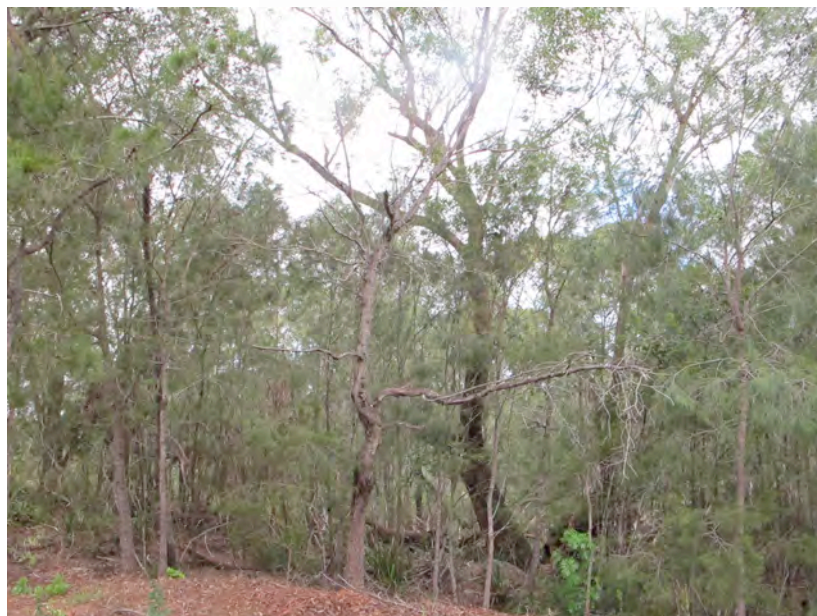
**Figure 2** Shows a section of the site heavily planted with She Oaks.

3.1.13 The development of the trees upper canopy however will impact on the proposed building line and require some canopy modification pruning that will affect up to 30% of the trees total canopy mass as documented in Figure 2.

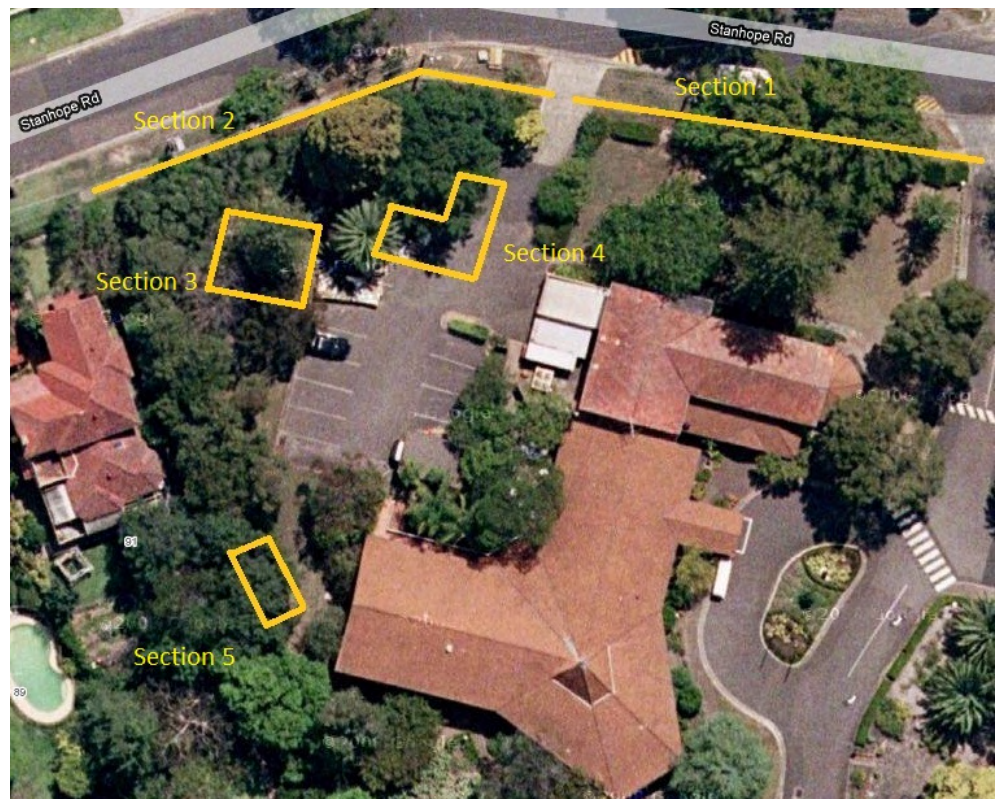
IMAGE 1: Outline of initial and extended survey area.

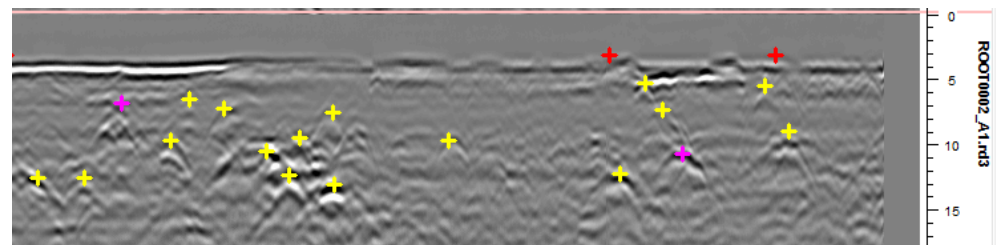
Features identified are assumed to be tree roots. The depth of penetration is 0cm to 70 cm.

IMAGE 2: Example of a processed 2D image with features marked.

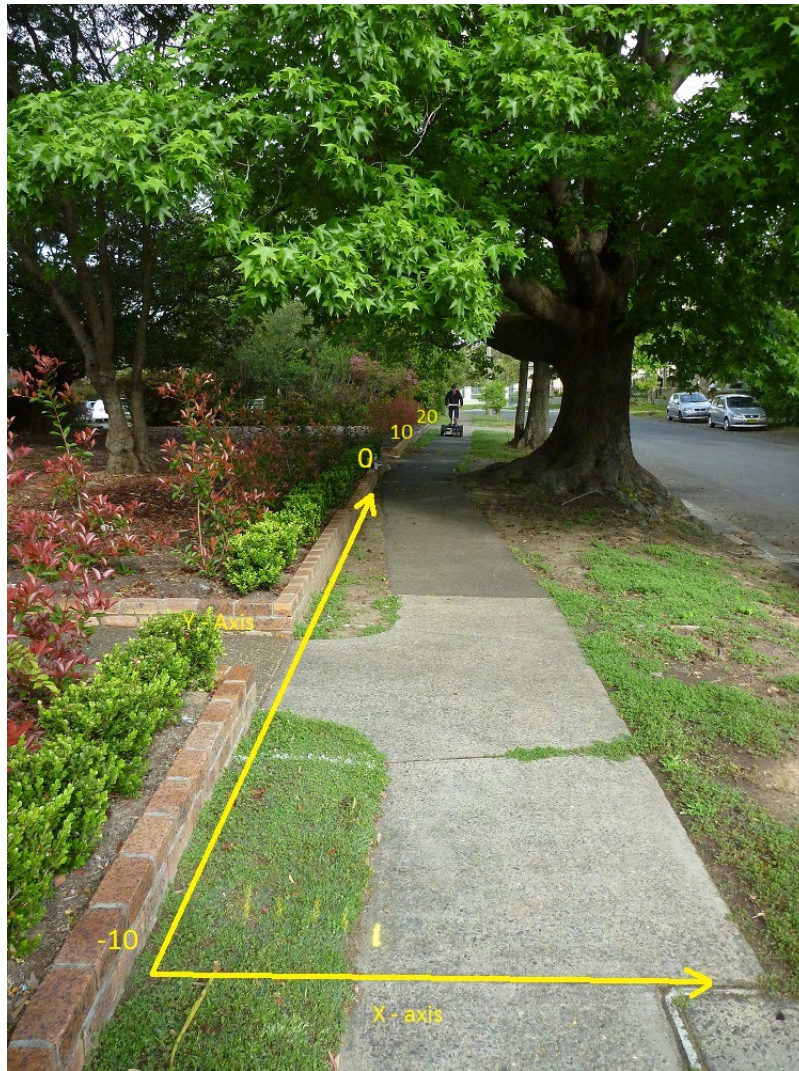
Picture 1: Section One

Section 1: Data was collected from east to west, the X axis running approximately north to south (Photo 1 in appendix)

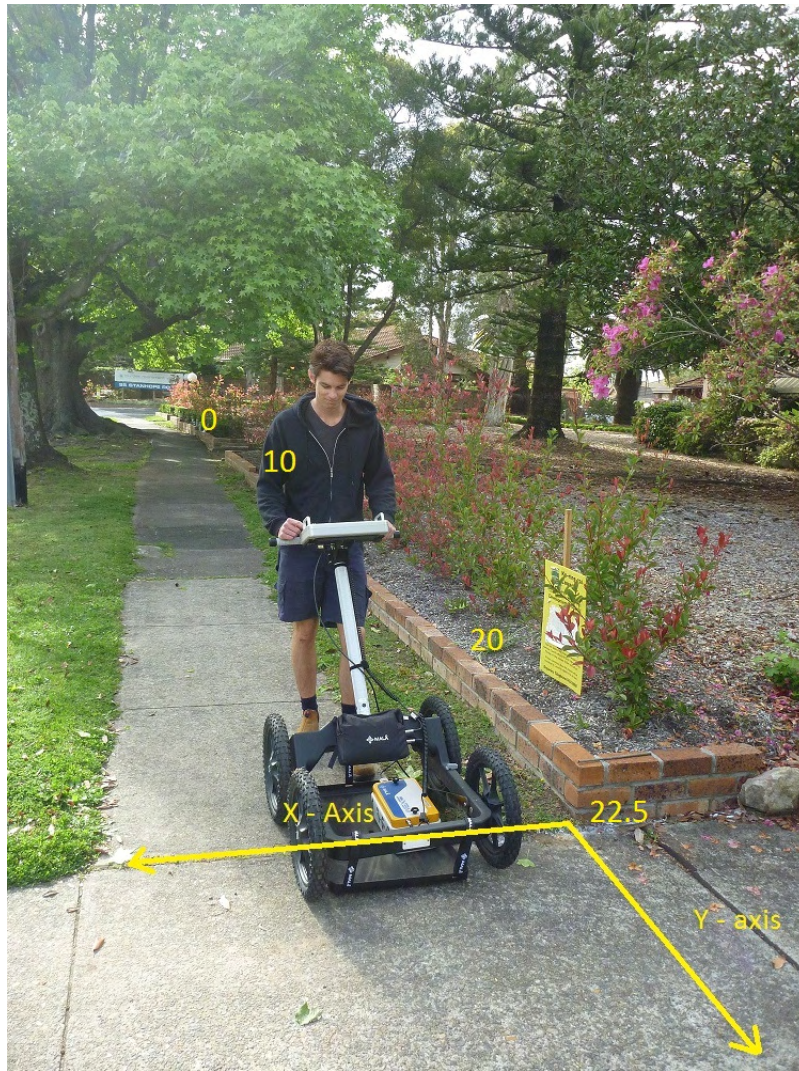
Picture 2 : Section 2

Section 2: Data was collected from east to west, the X axis running approximately north to south (Photo 2 in appendix)

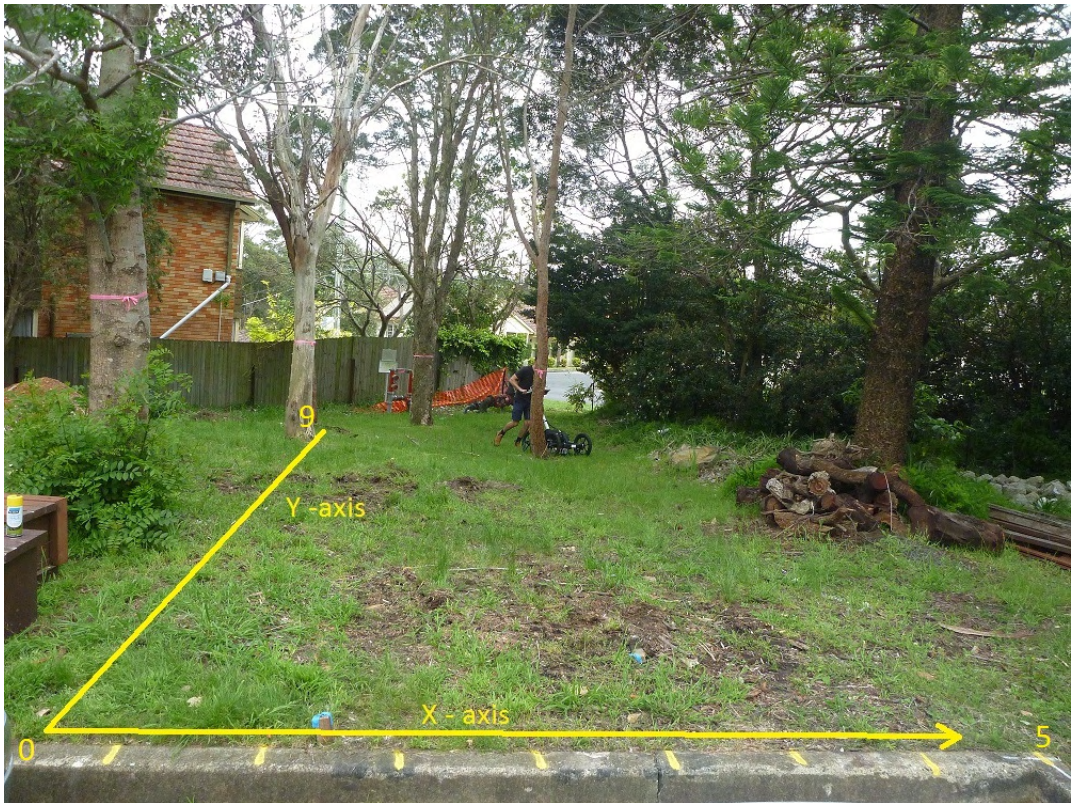
Picture 3: Section 3

Section 3: Data was collected from east to west, the X axis running approximately north to south (Photo 3 in appendix)

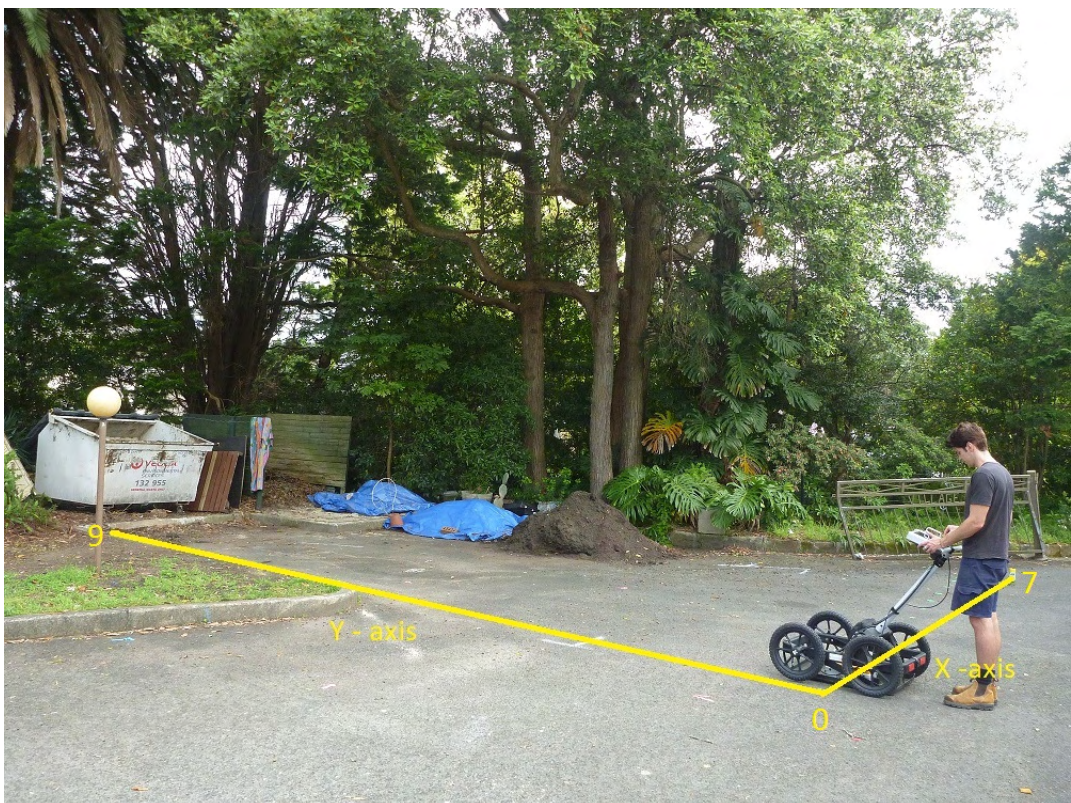
Picture 4: Section 4

Section 4: Data was collected from east to west, the X axis running approximately north to south (Photo 4 in appendix)
