Tree Report

**West Pymble Indoor Pool Facility
Ku-ring-gai Bicentennial Park, West Pymble
Revision 3**

For Colston Budd Hunt & Kafes Pty Ltd

December 2010

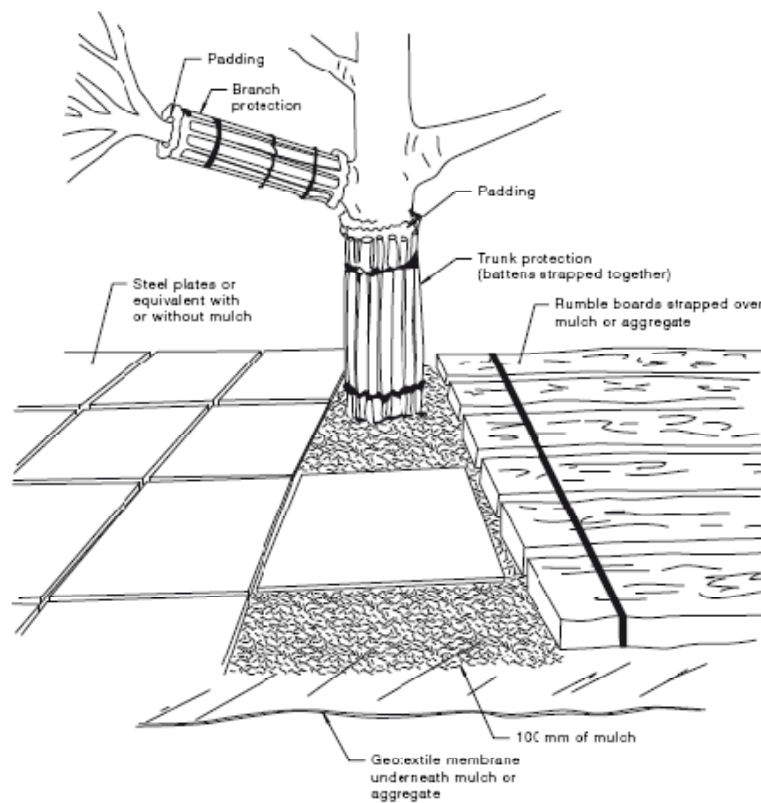
FIGURE 4 EXAMPLES OF TRUNK, BRANCH AND GROUND PROTECTION

Where necessary, install protection to the trunk and branches of trees as shown in Figure 4. The materials and positioning of protection are to be specified by the project arborist. A minimum height of 2 m is recommended.

If temporary access for machinery is required within the TPZ ground protection measures will be required. The purpose of ground protection is to prevent root damage and soil compaction within the TPZ. Measures may include a permeable membrane such as geotextile fabric beneath a layer of mulch or crushed rock below rumble boards as per Figure 4.

- 1 For trunk and branch protection use boards and padding that will prevent damage to bark. Boards are to be strapped to trees, not nailed or screwed.
- 2 Rumble boards should be of a suitable thickness to prevent soil compaction and root damage.

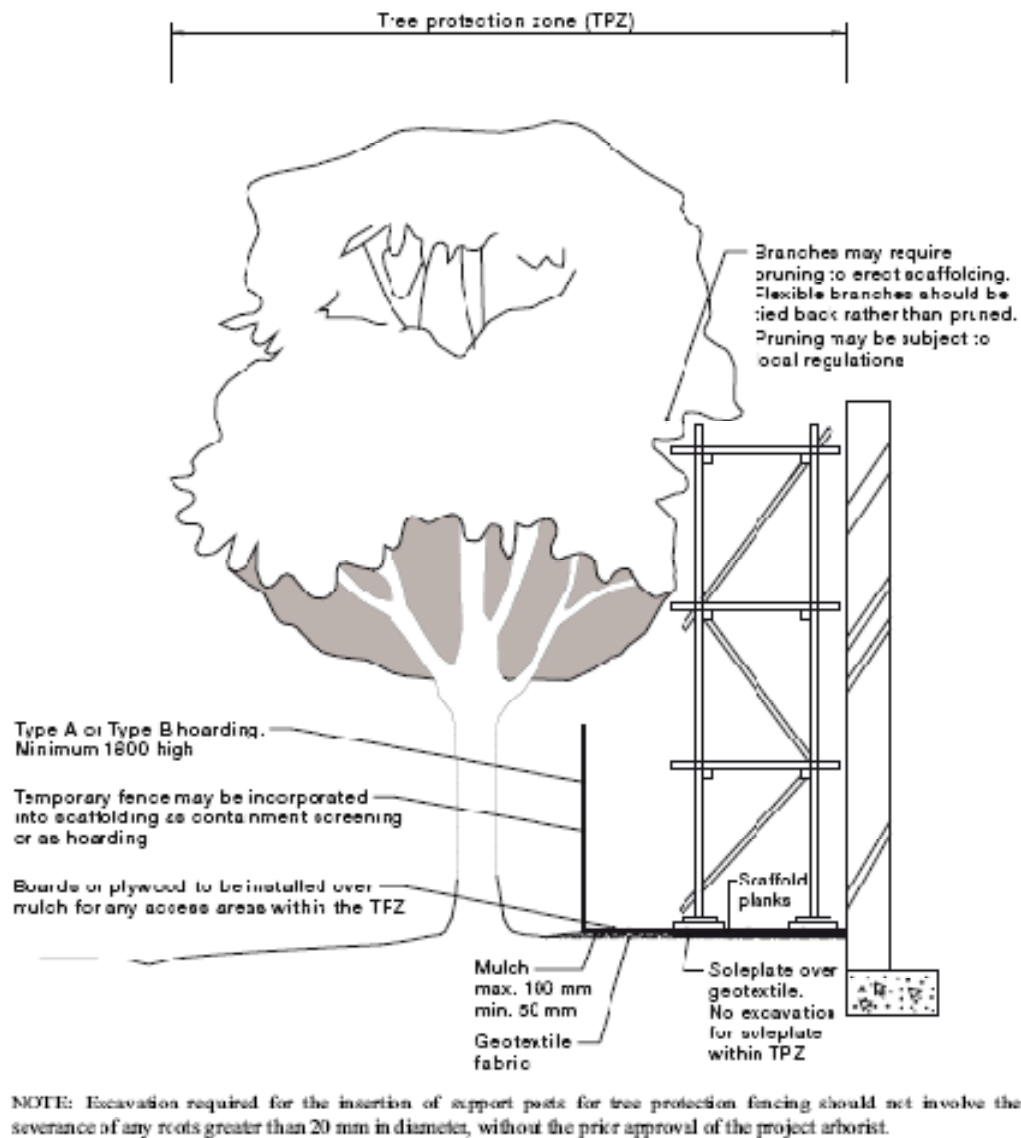
FIGURE 5 INDICATIVE SCAFFOLDING WITHIN A TPZ

Where access is required within these radii for building purposes, the fence should be set back 1.5m from the building face and the soil surface between the fence and the building should be protected by plywood sheets or strapped planking as noted in Figure 5 below.

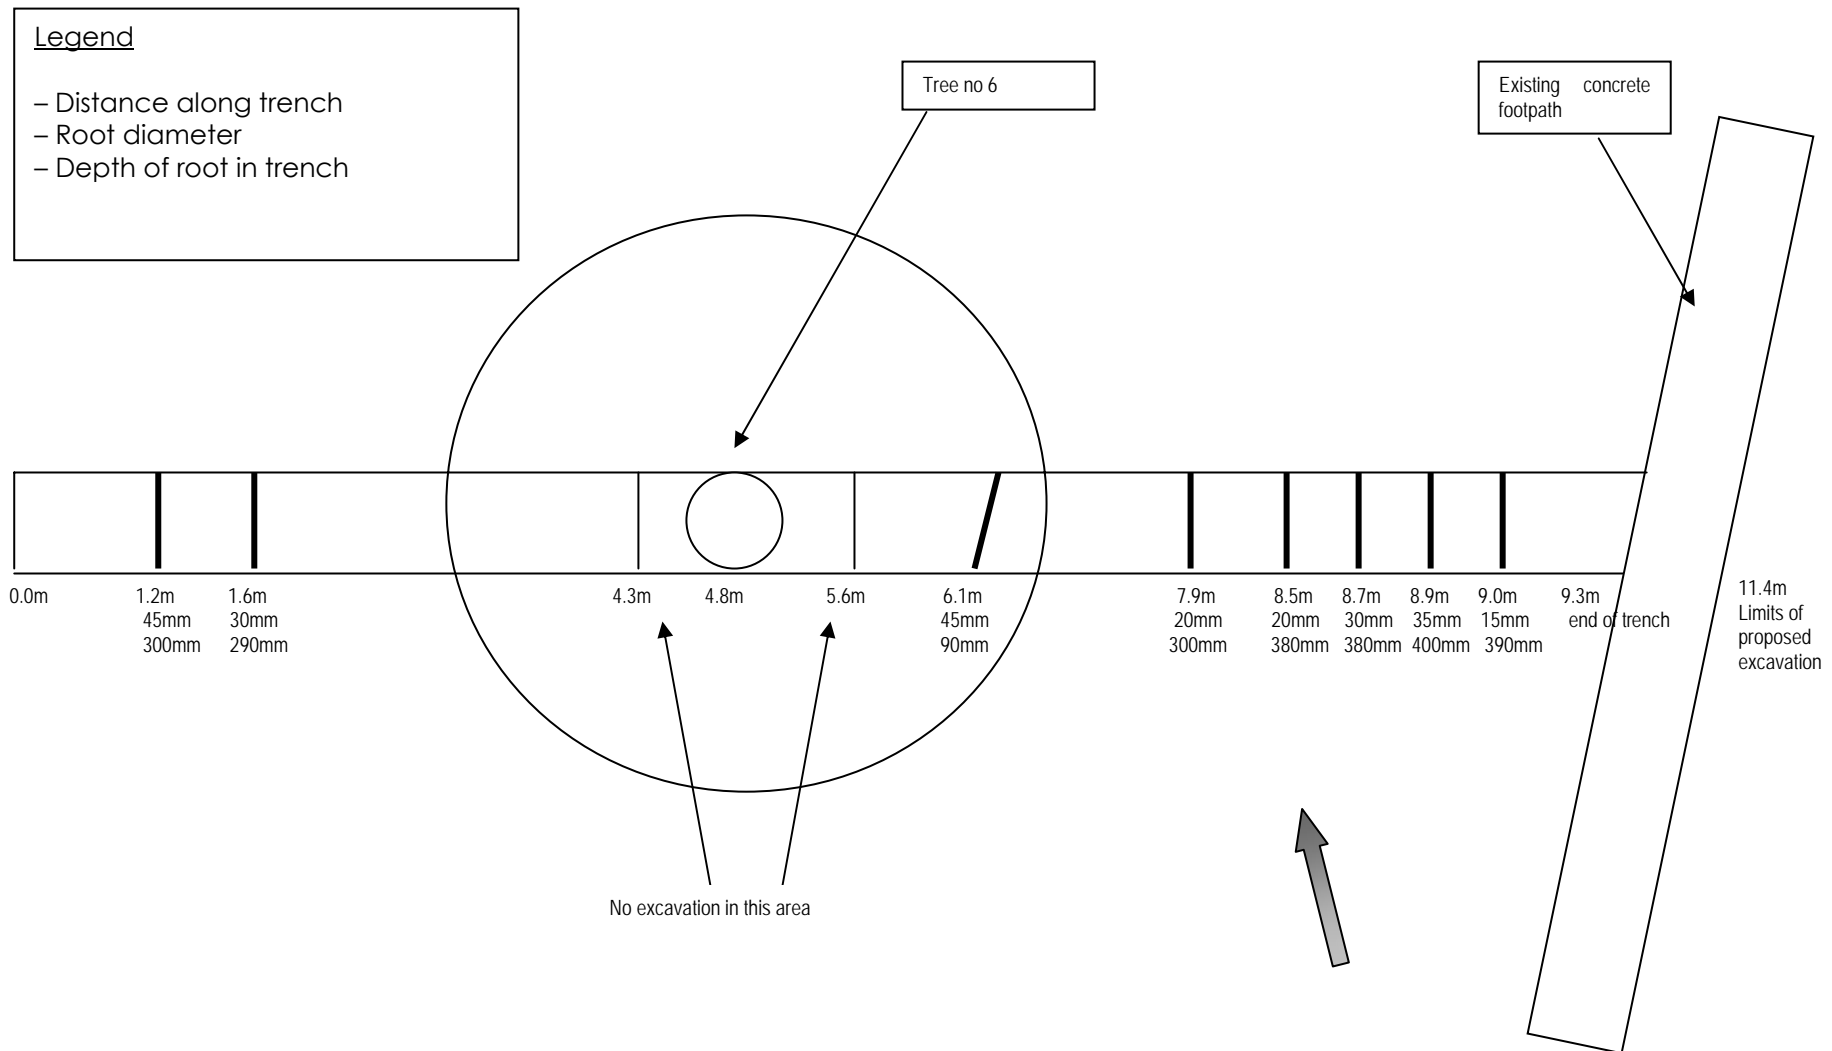
Eight small roots to a maximum diameter of 45mm were found in the trench. Other roots were smaller, with diameters between 15mm and 35mm. Roots were found at depths between 290mm and 400mm. See root investigation plan below.

Trench depth to 500mm. The clearly visible lower soil horizon comprises of hard compacted clay sub soils containing large sand stone boulders.
