Advanced Treescape Consulting Arboriculturist & Horticulturist

573 – 585 Pacific Highway, Killara

JRPP (Sydney West Region) 13 October 2011 – 2010SYW099 Request for Additional Information on Tree 27 being Root Mapping and Advise on Methods of Driveway Construction for an Acceptable Impact on subject tree

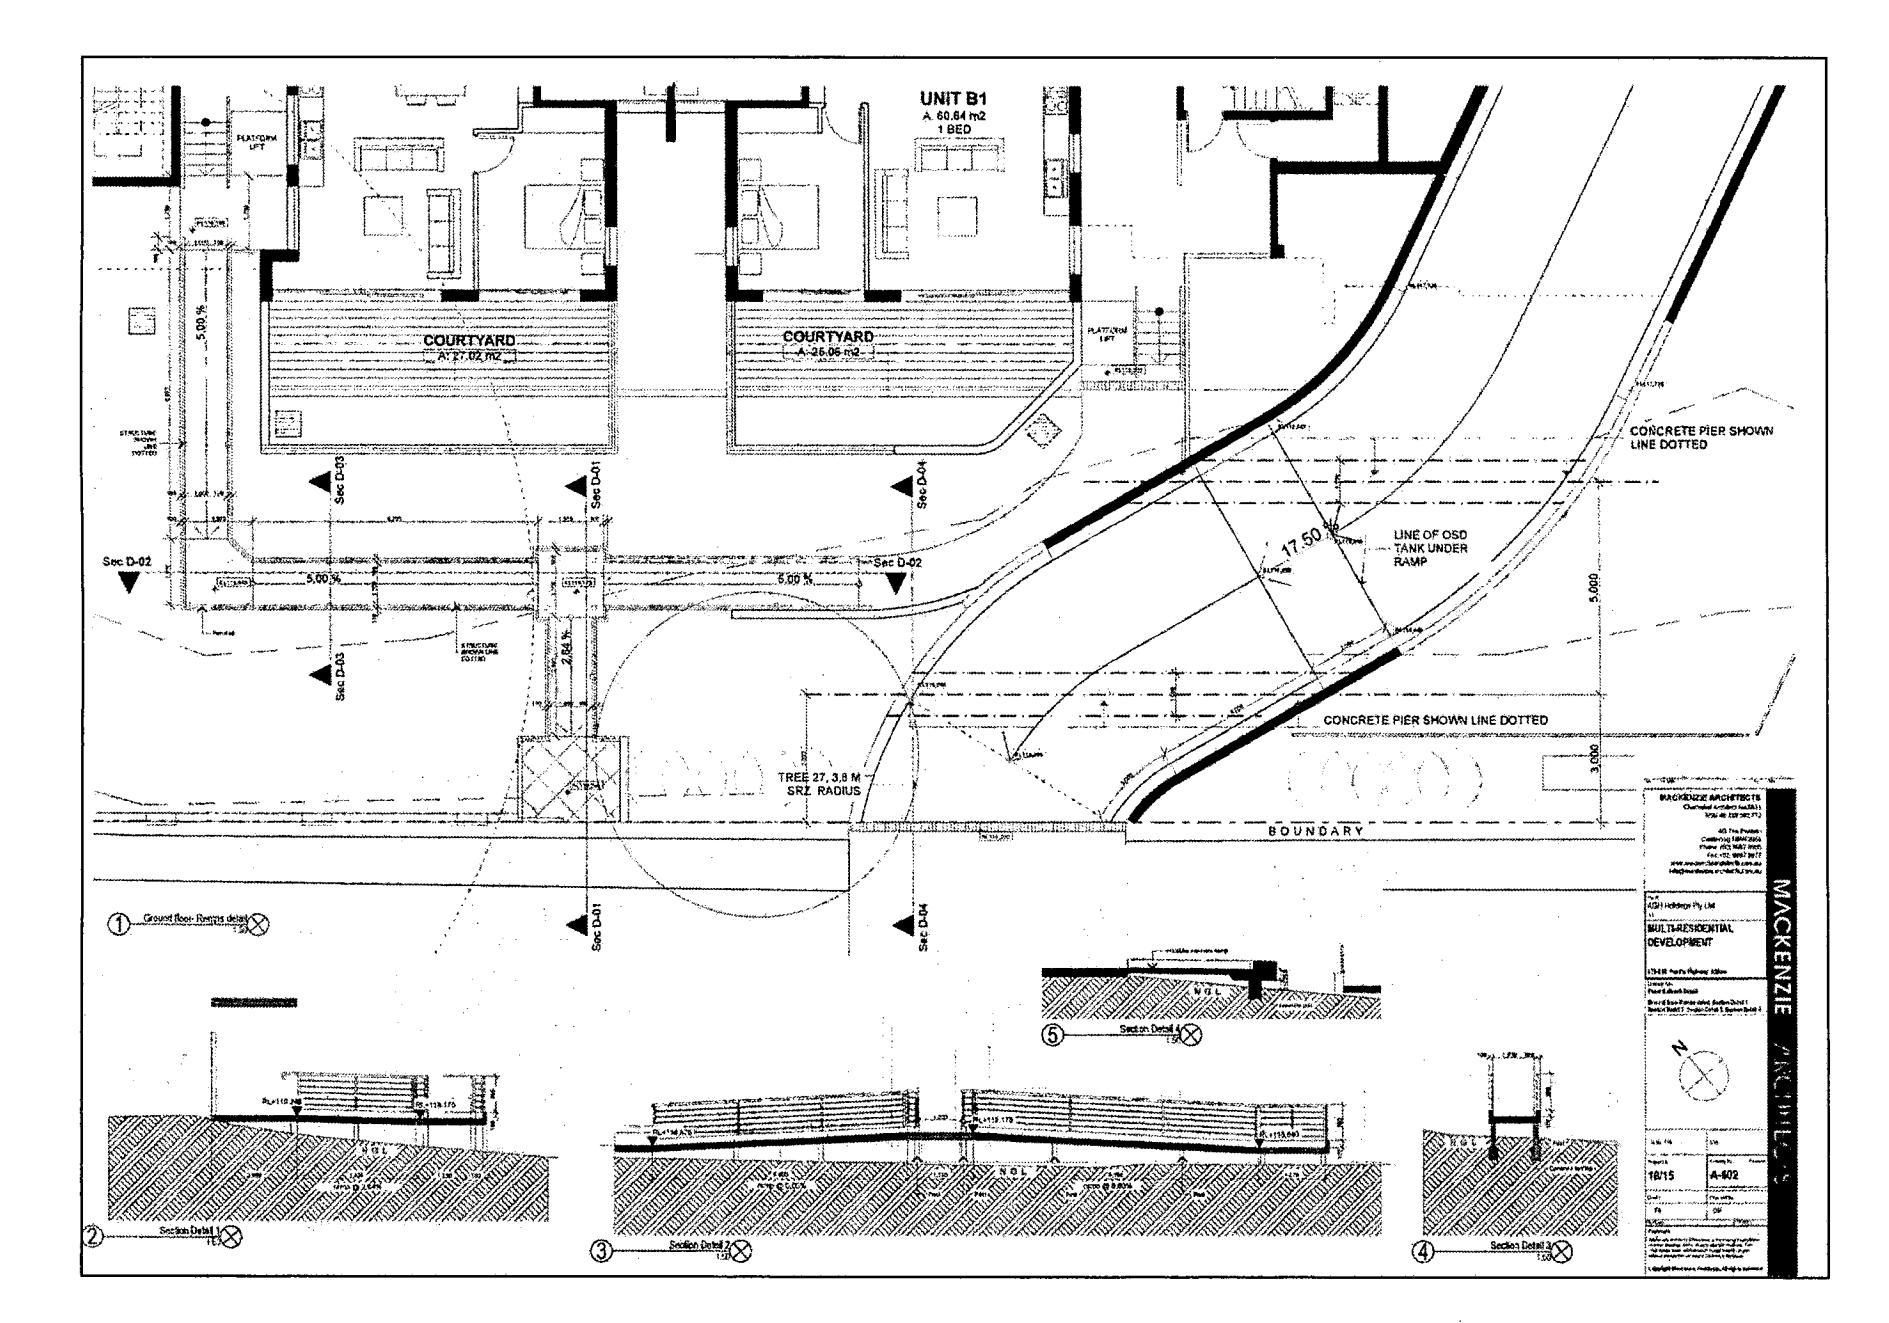
Showing Engineering Detail of proposed Driveway Slab Part Plan

Showing the location of the Support Piers and the Entry Portico Design
