Arborist Report

Client: Health One

Address: Corner Jacaranda Avenue &
Swan Street Raymond Terrace N.S.W 2324

Date: 14th March 2011

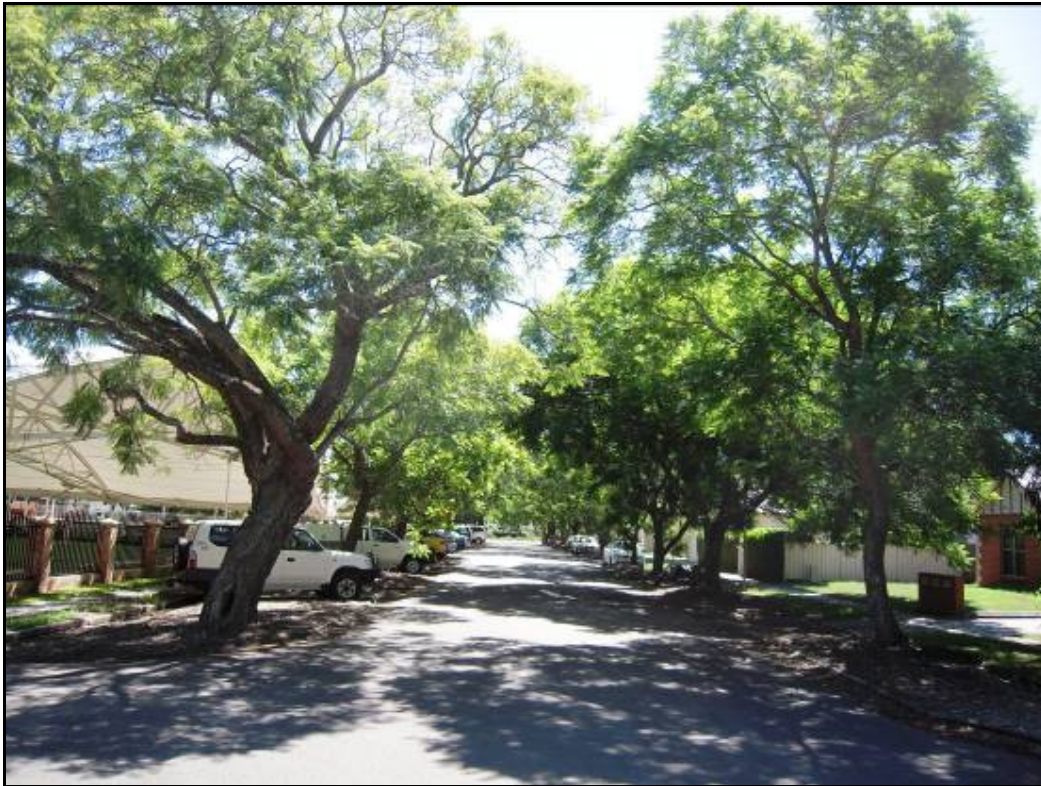
Figure 2 – Looking north along Jacaranda Avenue showing the avenue of Jacaranda mimisifolia. These trees are outside the scope of works however shows the character and streetscape that these trees provide.

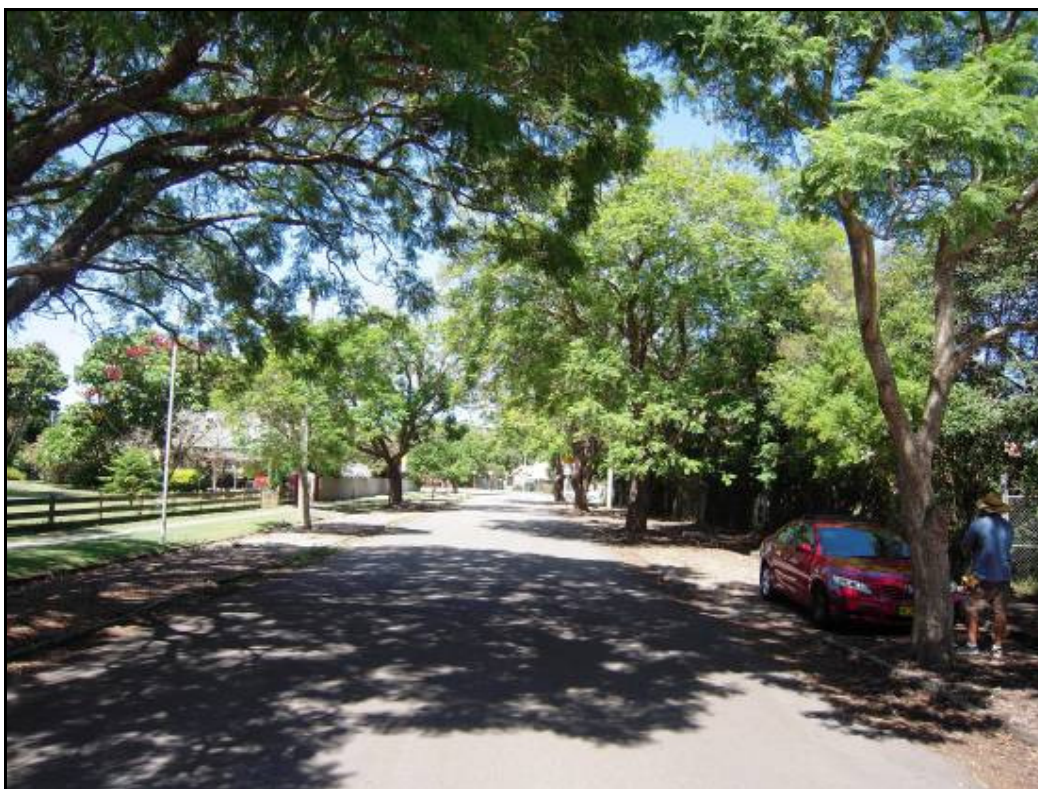
Figure 3 – Looking south along Jacaranda Avenue showing the start of the streetscape that extends down the street as indicated by Figure 2.
