Arborist Report

Client: Health One

Address: Corner Jacaranda Avenue &
Swan Street Raymond Terrace N.S.W 2324

Date: 12th December 2011

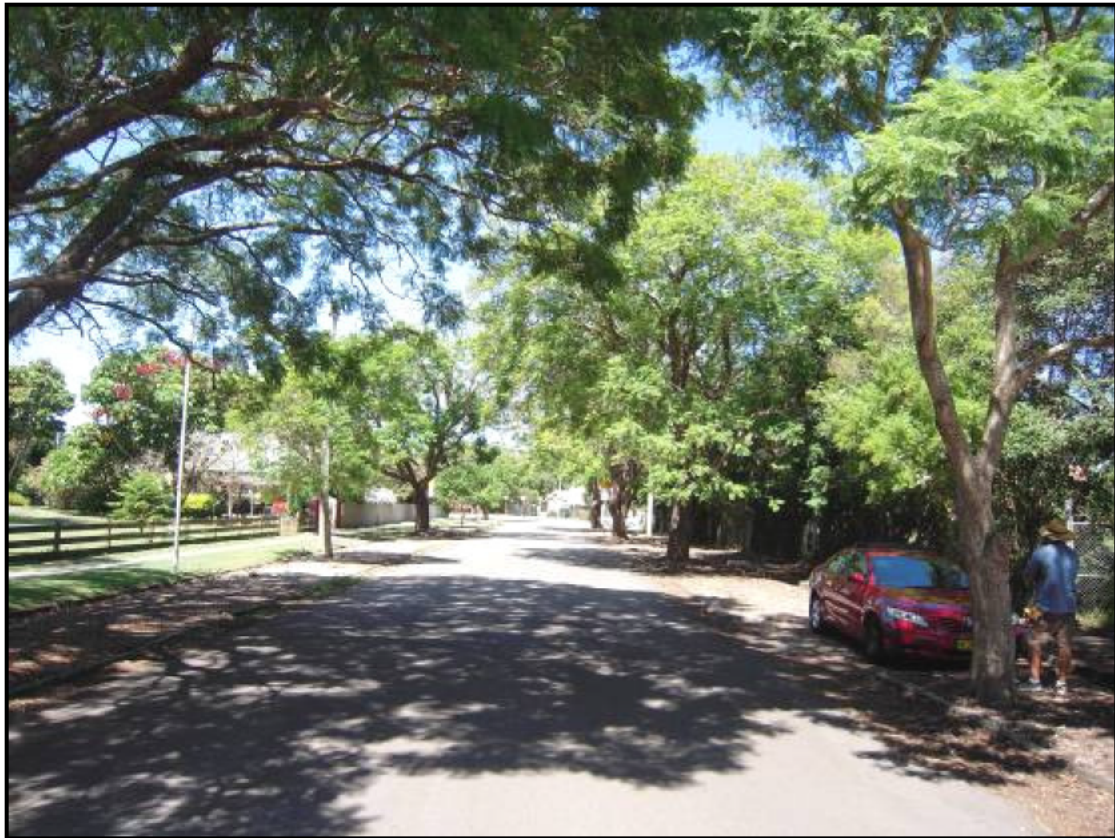
Figure 3 – Looking south along Jacaranda Avenue showing the start of the streetscape that extends down the street as indicated by Figure 2.
