## Windale Creek Restoration Plan

Prepared for  
**Masters**

October 24 2014

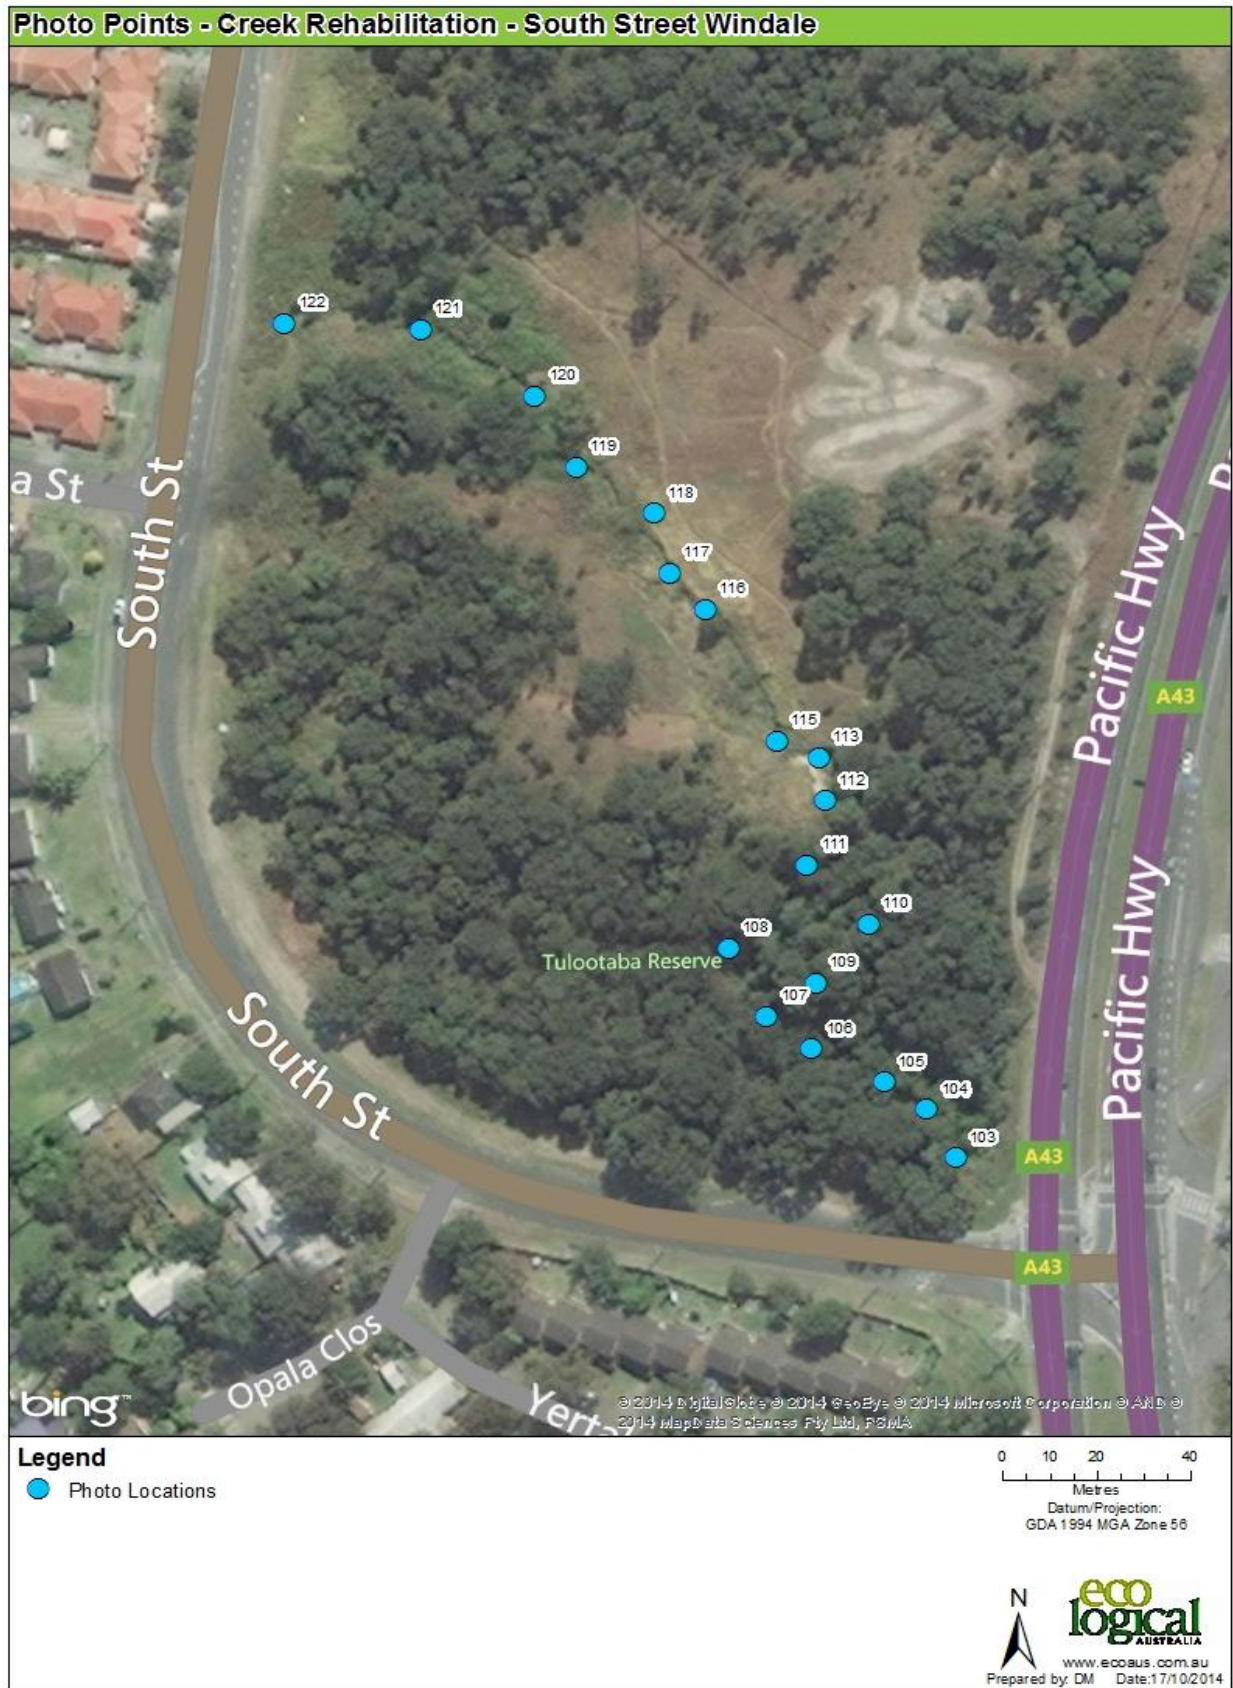
Figure 3 Photo point locations

Brief site inspections were undertaken on foot on the 13 October and 17 October 2014 to photograph, assess and identify the issues within the study area. This involved the establishment of 19 specific assessment points (**Figure 3**). Each point was located and recorded by a hand held GPS and at least one or a series of photographs were taken. Notes were recorded at each location documenting issues such as:

- extent of weed invasion noting the dominant invasive species
- detail of erosion and scouring of the creek banks
- locations of rubbish and other features
- presence and intactness of remnant native vegetation

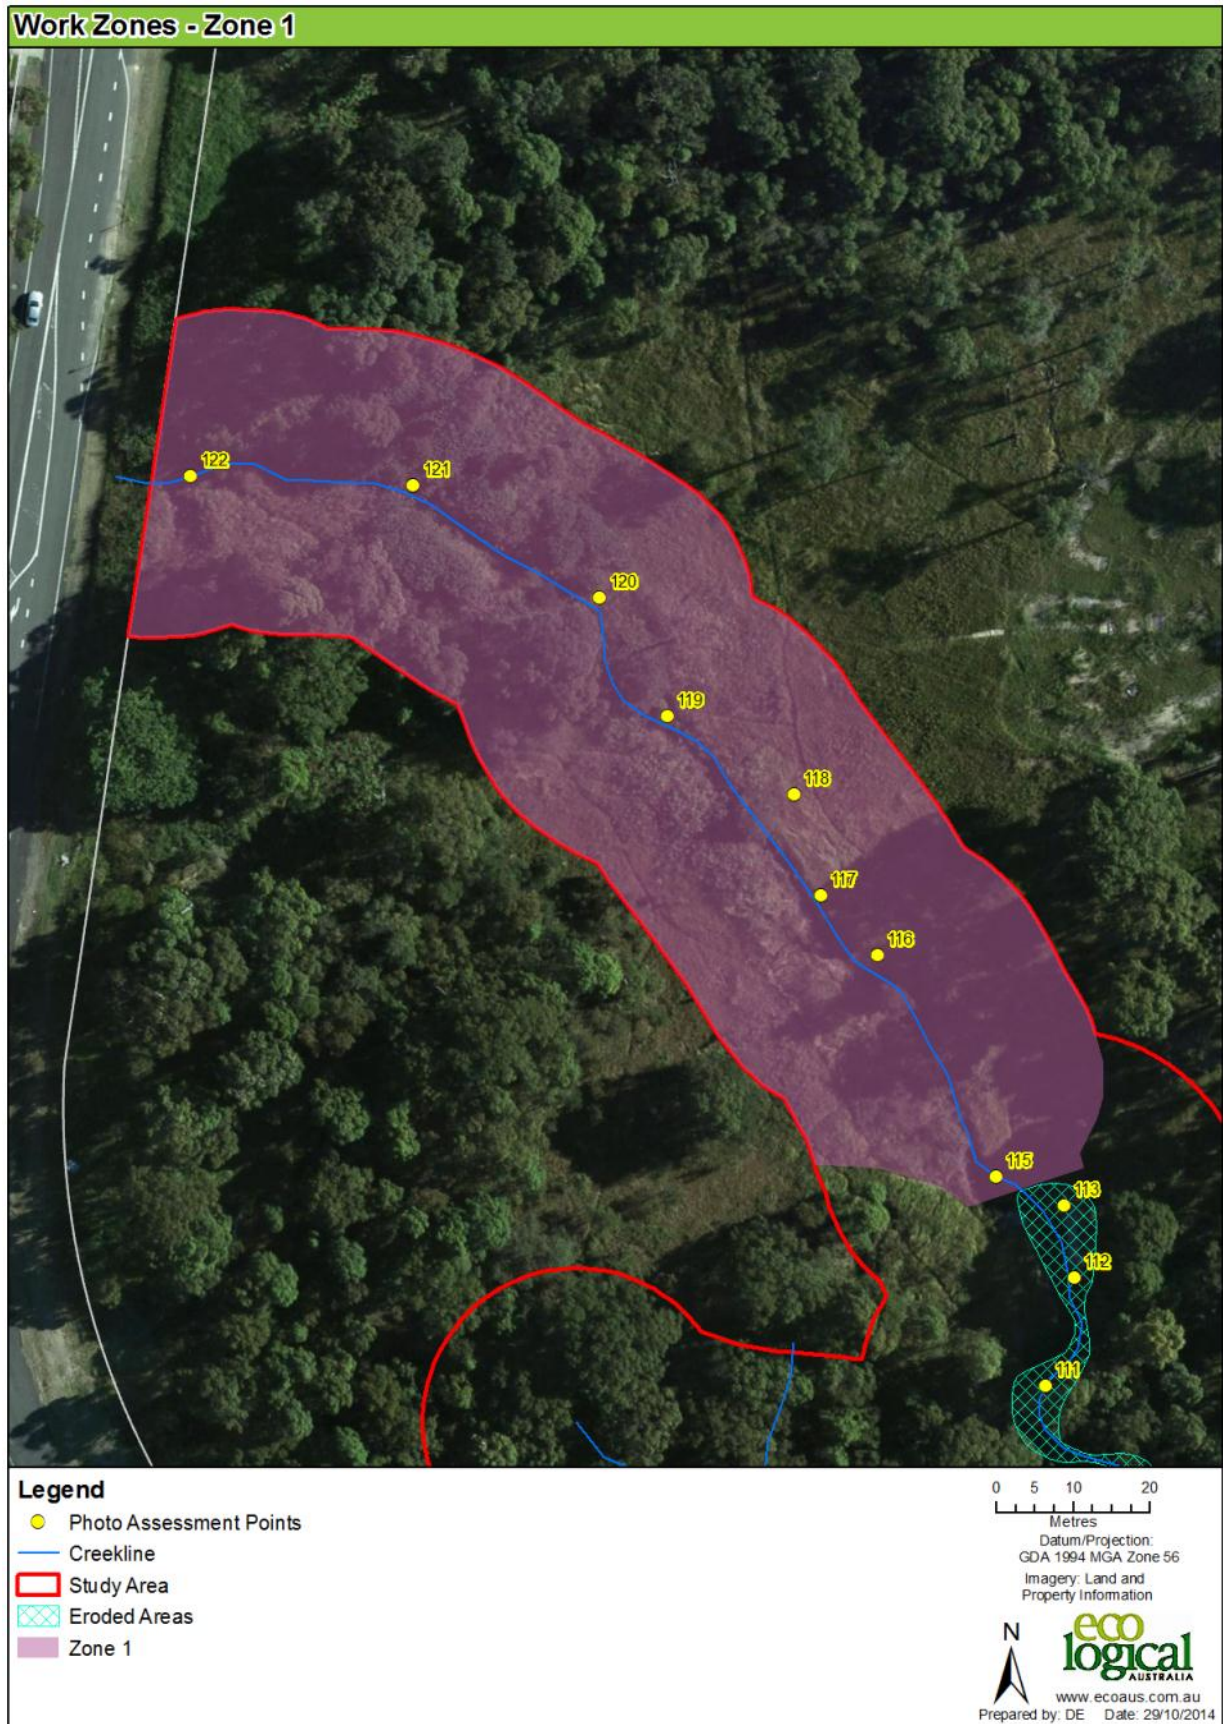
Figure 5 Location of Work Zone 1

Due to disturbances, emphasis will be placed on erosion and in-stream water flow control works associated, and weed control and revegetation works within the zone and at locations adjacent to the watercourse banks. A brief summary of the tasks required for Zone 1 (**Figure 5**) is presented in **Table 1**. All detailed site information relating to Zone 1 is presented in **Appendix A**.

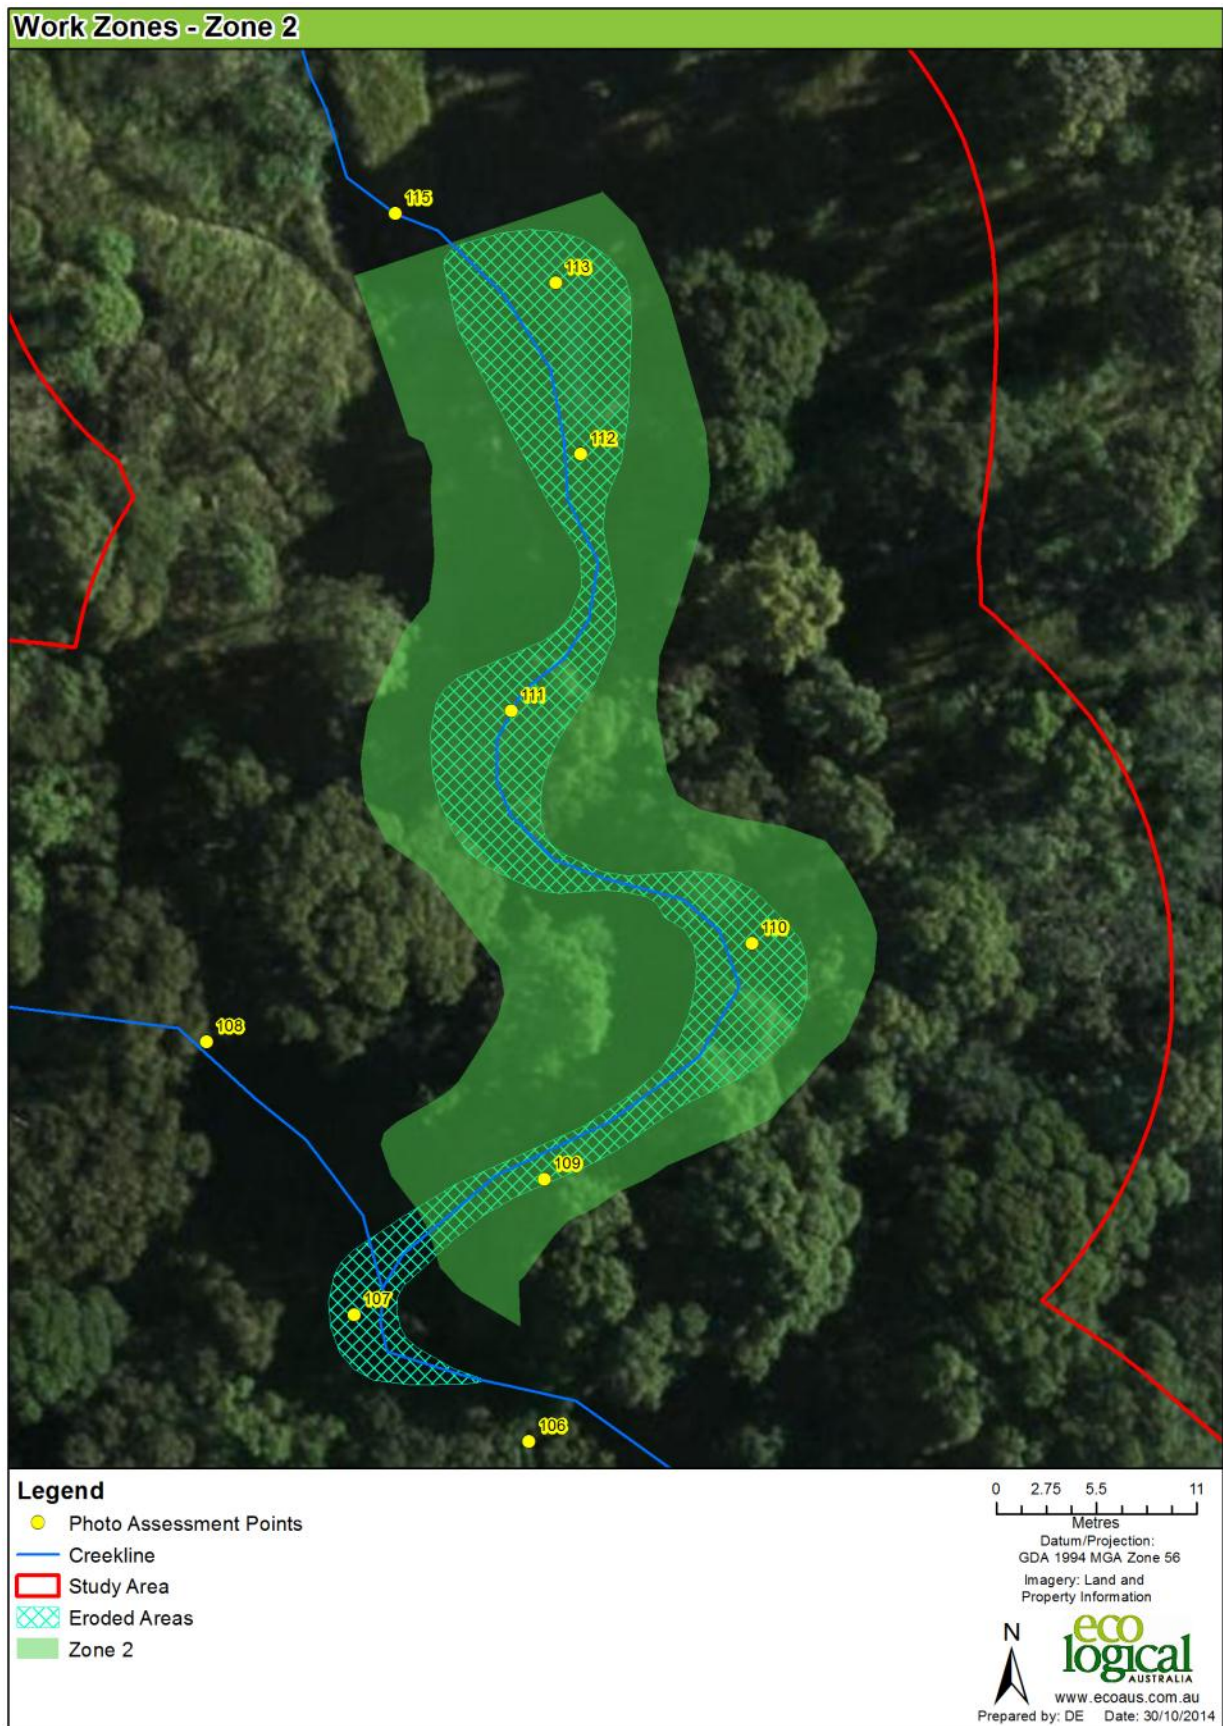
Figure 6 Location of Work Zone 2

This area comprises a highly degraded watercourse that will require a moderate degree of stabilisation and erosion control measures. Weeds are evident within the scoured and eroded areas, but remnant native vegetation is generally intact within the rest of the Zone. As a result, the majority of effort will need to be targeted toward erosion control and stabilisation (incl. revegetation). A brief summary of the tasks required for Zone 2 (**Figure 6**) is presented in **Table 2**. All detailed site information relating to Zone 2 are presented in **Appendix B**.

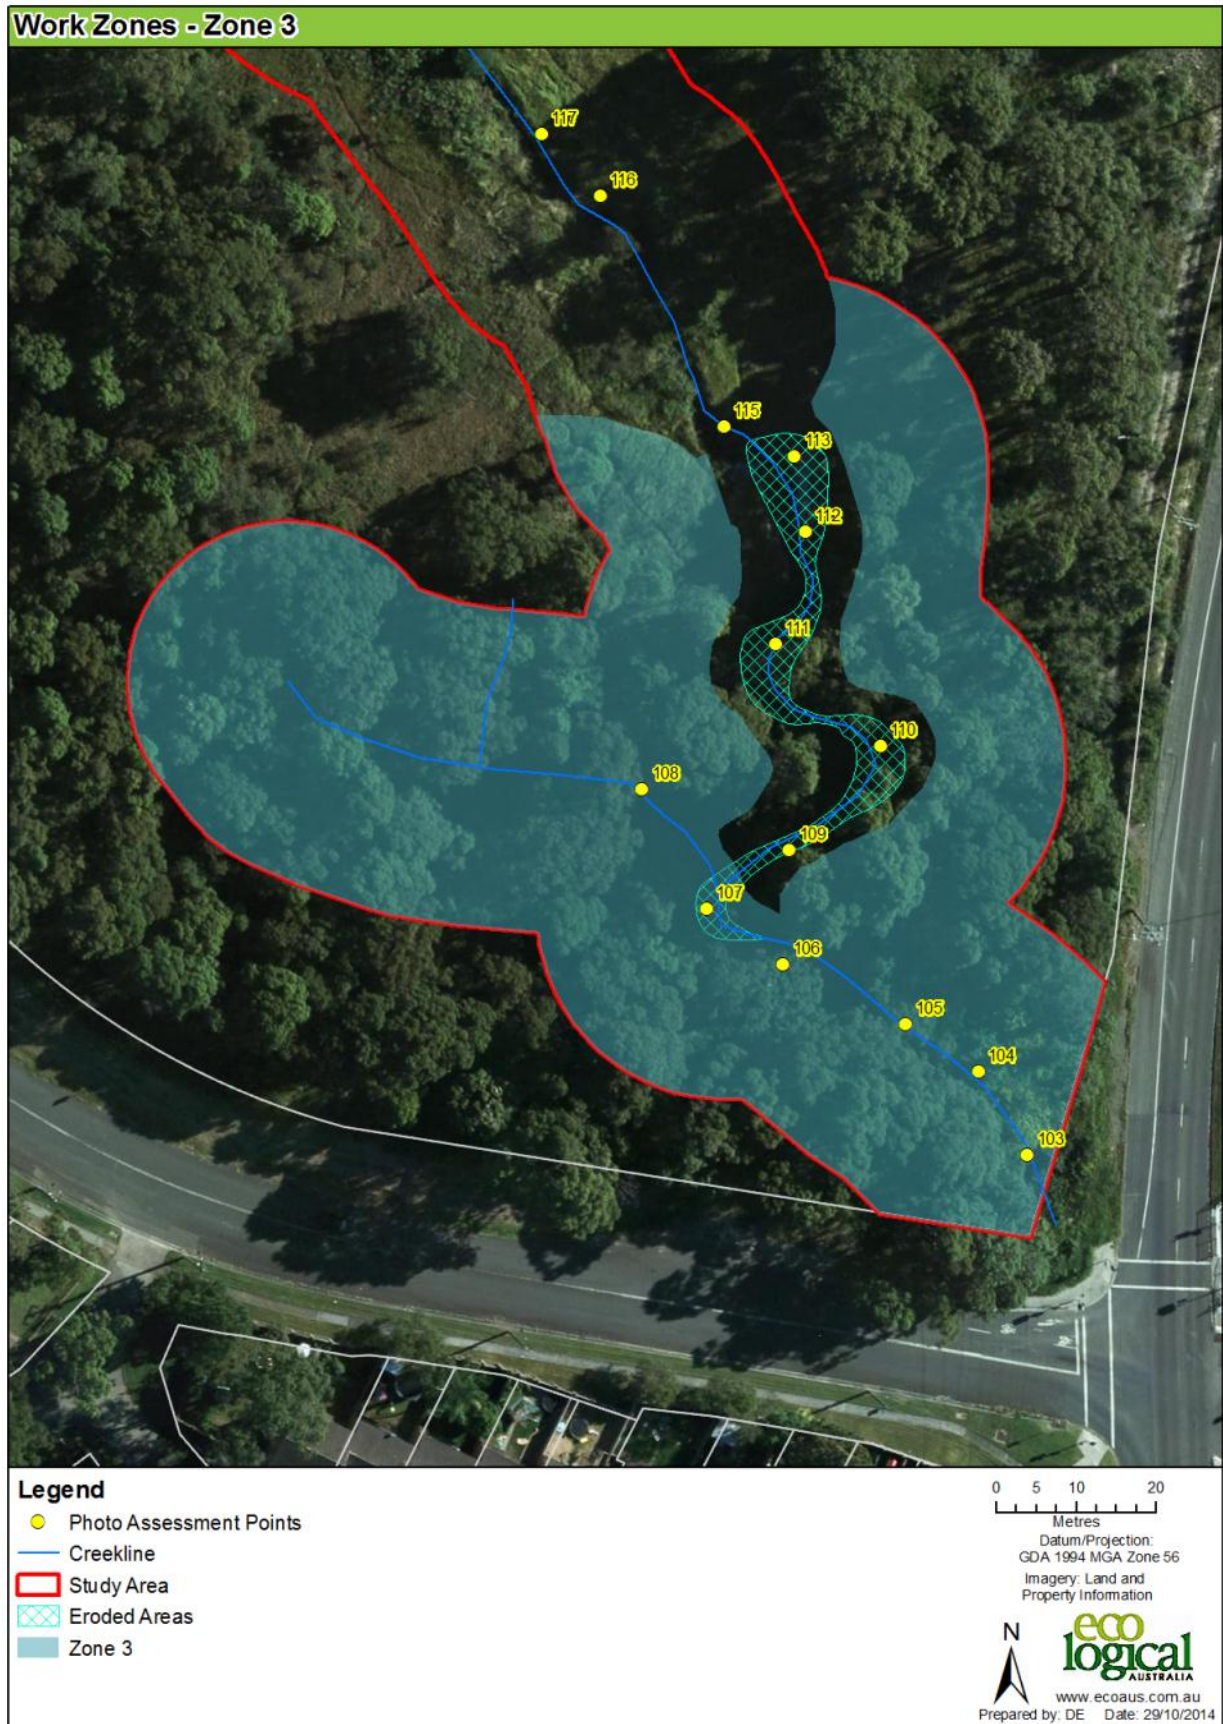
Figure 7 Location of Work Zone 3

This area comprises generally intact remnant native vegetation and will have an emphasis on weed control works, with only minor consideration to erosion control, revegetation and rubbish removal. A brief summary of the tasks required for Zone 3 (**Figure 7**) is presented in **Table 3**. All detailed site information relating to Zone 3 are presented in **Appendix C**.
