Statement of Environmental Effects

Demolition of Existing Structures and
Two Lot Subdivision
82 Bong Bong Road, Renwick

Prepared for: Landcom
Project No: 6946A
Date: October 2012

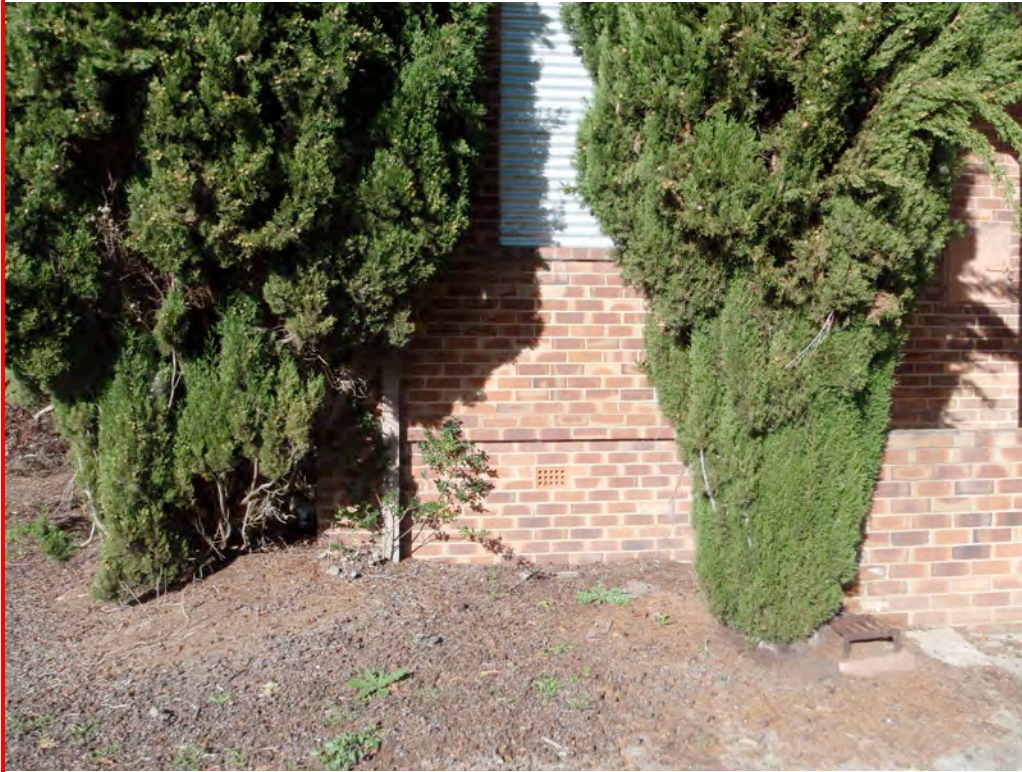
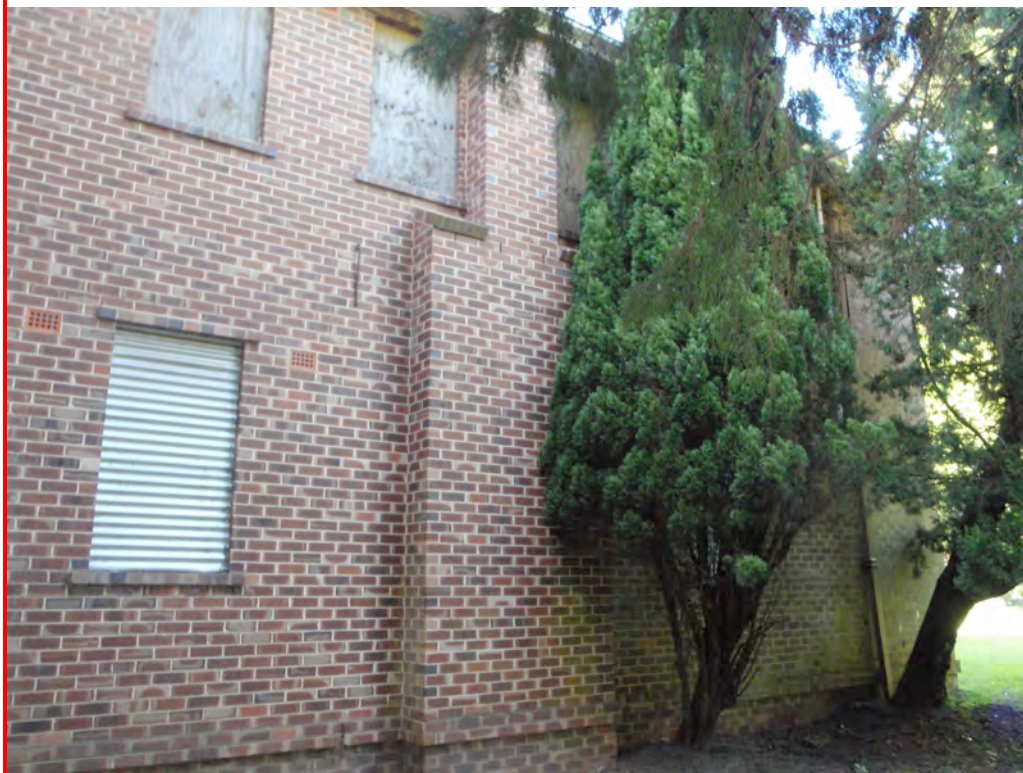
Remove large pine trees growing directly against the external walls at the rear access steps and front of the building in several areas. These trees are damaging the brickwork and causing footing problems.

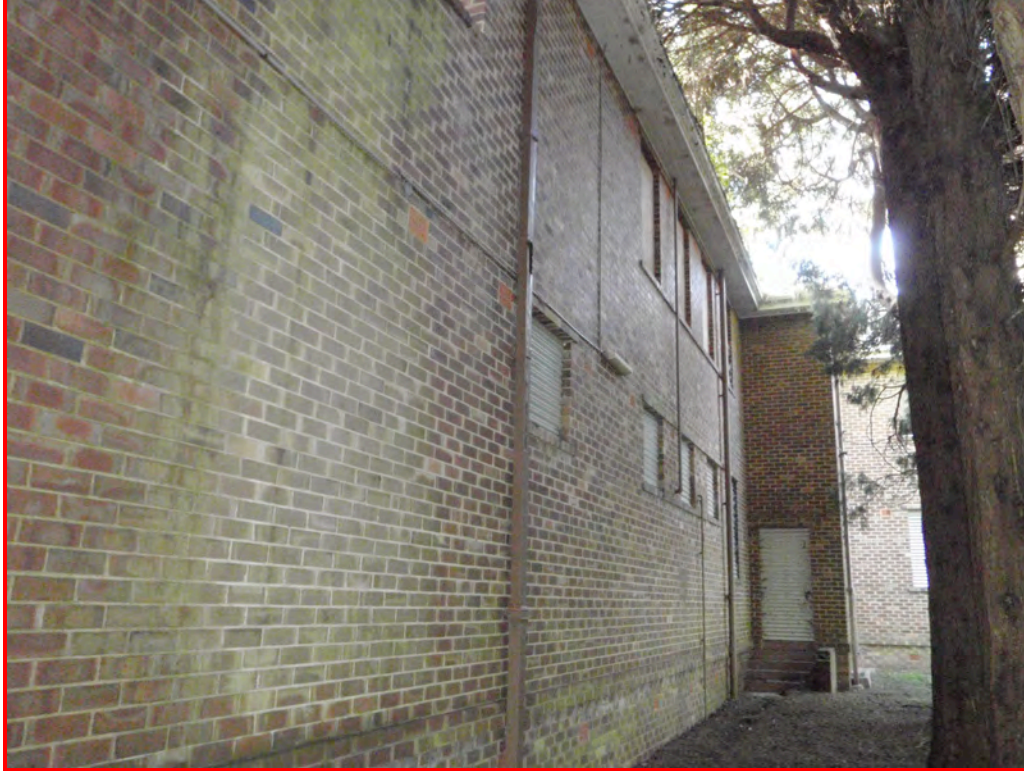
Large pine trees to the left side do not appear to have effected the building structurally, however, should be trimmed back as branches are damaging the roof area.

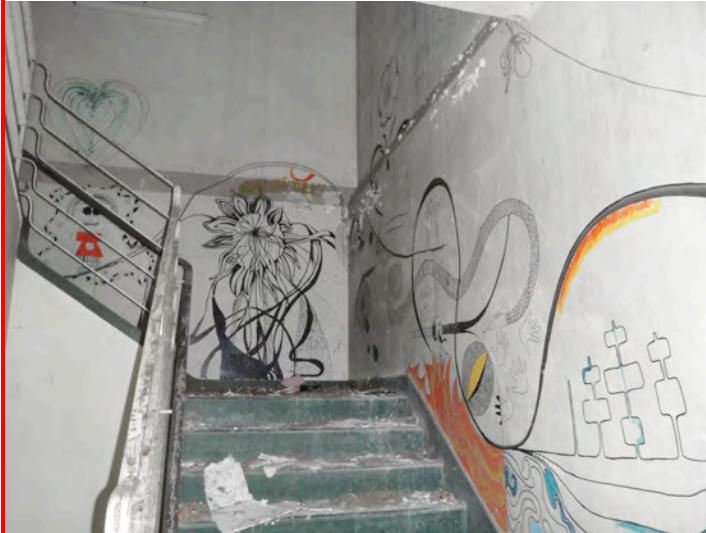
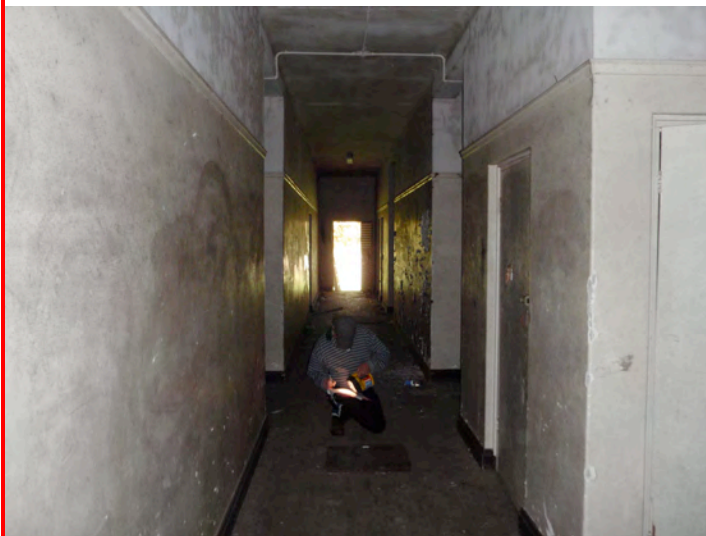
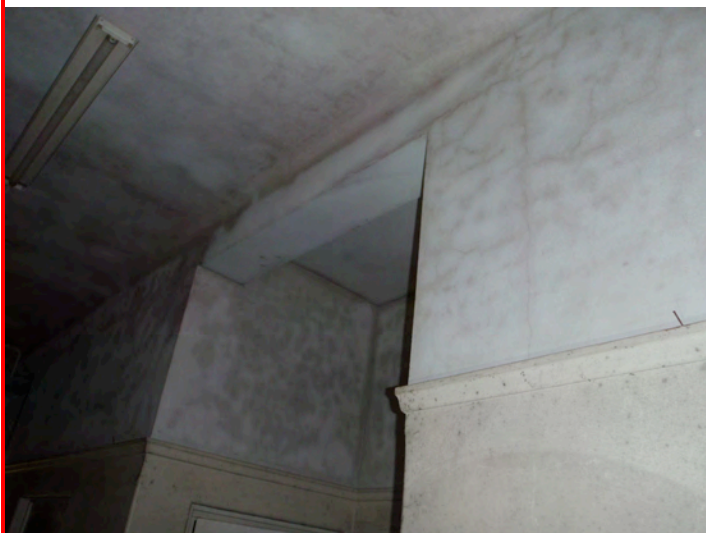
Walls throughout the entire property have been vandalised with graffiti and require complete re-painting. Render to walls throughout will require repair prior to re-painting as it has been damaged by general age, some moisture entry and vandalism.
