Re: Fire Engineering Letter in support of Development Application
Project: New Classroom and Library Building
Address: Harbord Public School, Freshwater

TREE SURVEY PLAN TSP-01

Harbord Public School New Development Geotechnical Investigation

Limited Destructive Hazardous Materials Survey Report

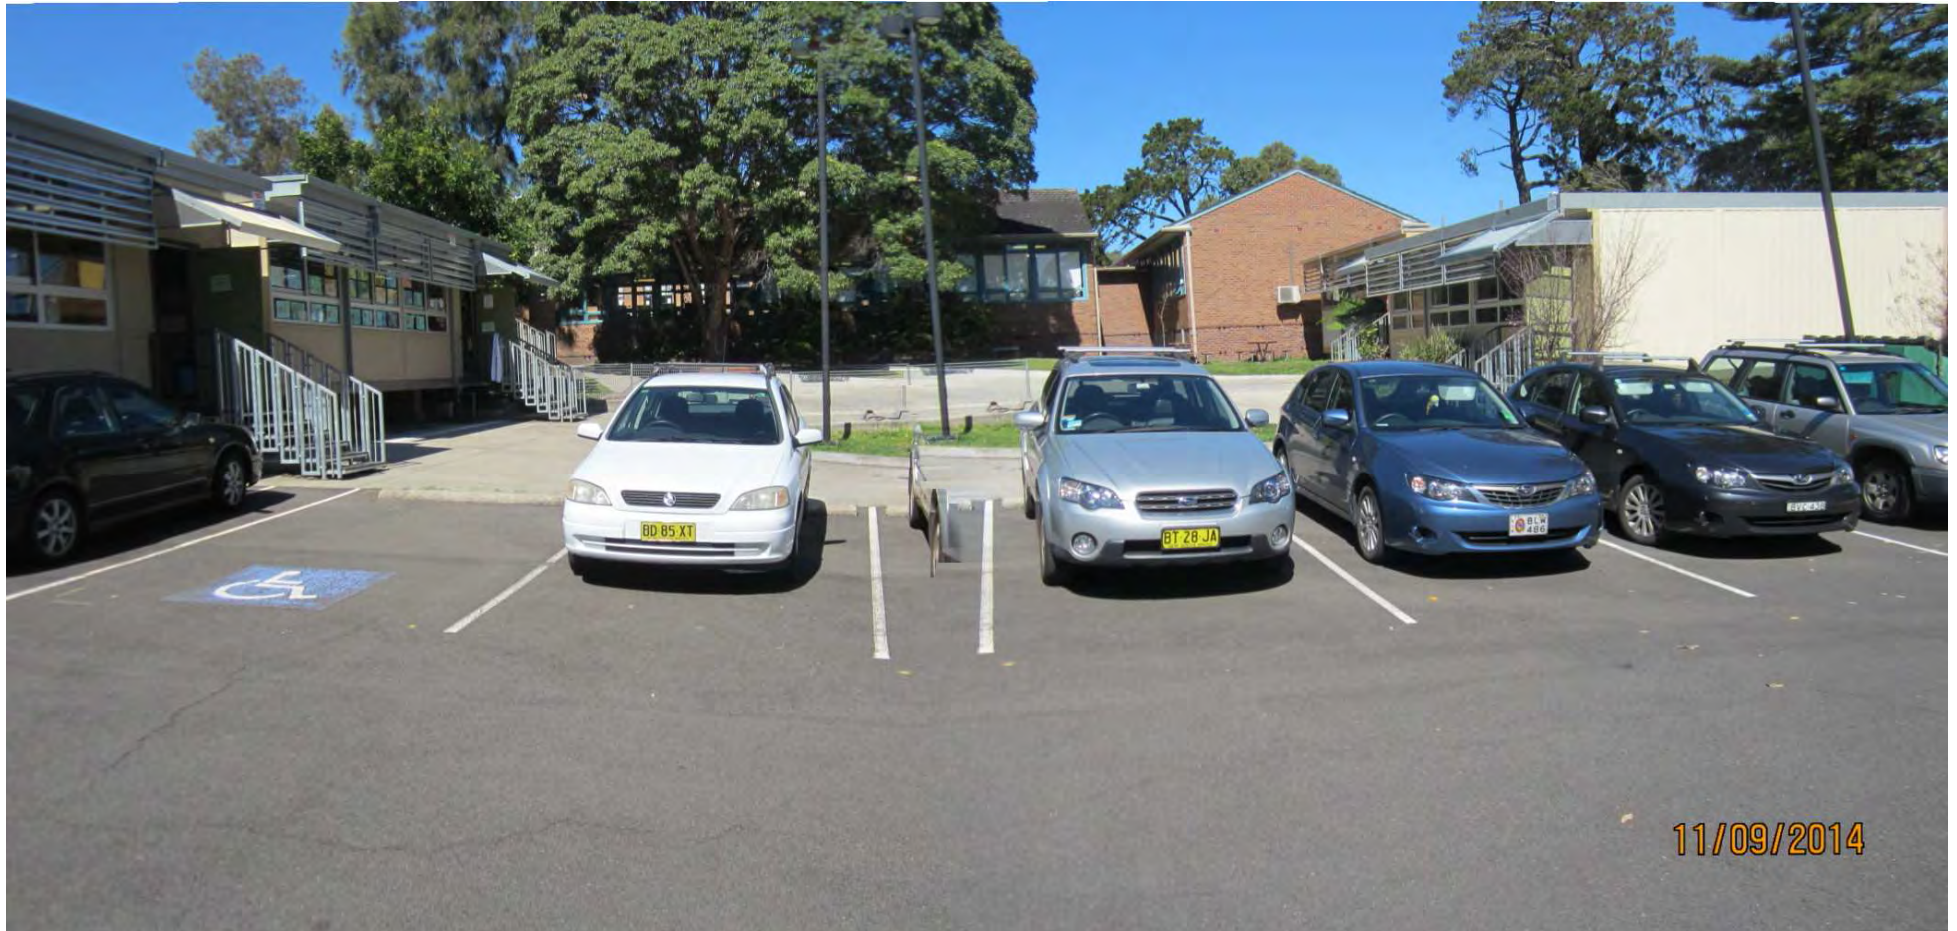
PLATE 2 : View towards the south of the Investigation Area. The existing carpark is seen in the foreground and Block A, visible in the background, will be demolished to make way for the construction of a new building.

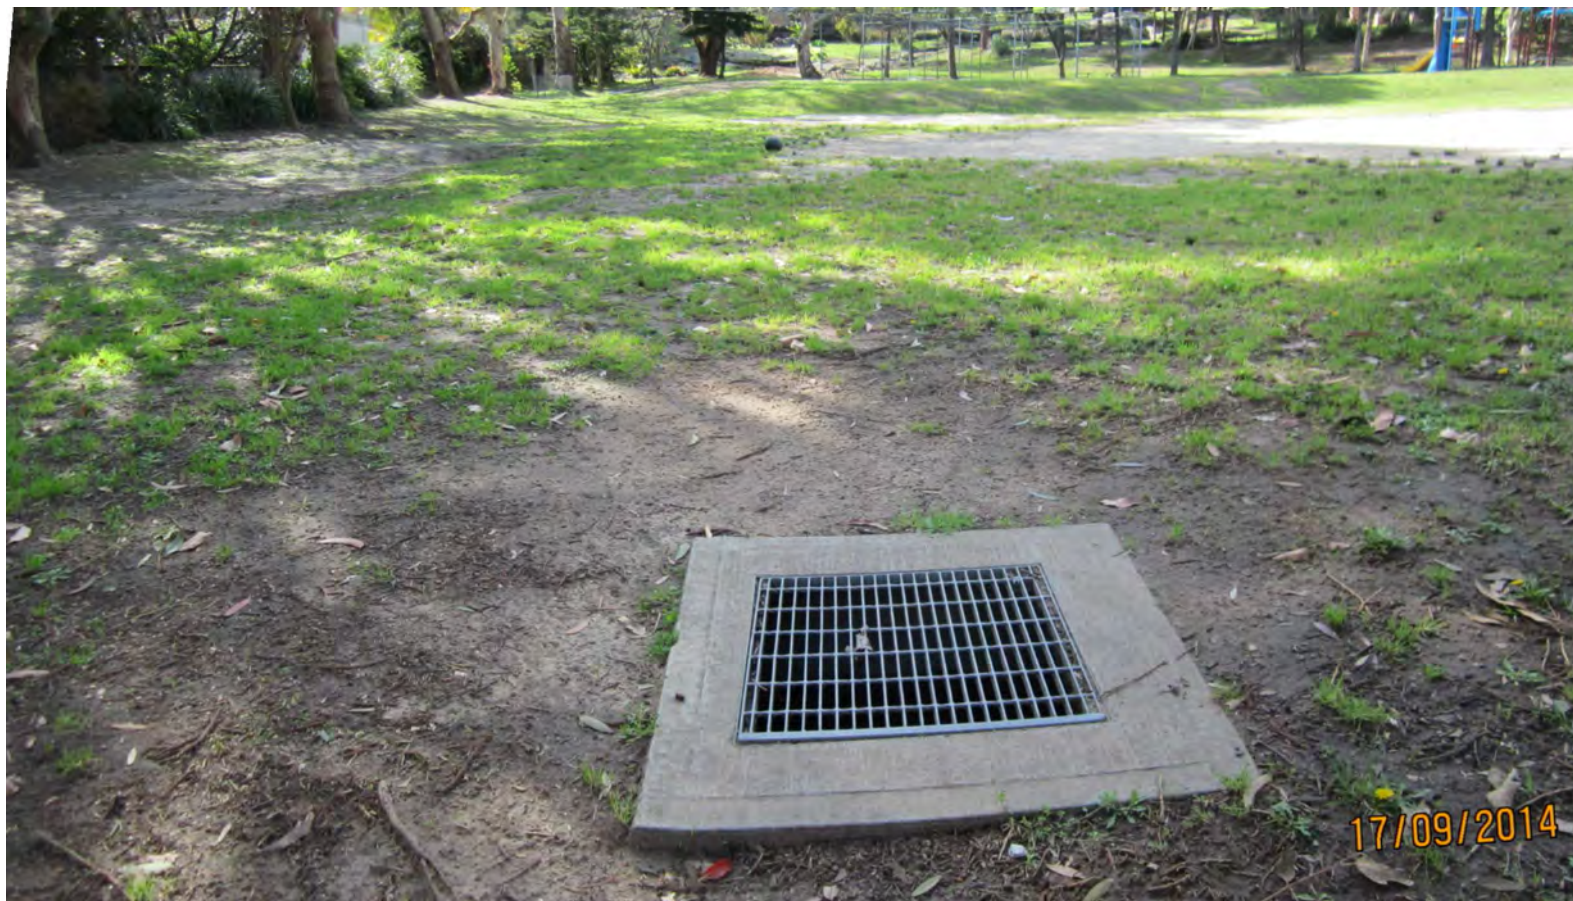
PLATE 4 : View towards the east of the area possibly proposed for a small new carpark.

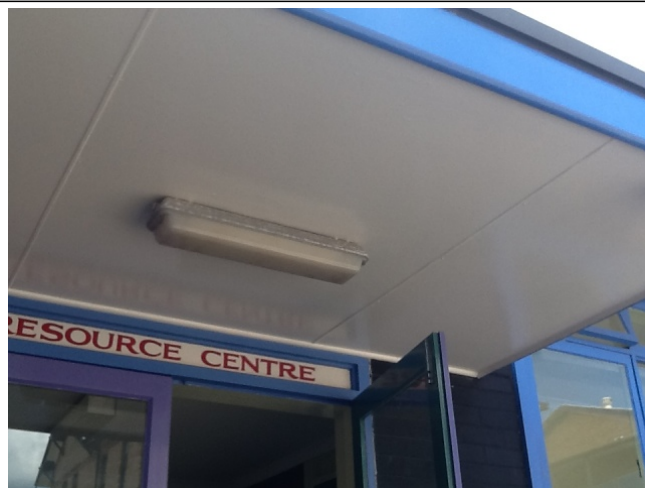
Photo No: J128920-003-Photo037
Result: Asbestos - Previously Sampled Positive
Building/Level: Building A-Ground Level
Room/Location: Exterior-Throughout
Feature/Material: Awning-Flat Cement Sheetting

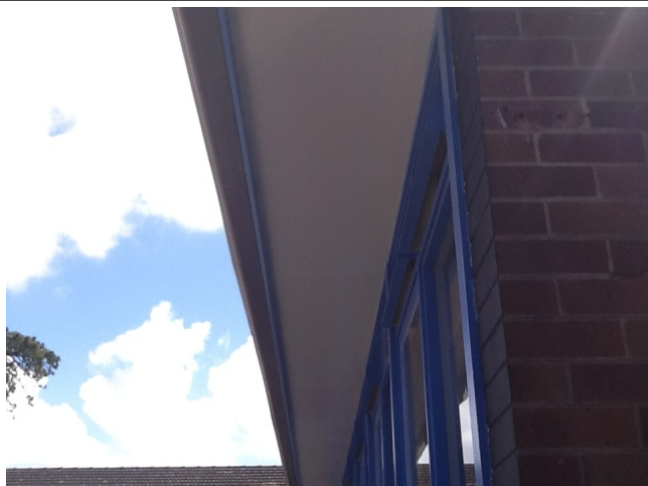
Photo No: J128920-003-Photo036
Result: Asbestos - Previously Sampled Positive
Building/Level: Building A-Ground Level
Room/Location: Exterior-Throughout
Feature/Material: Eaves-Flat Cement Sheetting

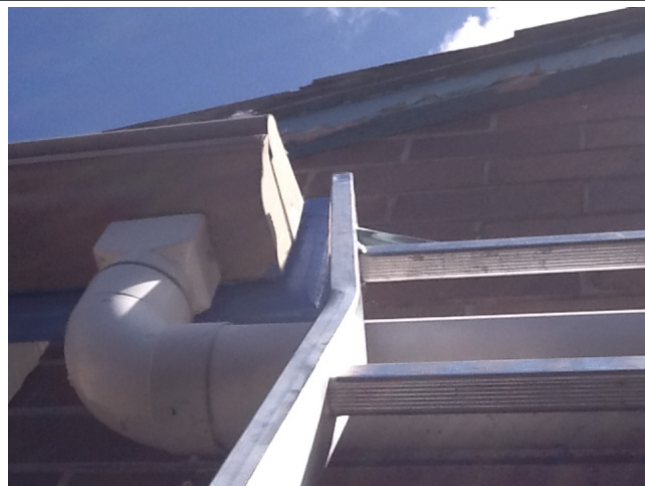
Photo No: J128920-003-Photo034
Result: Asbestos - Positive
Building/Level: Building A-Ground Level
Room/Location: Exterior-Throughout
Feature/Material: Gable Verge Lining-Flat Cement Sheetting

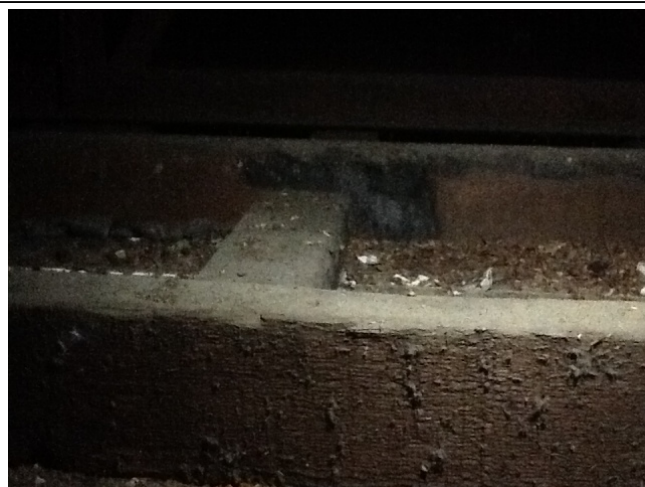
Photo No: J128920-003-Photo031
Result: Lead (Dust) - Positive
Building/Level: Building A-Ground Level
Room/Location: Ceiling Space-North
Feature/Material: On Top of Ceiling-Dust - Lead

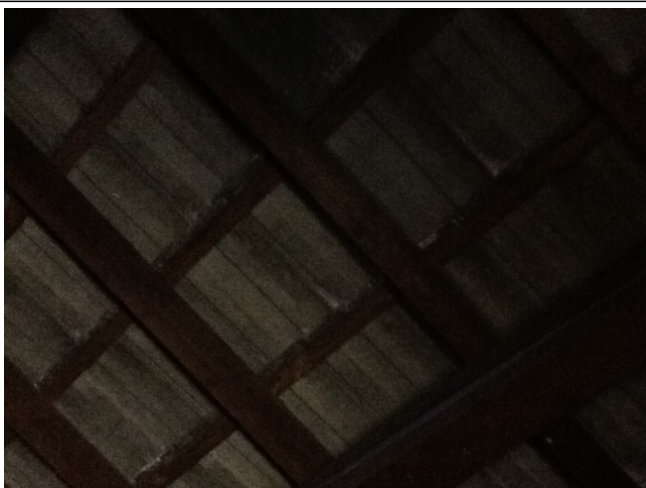
Photo No: J128920-003-Photo020
Result: Asbestos - Presumed Positive
Building/Level: Building A-Ground Level
Room/Location: Ceiling Space-West
Feature/Material: Ceiling-Corrugated Cement Sheet

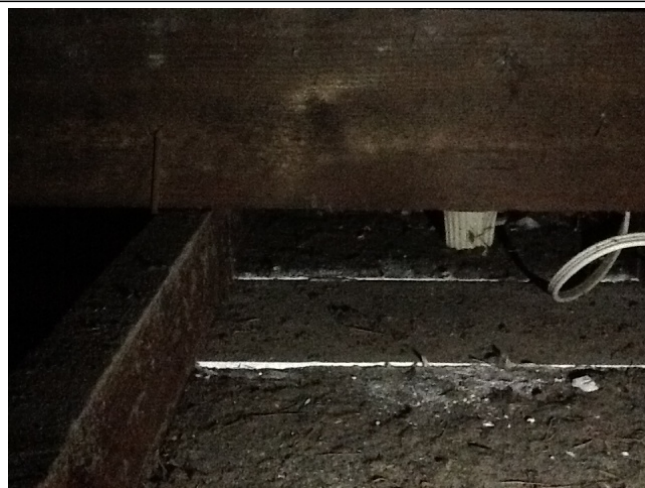
Photo No: J128920-003-Photo022
Result: Lead (Dust) - Positive
Building/Level: Building A-Ground Level
Room/Location: Ceiling Space-West
Feature/Material: On Top of Ceiling-Dust - Lead

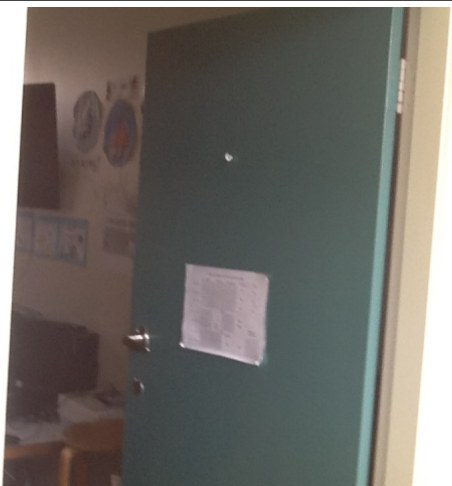
Photo No: J128920-003-Photo027
Result: Lead (Paint) - Presumed Positive
Building/Level: Building A-Ground Level
Room/Location: Computer Room - R0018-North
Feature/Material: Door-Paint System/s

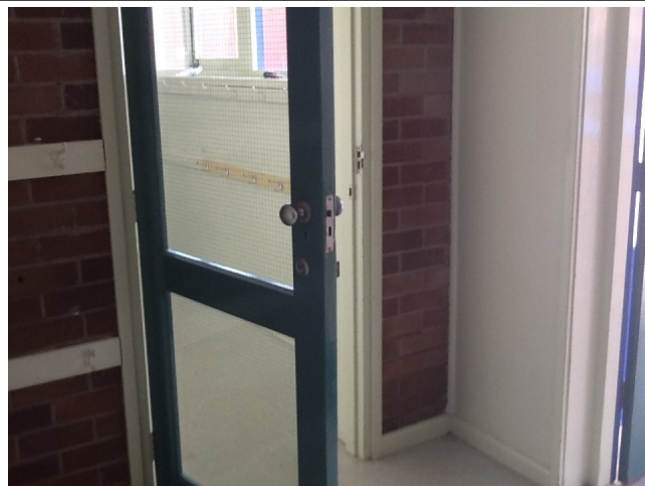
Photo No: J128920-003-Photo026
Result: Lead (Paint) - Presumed Positive
Building/Level: Building A-Ground Level
Room/Location: Movement - AR0011-East
Feature/Material: Door-Paint System/s

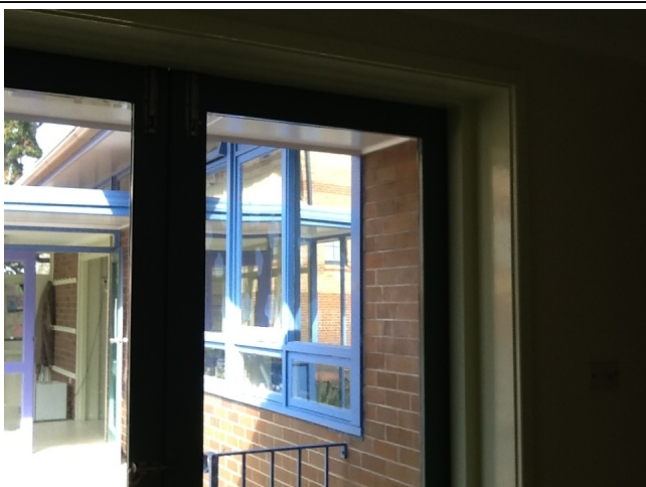
Photo No: J128920-003-Photo016
Result: Lead (Paint) - Presumed Positive
Building/Level: Building A-Ground Level
Room/Location: Movement - AR0019-North
Feature/Material: Door-Paint System/s

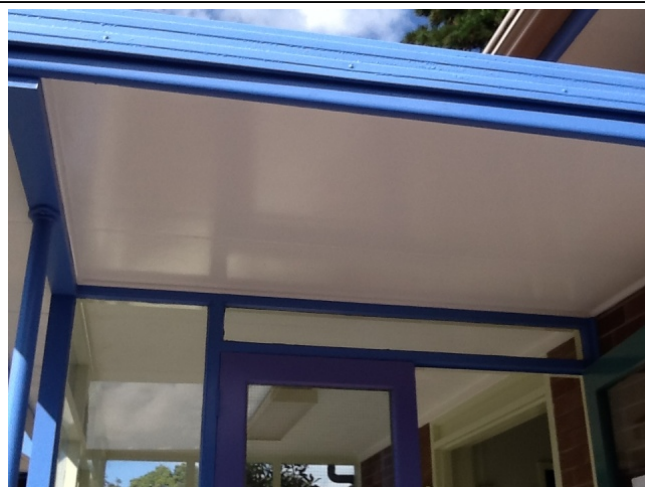
Photo No: J128920-003-Photo001
Result: Asbestos - Previously Sampled Positive
Building/Level: Building A-Ground Level
Room/Location: Movement - R0016-Throughout
Feature/Material: Ceiling-Fibre Cement Sheet

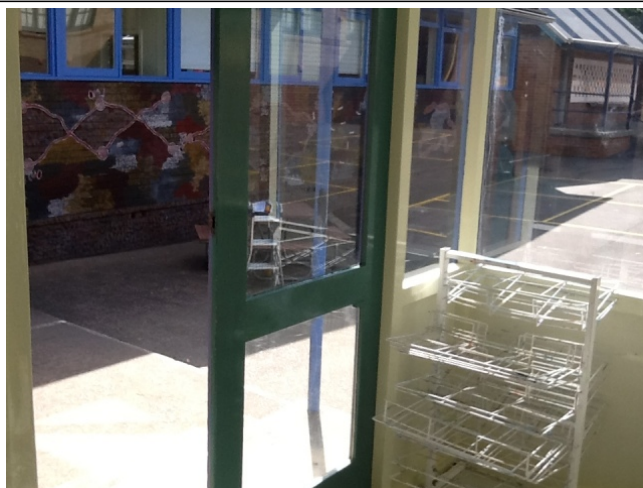
Photo No: J128920-003-Photo004
Result: Lead (Paint) - Positive
Building/Level: Building A-Ground Level
Room/Location: R0002-Throughout
Feature/Material: Door-Paint System/s

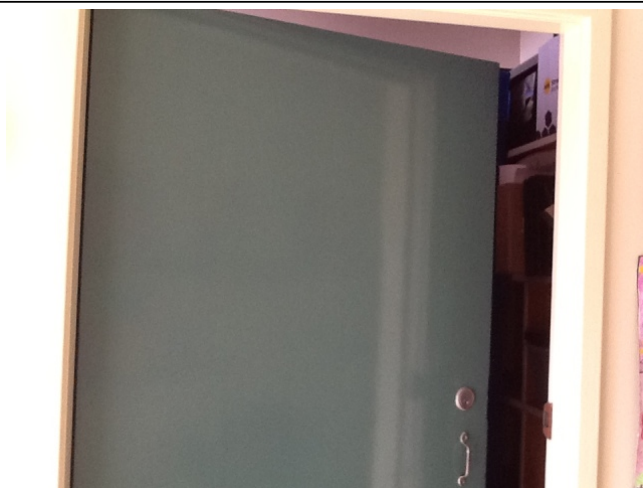
Photo No: J128920-003-Photo008
Result: Lead (Paint) - Presumed Positive
Building/Level: Building A-Ground Level
Room/Location: R0003-North
Feature/Material: Door-Paint System/s

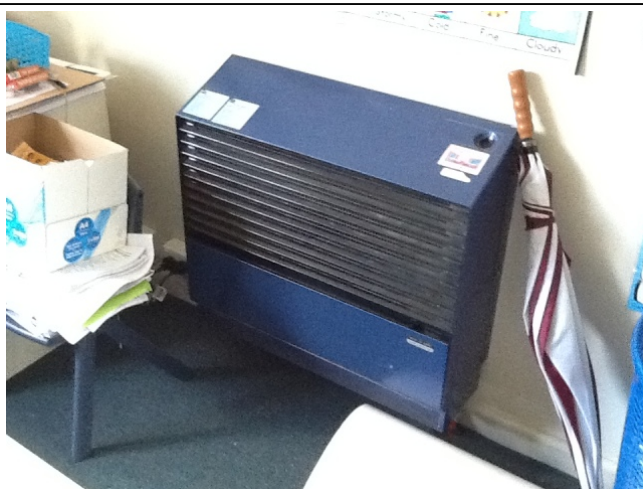
Photo No: J128920-003-Photo011
Result: Asbestos - Presumed Positive
Building/Level: Building A-Ground Level
Room/Location: R0005-North
Feature/Material: Heater-Insulation

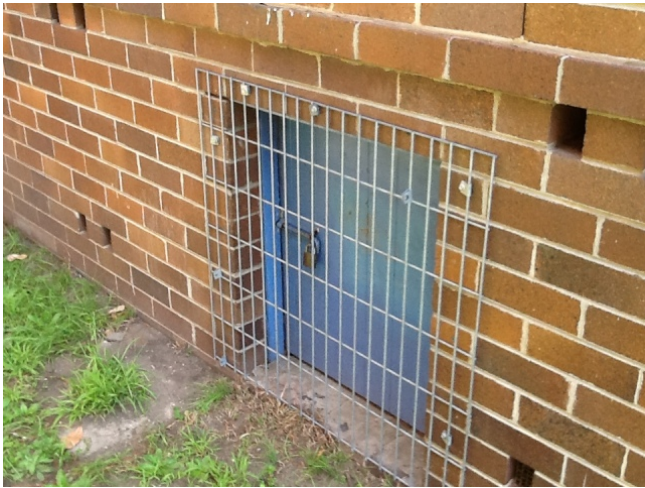
Photo No: J128920-003-Photo042
Result: Asbestos - Presumed Positive
Building/Level: Building A-Sub-Floor
Room/Location: Exterior-Throughout
Feature/Material: Packer-Fibre Cement Sheeting

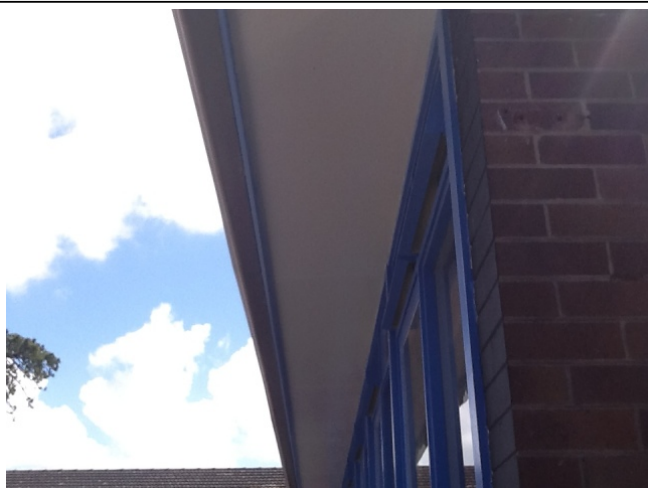
Photo No: J128920-003-Photo036
Result: Asbestos - Previously Sampled Positive
Building/Level: Building A-Ground Level
Room/Location: Exterior-Throughout
Feature/Material: Eaves-Flat Cement Sheetting

Exterior - Throughout Eaves - Flat Cement Sheeting	Asbestos	Previously Sampled NAA Similar To: S1	Previously Sampled Positive	J128920-003-Photo036	100 m ²	Good	Non Friable	Low	Low	Not Labelled	25-09-2015	P4	similar To S1 Maintain in current condition, label and incorporate into an HMMP. Remove by licensed asbestos contractor prior to demolition or refurbishment.	
Exterior - Throughout Expansion Joint - Bituminous Material	Asbestos	J128920-003-007	Negative											
Exterior - Throughout Gable - Paint System/s - Fluoro Green	Lead (Paint)	J128920-003-LP-002	Negative, 0.4%											
Exterior - Throughout Gable Verge Lining - Flat Cement Sheeting - North, south and East facing	Asbestos	J128920-003-005	Positive	J128920-003-Photo034	30 m ²	Good	Non Friable	Low	Low	Not Labelled	25-09-2015	P4	Maintain in current condition, label and incorporate into an HMMP. Remove by licensed asbestos contractor prior to demolition or refurbishment.

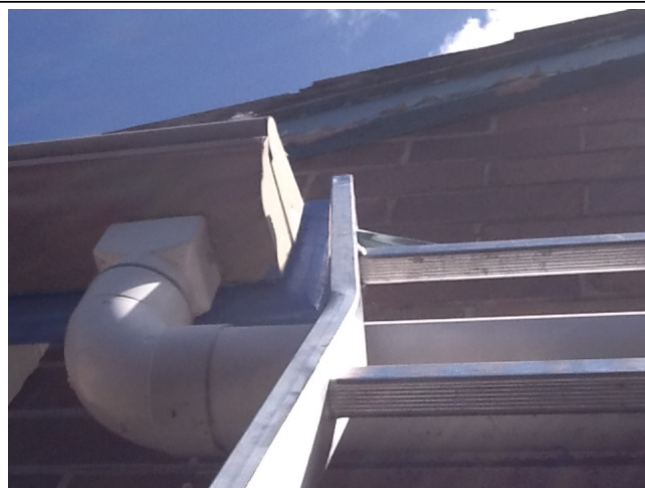
Photo No: J128920-003-Photo034
Result: Asbestos - Positive
Building/Level: Building A-Ground Level
Room/Location: Exterior-Throughout
Feature/Material: Gable Verge Lining-Flat Cement Sheetting

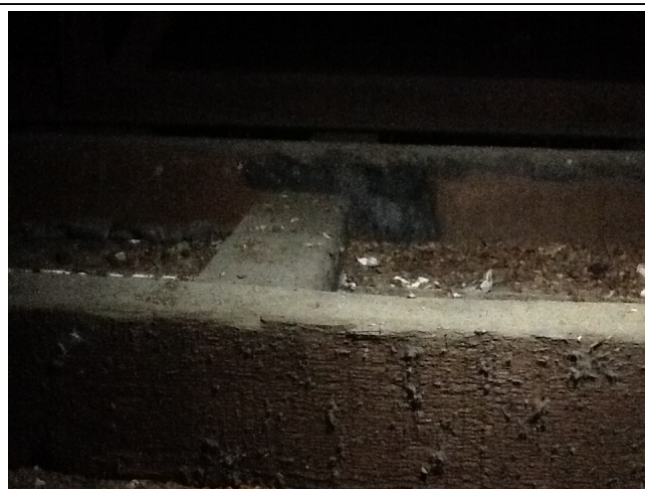
Photo No: J128920-003-Photo031
Result: Lead (Dust) - Positive
Building/Level: Building A-Ground Level
Room/Location: Ceiling Space-North
Feature/Material: On Top of Ceiling-Dust - Lead

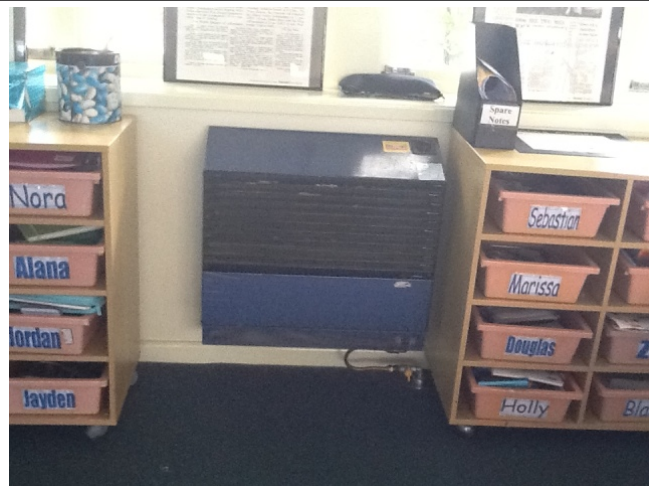
Photo No: J128920-003-Photo033
Result: Asbestos - Presumed Positive
Building/Level: Building A-Ground Level
Room/Location: R0010-North
Feature/Material: Heater-Insulation
