## Tree Assessment

Residential Aged Care Facility

158 Macquarie Road,  
CARDIFF

November 2016  
REF: (A15069T)

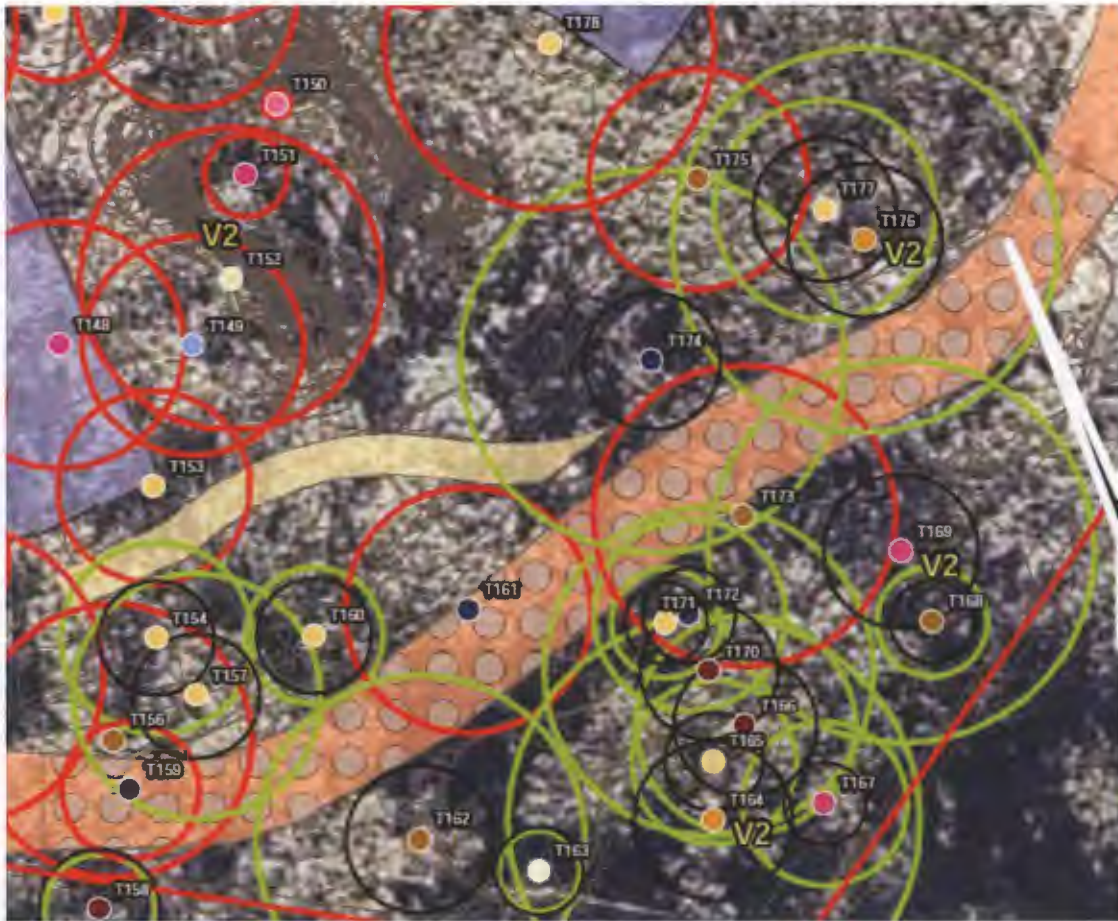
Figure 4 - Map of South East part of fire trail (Travers Ecology)

Below is a map showing the positions of the 8 trees inspected along the fire trail in the South-East corner.
