Arborist Report

**Client: Hunter New England Local
Health District**

Address: 1a (Lot 10) Dudley Road
Charlestown N.S.W 2290

Date: 4 January 2016

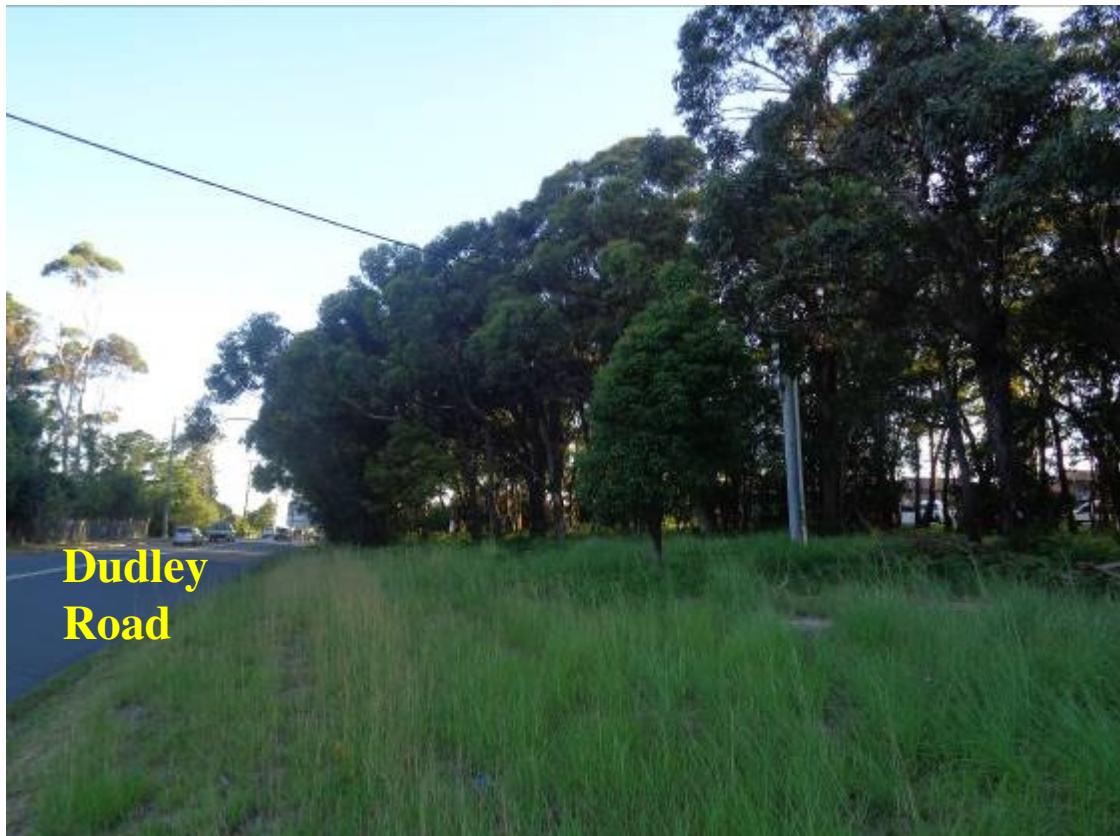
Figure 2 – Location of subject property identified as 1a Dudley Road, Charlestown. This photograph is taken at the front of the subject property overlooking the trees and the location in relation to Dudley Road.

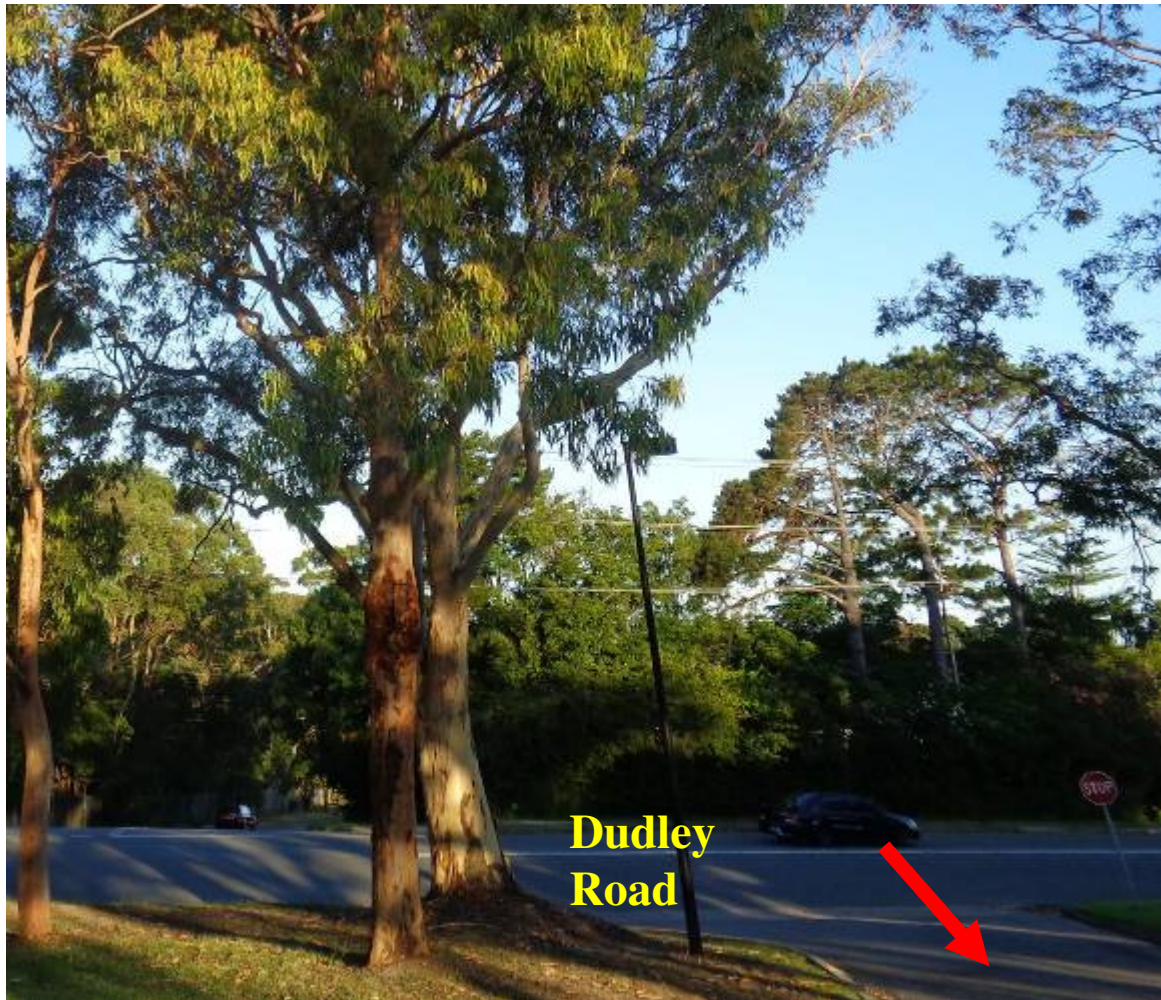
Figure 3 – showing the main entrance off Dudley Road & the red arrow pointing to the internal access road that will be utilised to access the proposed car park.

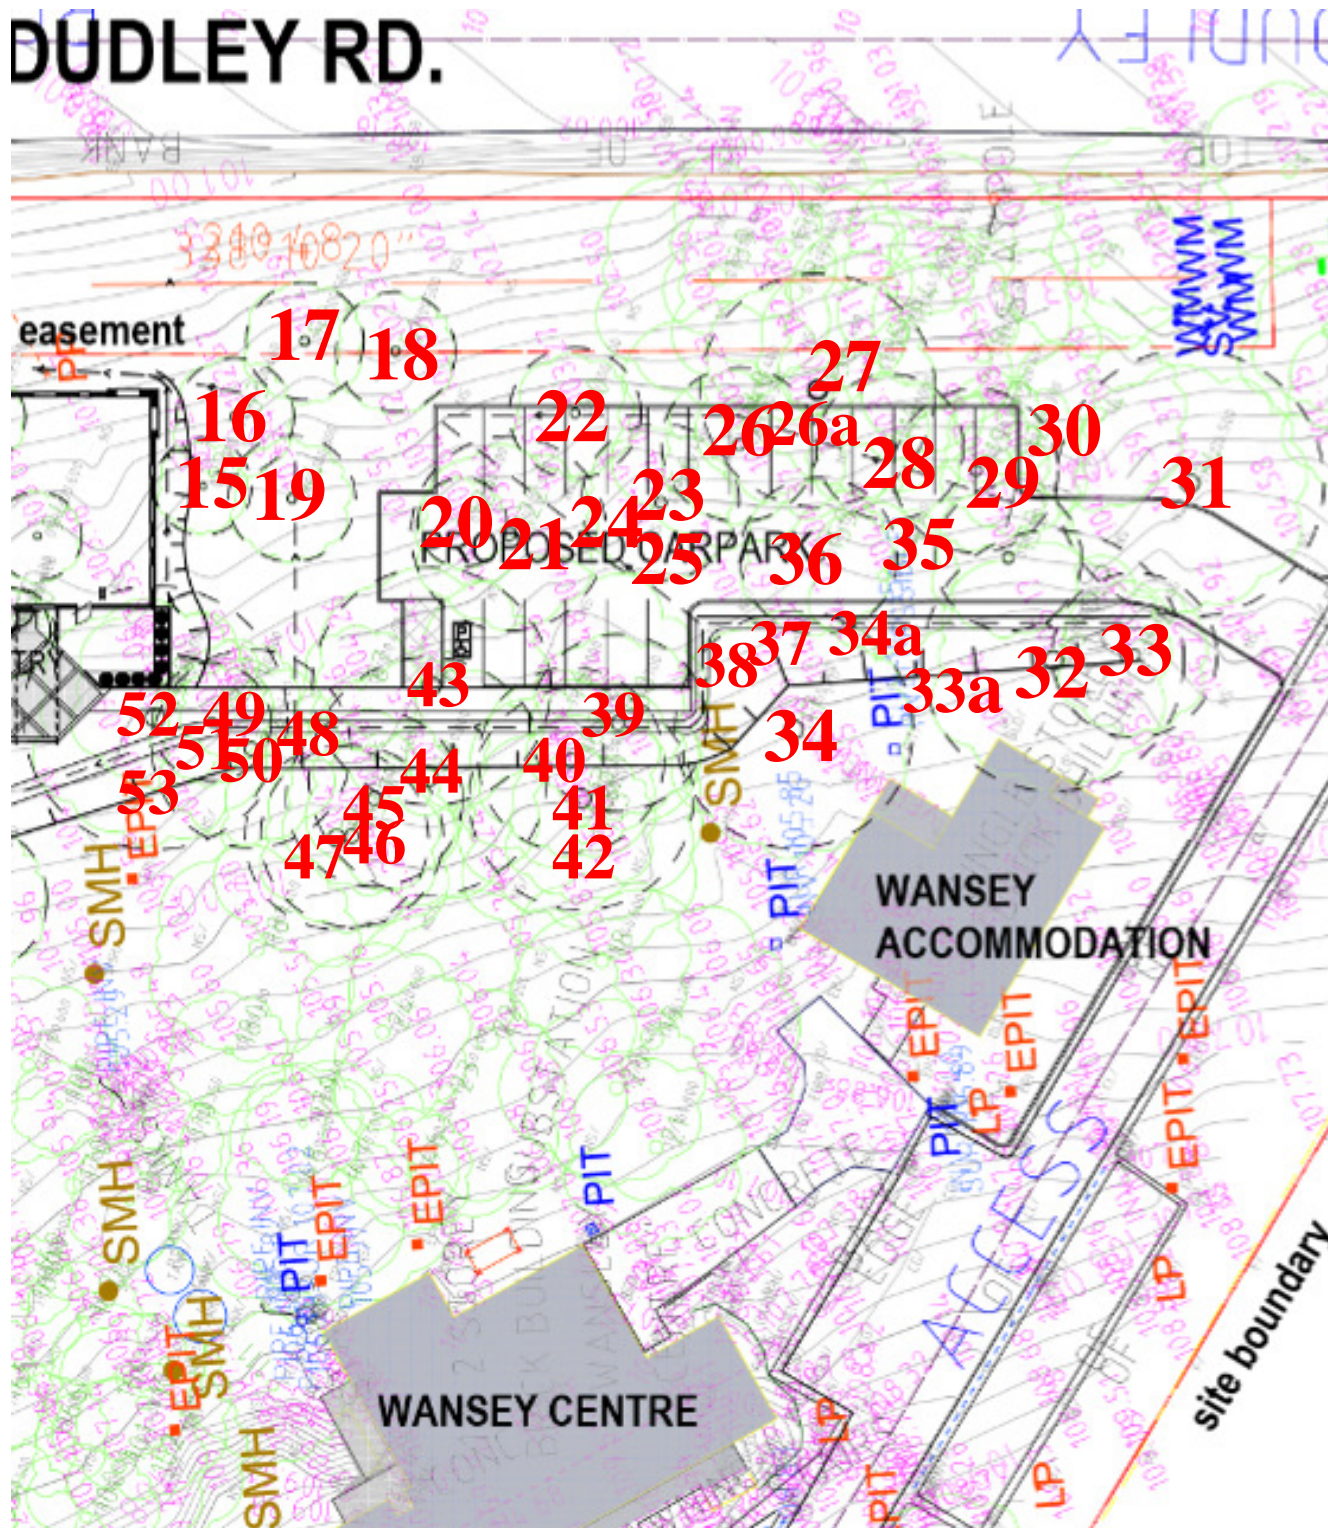
Figure 8 - Close up of the subject property and canopy area of Trees 15 - 53. Not to scale

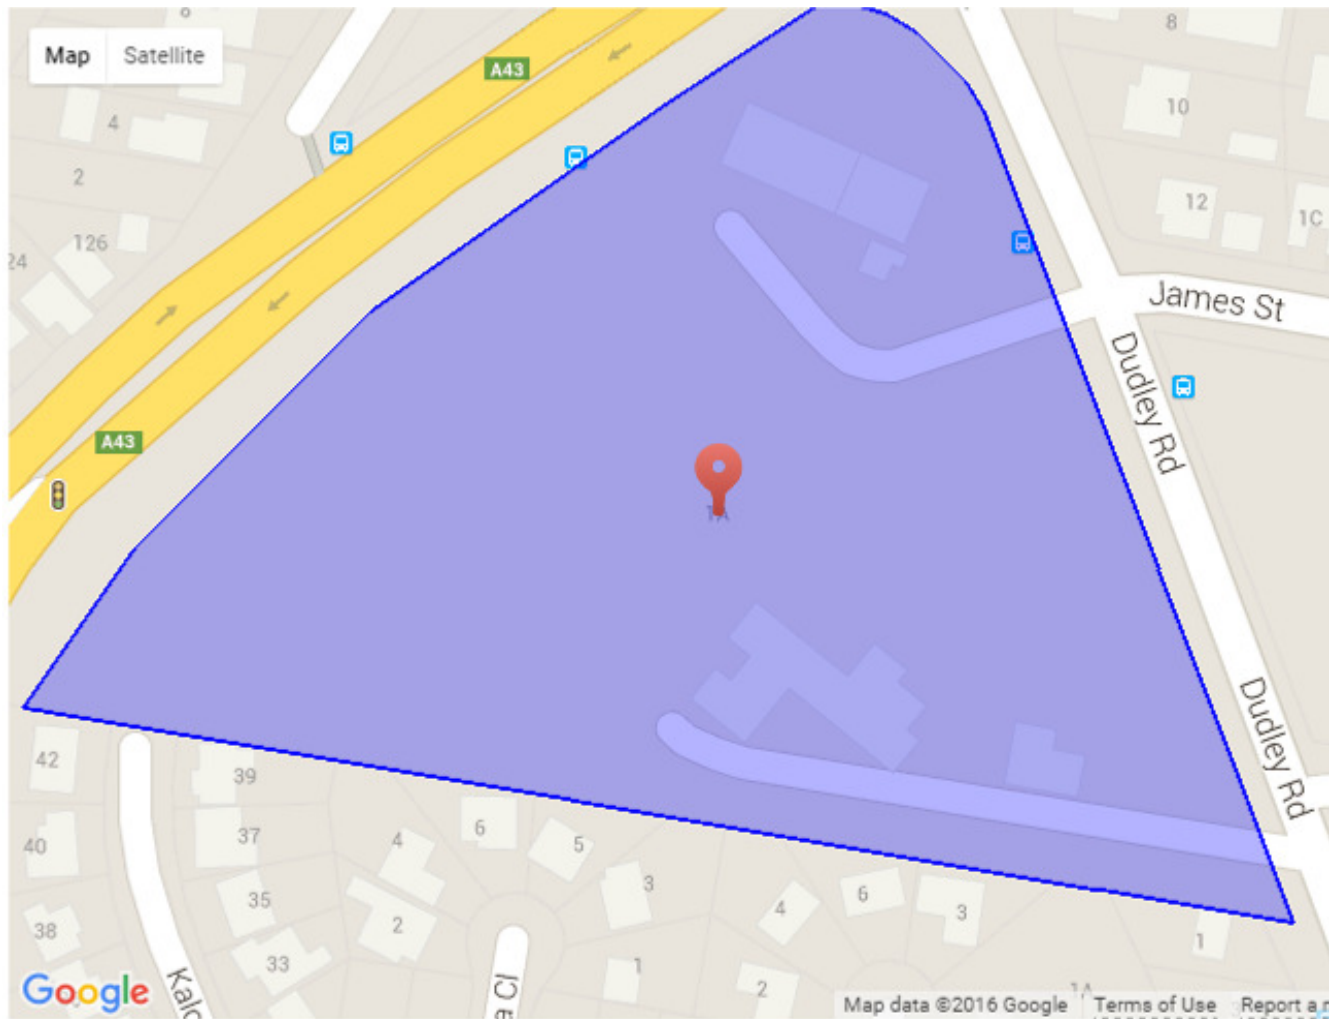
The site is bushfire prone & therefore I have applied the Rural Fire Service (RFS) 10:50 code to the site in relation to the proposed development. The RFS website shows the entire site as coming under the requirements of RFS 10:50 Code (Figure 9). The trees form a continuous canopy within the subject property. This is the limit of the scope of works and all work pertaining to bushfire requirements must be assessed by a BPAD Assessor. Trees 1 – 5 are located within the proposed facility as outlined in figures 7 & 8. In order for the development to proceed in its current format will require the removal of Trees 1 – 5.

Your 10/50 search result
