Report on Geotechnical Investigation

Proposed Junior School Building St Philip's Christian College, Gosford Campus 20 Narara Creek Road, Narara

> > Project 75957 September 2015

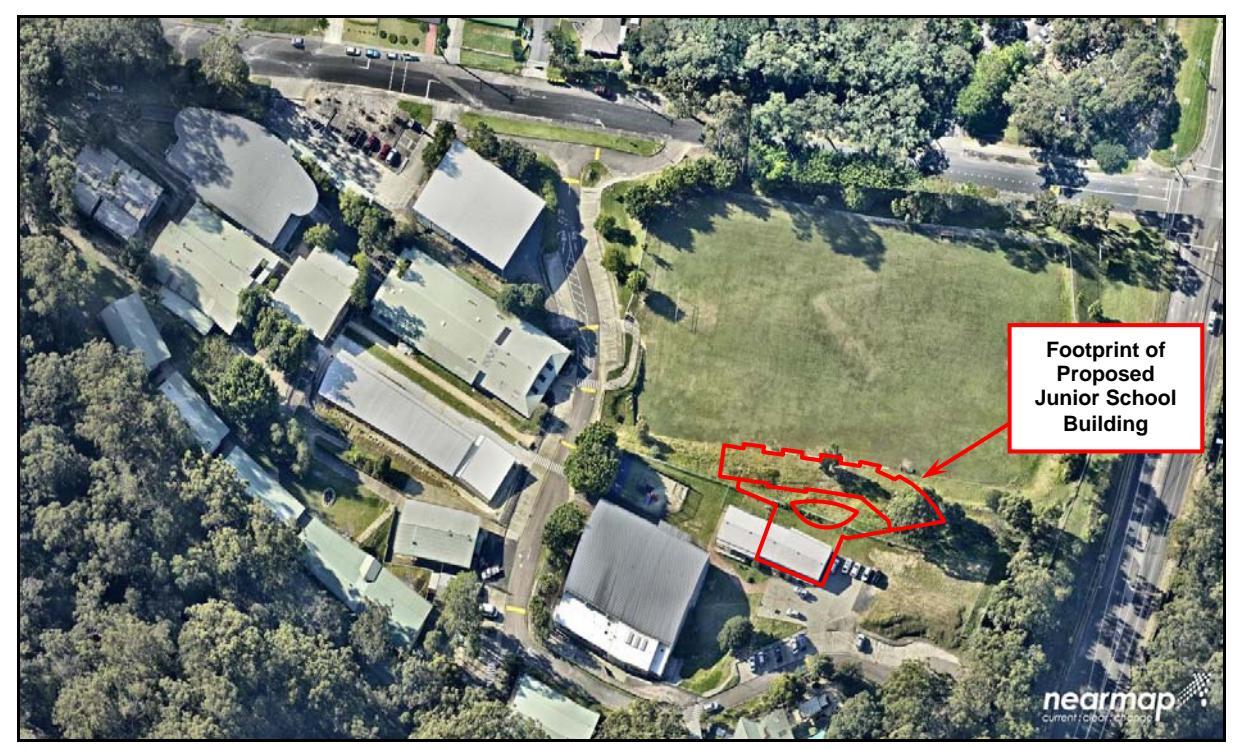
Figure 1: Area of proposed development. (Image sourced from Nearmap Photomaps and dated 15 April 2015)

Figure 1 shows a recent aerial view of the proposed development area (hereafter referred to as the "site") and has been marked-up to show the approximate location of the proposed building. Figure 2 shows the existing batter into which the building would be set.
