# *Arborist Report*

**Client:** Aveo Pty Ltd

Address: Vale Street,  
Shortland N.S.W 2287

Project: Vale Street, Shortland NSW 2287 (Shortland Waters Golf Club)

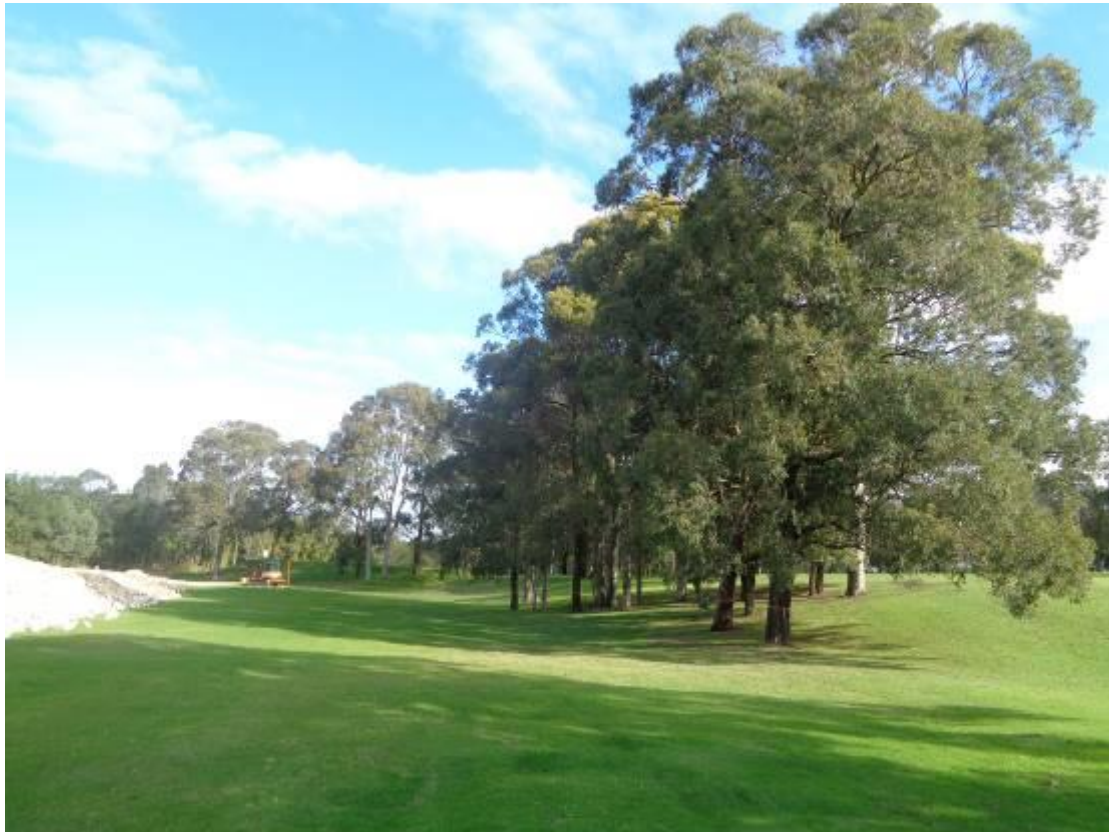
Figure 2 – Location of subject property identified as Shortland Waters Golf Course (Vale Street, Shortland). The first layer of trees alongside the existing green include Trees 1 - 15

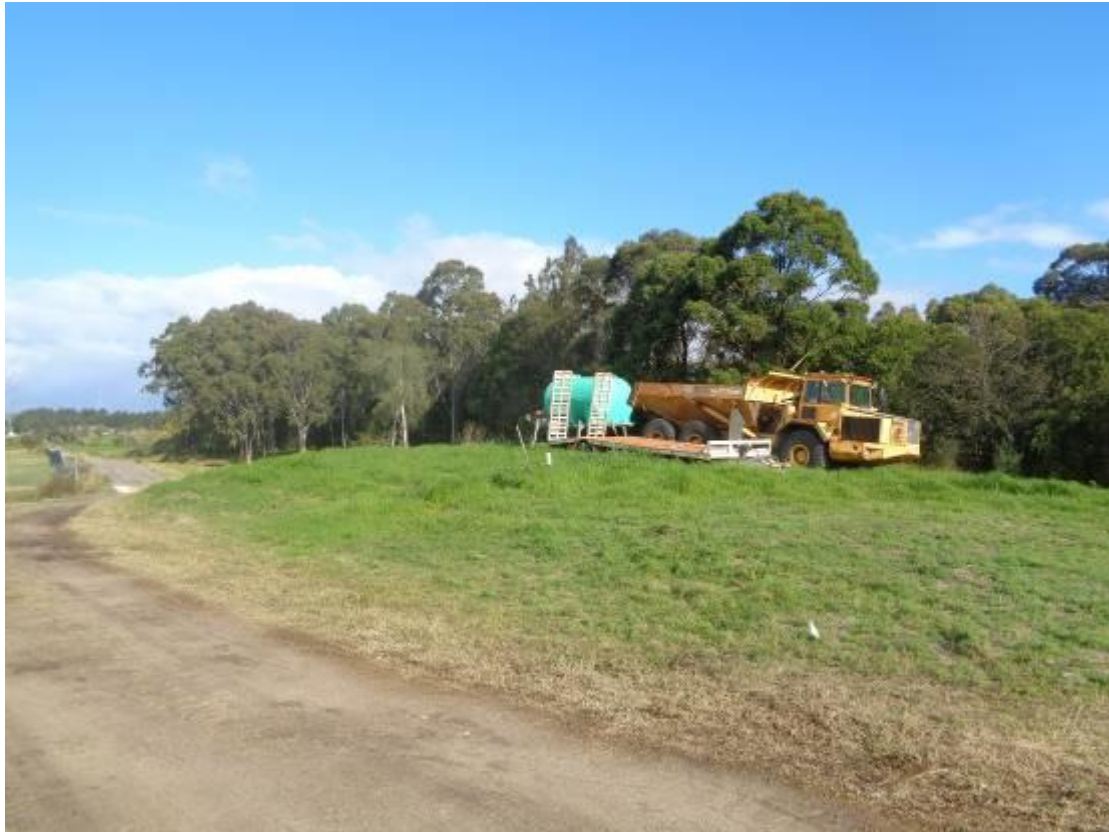
Figure 3 – showing the location of the next cluster of trees that include Trees 16 - 86. These trees are located next to the artificial pond next to the green.

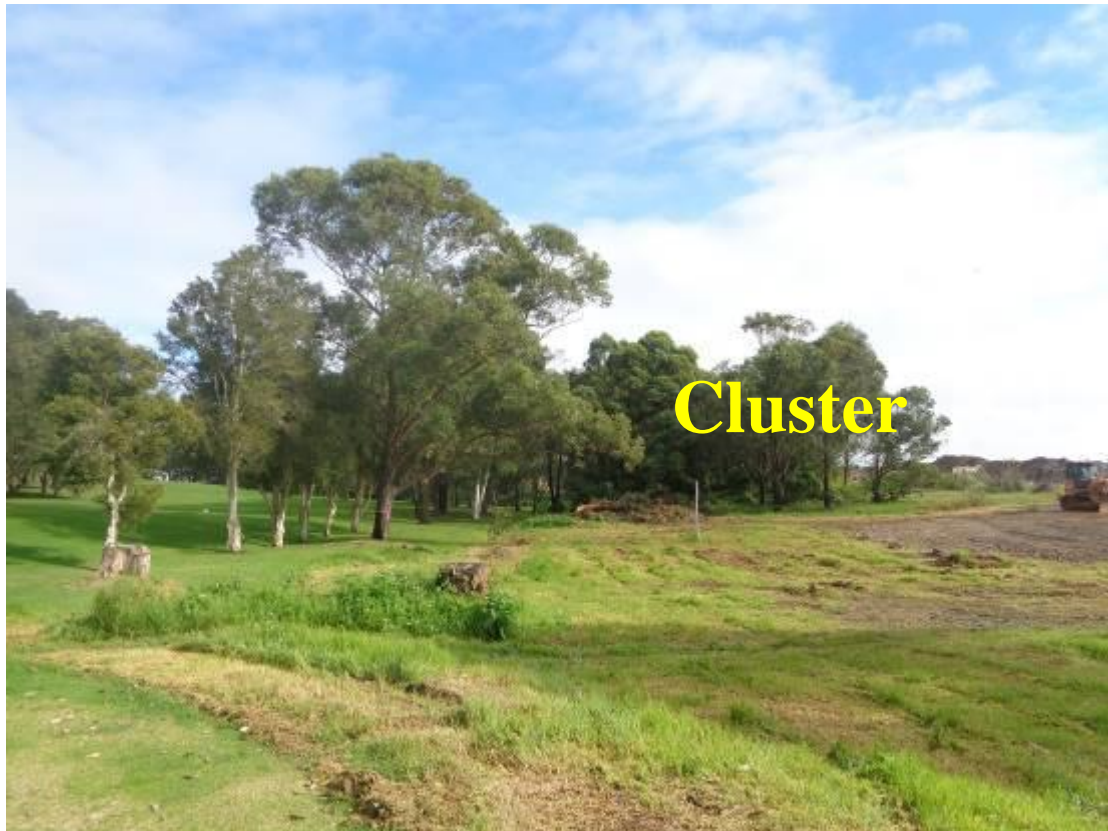
Figure 4 – The remainder of the trees are located next to the fairway and comprise of Trees 87 – 92 that are in the open field area and Trees 93 – 178 are in a cluster on a small mound next to the fairway.

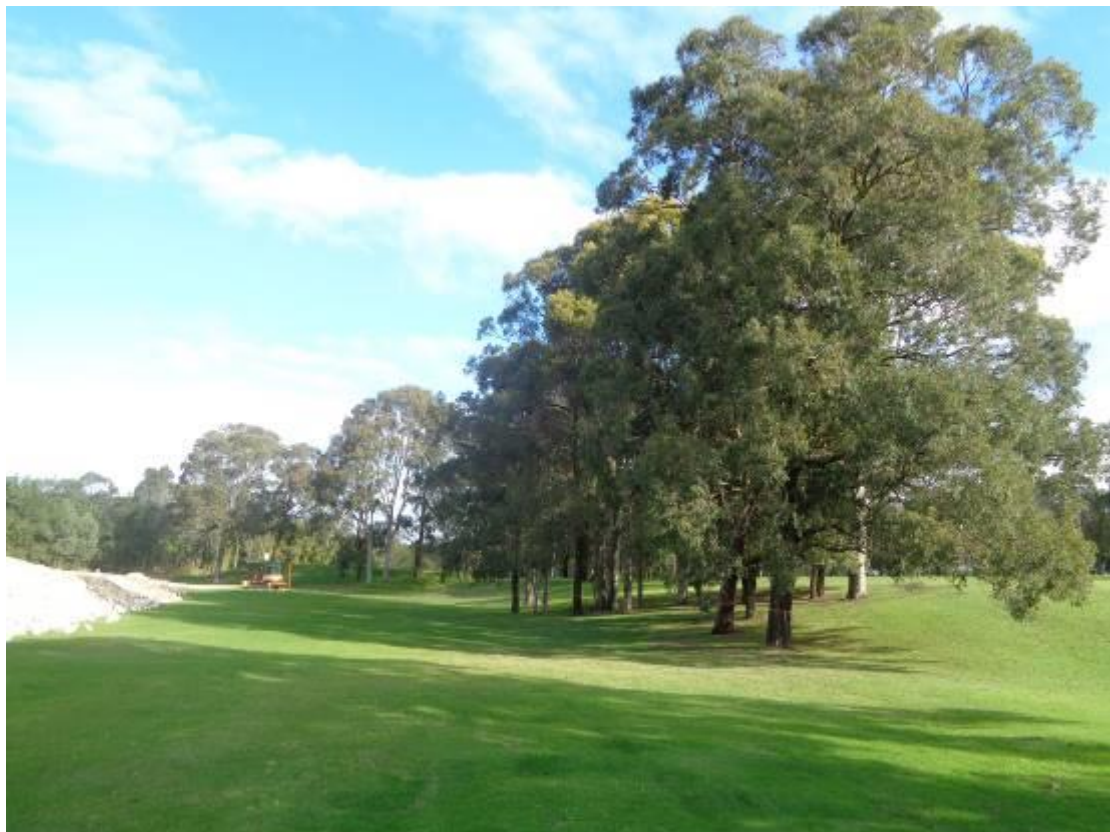
Figure 5 – showing the location of the new fairway that will be raised by up to 1.5 metres and will therefore require the removal of several trees on site.
