Arborist Report

Project No: 11506.54

Location: 48 Brown Street
Newcastle East, NSW 2303

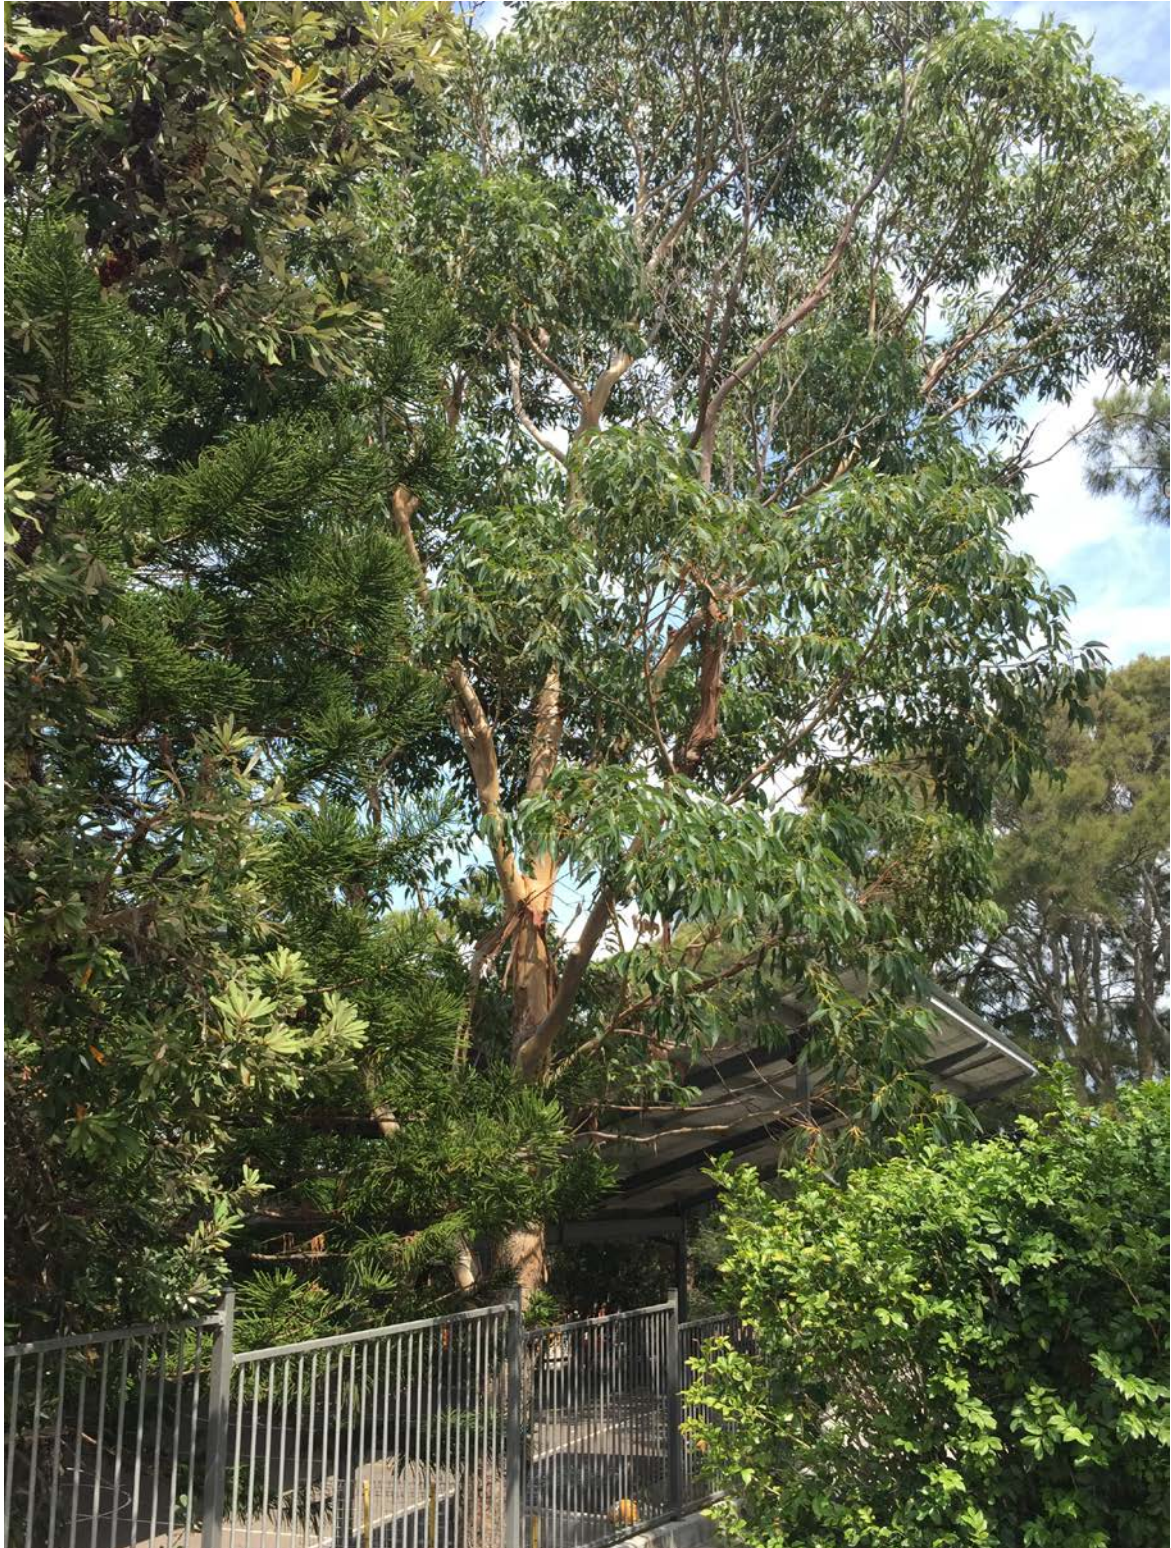
Low first order branch scaffolds are well tapered with the presents of juvenile foliage.

This tree is located in a position which could promote future growth and requires minimal maintenance at this stage.

FIGURE 16: TREE 11 LOCATED NEAR COVERED PLAY AREA AND MAIN ENTRY PATH WAY ON BROWN STREET.

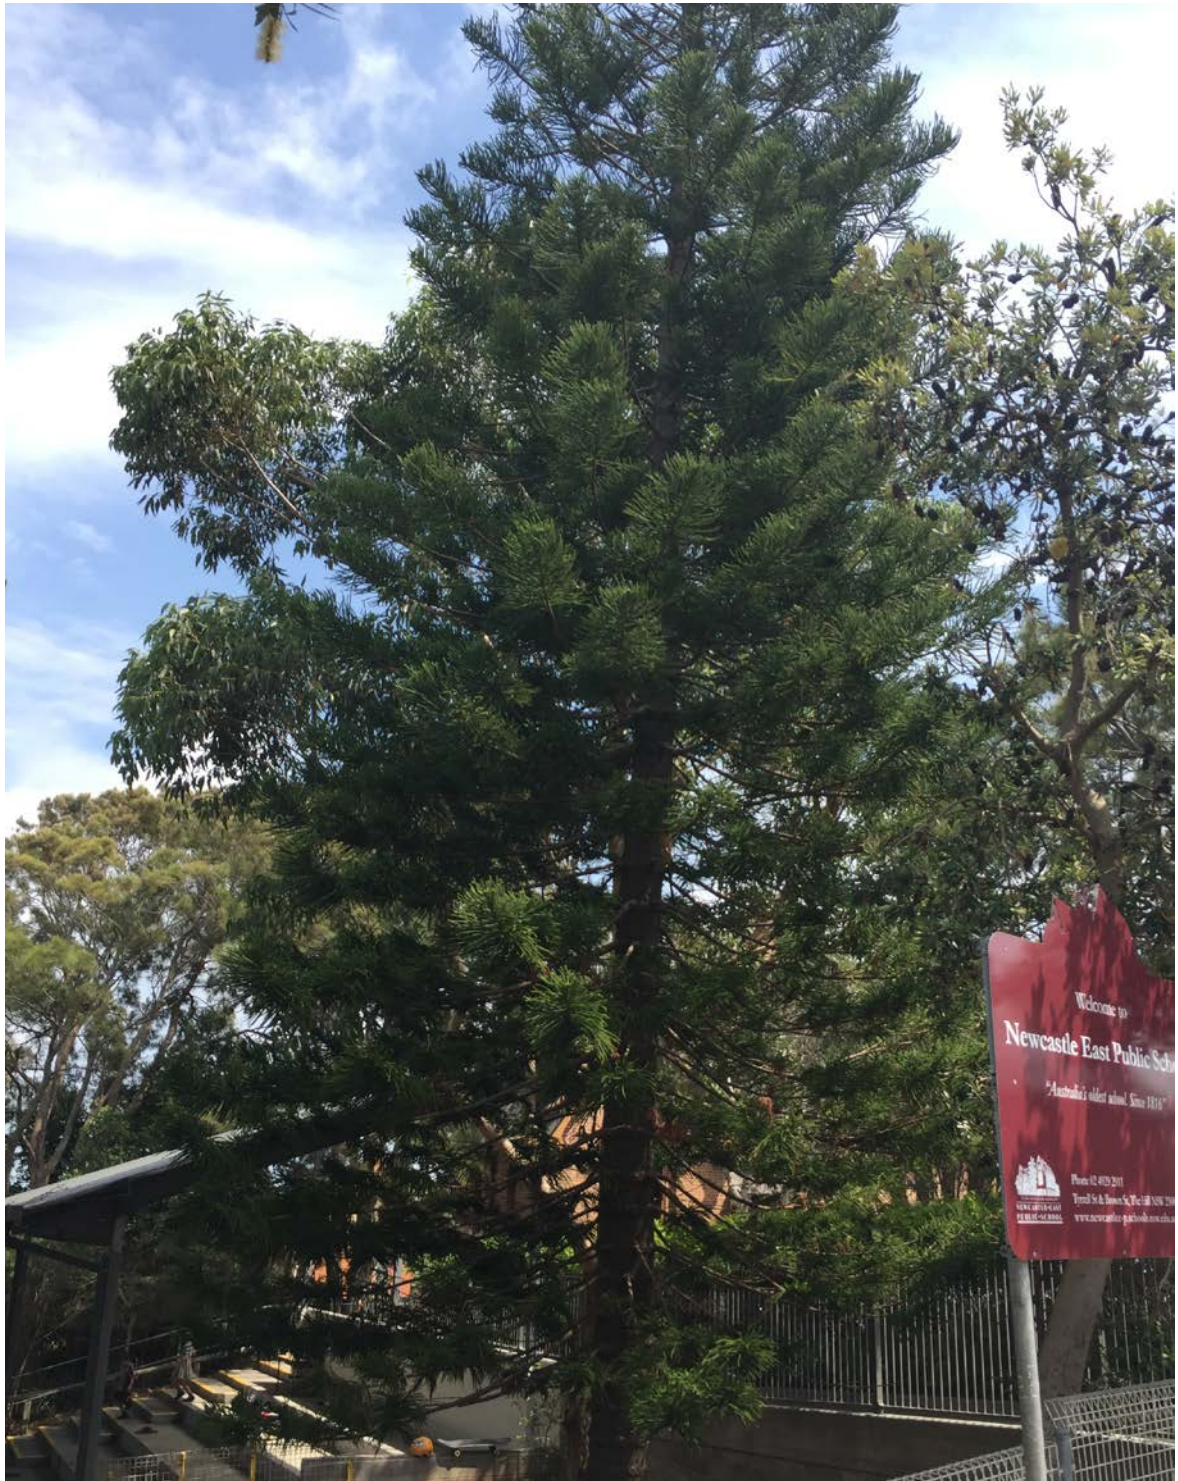
Tree 12: *Araucaria heterophylla* [Norfolk Island Pine] is a semi-mature single stemmed pine with a slight lean at the base of the tree which could indicate a completion for light and space within the earlier stages of growth development.

This tree is located in a position which could promote future growth and requires minimal maintenance at this stage.

FIGURE 17: TREE 12 NORFOLK ISLAND PINE NEAR THE BROWN STREET ENTRANCE.

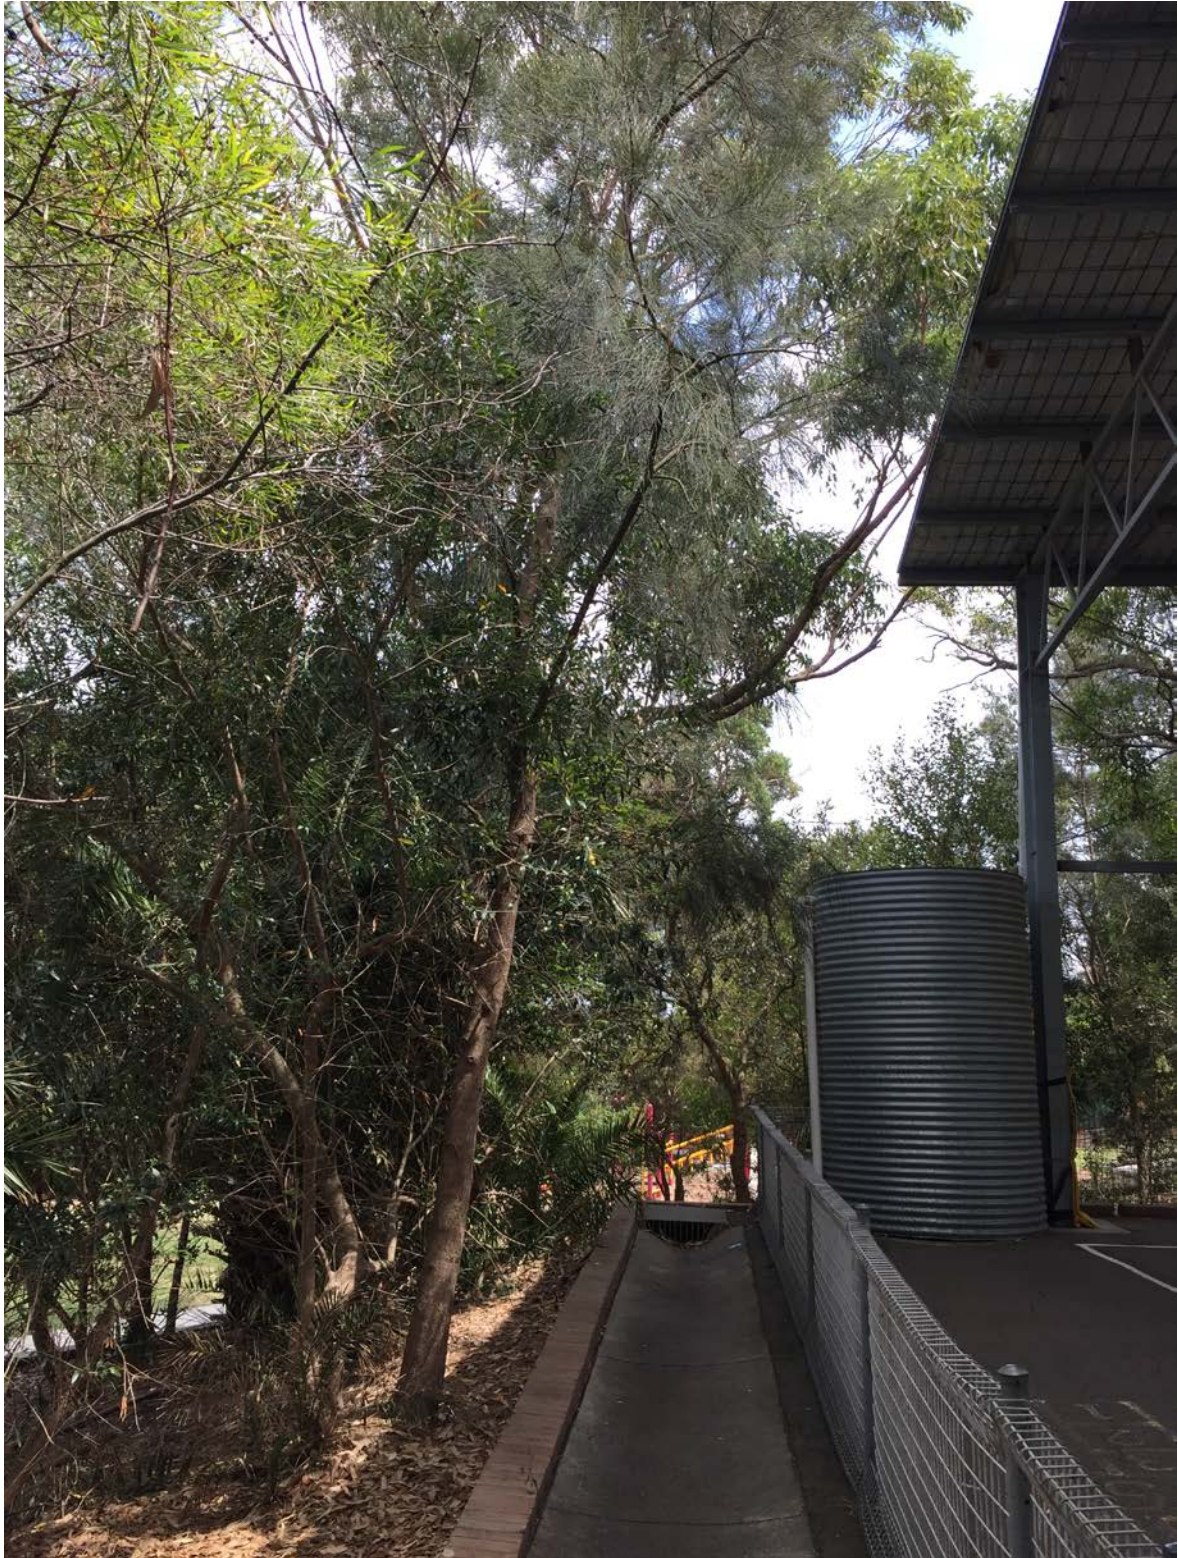
Tree 19: *Casuarina glauca* [Swamp She-oak] is a semi mature tree which is assumed to be propagation from seed dispersal.

FIGURE 25: SEMI- MATURE SWAMP SHE-OAK

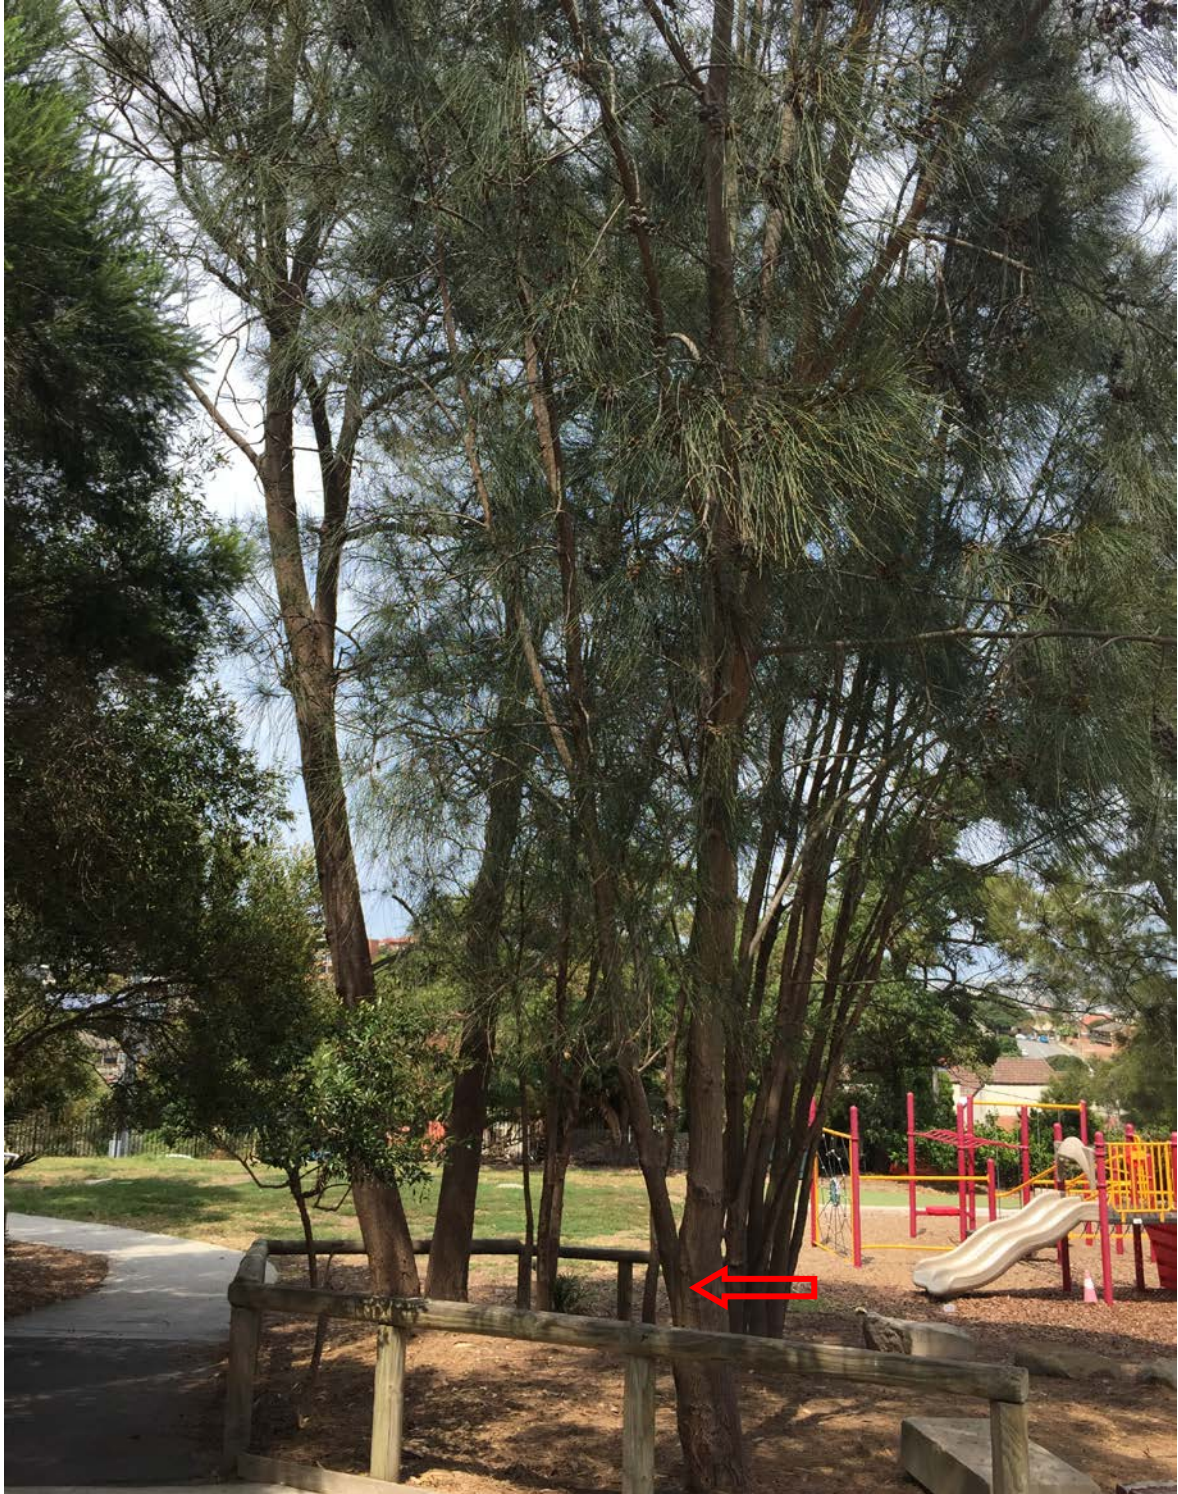
Tree 23: *Casuarina glauca* [Swamp She-oak] is a semi-mature, co-dominant tree with a multi-stemmed canopy structure.

FIGURE 29: TREE 23 SEMI-MATURE WITH A CO-DOMINANT STRUCTURE (REDARROW)

RECOMMENDATION (IF RETAINED):: Applying mulch around the root zone would benefit the tree by improving vigour and health, also protecting the surface roots from foot traffic.
