# SCHEDULE OF CONSERVATION WORKS

**Proposed works at  
29A Greenacre Road  
South Hurstville**

Job No. 2978  
December 2017

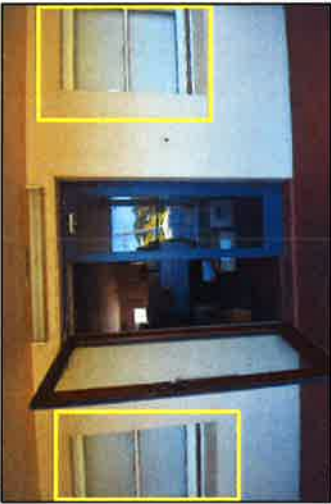
| Description / Image(s) | Condition | | Significance | Conservation Action/Treatment | |
|---|---|---|---|---|---|
| Entry at veranda of the first level.<br> | | | | | |
