CONSERVATION WORKS SCHEDULE

RAITH
74 -92 Fern Avenue, Bradbury

November 2018

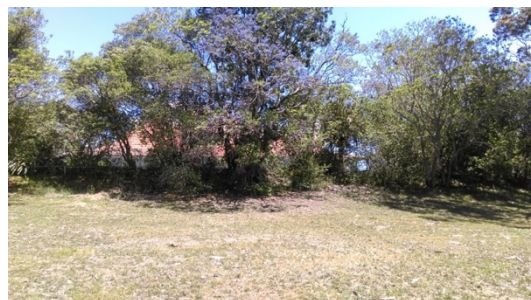
House from frontage garden along Fern Avenue

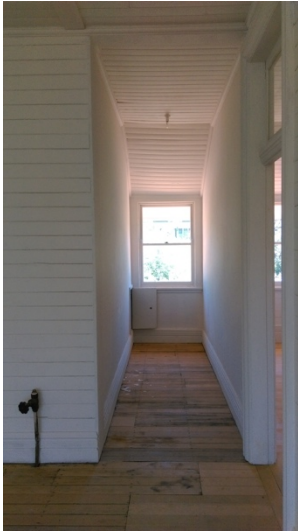
Hall 5 Sagging ceiling
