24 August 2018

Project No. 1786325-005-L-Rev3

**BIALA WIND FARM, CROOKWELL, NSW – ASSESSMENT OF TRENCHING ACTIVITIES**

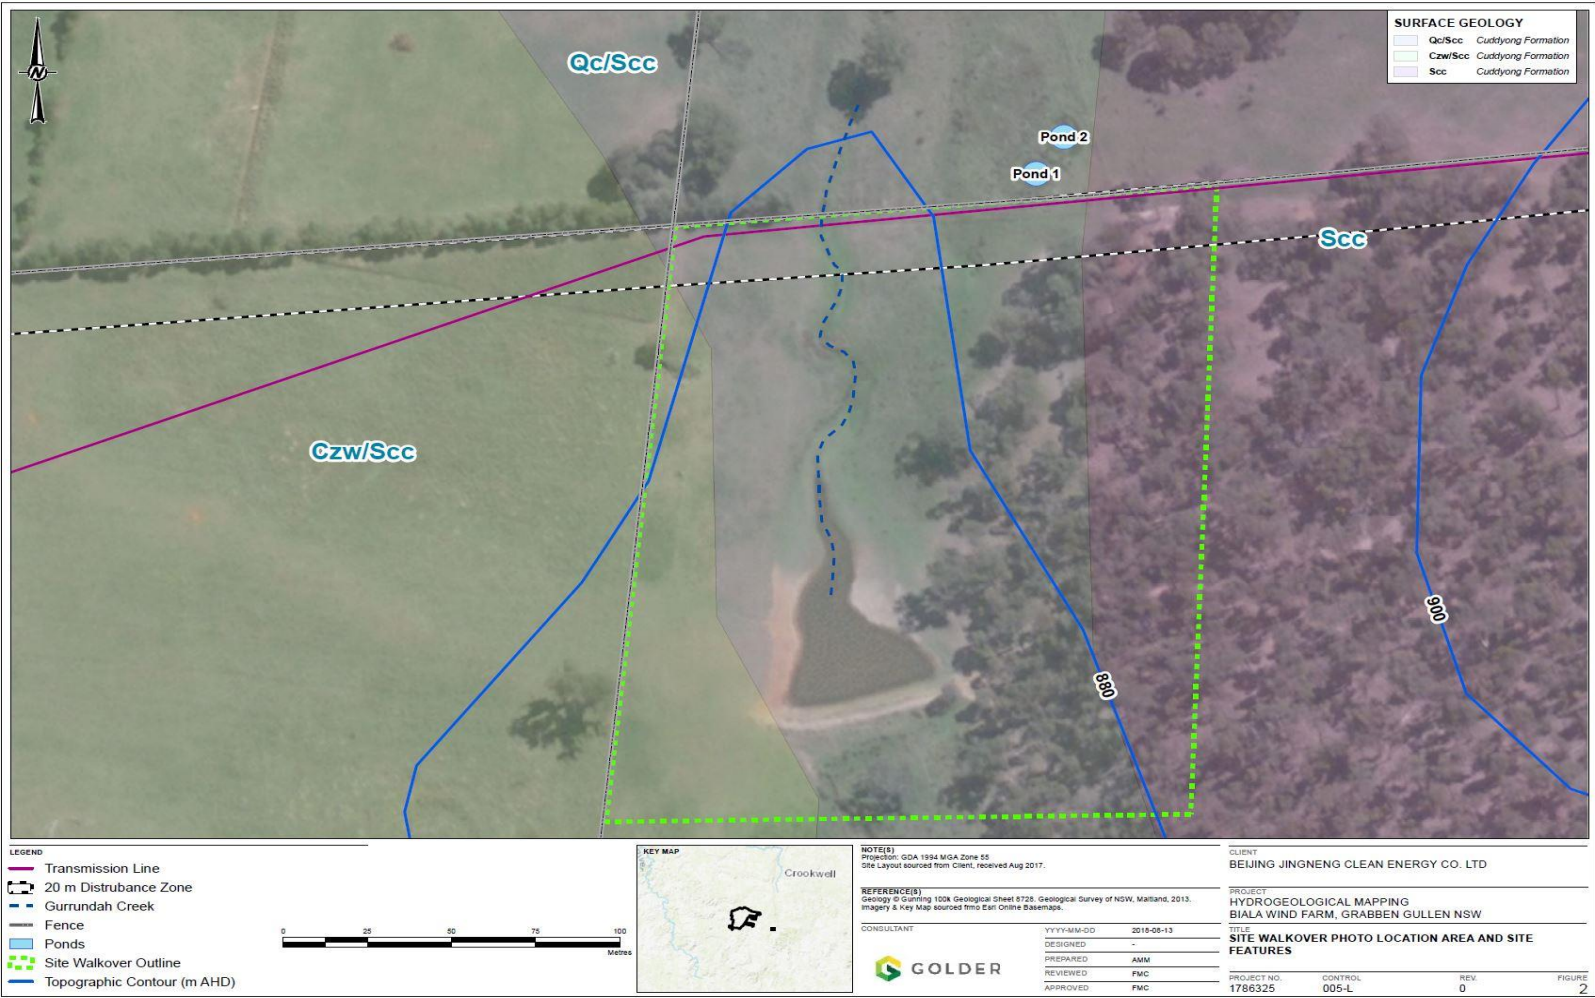
Figure 2: Site Walkover Area and Site Features

The site walkover area is shown on Figure 2. Due to landholder restrictions, Golder was unable to access either of the two springs during the site visit.

The ponds, Pond 1 and Pond 2, are to the north of the fence (black line in Figure 2). Pond 1 is approximately 10 – 15 m north of the fence (shown in grey) and Pond 2 is roughly 20 – 25 m north of the fence. The proposed alignment of the trench is shown in purple. It is understood the trench can be placed within a 20 m wide area designated for the cable trench known as the ‘disturbance zone’. The disturbance zone has a northern edge along the fence line and can extend 20 m south of the fence (shown in grey and white dashed line). The Gurrundah Creek flows north- south directions and blocked by a permanent dam that is approximately 2.5 m in height.

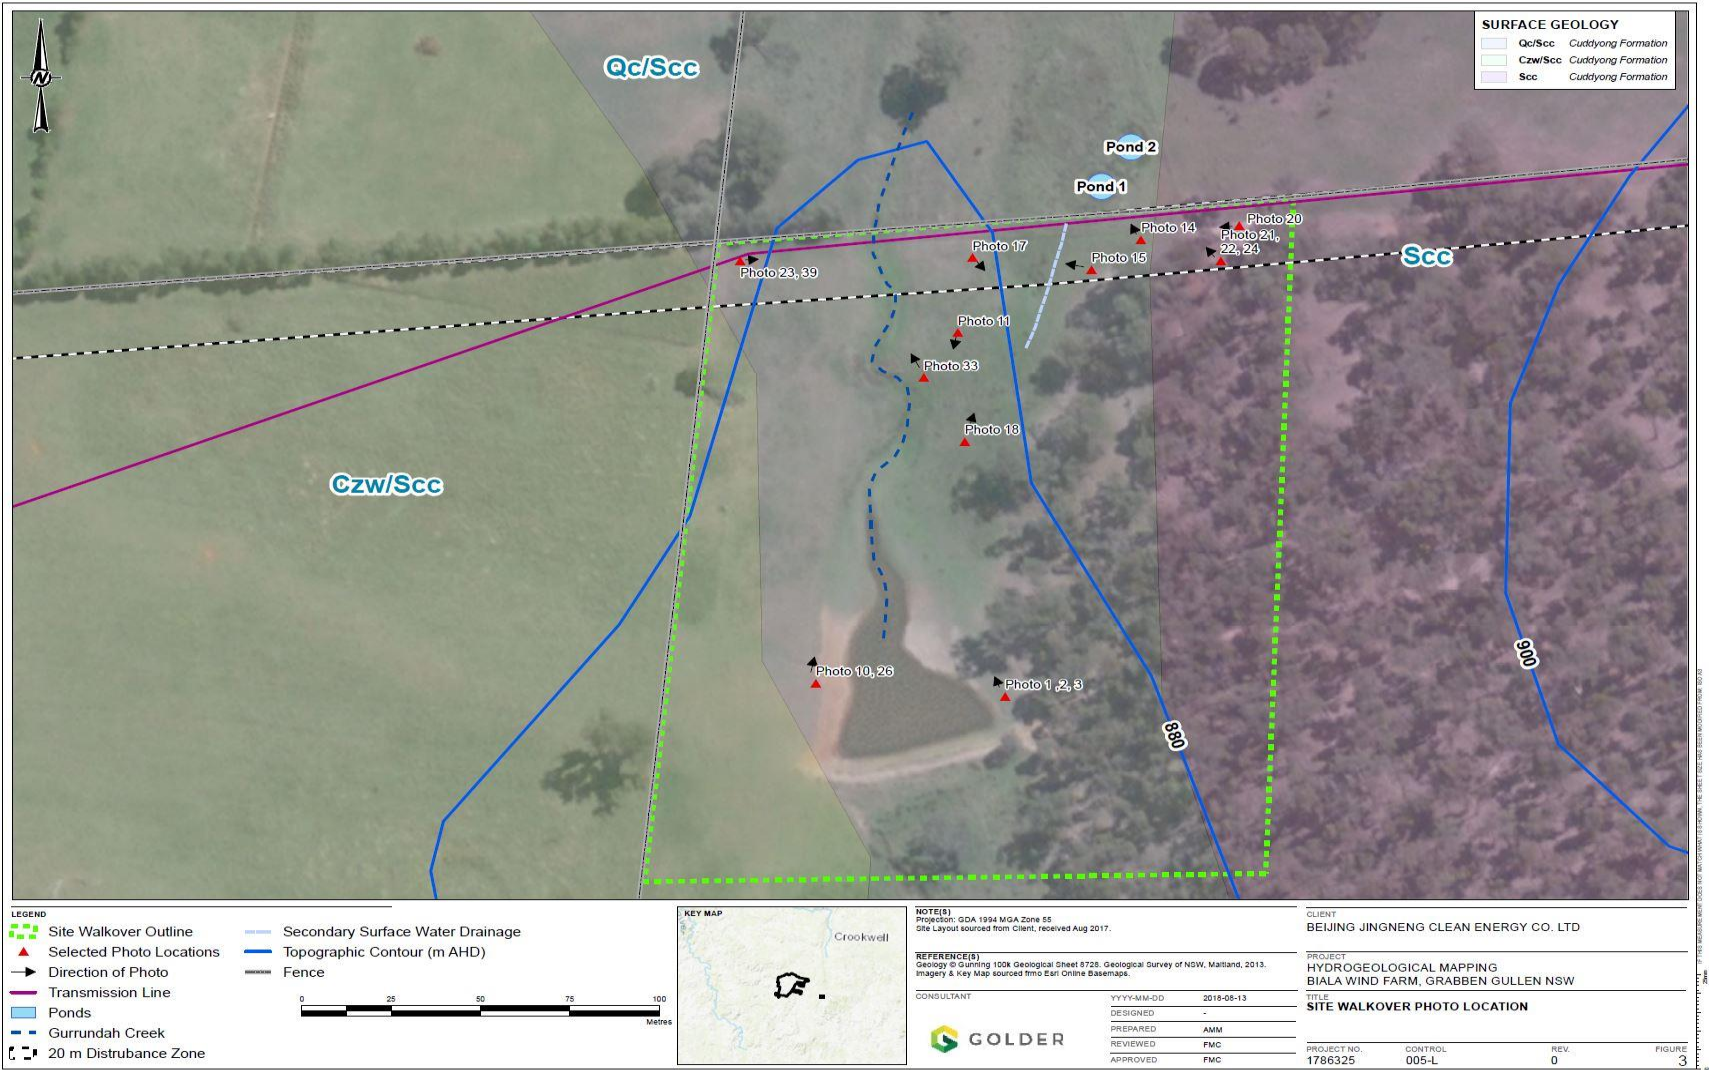
Figure 4: Site Walkover Photo Locations

- The walkover area gently slopes towards the Gurrundah Creek. A small surface drainage feature roughly 15 m south of Pond 1 was also observed.
- Topography slopes are slightly steeper on the western side of the creek than on the eastern side.

- The flow of the Gurrundah Creek is restricted by a number of barriers, creating a number of small reservoirs to the north and south of the disturbance zone. The dam roughly 80 m to the south of the disturbance zone was observed during the site visit. The dam wall was roughly 2.5 m in height. Water flow was not observed to the south of the barrier.
- Water flow along the Gurrundah Creek was intermittent, with some areas ponding and was no more than 0.2 m deep within the centre of the channel.
