# arboricultural impact assessment report

## AIA-01

Revision B, Issued for Development Application  
9 March, 2018

**Adventist Aged Care –  
RACF Extension and New ILU's  
54-56 Elsom Street, Kings Langley**

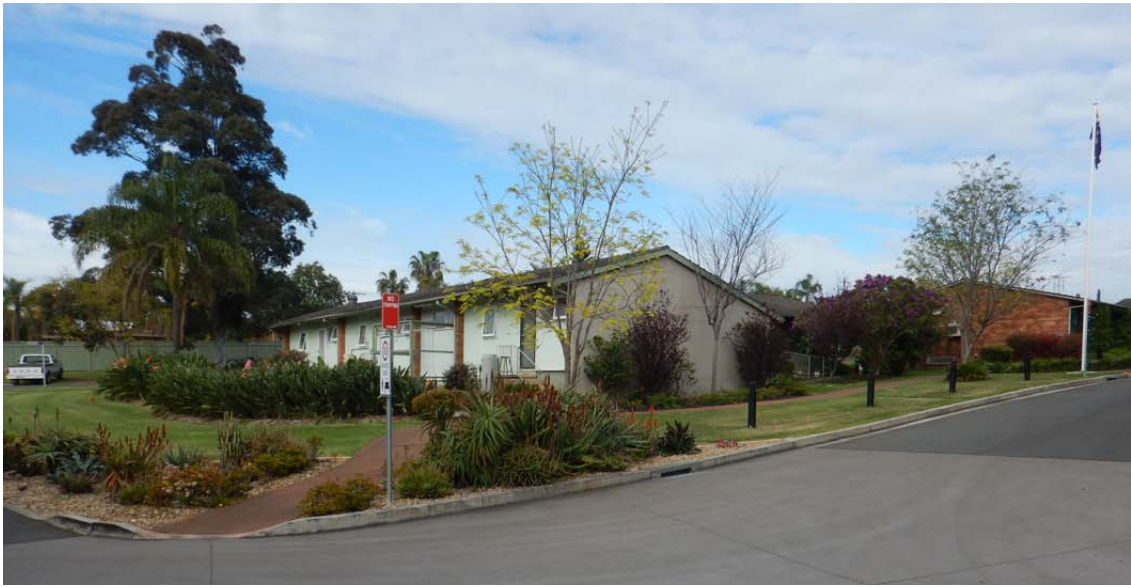
*Figure 3 – The site is generally out-of-date independent residential living units with scattered amenity planting surrounding the units and site periphery. There are only a few large or significant trees on the site. Most are relatively small exotic trees.*

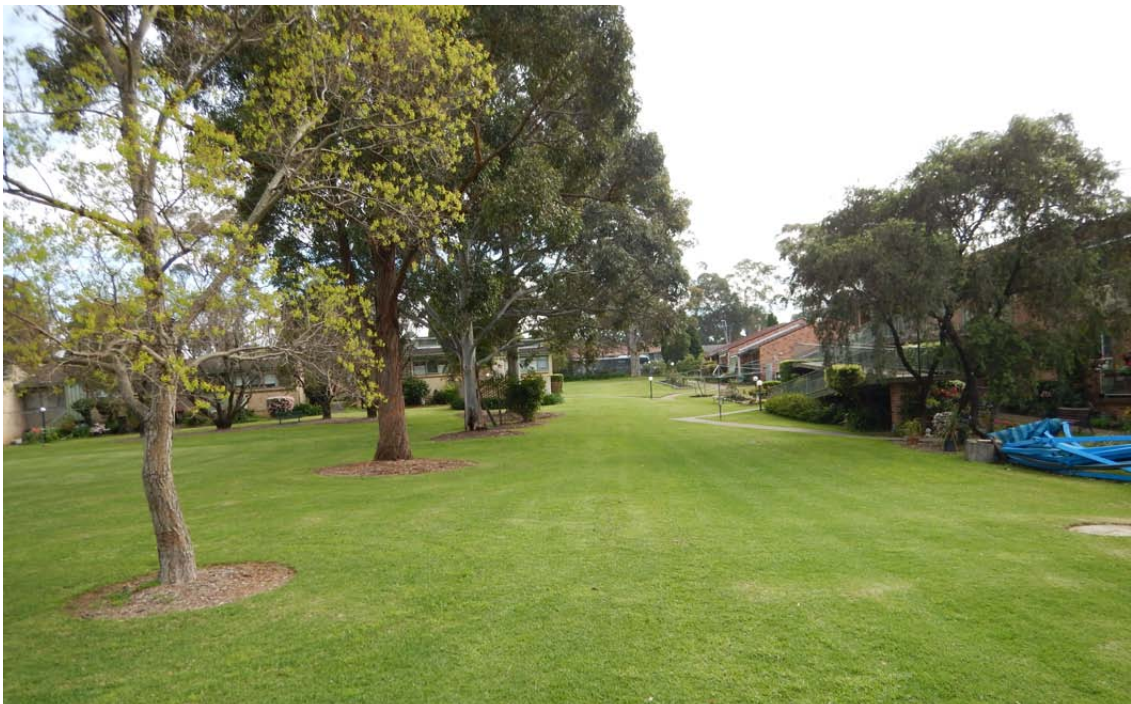
*Figure 4 –Photo illustrating the few larger and more significant trees on the site. With the proposed changes to the proposed site planning layout some of these tree are now able to be retained.*
