## **Sub-division Tree Survey**

Bathurst Regional Council  
197 Limekilns Road Kelso  
Version #1  
20/07/17

**RE: Sub-division Tree Survey at property 197 Limekilns Road Kelso, 2795**

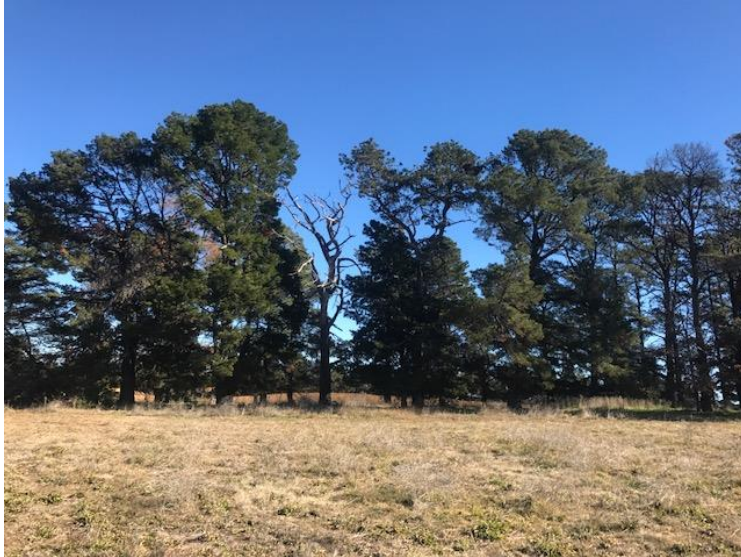
Figure 3:

**GROUP 1: INCLUDES RED ZONE A, B AND C**

Part of the windbreak, consist of mature *Pinus radiata* trees

I highly recommend that all trees within Group 1, Group 2, Group 3 and Group 4 are removed in order to provide a newly planted street scape that can evolve from the newly cultural conditions.
