Our Ref: 217032_STR_002a.docx

12 August 2016

WELLINGTON SWIMMING POOL – STRUCTURAL CONDITION ASSESSMENT. FULL REPORT.

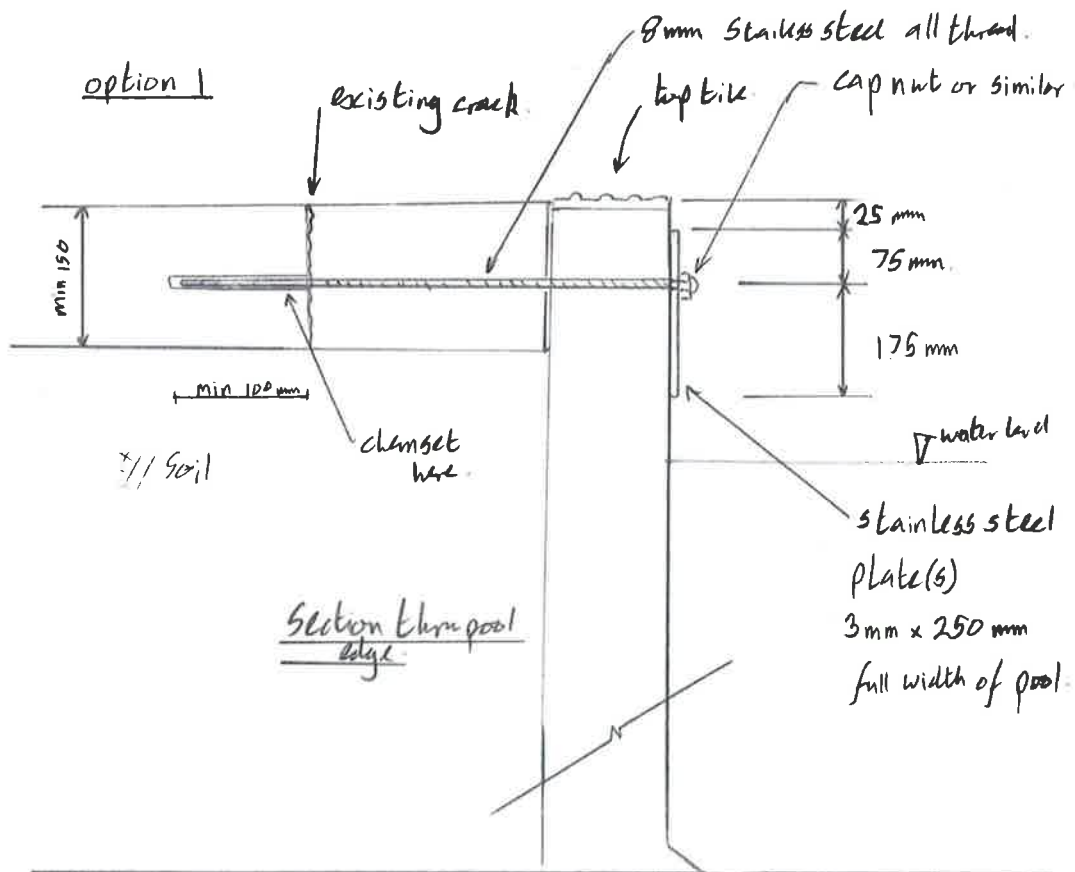
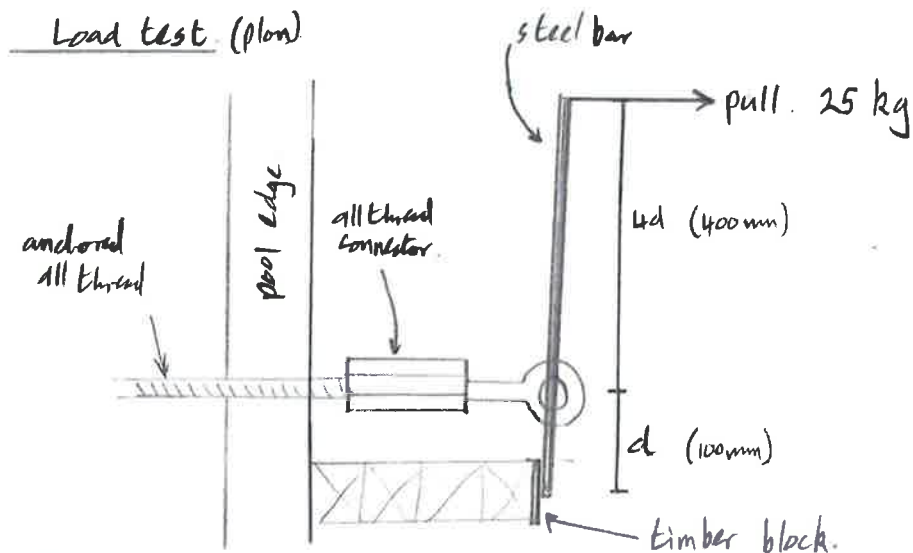
Sheet: 1 of 1

The purpose of this repair is to secure the edge of the pool back to the ground behind so that a swimmer cannot accidentally pull the wall down onto themselves. This repair is temporary repair and is safe for 3 years. After 3 years it will need reassessment to determine on going effectiveness or alternative repairs.

1. Drill 10mm dia horizontal holes through side of pool at approx. 100 mm below the top, 500mm spacing.
2. Blow dust/debris out of holes
3. Insert chemset Reo 502 into hole (end of hole only), use long tube to ensure chemical is at the end of the hole in the sound concrete,
4. Insert stainless steel all thread. Turn as it is inserted to spread the chemset epoxy.
5. Allow to set.
6. Load test anchors as described
7. Mark and drill holes in stainless steel plate
8. Trim protruding length of all thread to suit
9. Place stainless steel plate (see specifications on next page)

1. Attach connector and hook or eye to all thread.
2. Direct pull 100kg. OR
3. Use timber blocking against pool side
4. Insert bar in hook, use 4:1 mechanical advantage and pull 25kg. (Suggested dimensions shown).
 - a. Note: 25 kg is a reasonably good effort by a worker, using his foot against the side of the pool and pulling back.
 - b. Approximate load (25kg) is ok, this need not be exact.
 - c. Anchor passes if it remains in place or moves less than 2mm after load is removed. (Measure length before and after load test).
 - d. Anchor fails if it breaks or moves more than 2mm after load is removed. Take care that a sudden break does not injure the tester.
5. If the anchor fails the test at 50kg or more, increase the spacing in the anchors to 250mm c/c. If the anchor fails the test at less than 50kg, abandon and use method 2.

1. Cut holes in concrete slab min 100 dia (recommended 150mm, but limited by ability to put a hand down and manipulate a washer and bolt)
2. Drill hole through side of pool.
3. Insert all thread into hole until the end is in the centre of the excavation
4. Place a washer and nut onto the all thread. Washer to be min 50 mm dia.
5. Pour concrete into hole and finish at the surface level surface.
6. After concrete is cured, install stainless steel plate
7. Mark and drill holes in stainless steel plate
8. Trim protruding length of all thread to suit
9. Place stainless steel plate
10. Place acorn (cap) nut on and tighten to suit. (other smooth fixings without sharp edges may be used instead)

- Anchors should be 500 mm apart (unless they fail the load test as per above). Spacing can vary +/-100mm provided the average is 500mm or less.
- Plates should be min 1200mm long with 3 anchors in each
- The gap between plates should be 400mm or less.
- Plates should be bolted no more than 100mm from the edge
- Plate corners and edges should be rounded to remove any sharp edges.
- Plates, nuts and all threads should be matching grade of stainless steel, Grade 304 or 316
