Arboricultural Impact Assessment Report

461-473 Pacific Highway
Asquith NSW

Prepared for: Calder Flower Architects
c/- Chinese Australian Services Society
Limited

Prepared by: Jack Williams
Urban Arbor Pty Ltd
Ref: 18/08/23/461PHA
Date prepared: 26 June 2019
Revision: A

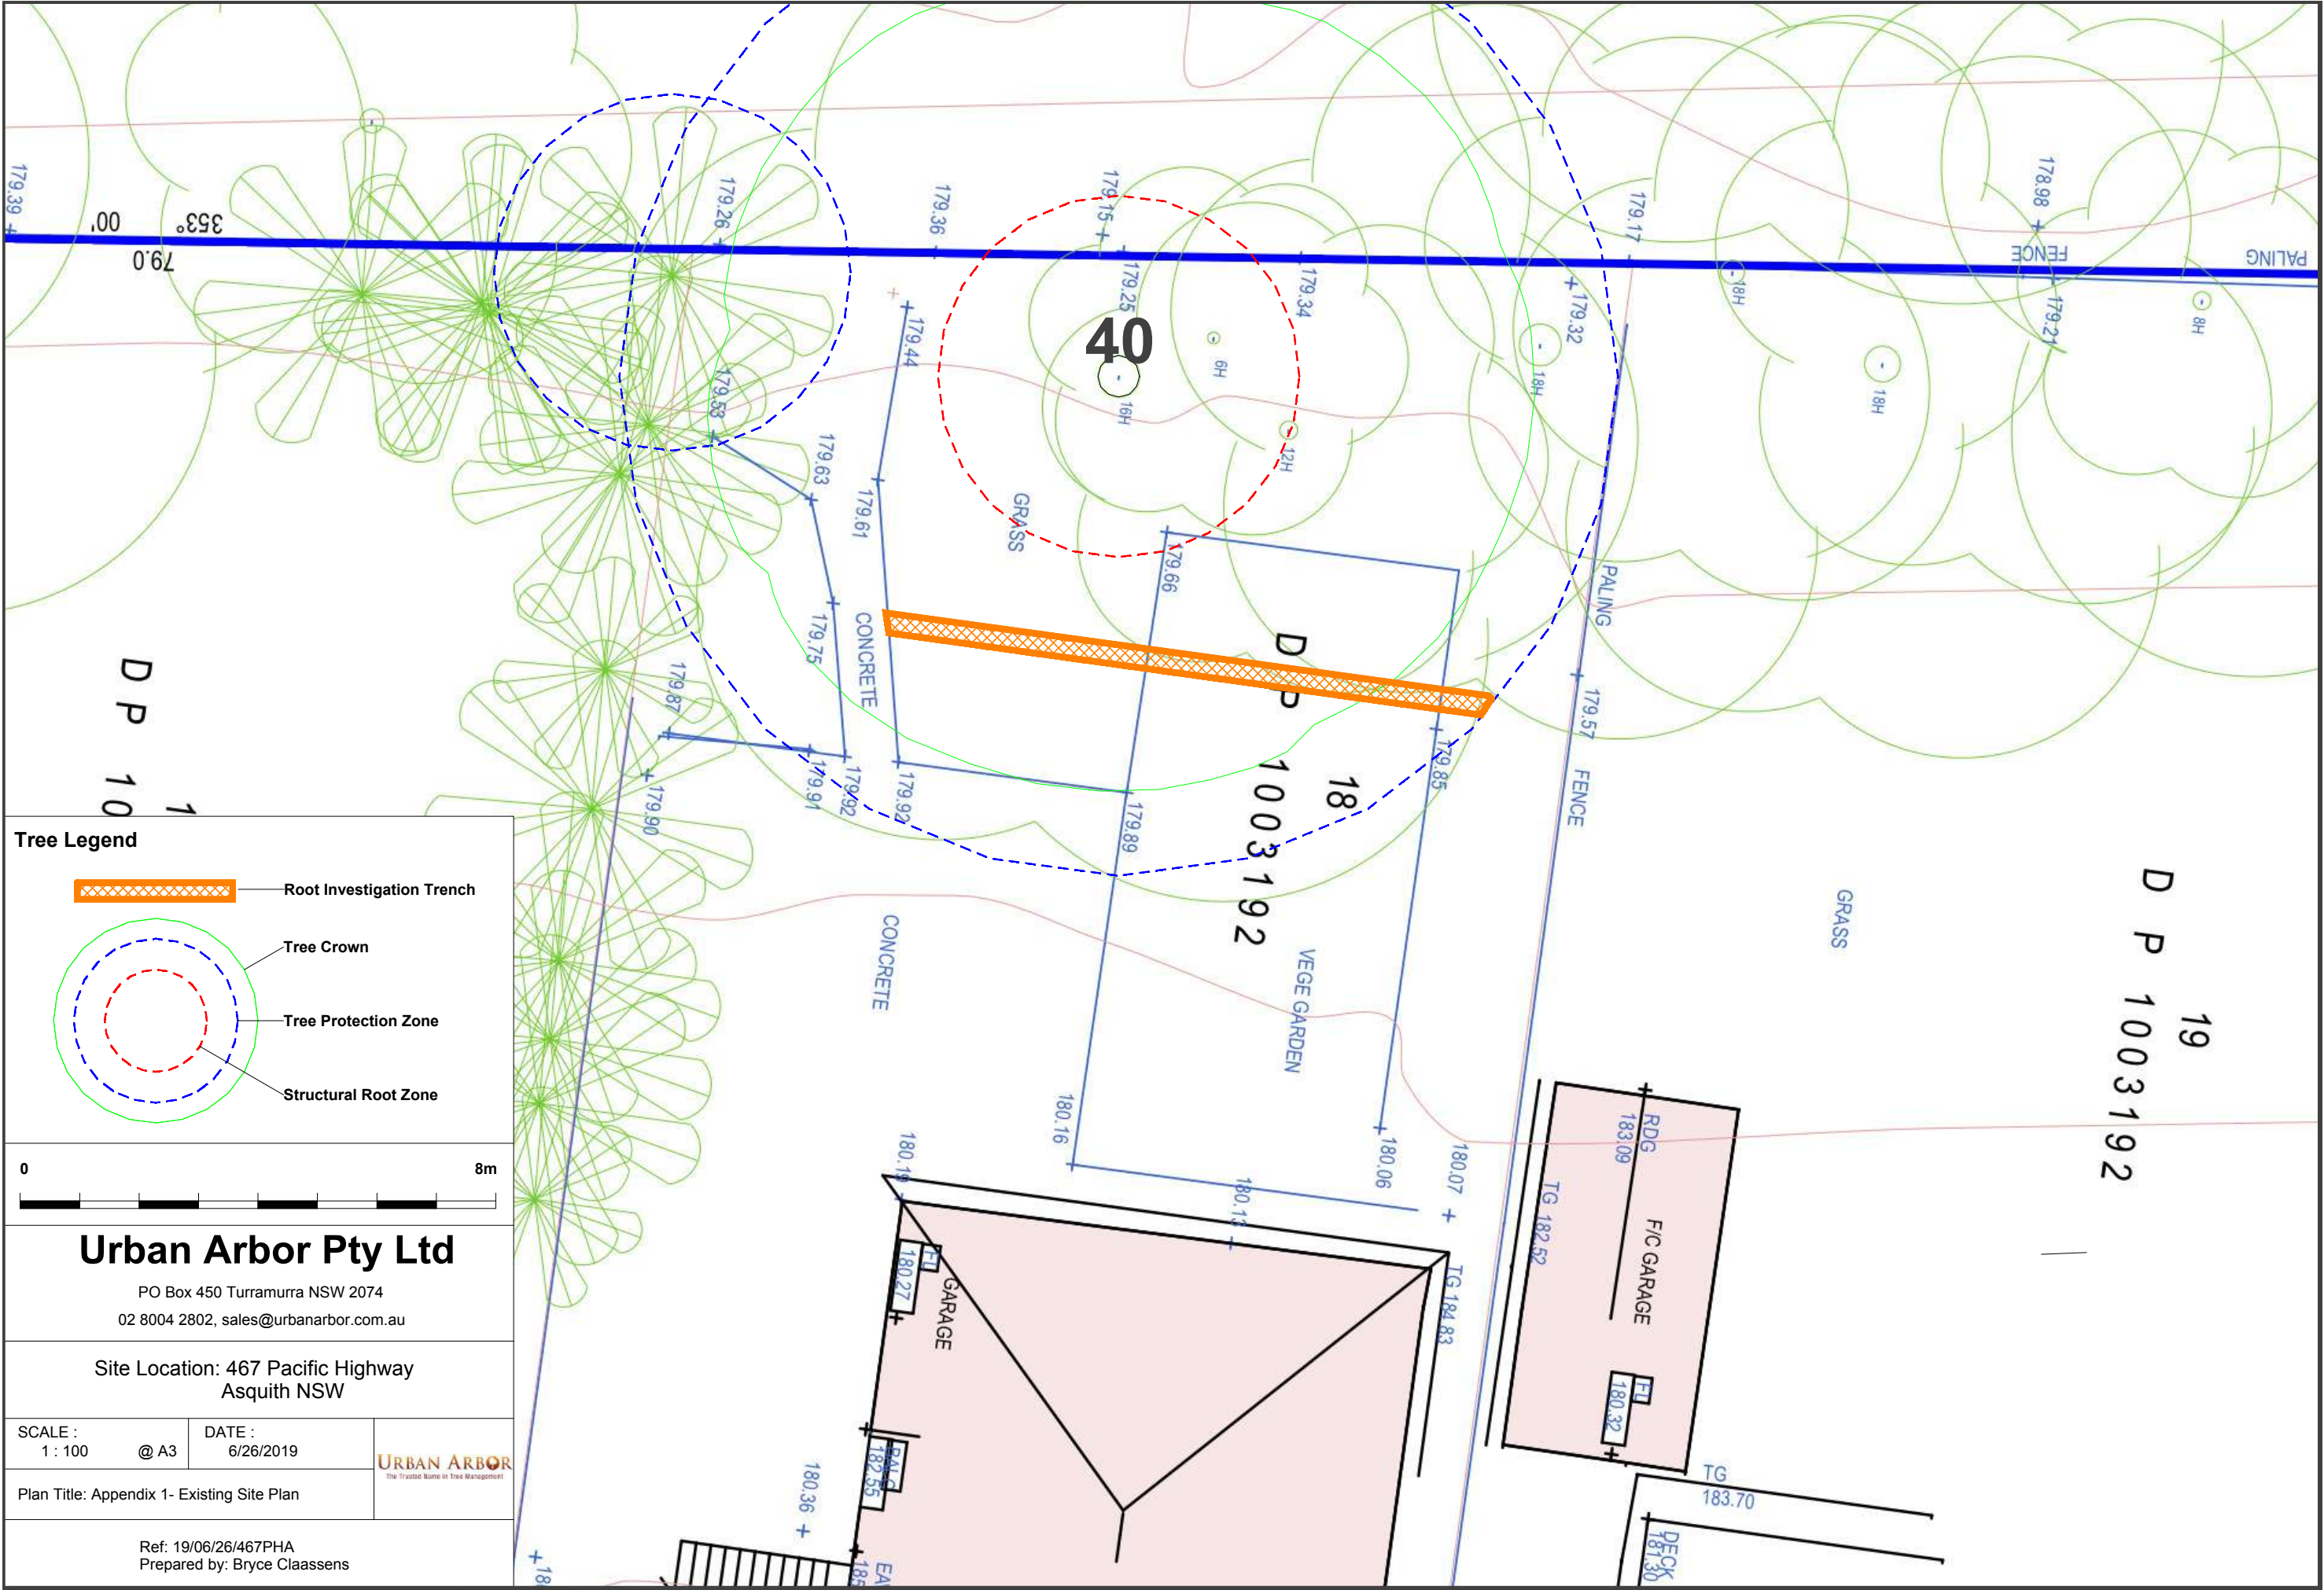
- 10.4 Root investigations were completed in the location of the proposed basement excavations within the TPZ of tree 40 on 25 June 2019. No significant roots were identified within the root investigations trench. Therefore the proposed basement excavations will not significantly impact the condition of tree 40 and the tree can be retained in a viable condition. See appendix 4 for the Arboricultural Root Investigations Report.

5.1.2 **Root Information:** Root investigations were completed in the location of the proposed excavations for the basement car park within the TPZ of tree 40 (Image 1). One root investigation trench was completed and is referred to as trench 1. See appendix 1 for a plan showing the location of trench 1.
