CONSERVATION MANAGEMENT PLAN

Former Fire Station No. 3 William Street, Fairfield

January 2020

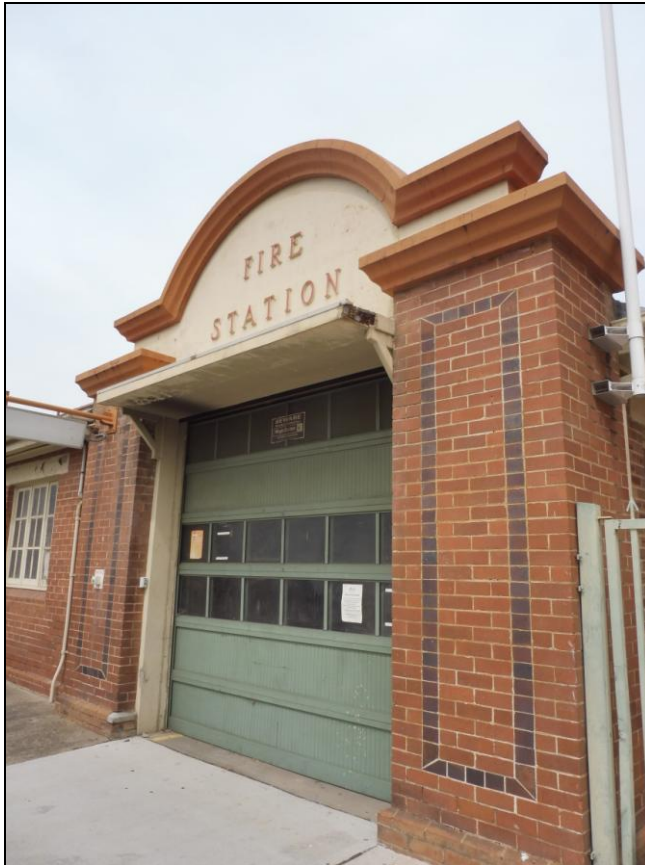
Figure 3.11 The front façade comprises of two bays. The northern bay retains wide opening which was modified as part of the c. 1997 work, but retains the original wide brick piers. The hood was also replaced a modern panel door has also been added to the opening as part of the c. 1997 works to the building.

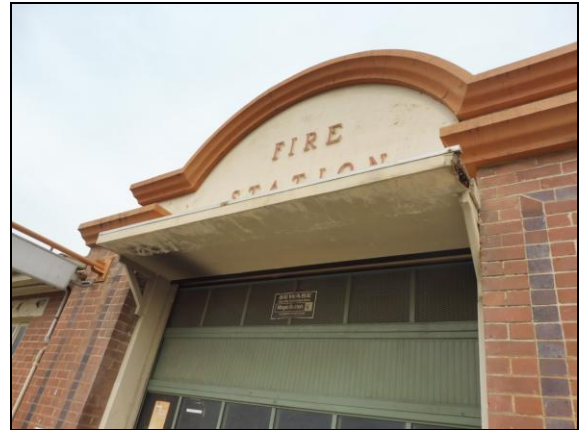
Figure 3.12 Service elements including the emergency call button and signs have been added (and removed) from the façade. The brickwork at the base of the central pilaster has sustained some damage. Some of the mortar joints in the brickwork have also failed.

- repair to damaged brickwork and failing mortar joints on the front façade;
- repair of cracked brick and infill of an opening on the north eastern brick façade;

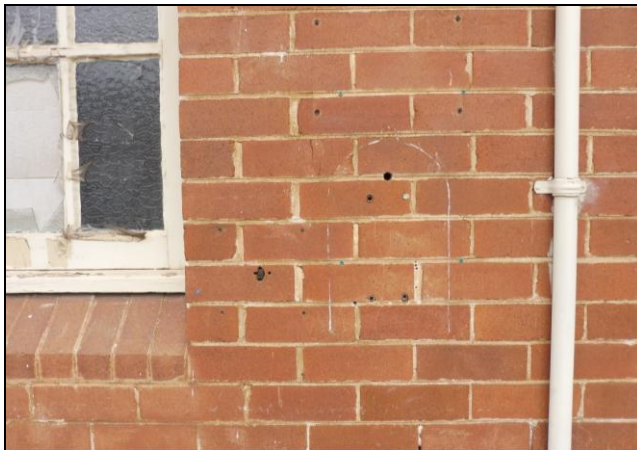
Figure 3.15 Evidence of past elements and fixing holes on the façade.

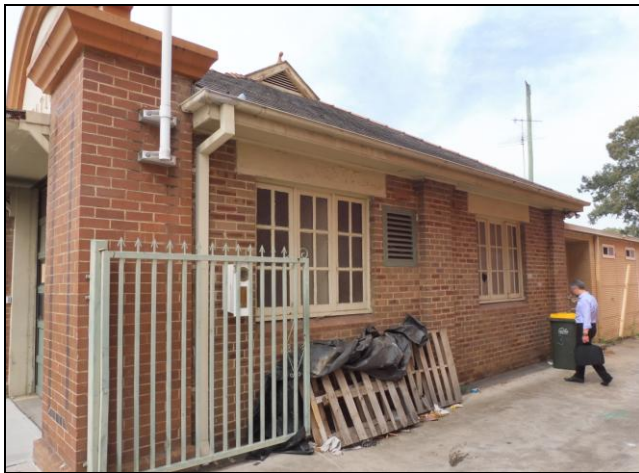
Figure 3.18 The northern façade of the main wing of the building also comprises of two bays divided by projecting pilaster. A gate post and flag pole been added to the north eastern corner (c. 1997). A vented opening also appears to have been added at this time.

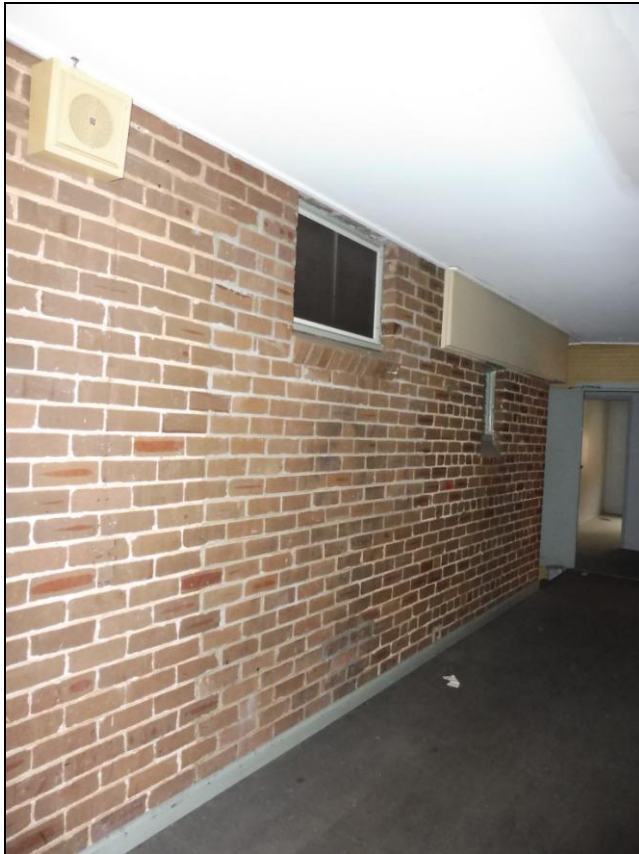
Figure 3.27 Differing brickwork further along the northern façade of the rear wing and bulkhead occurs in line with what is assumed to be an early, skillion roofed addition. The bulkhead/ infill is assumed to have been added as part of the c. 1997 works.

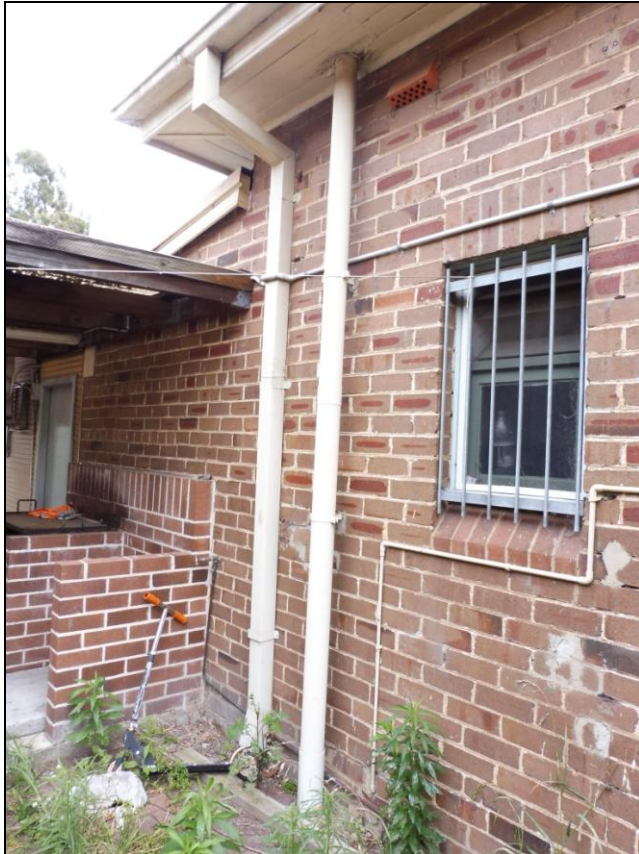
Figure 3.33 The brickwork at the southern façade has no signs of additions, however some variation in the bond is evident. The original plan shows a “drill tank” at the end of the rear wing which may have been enclosed by a brick wall. In 1938, by which time it is assumed that the brick skillion roofed section is assumed to have been added, the tank was shown in the location of the B-B-Q.

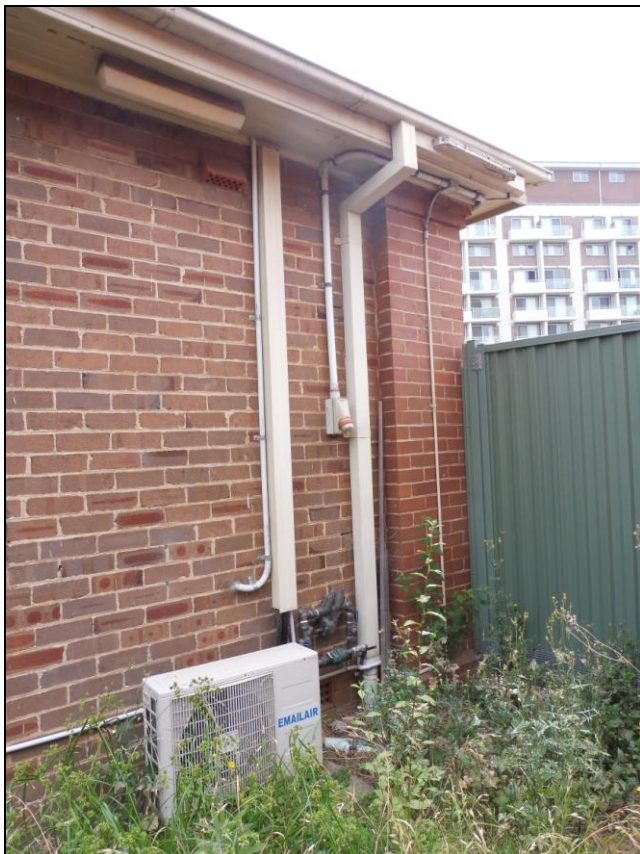
Figure 3.37 Service elements and fence with gate fixed to the south eastern corner of the building.

- removal of metal bars and hoods (southern façade), repair of timberwork and flashings and replacement of broken glass panes to the windows to match;
- removal of redundant services and conduits, air conditioning units, water pipes, taps and sink (southern façade) and repairs to the brickwork, infill patching, repointing of the front, northern and southern facades;

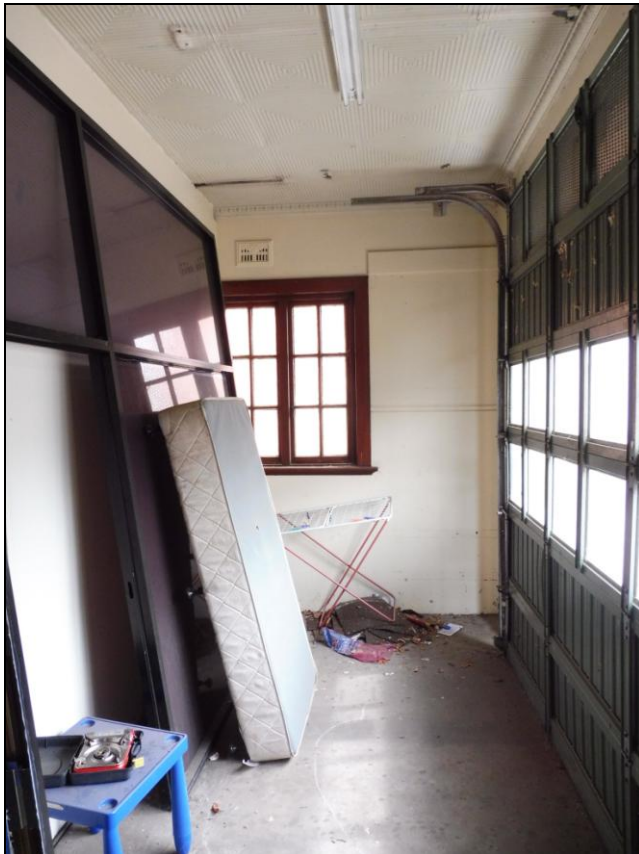
Figure 3.38 The former engine bay which has concrete floor and high pressed metal ceiling and cornice. The original timber doors have been replaced with a model panel door. An inscription in the rendered surround indicates that work was also undertaken to this area in 1997.
