SCHEDULE of CONSERVATION WORKS

3 William Street

FAIRFIELD

Job No. 8842

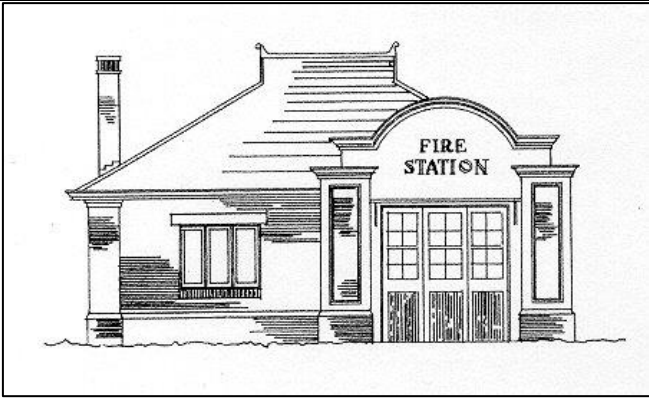
FAIR - GOOD	HIGH	<p>Slate shingle hipped roof with gablet and terracotta capping, timber fascia and ram horn finials to be retained and conserved in situ.</p> <p>Retain and conserve face brick masonry interspersed with columns and a rendered semi-circular pediment, timber window with rendered lintel and large metal roll up garage door for fire engine.</p> <p>Original chimney stack still intact. This is to be retained.</p> <p>Primary driveway along northern edge and secondary entrance along southern extent.</p> <p>Allow general cleaning of façade before beginning conservation works.</p> <p>All drainage, water supply and electrical fitting should be rationalized and decluttered.</p> <p>Remove metal roll-up door and reinstate original timber door as shown in original elevation drawing.</p>

<p>Where a new ramp is to be introduced for BCA compliance at the entry to the east, it is as far as possible, not to be fixed to the original brickwork and materials of this elevation. New fabric should be, as far as possible, self-supporting/freestanding, and or fixed to non-significant fabric.</p> <p>Where new entry door to the eastern elevation is to be introduced, the original door should be reinstated based on photographic evidence (see image in table across).</p>
Roof – Slate shingles

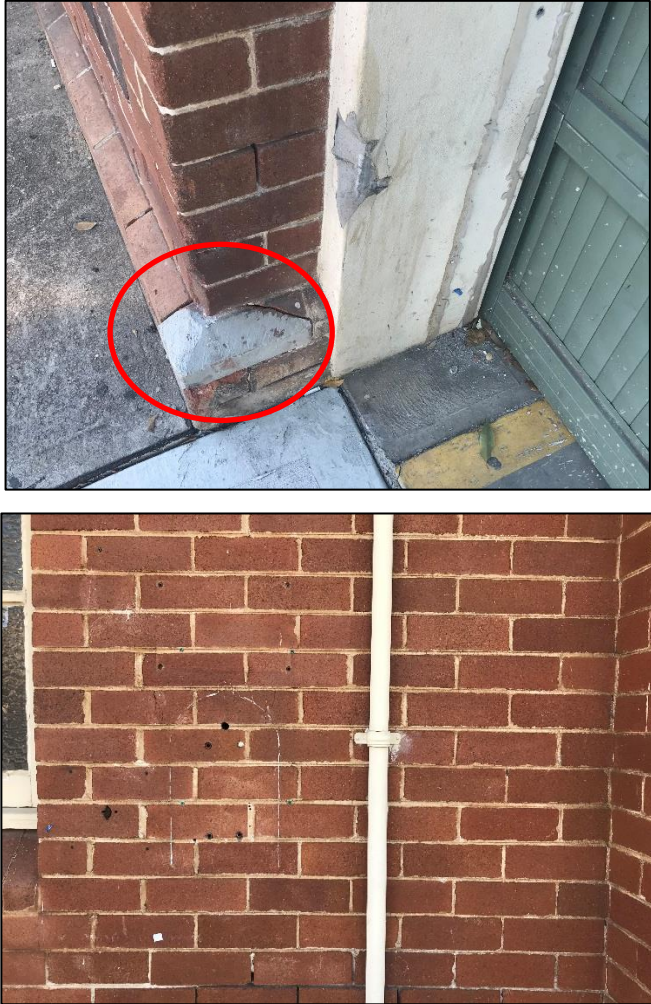
Table 3.2.1: East Elevation				
ELEMENT	PHOTOGRAPH	CONDITION	SIGNIFICANCE	CONSERVATION ACTION FOR DA
				External painted scheme should be kept.
External Boundary – Face brick masonry

GOOD - FAIR	HIGH	<p>Face brick masonry in running bond with coloured accents in columns.</p> <p>Loss of pointing in isolated areas of the northern elevation. Repointing to be undertaken with Westox pointing mortar in flushed finish. Mortar to be pre-mixed by weight and not volumetrically. Take care to point all corners.</p> <p>Isolated incidents of discolouration at the base of the wall. General cleaning recommended prior to the commencement of any conservation works.</p> <p>Missing and spalled bricks to be replaced like for like onto the original brick courses.</p> <p>Remove concrete infill at the base of the southern column of roll up door (red outline) and replace with specifically cut brick onto original brick.</p> <p>Inclusions and drill holes may be retained.</p> <p>All drainage, water supply and electrical fitting should be rationalized and decluttered. Remove all PVC pipes and replace with age appropriate materials.</p>

Where a new ramp is to be introduced at the entry to the east, it is as far as possible, not to be fixed to the original brickwork and materials of this elevation. New fabric should be, as far as possible, self-supporting/freestanding, and or fixed to non-significant fabric.

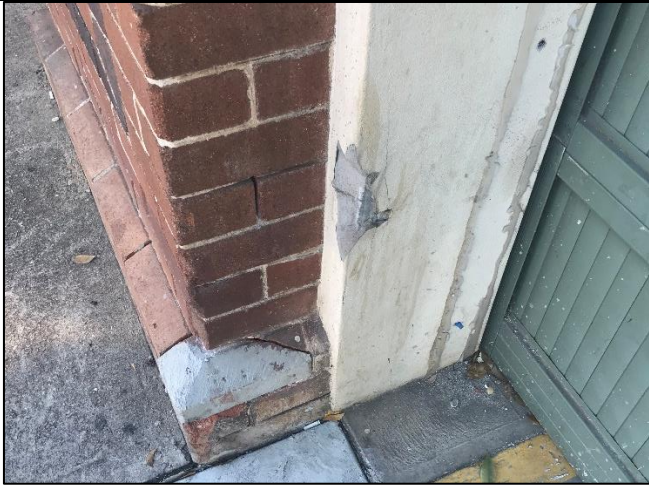
POOR – VERY POOR	MODERATE	Side panels along engine room entrance show signs of damage possibly caused by approaching or reversing vehicles. Repair render like for like to match existing. Repaint entire panel in matching colour scheme after consultation with the appointed Heritage Architect.

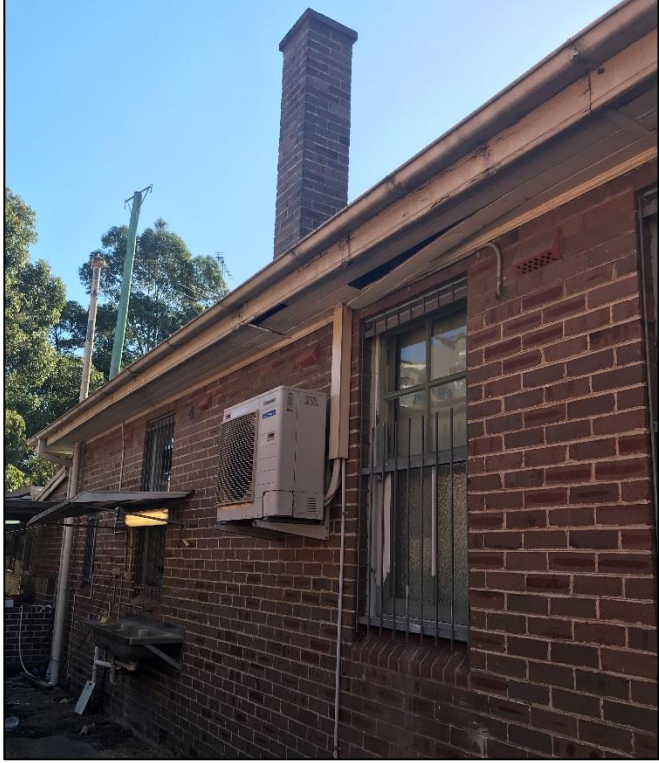
FAIR – POOR	HIGH	<p>Face brick masonry appears in poor condition due to later repointing that is feathered. Rack joint and repoint using Westox pre-mixed mortar in flushed finish. Mortar to be supplied pre-mixed by weight and not volumetrically.</p> <p>Isolated incidents of discolouration due to water ingress. Source of water damage to be investigated and repaired. General cleaning recommended prior to the commencement of any conservation works.</p> <p>Missing and spalled bricks to be replaced like for like onto the original brick courses.</p> <p>Terracotta ventilators and chimney stack are in fair condition and should be retained and conserved.</p>

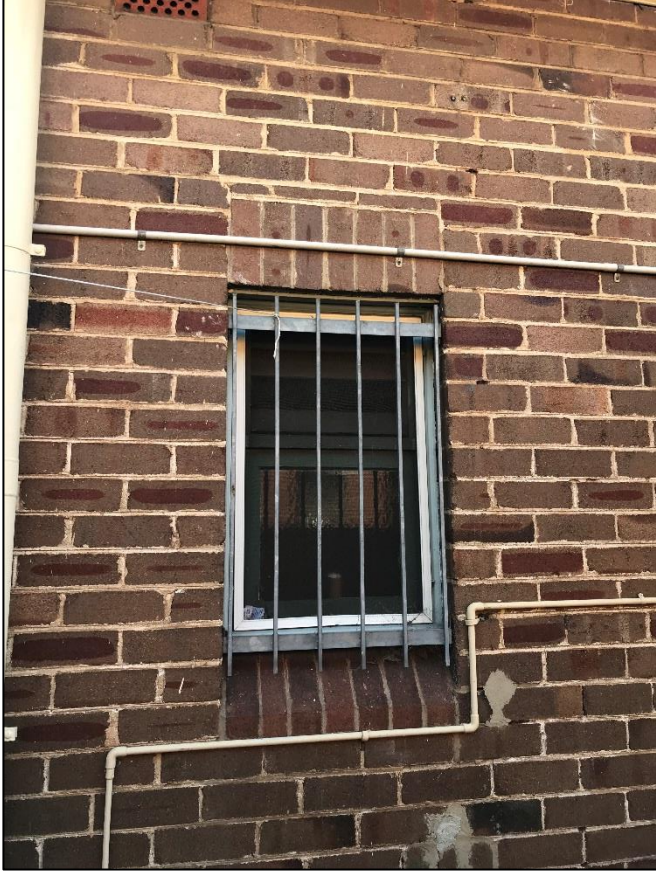
POOR	HIGH	<p>Timber window with rendered lintel, brick sill and textured glass panes.</p> <p>Minor damages to window frames to be repaired.</p> <p>Window should undergo further inspection to ensure all leaves, sash cords are in working condition and all hardware is sound. Replace like for like if any damages found.</p> <p>Face putty along muntins requires cleaning and repair as years of over painting have resulted in putty being unequal and covering glass panes. This can be done at a later time.</p> <p>Glass panes are in fair condition. Remove paint from panes. Missing or broken panes should be replaced with like for like.</p> <p>External painted scheme should be matched to other elevations.</p> <p>Aluminium grills to be removed from the original fabric.</p> <p>Light attached to window details should be removed.</p>

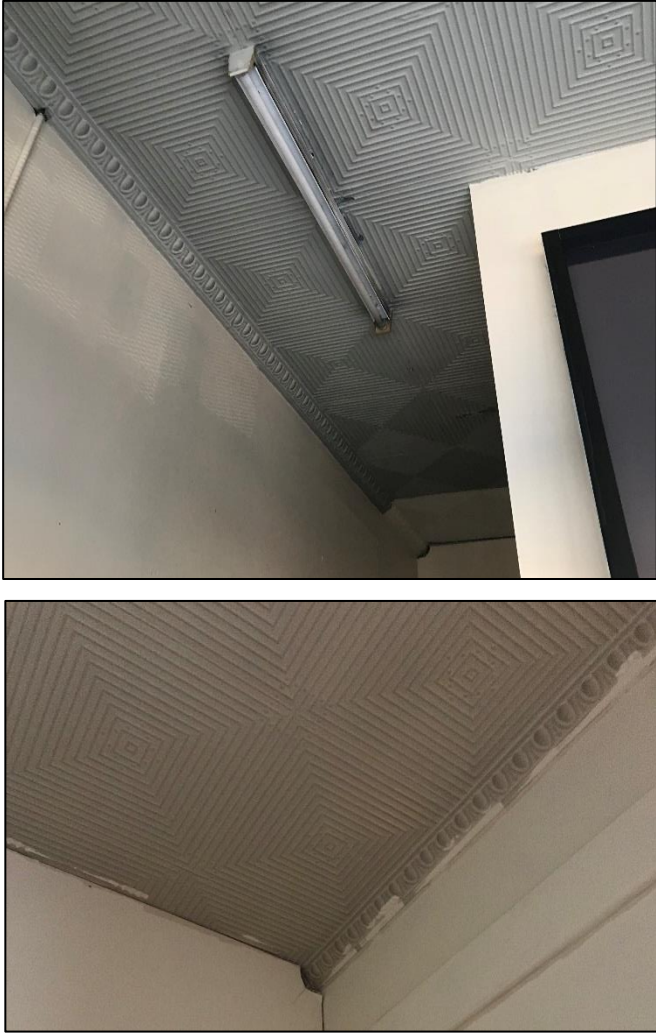
Cornices		FAIR	HIGH	<p>Original cornices appear in fair condition. Repaint to match new colour scheme after consultation with appointed Heritage Consultant. Minor repair should be undertaken as specified in specifications.</p> <p>Where cornices are damaged, they are to be made good.</p> <p>Inspection and testing of paint must be undertaken to assess the likely presence of lead-based paints. Where lead paint is present, it should be removed in accordance with the appropriate Australian Standards and EPA guidelines. The surface is then to be and repainted. Paint should be removed using non-abrasive removal techniques after consultation with the appointed Heritage</p>

<p>Architect. Colour Scheme to be like for like or other age appropriate to match building style and period, selected after consultation with the appointed Heritage Architect.</p> <p>Where new internal partition walls are to be inserted, care must be taken that the walls are not fixed to the pressed metal cornices.</p>

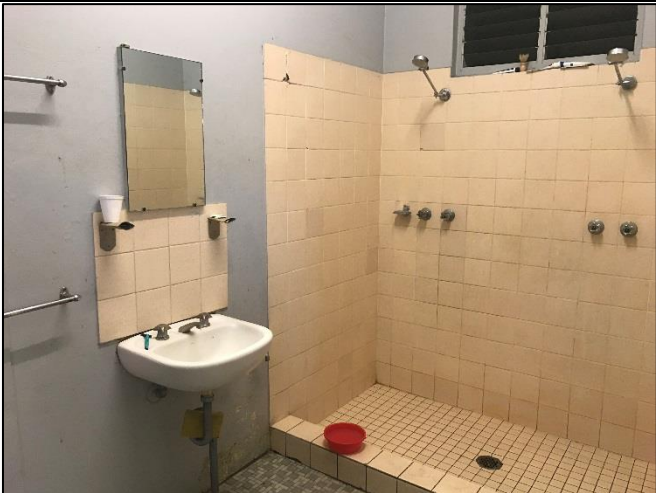
POOR	LITTLE	<p>Kitchen fixtures along internal walls should be removed. All shelves and other fittings attached to original masonry walls to be removed. All resulting drill holes to be filled in pre-mixed Westox Plaster.</p> <p>Allow the heritage architect to carry out intermediate and final inspection of the work as it ensues.</p>
Bathroom Fixtures		POOR	LITTLE	<p>Bathroom fixtures appear to be later addition with exception to the Moravian tiles which should be retained. Rationalise based on future use. Fixtures should be replaced accordingly.</p> <p>If the bathroom fittings are to be replaced, or new fixtures are to be added for BCA compliance, the new fittings are to be period appropriate fittings or sympathetic and compatible simple contemporary fittings.</p>

Allow the heritage architect to carry out intermediate and final inspection of the work as it ensues.
Ventilators

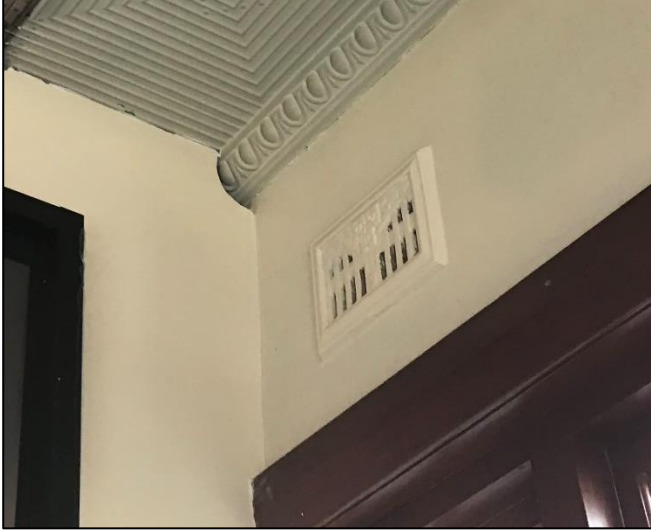
FAIR	HIGH	Original ventilator screens are in fair condition. General cleaning is advised. If internal walls are being repainted, grills should be stripped off paint and repainted.

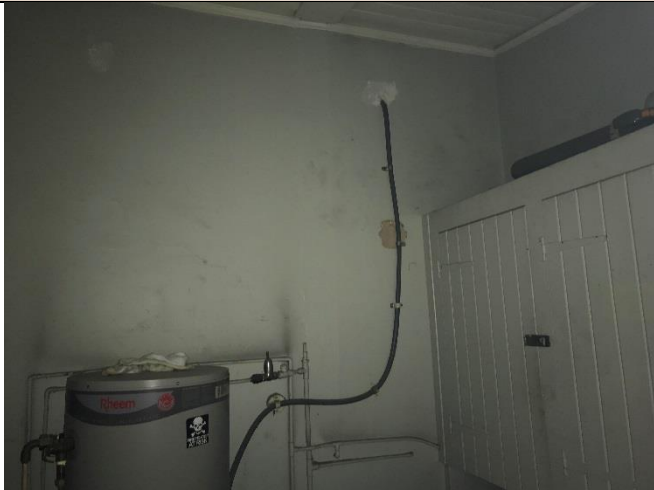
The exhaust is to be protected insitu during demolition, construction and conservation works to other fabric.
Cupboards in Storage		FAIR	LITTLE	<p>Timber built-ins in storage area may be retained.</p> <p>A qualified heritage carpenter is to inspect all existing timber elements and determine condition of each timber built-ins in storage area.</p> <p>Where repairs are required to timber, works are to be taken in situ using the geometric splicing method. This includes removing the entire thickness of the damaged area and geometrically splice in a matching section exactly to the thickness, shape, profile, form and species</p>

<p>of the original timber. Where damage to fabric is small (less than 5mm), infill is not necessary.</p> <p>All new sections of timber introduced into original components are to be date stamped.</p> <p>Sand all repaired and sound timber elements to timber substrate and prepare for repainting in accordance with the paint manufacturer's specifications and AS 2311. Colours to be chosen in consultation with the heritage architect.</p> <p>If required, repolish to match the surrounding timber.</p> <p>All works, and repairs are to be undertaken in accordance with the National Timber Framing Code (AS 1684).</p> <p>Where timber is to be repainted, previous layers of paint are not to be removed.</p> <p>Where timber is to be repainted, paint scraping should be undertaken to ascertain original colour. Retain or replace (optional) original colour scheme after appropriate approvals have been granted.</p>

Table 3.3.5: Fixtures				
ELEMENT	PHOTOGRAPH	CONDITION	SIGNIFICANCE	CONSERVATION ACTION FOR DA
				<p>The advice of a Heritage Architect is to be obtained and a colour scheme appropriate to the architectural style and period of the building is to be chosen.</p> <p>Timber is to be protected with protective material during demolition and conservation works to other fabric.</p>
