Arboricultural Development Assessment Report

Anglicare, St Lukes 4 Lindsay Evans Place, Dapto NSW 2530 RAC PROJECT 16th July 2019

Prepared by: Paul Vezgoff Consulting Arborist ISA, AA Arboriculture Australia Registered Consultant

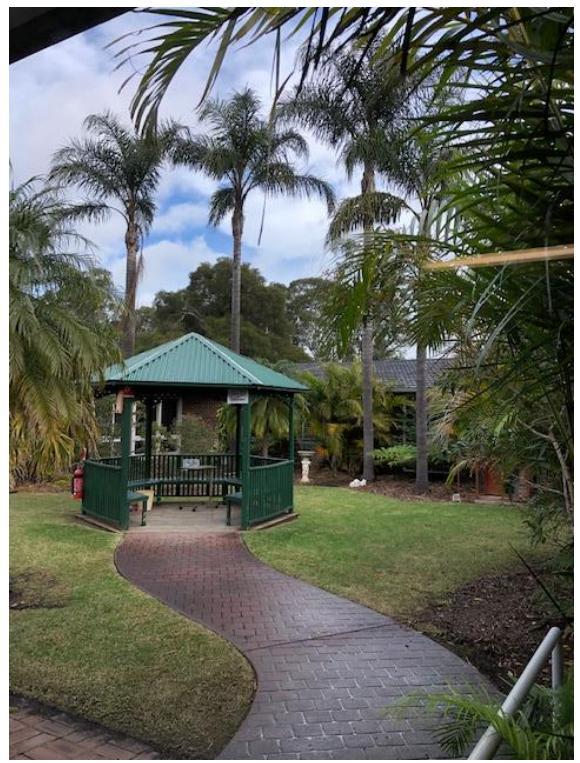
Plate 2: Internal court yard areas containing mostly exotics. P. Vezgoff.

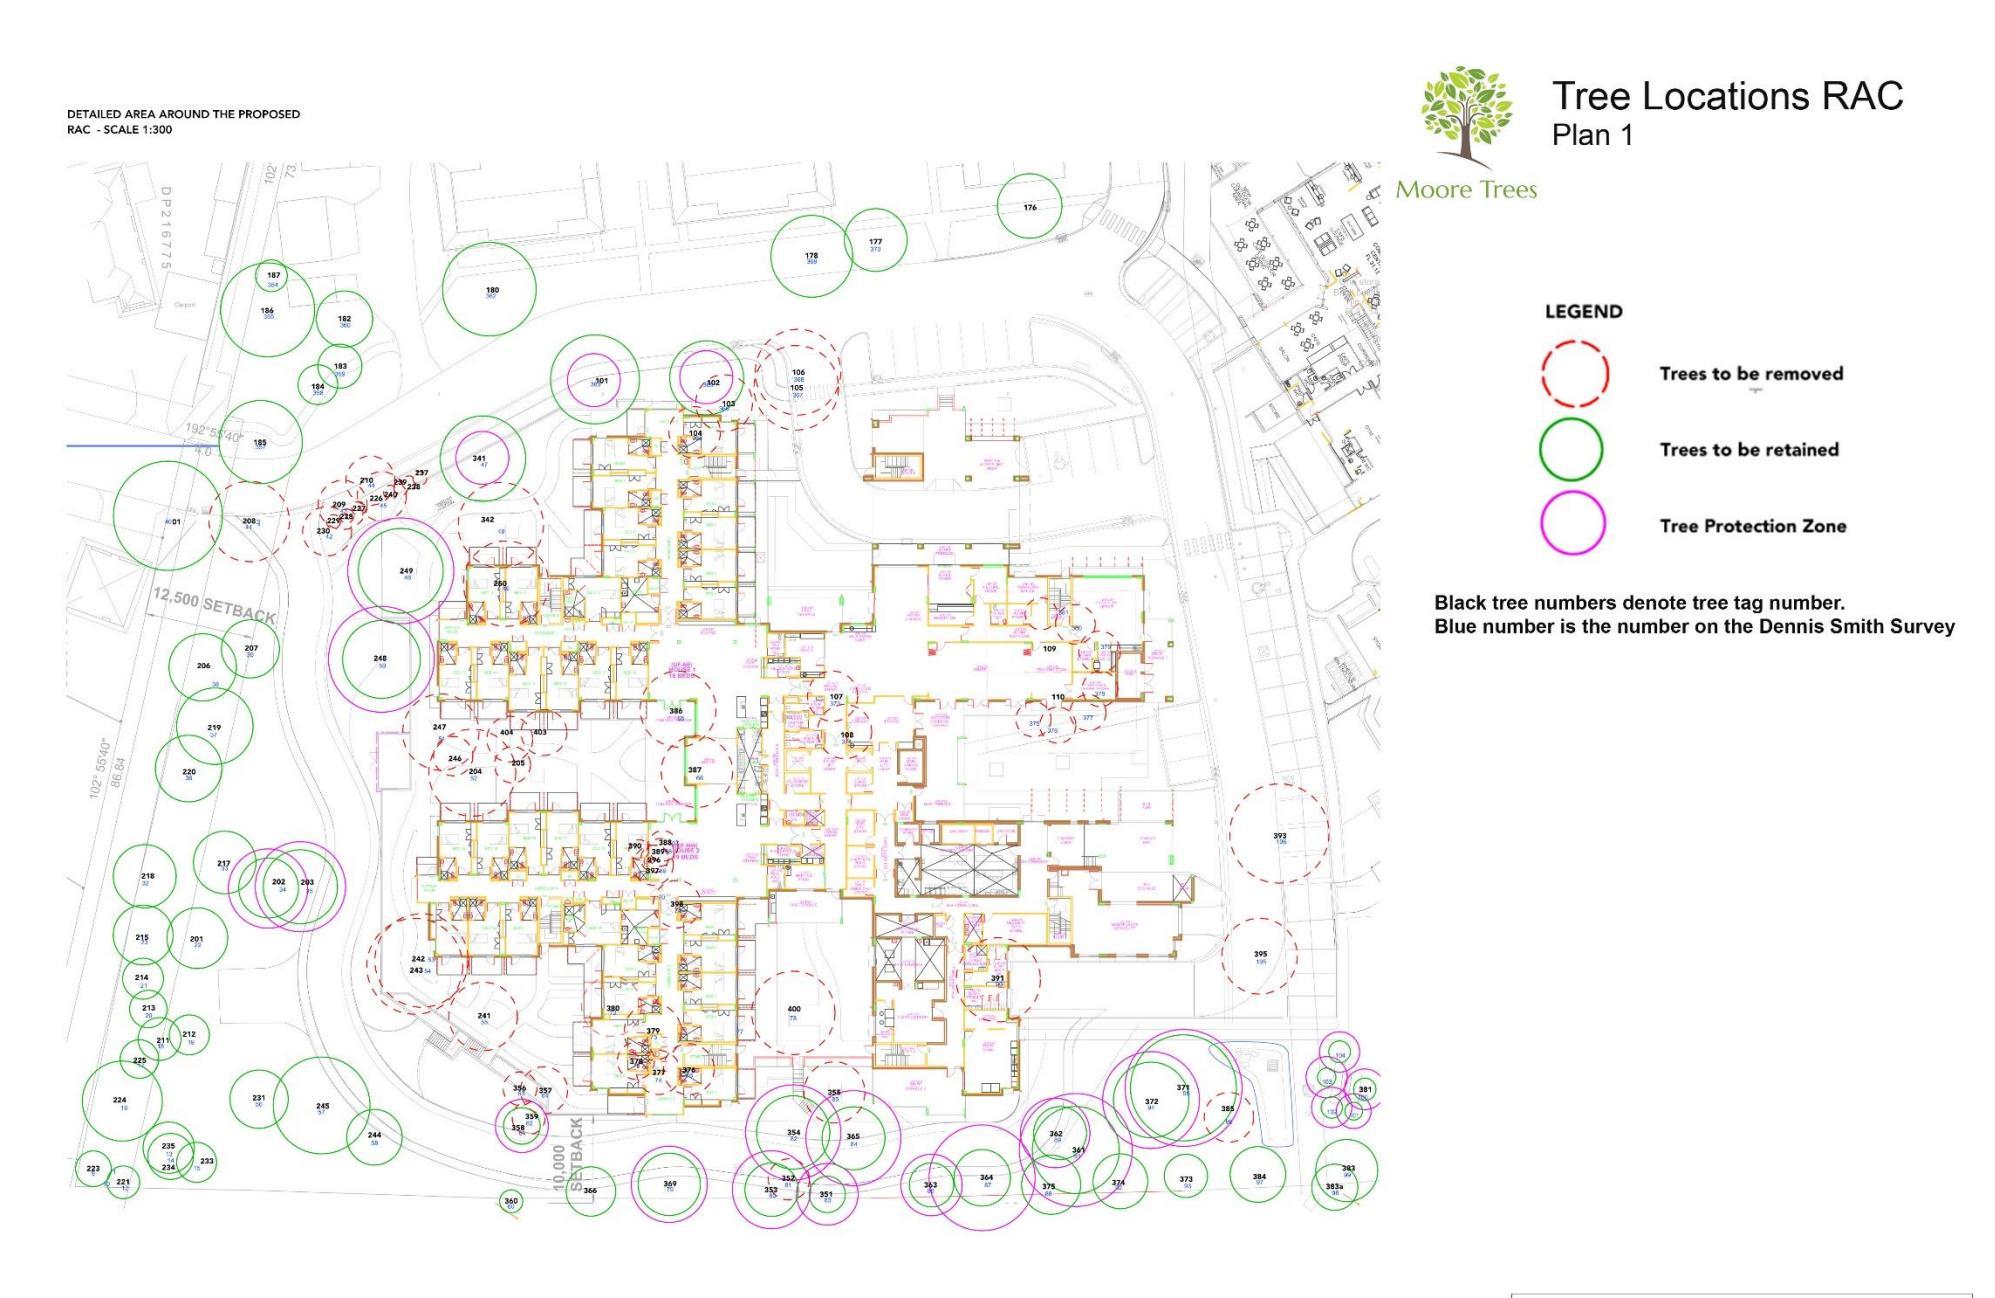
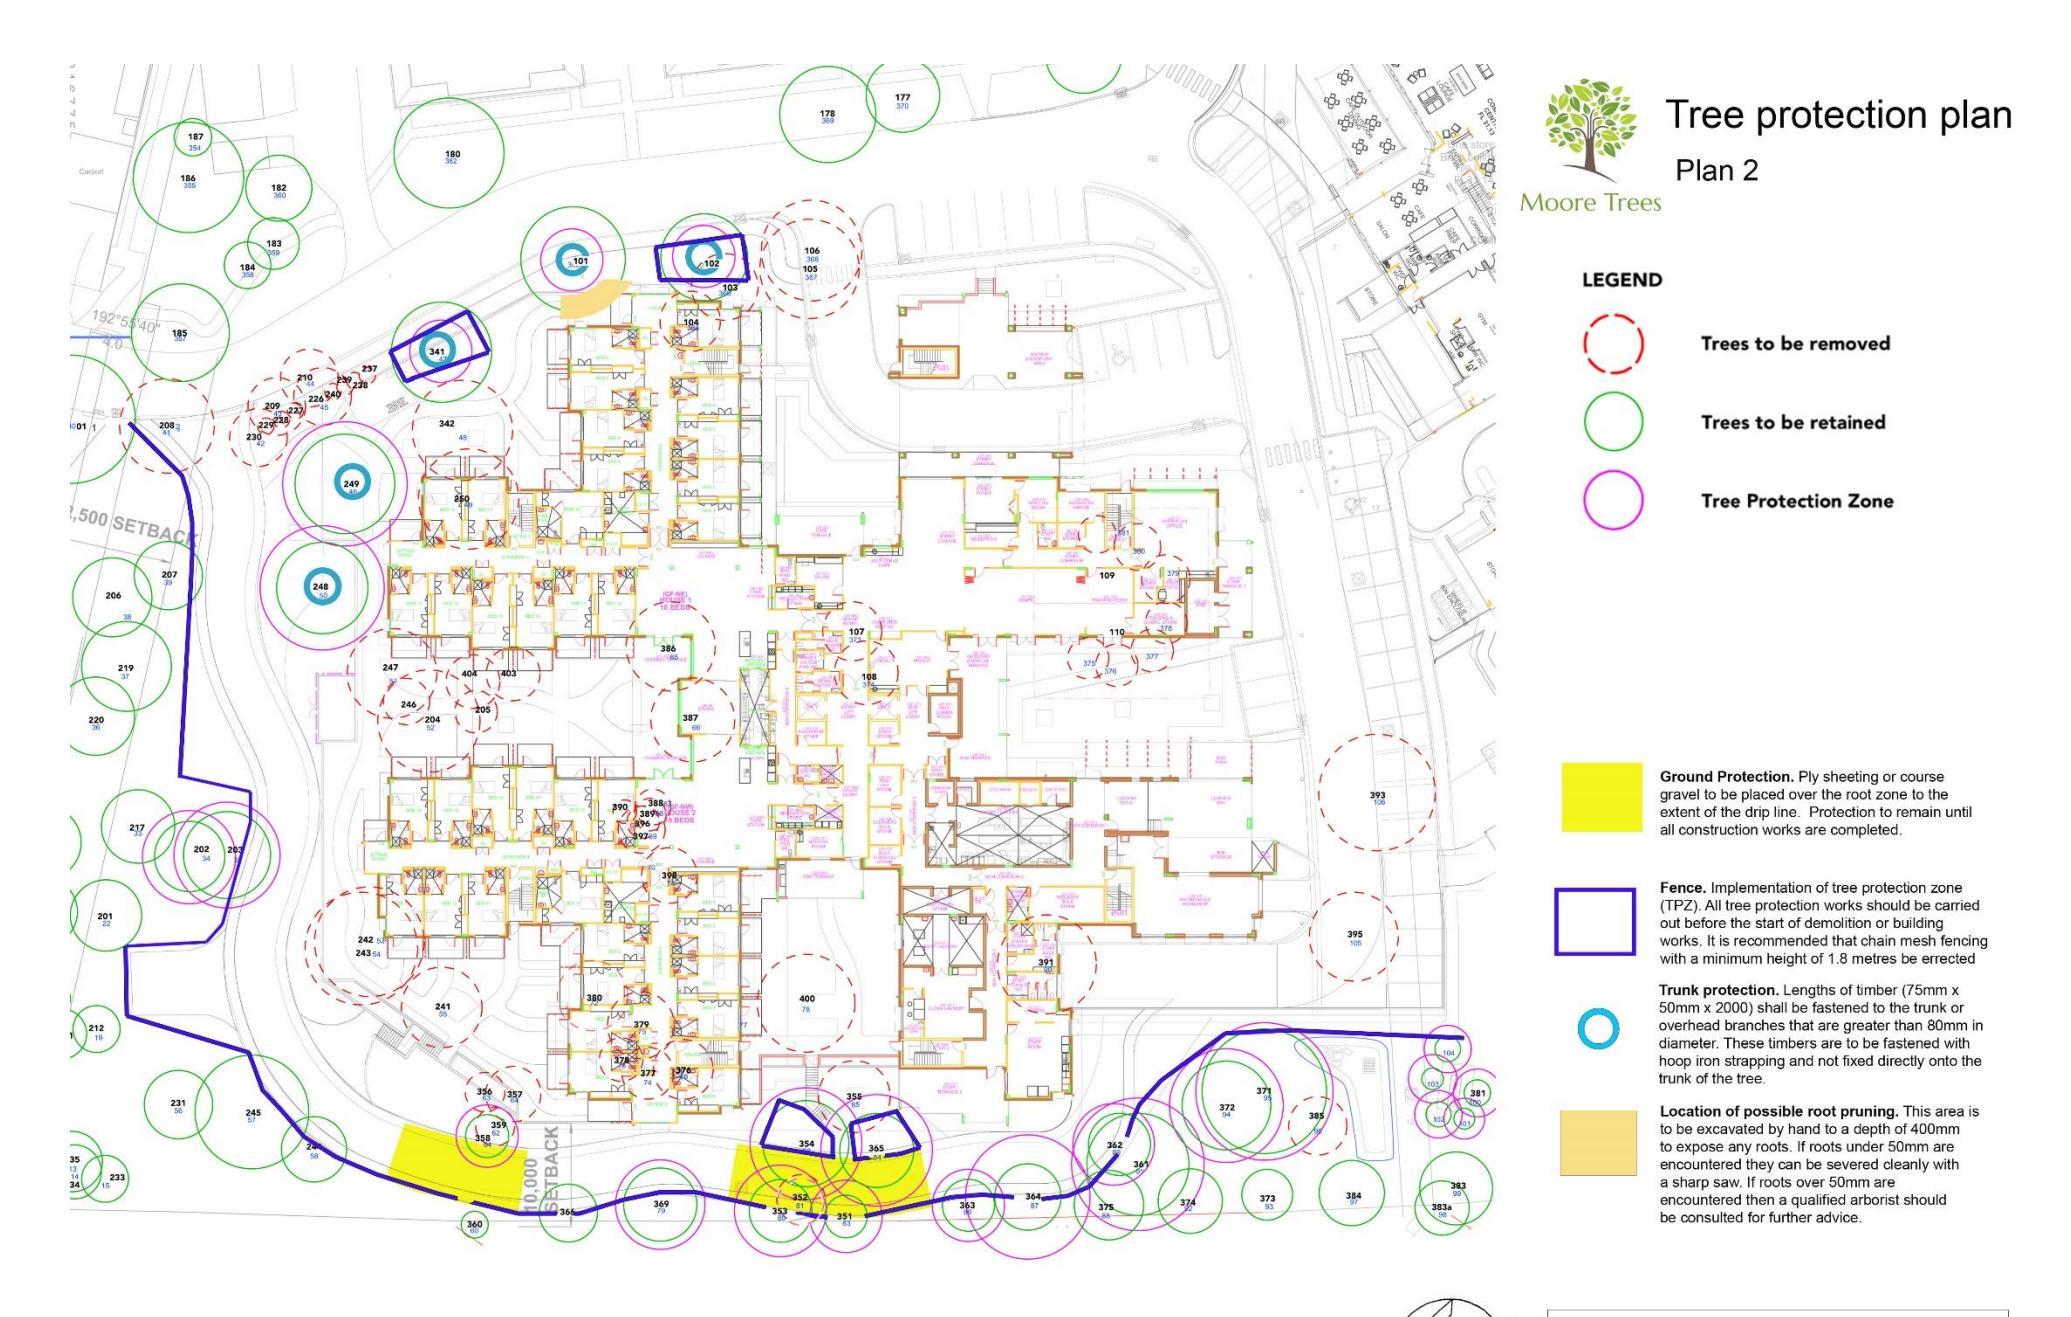
Tree Protection Plan 2

Based on the proposed designs require the following trees to be removed being; 103, 104, 105, 106, 107, 108, 109, 110, 204, 205, 208, 209, 210, 226, 227, 228, 229, 230, 237, 238, 239, 240, 241, 242, 243, 246, 247, 250, 342, 352, 355, 356, 357, 359, 376, 377, 378, 379, 380, 385, 386, 387, 388, 389, 390, 391, 393, 395, 396, 397, 398, 400, 403 and 404. Total tree removal and retention numbers can be seen in tabulated format in Appendix 2. Trees to be retained and removed can be seen in the Tree Protection Plan (Appendix 1).

Trees to be retained will require various site specific tree protection measures as specified in Section 5.2 of this report.
