6 April 2018

Ref: 4551

This is an update of Ref: 3888 Rev A with added information from additional tree assessments

Preliminary Arboricultural Report Goulburn Aquatic Centre and Surrounds

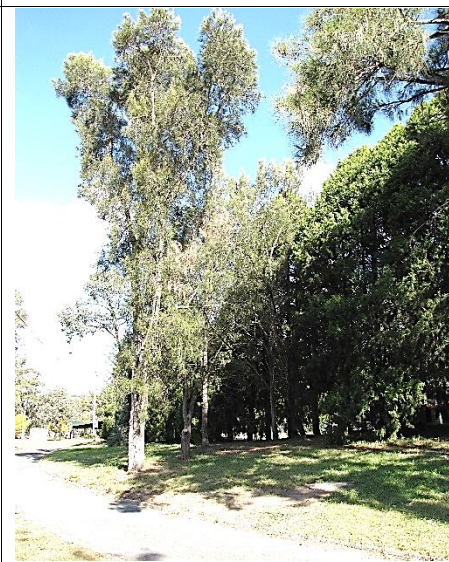
Tree 65, 66, 67, 68 (Left to Right)

| Tree Number | Species | Height | Canopy Spread | | | | Health | Structure | Tree Protection Status | Tree Quality Classification | Comments | Circumference ⁴⁹⁷⁰ | | | | | Radius TPZ ⁴⁹⁷⁰ | Radius SRZ ⁴⁹⁷⁰ |
|---|---|---|---|---|---|---|---|---|---|---|--|---|---|---|---|---|---|---|
| 65 | Casuarina sp - She-oak | 19 | 4 | 4 | 6 | 6 | Good | Good | Park Tree | Medium | Massive surface root knot near footpath, a number of previous branch failures | 1.86 | | | | | 7.1 | 2.9 |
