# ***Arborist Report***

**Client: ICONFM Australia Pty Ltd**

Address: 1 Larapinta Place,

Glenhaven N.S.W 2156

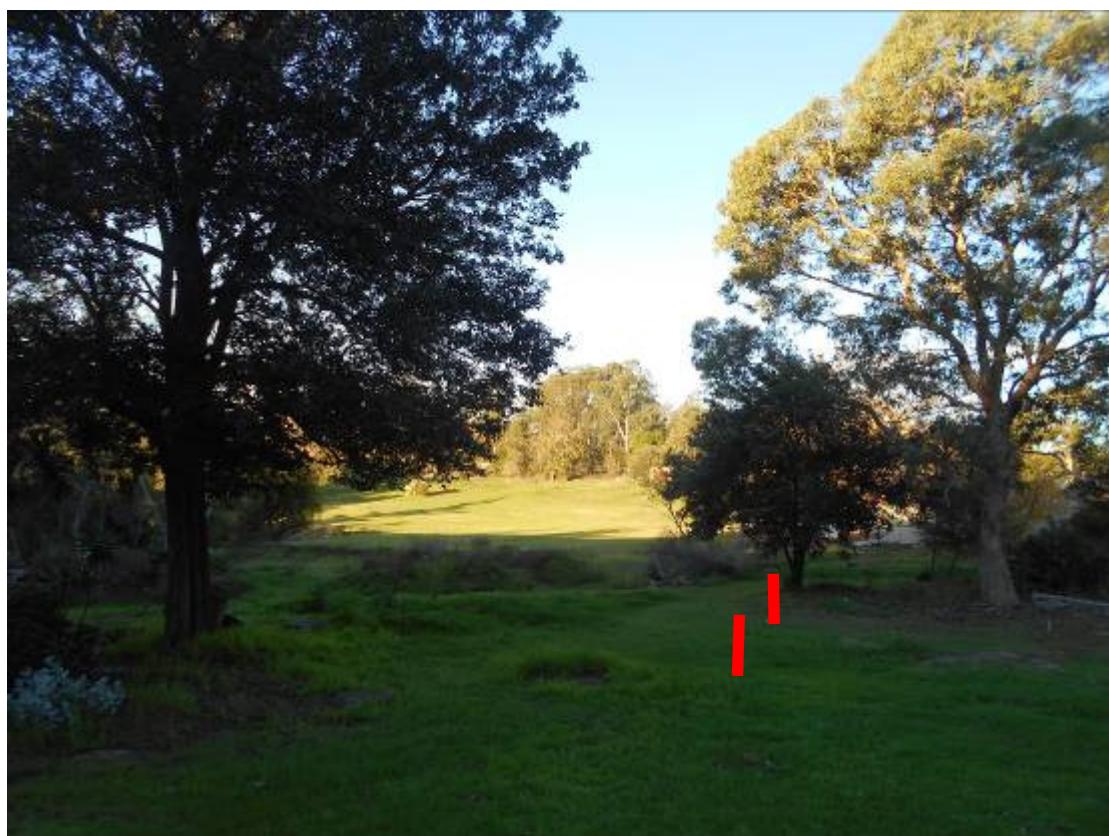
Figure 3 – showing the location to the north entrance of the building followed by the car park to the north. The entrance is highlighted in red. Ten metre intervals were taken from the north entrance of the proposed development.
