Arborist Impact  
Assessment

54 -68 Ferndell Street  
South Granville 2142  
New South Wales

5th of June 2019

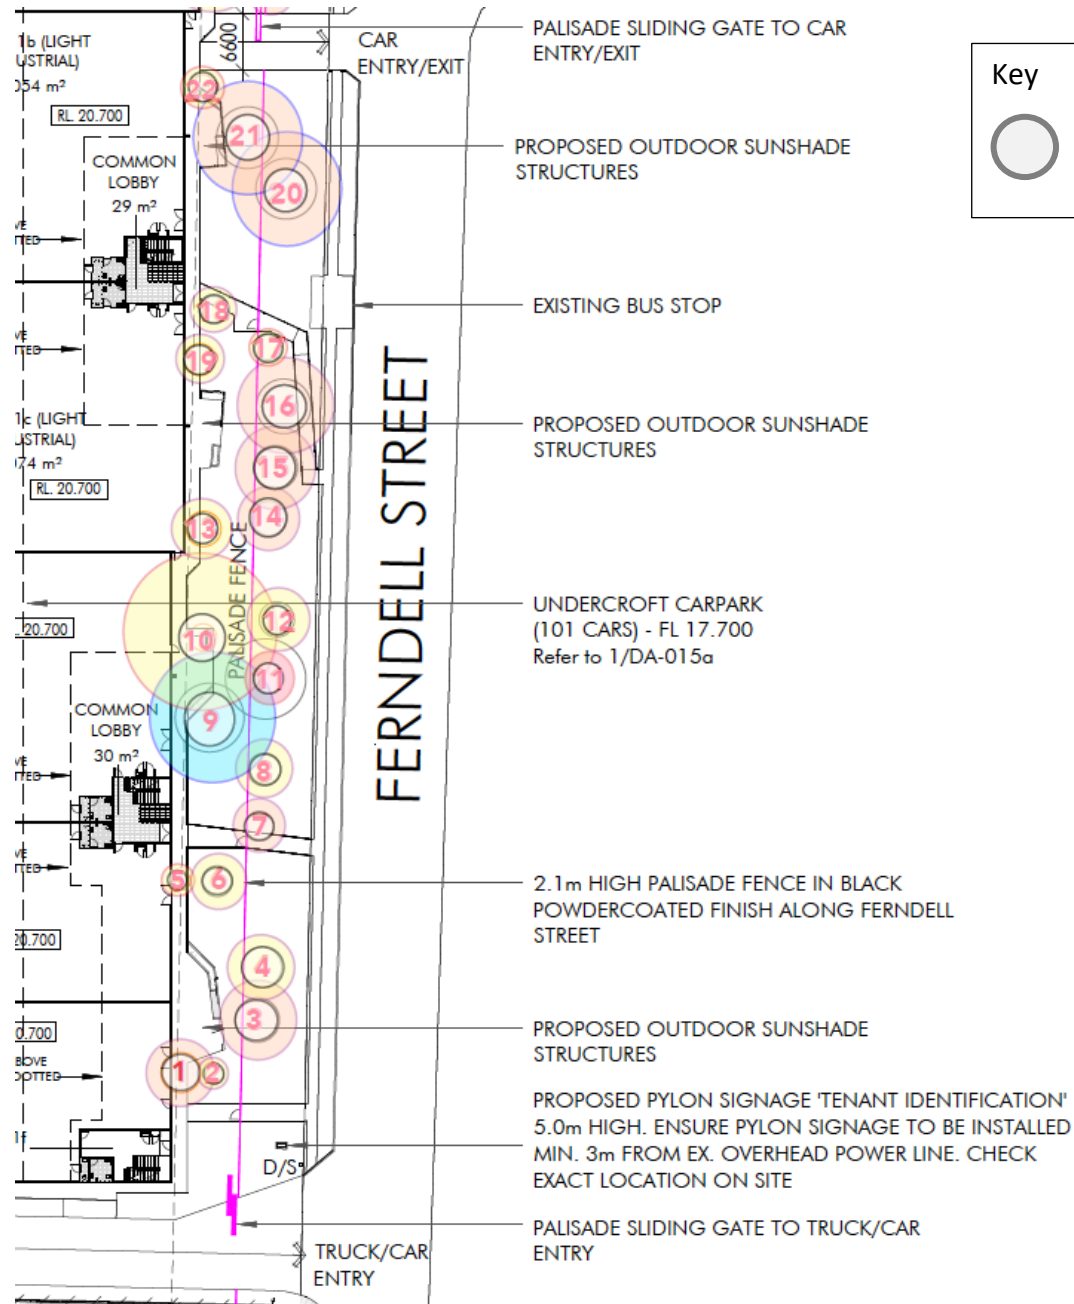
# 11.5 TREE PROTECTION ZONE & STRUCTURAL ROOT ZONE – STREET FRONT IN DETAIL (PART 1)

- 1.5 Design alterations are recommended to reconfigure the path and outdoor area outside of the SRZ of trees 9, 16 and 21 which would reduce the impact on the moderate to high value trees, making them viable for retention.

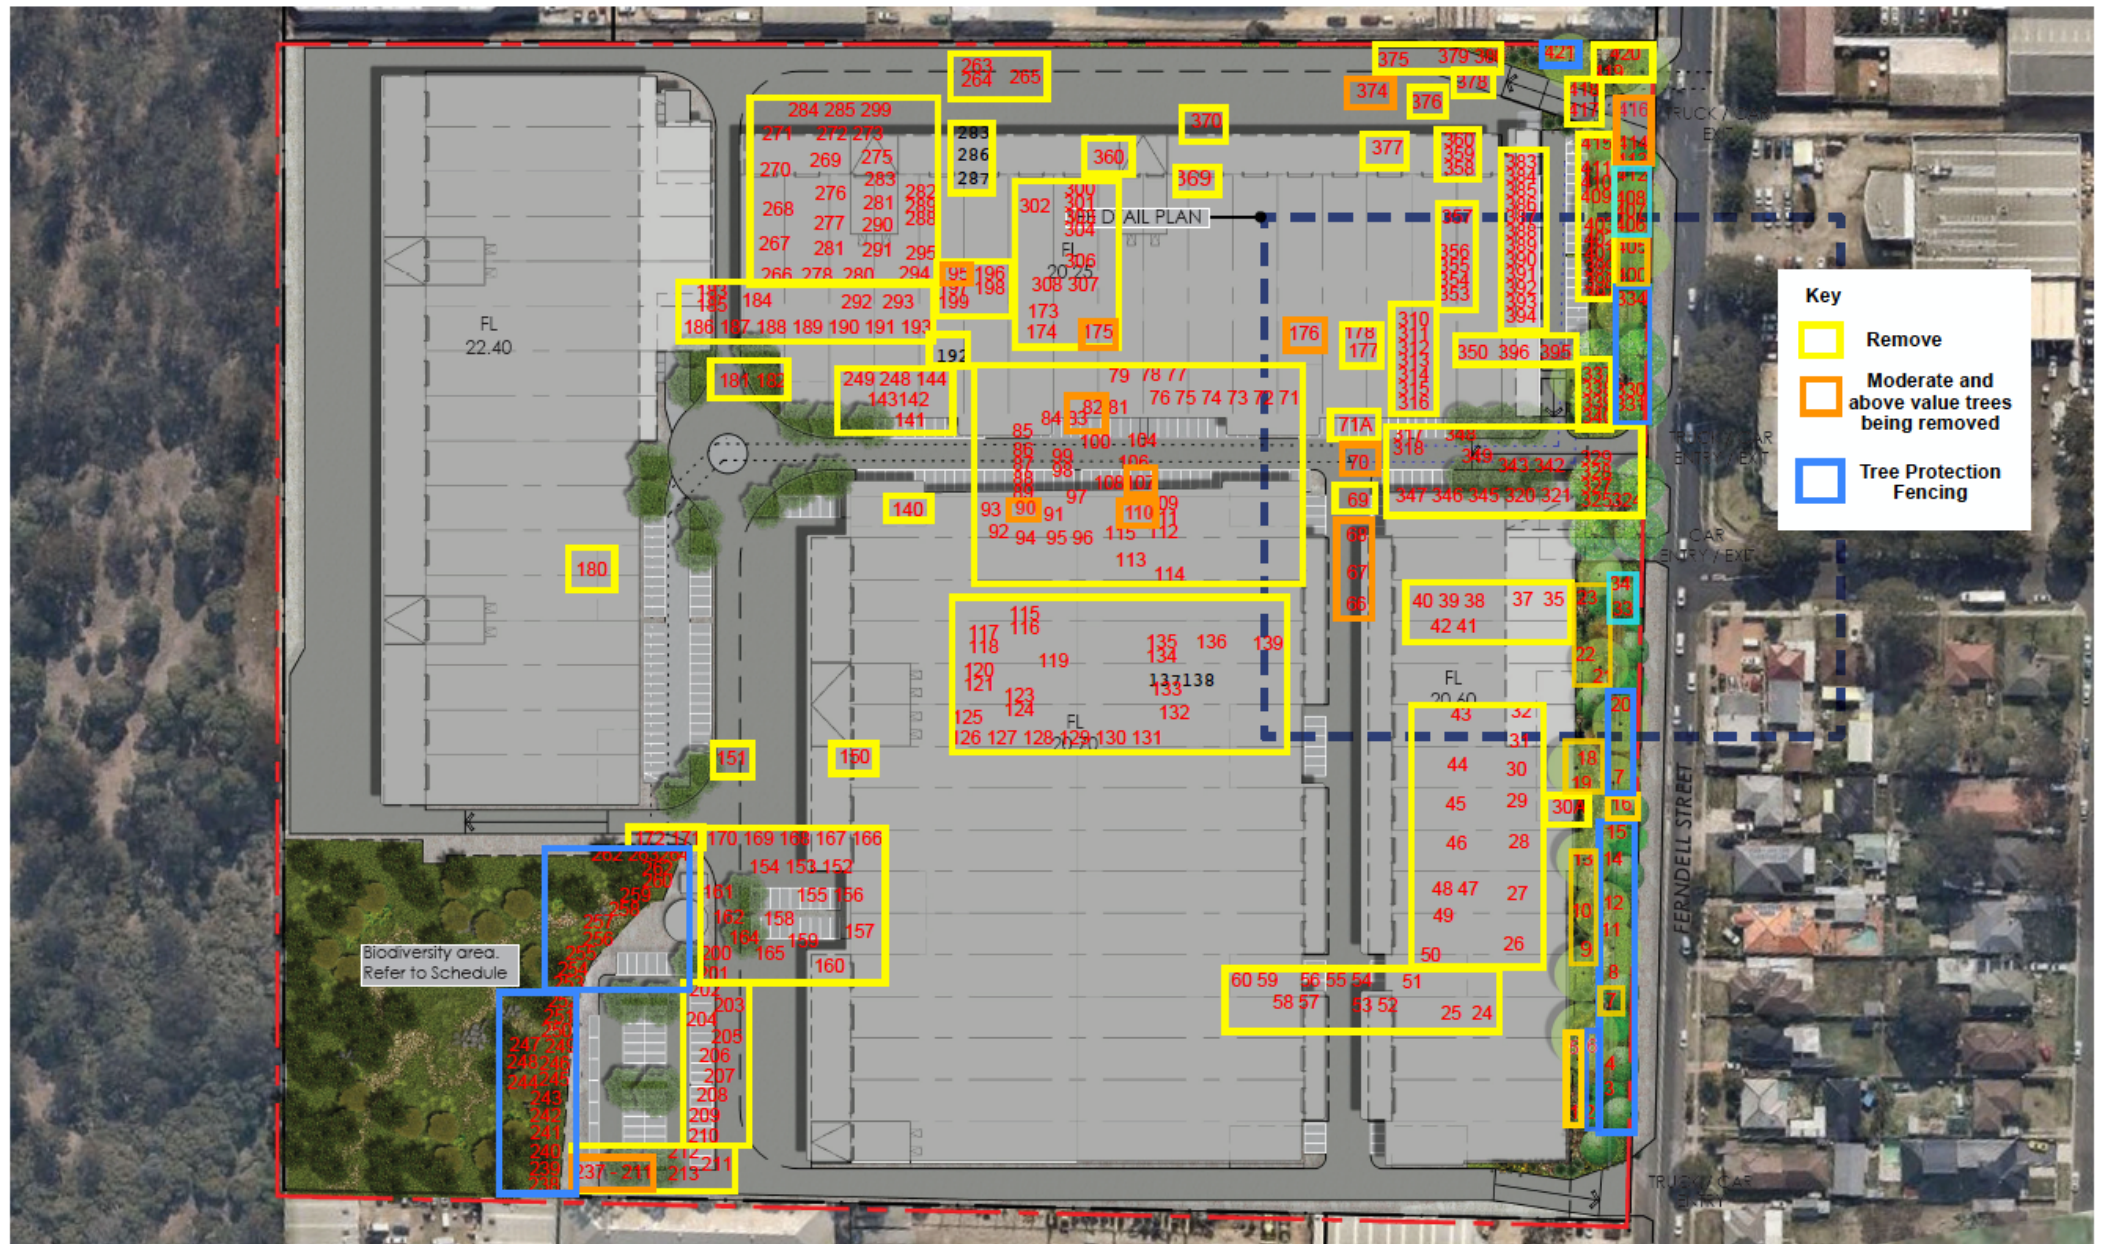
# 12.0 TREE MANAGEMENT PLAN

2.3 The proposed new development will impact majority of the trees on the site which will require the removal and replenishment of three hundred and ninety-one (391) trees numbered 1, 5, 7, 9, 10, 13, 10, 16, 18, 21, 22, 23, 24-32, 35-60, 66-329, 332,337-403, 409-411,414-418. Additionally, 400, 405 and 419 are dead and are recommended to be removed. The street frontage and the Biodiversity area at the rear of the property will be impacted on and will have some trees removed from this area. Three hundred and ninety-one (391) trees are to be replenished on site using new stock indigenous trees of 30-litre (potted volume) and are to be planted according to the landscape plan.

2.4 Thirty-four (34) trees numbered 2, 3, 4, 6, 8, 11, 12, 14, 15, 17, 20, 33, 34, 61, 62, 63, 64, 65, 330, 331, 333, 334, 335, 336, 404, 406, 407, 408, 412, 421, 422, 423, 424, 425 are to be retained and protected and require protection via tree protection fence line/tree trunk protection and mulch 75mm depth over the TPZ. Sensitive construction is required for any works with the TPZ of Tree 15 and an AQF level 5 Arborist must supervise all works within the TPZ of all retained trees. Reconfiguration of the path and outdoor area is recommended in order to retain trees 9, 16 and 21.
