**TOGA WICKS PARK  
DEVELOPMENTS PTY  
LTD**

**Hazardous Materials  
Survey**

182-198 Victoria Road & 28-30 Faversham  
Street, Marrickville, NSW

**Report No:** E24098.E10\_Rev0

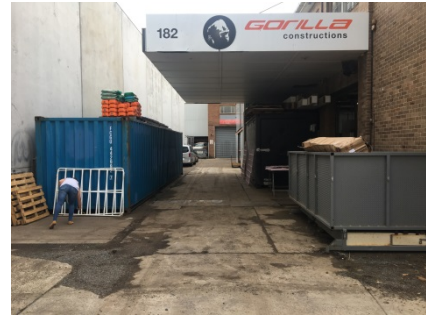
Two storey, brick and metal commercial building (182 Victoria Road). A single storey, metal commercial building was attached to the southern side and attached to the northern side was a metal and fibrous cement sheeting awning. Comprised of spray painting areas (including spray booth), store rooms, offices and amenities.

The buildings had metal roofing, brick and metal external walls, brick, metal and plasterboard internal walls and asbestos cement sheeting awning ceiling with concrete floors.
