Report on  
Geotechnical Investigation

Alterations and Additions  
20 Illawong Avenue, Tamarama

Prepared for  
Strata Plan 1731

Project 72261.06  
November 2018

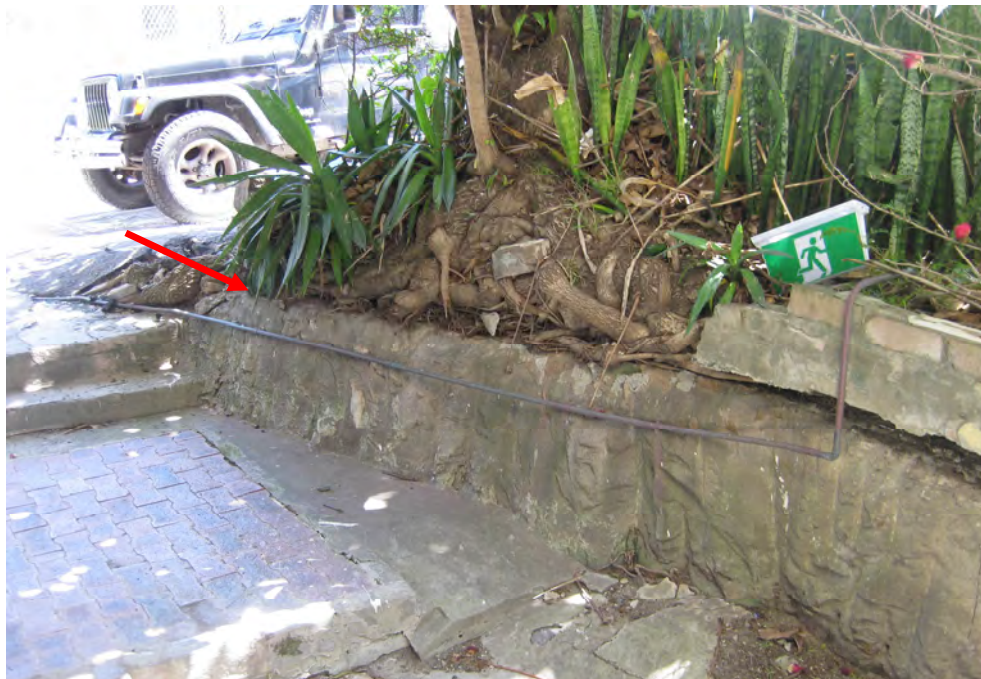
An exposure of massive, high strength sandstone was observed adjacent to the car park, near the south-western end of the unit block (refer Photo 12 in Appendix B). A sandstone cliff is present along most of the south-western boundary (i.e. on the side furthest from the proposed basement excavation and closest to the gully above Tamarama Park), having a height between 4 - 8 m and being mostly obscured by vegetation. The terraces of the building are supported by a brick retaining wall up to about 3.4 m high, curved in places, which has been constructed adjacent to and set-back from the cliff crest by between 0 - 5 m.

Photo 12 – View north-west towards existing car park. Rock exposure indicated as shown

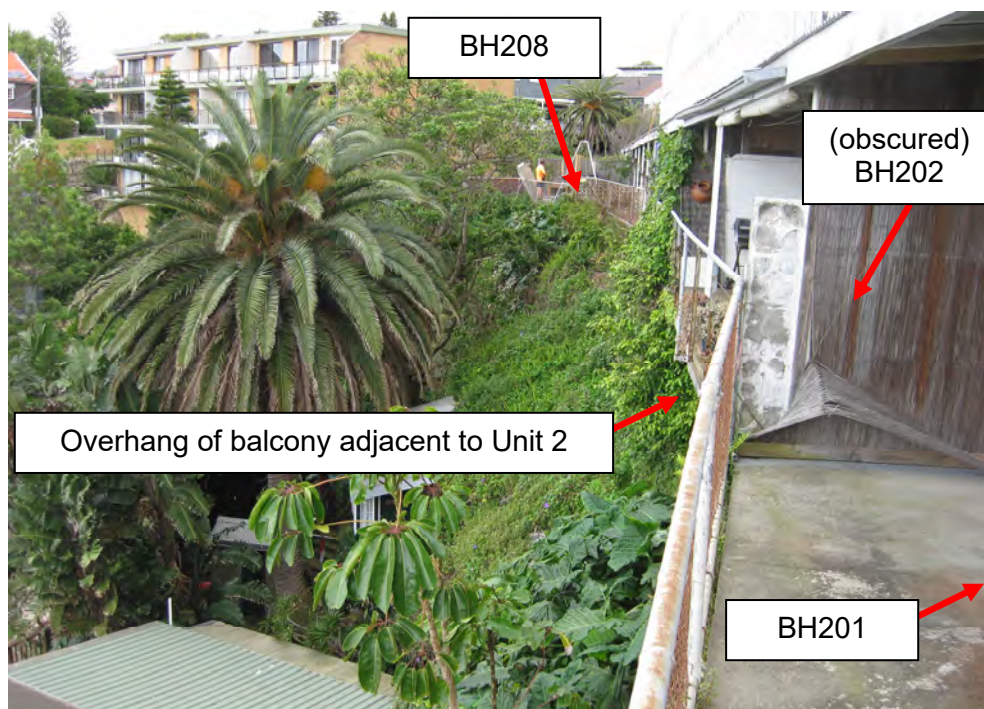
Photo 13 – View south-west along balcony edge from Unit 1. Current test locations indicated as shown.

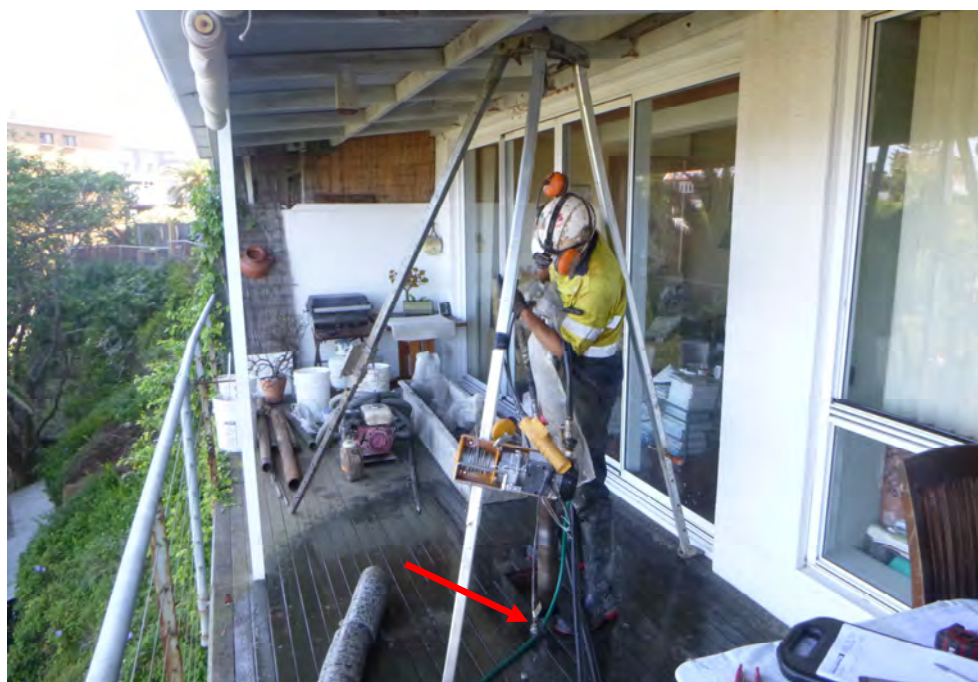
Photo 14 – View south-west along balcony of Unit 2. The position of BH202 is indicated as shown.

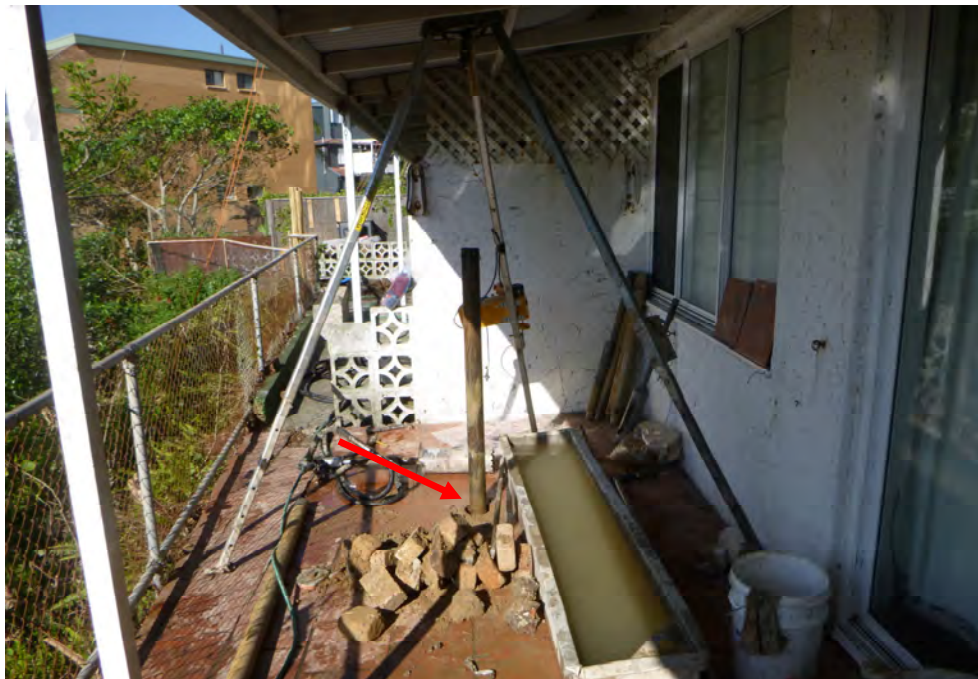
Photo 16 – View south-west along balcony of Unit 5. The position of BH206 is indicated as shown.

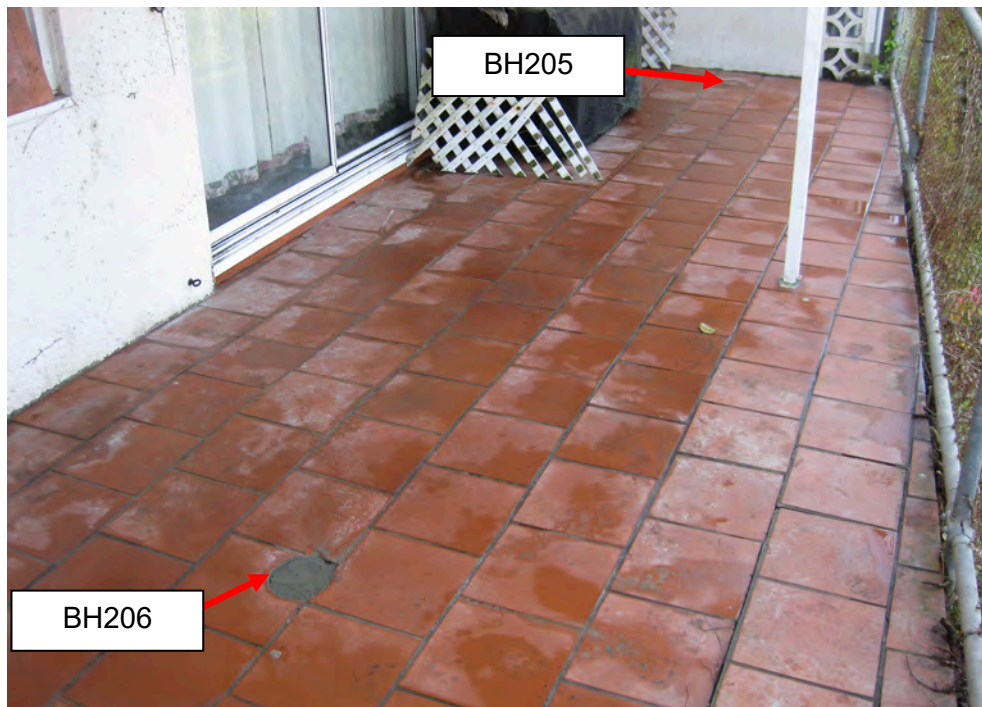
The width of the terraces between Unit 1 and Unit 5 (i.e. the distance between the building and the brick retaining wall at the northern end of the building) is between 2.5 - 3 m, widening to 8 m at Unit 8 and Unit 9, then narrowing again to 4 m at Unit 10. It is noted that the terraces of Units 2 and 3, which are surfaced with timber decking, have been constructed to overhang the brick retaining wall by between 0.5 - 1 m (refer Photo 13 in Appendix B). Some of the other terraces were also partially or entirely surfaced with timber decking or tiles, over concrete slabs (e.g. Photos 17 and 18 in Appendix B).

Photo 17 – View north-east along balcony of Units 5 and 6. Borehole positions are indicated as shown.

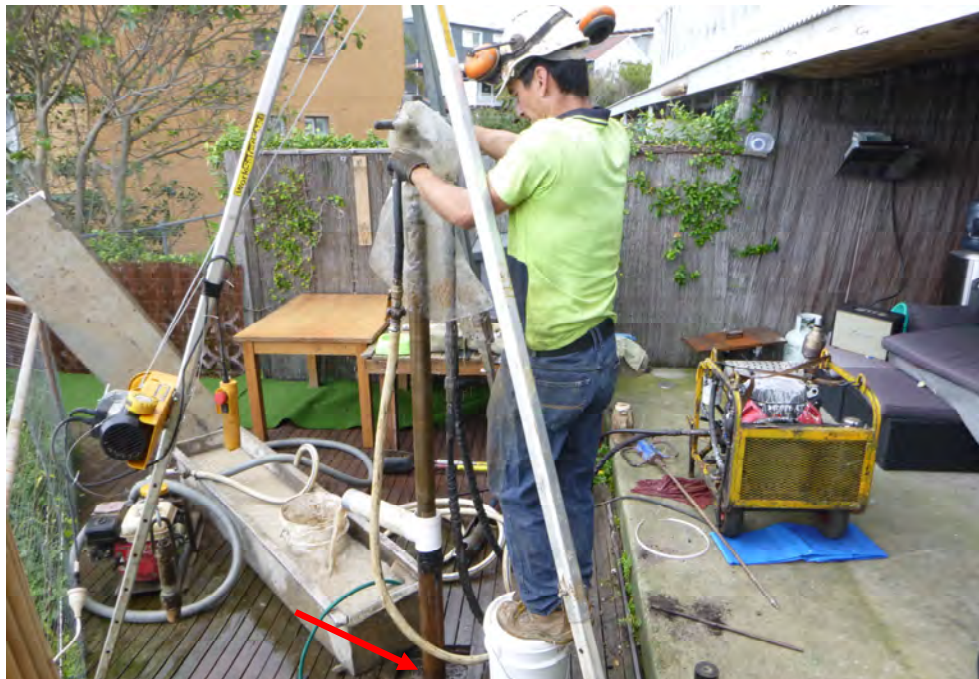
Photo 18 – View south-west along balcony of Unit 7. The position of BH208 is indicated as shown, below a timber deck.

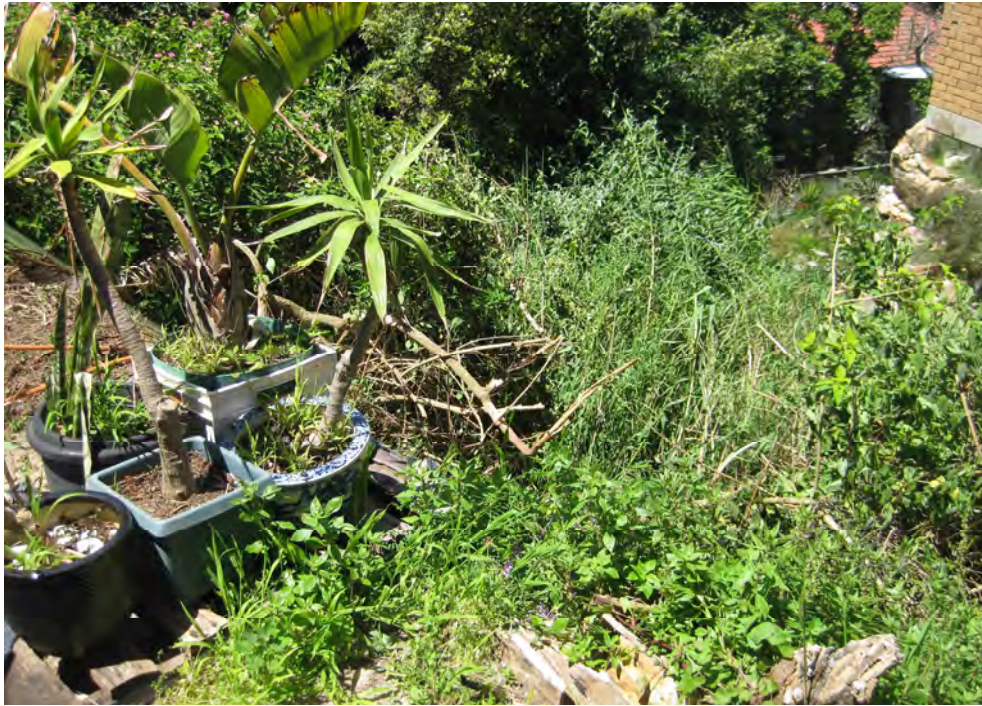
Photo 21 – View east at southern end of balcony / terrace of Unit 10, adjacent to cliff edge.

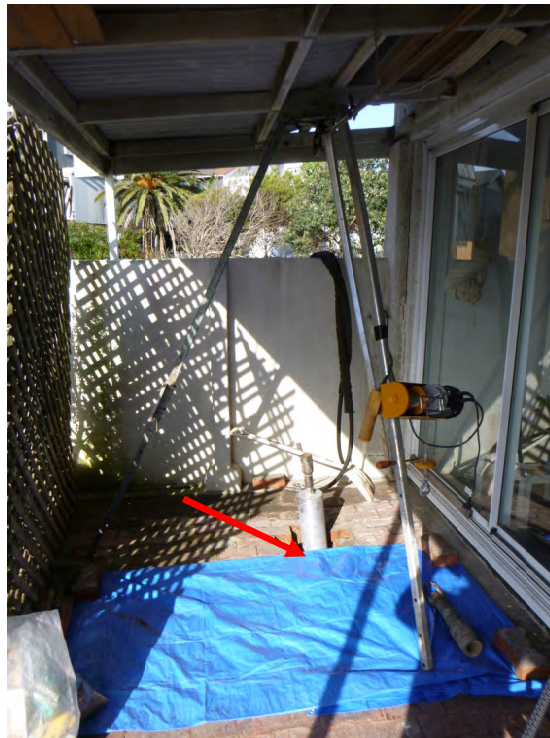
Photo 22 – View south-west at southern end of balcony / terrace of Unit 10. The position of Borehole BH210 is indicated as shown.

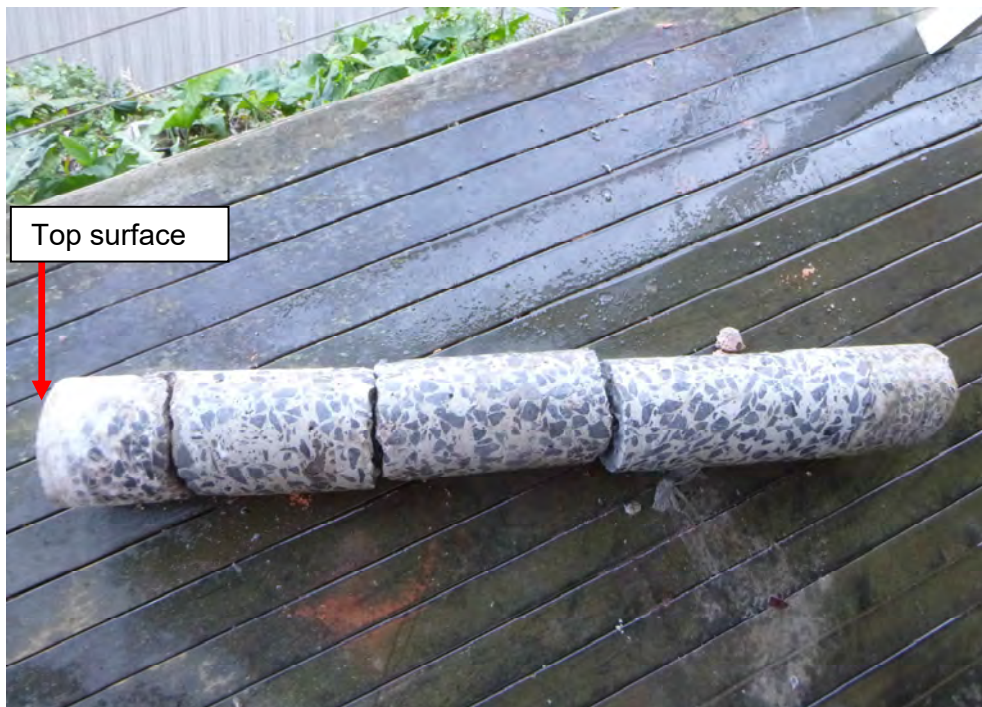
Photo D1 – View of concrete cored from beneath the balcony of Unit 2 (Borehole BH202). The start / top of the core is indicated as shown.

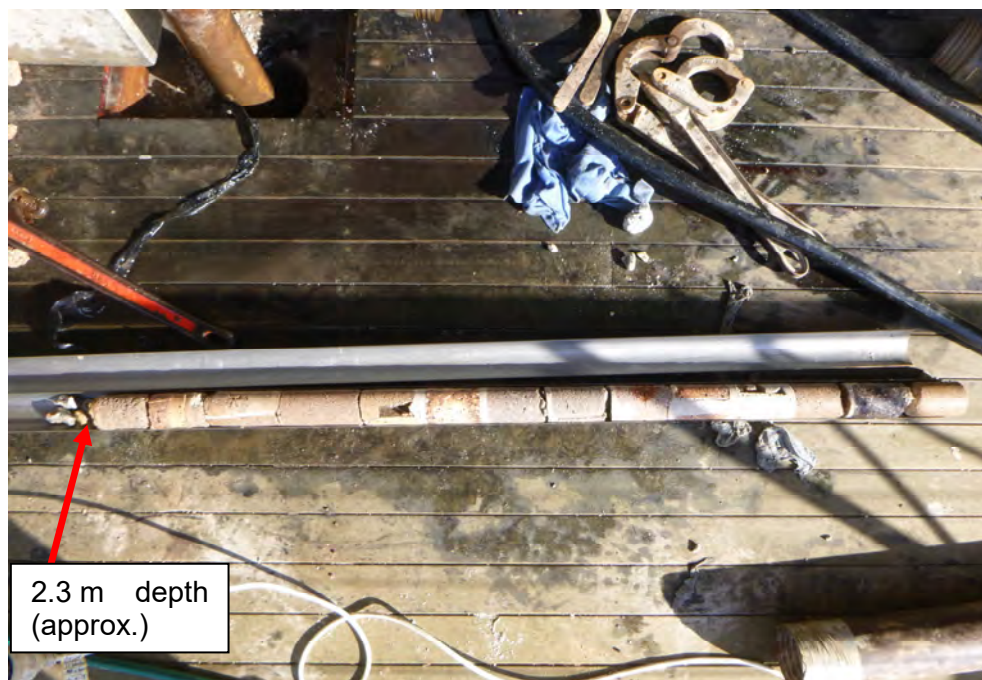
Photo D2 – View of mortared bricks within Borehole BH202. The start / top of the bricks is indicated as shown (approximate start / top depth of 2.3 m).

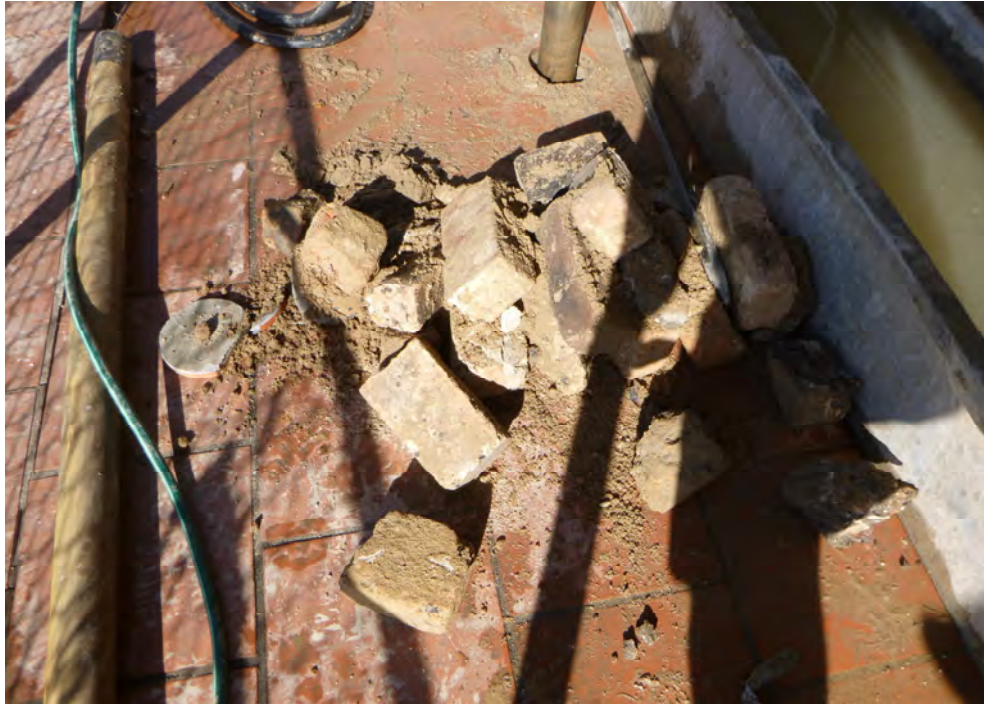
Photo D3 – View of rubble filling removed from Borehole BH206, drilled within the balcony of Unit 6.

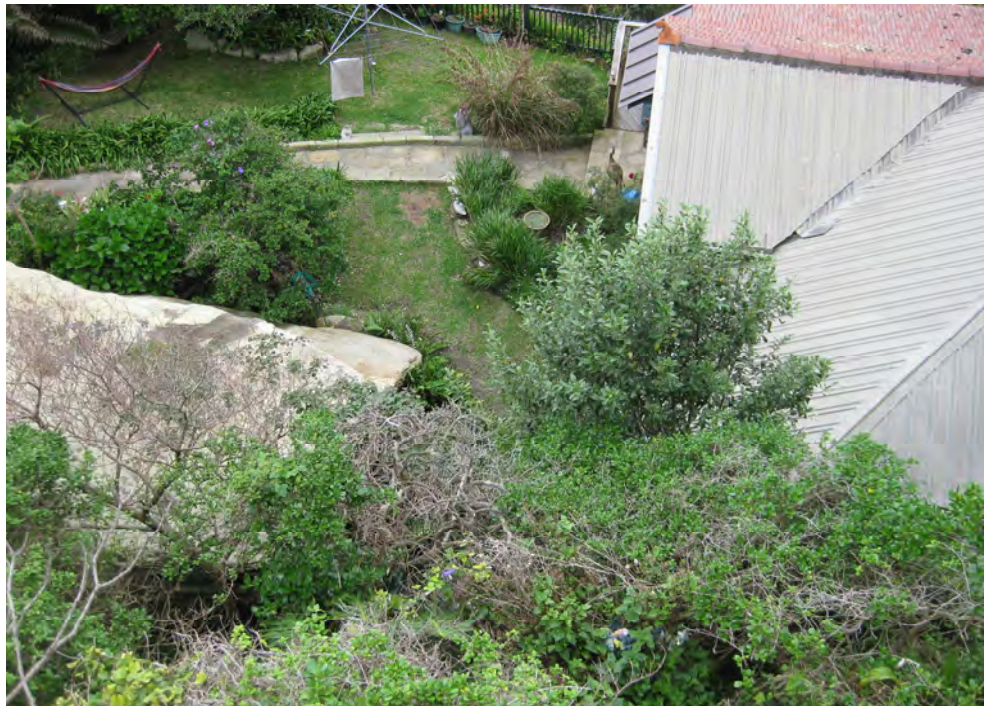
Mapping Traverse 101, Photo 1 – View south-east from Unit 1 (ground floor), down towards No. 14 Illawong Avenue below. The upper part of the mapping traverse is in the foreground.

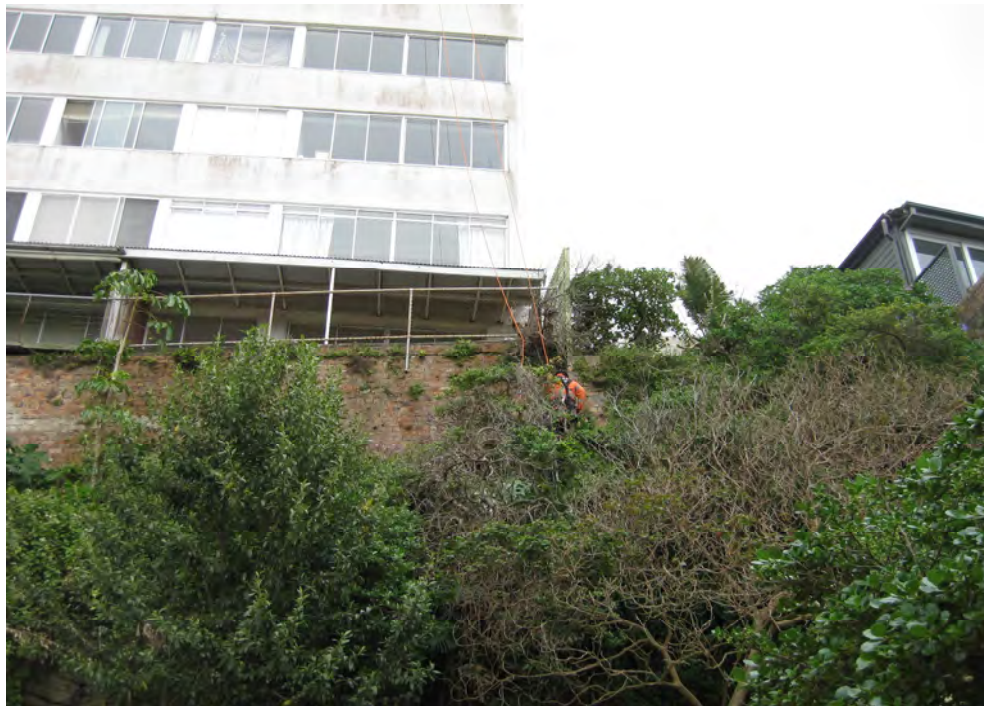
Mapping Traverse 101, Photo 4 – View north-west towards Unit 1 from the base of the cliff, at cliff mapping traverse 101.

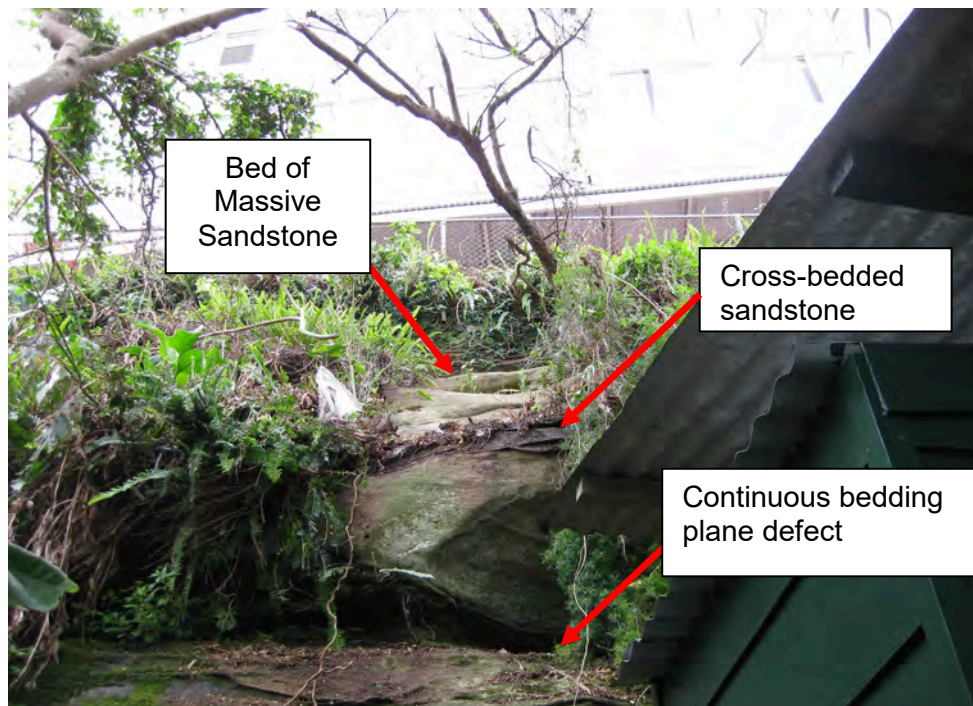
Mapping Traverse 103, Photo 1 – View of upper part of mapping traverse 103 from below, with a bed of massive sandstone forming the upper part of the cliff, over cross-bedded sandstone, as shown.

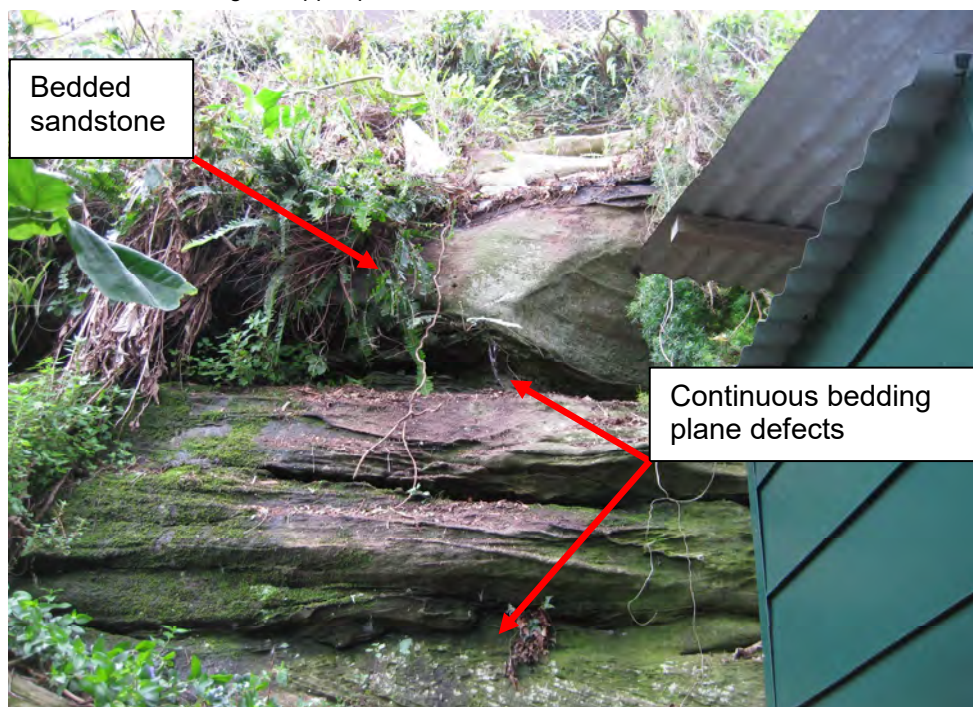
Mapping Traverse 103, Photo 2 – View of cross-bedded sandstone at mapping traverse 103..

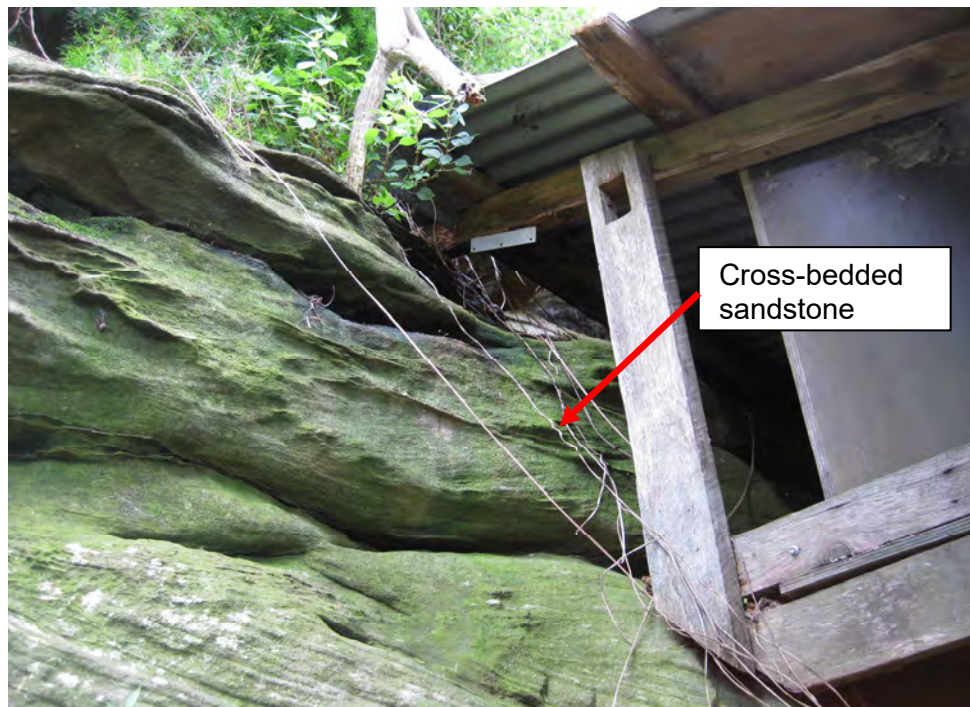
Mapping Traverse 103, Photo 3 – Oblique view of mapping traverse 103 from below, with cross--bedded sandstone exposed, as shown.

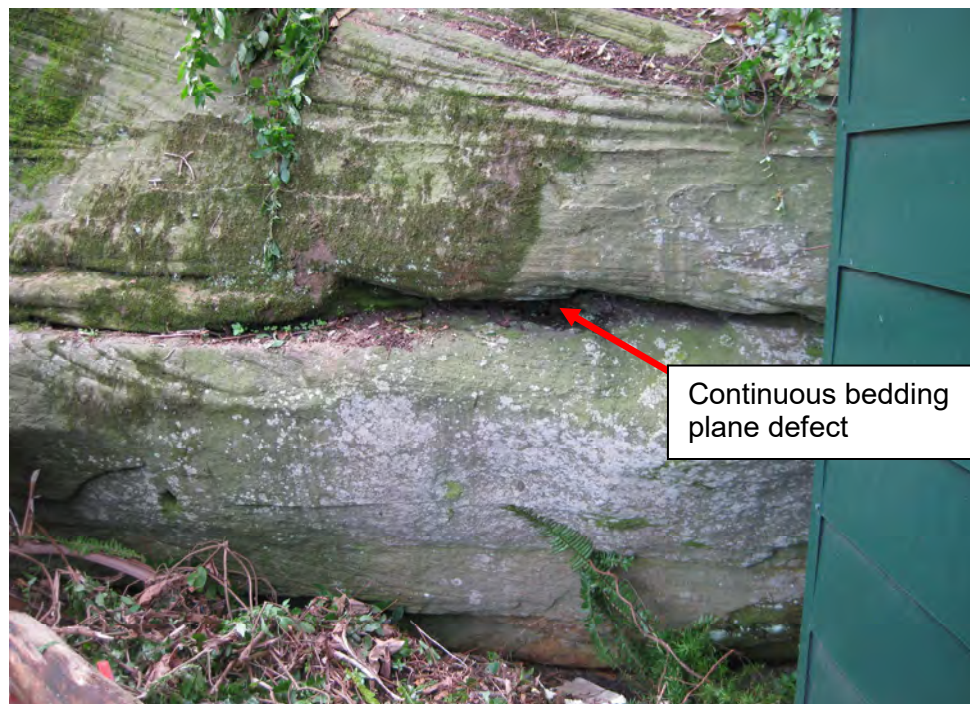
Mapping Traverse 103, Photo 4 – View of lower part of cliff at traverse 103.

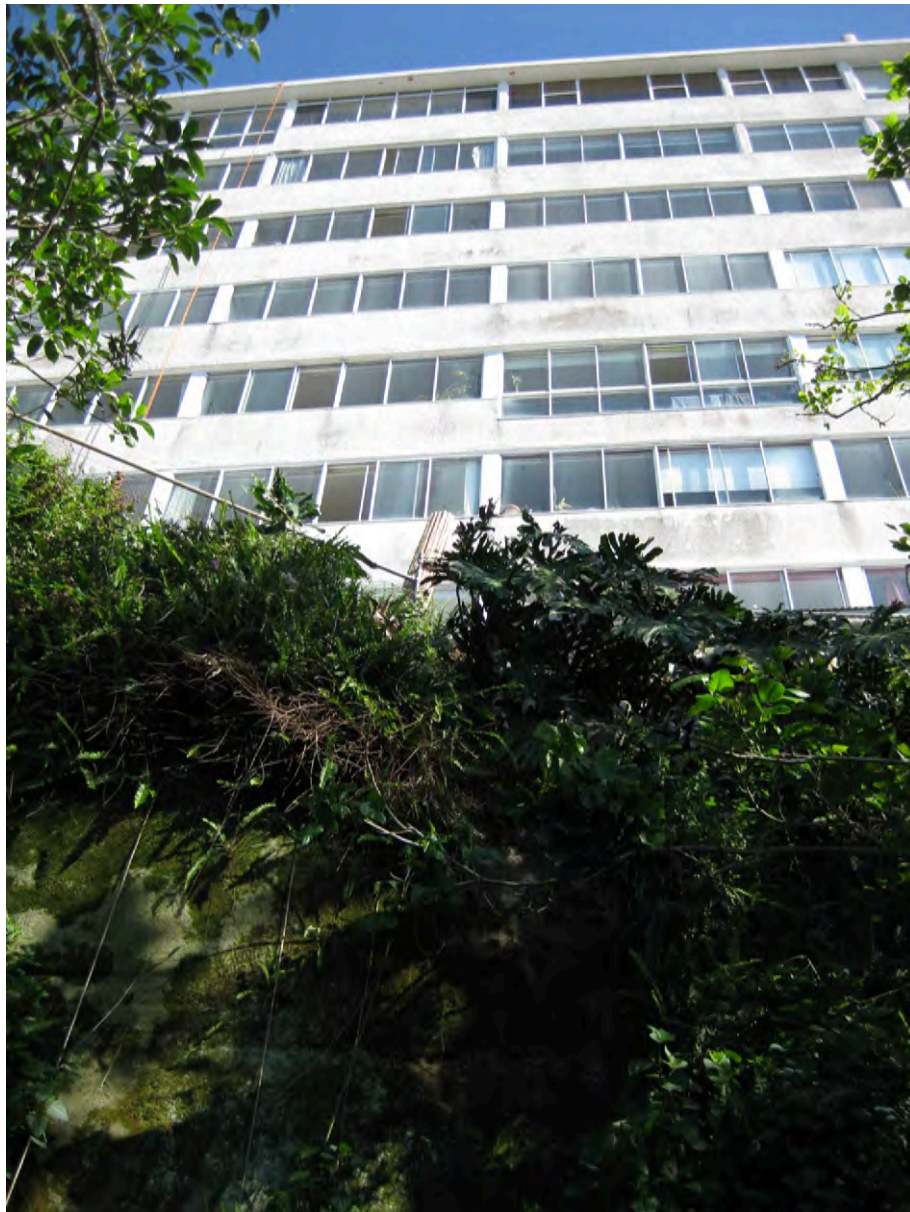
Mapping Traverse 104, Photo 1 – View towards the existing unit building at mapping traverse 104. Solid sandstone exposed for most of the lower part of the slope.

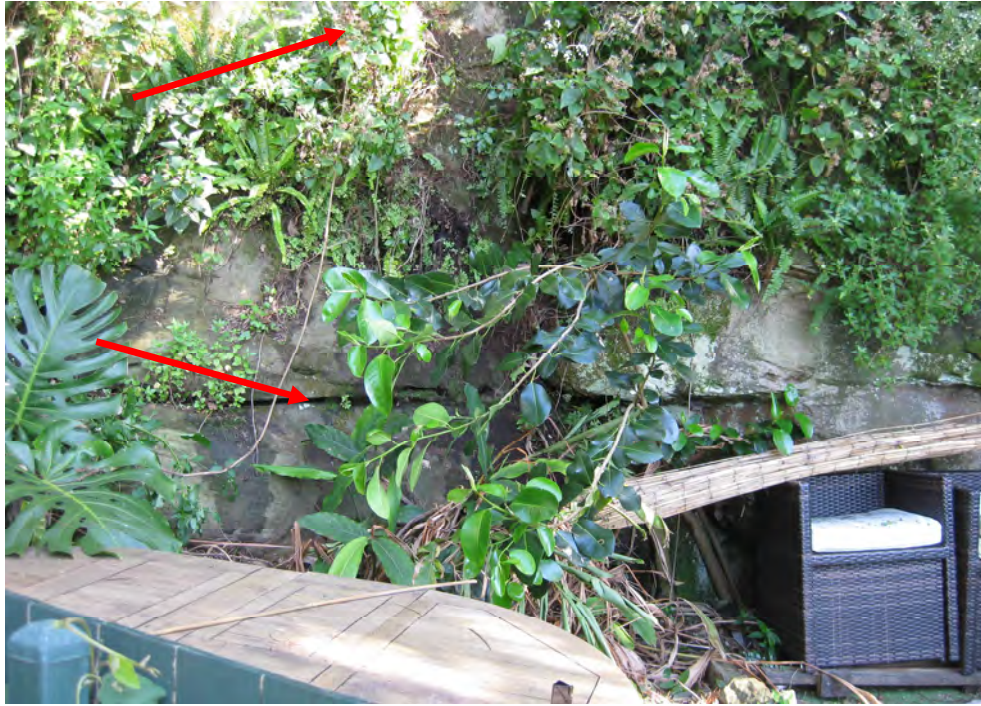
Mapping Traverse 104, Photo 2 – View of the lower part of the traverse, exposing thin, continuous seams / bedding partings, which are indicated as shown.

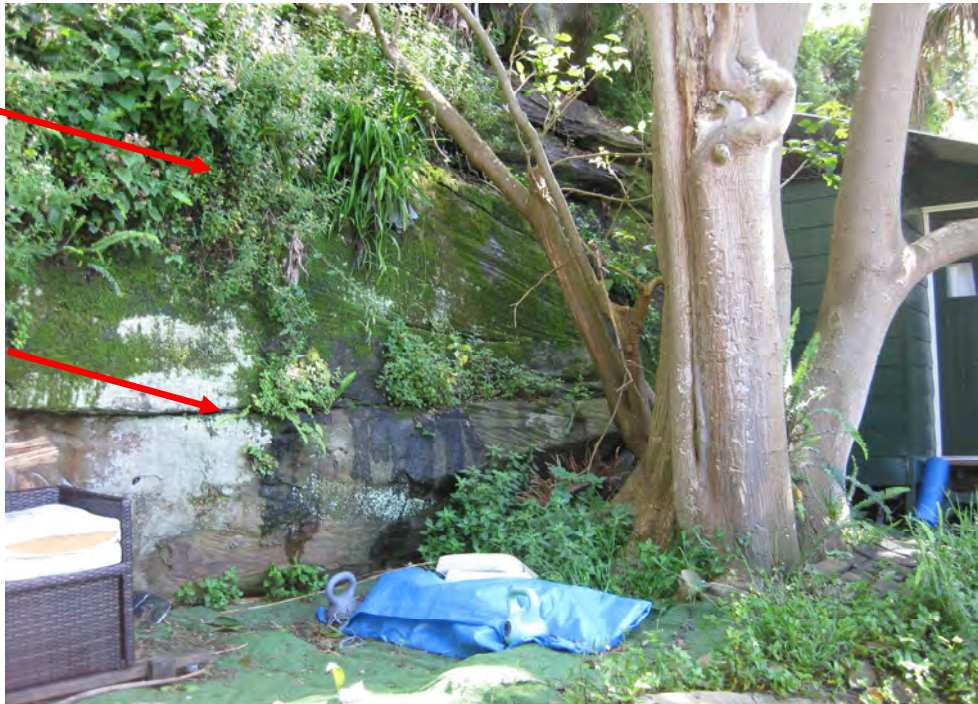
Mapping Traverse 104, Photo 3 – View north of mapping traverse 104. Continuous bedding planes within cross-bedded sandstone are indicated as shown.

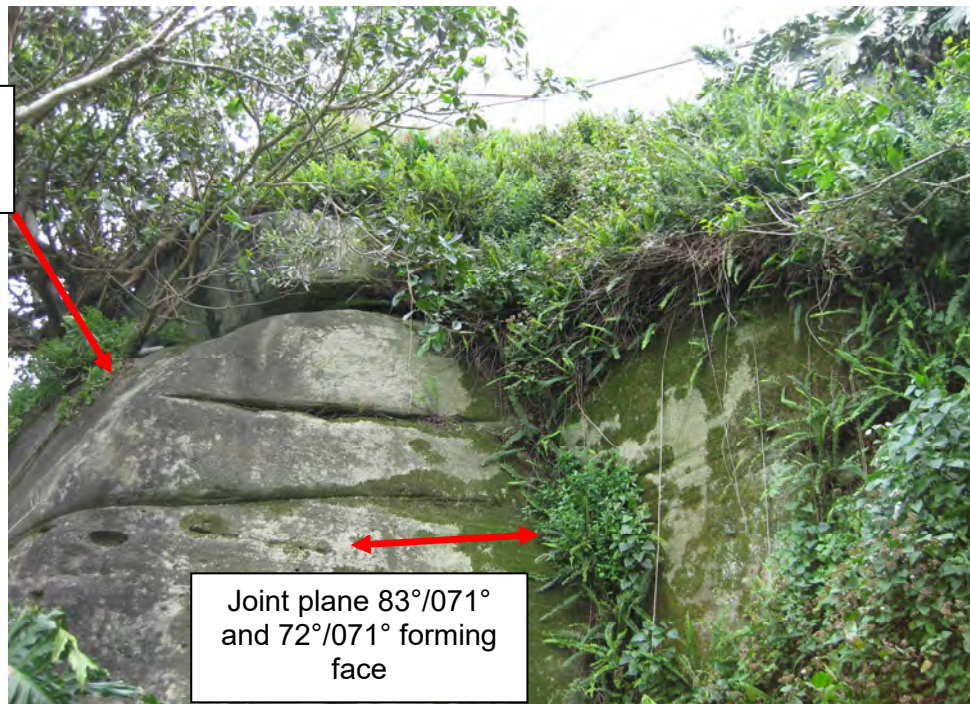
Mapping Traverse 105, Photo 6 – Side view of mapping traverse 105 (indicated). Persistent sub-vertical joint, forming a face, is indicated as shown.

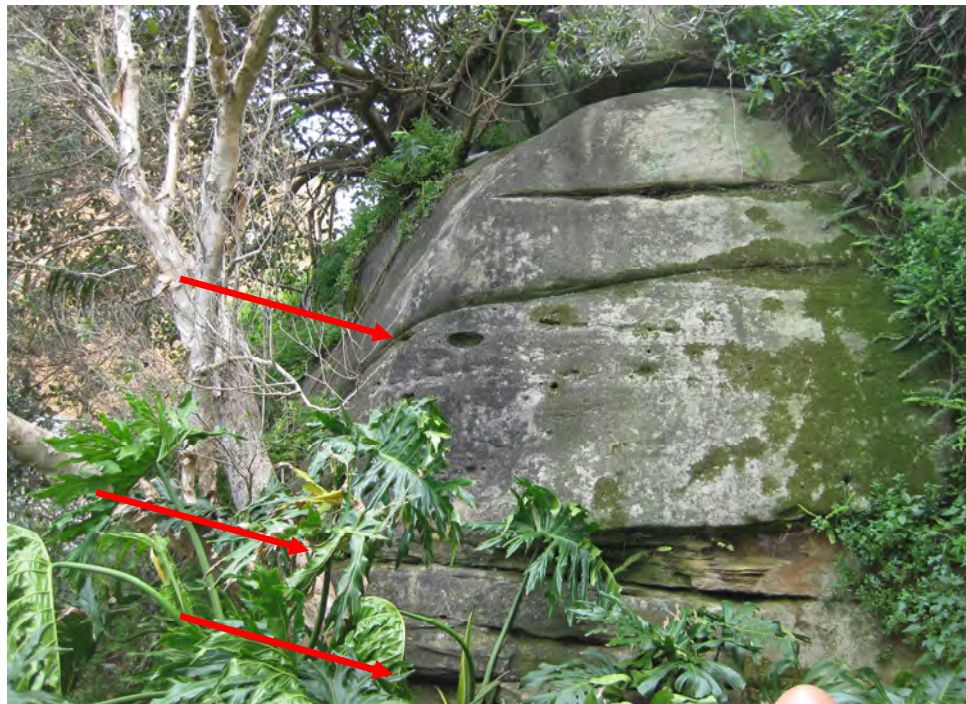
Mapping Traverse 105, Photo 7 – View towards mapping traverse 105. Continuous bedding partings within cross-bedded sandstone are indicated as shown.

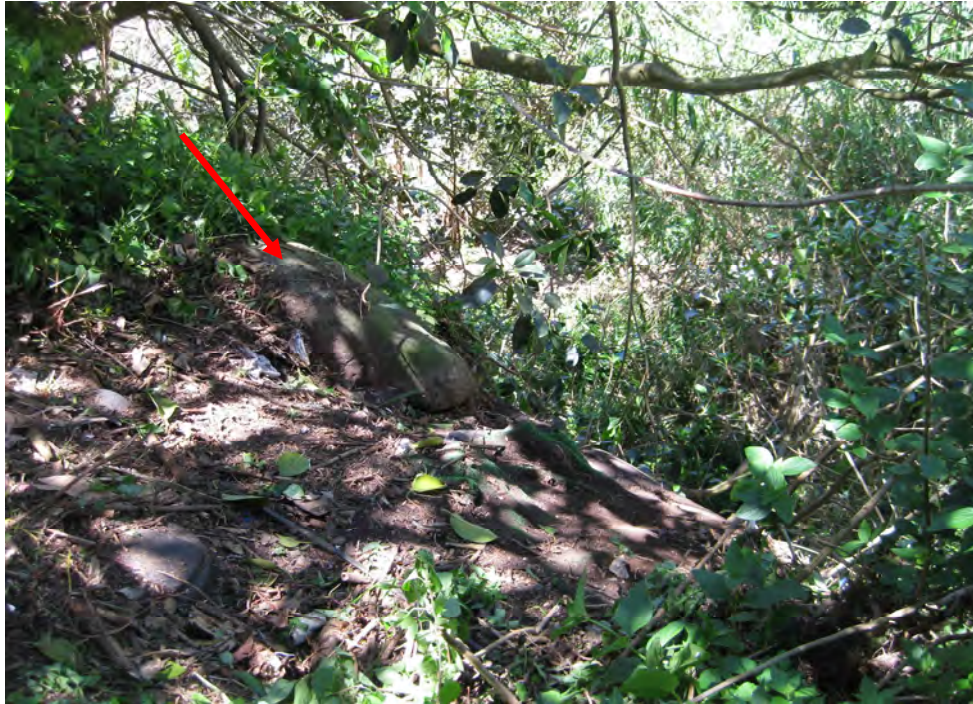
Mapping Traverse 106, Photo 1 – View downslope from the crest of mapping traverse 106, showing some boulders at the slope crest, indicated as shown.

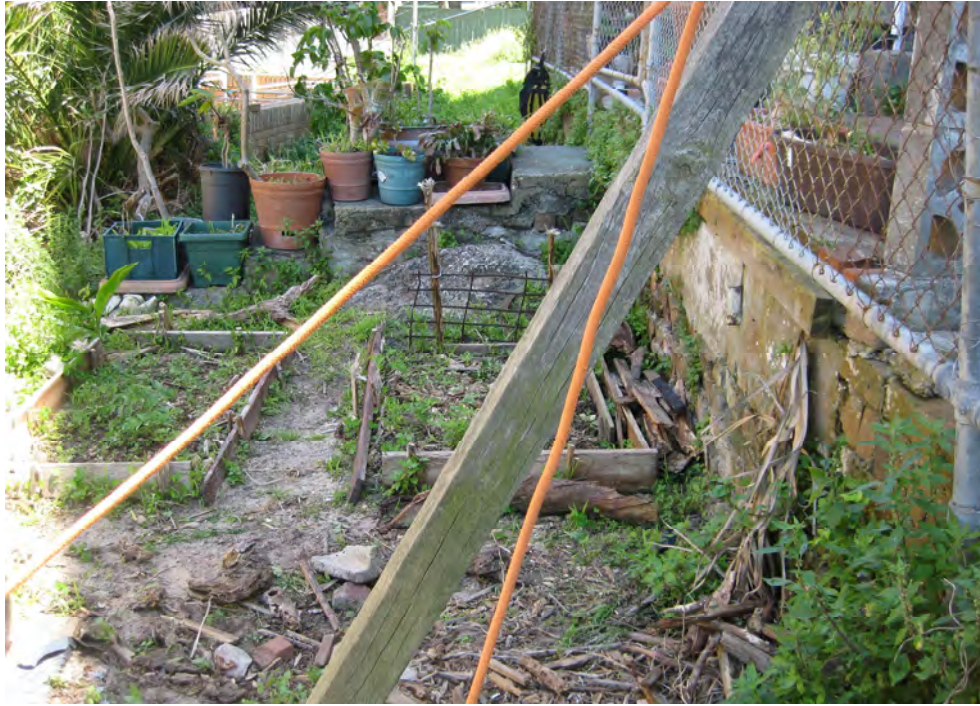
Mapping Traverse 107, Photo 1 – View south-west along crest of slope near the start of mapping traverse 107, showing an informal garden area.

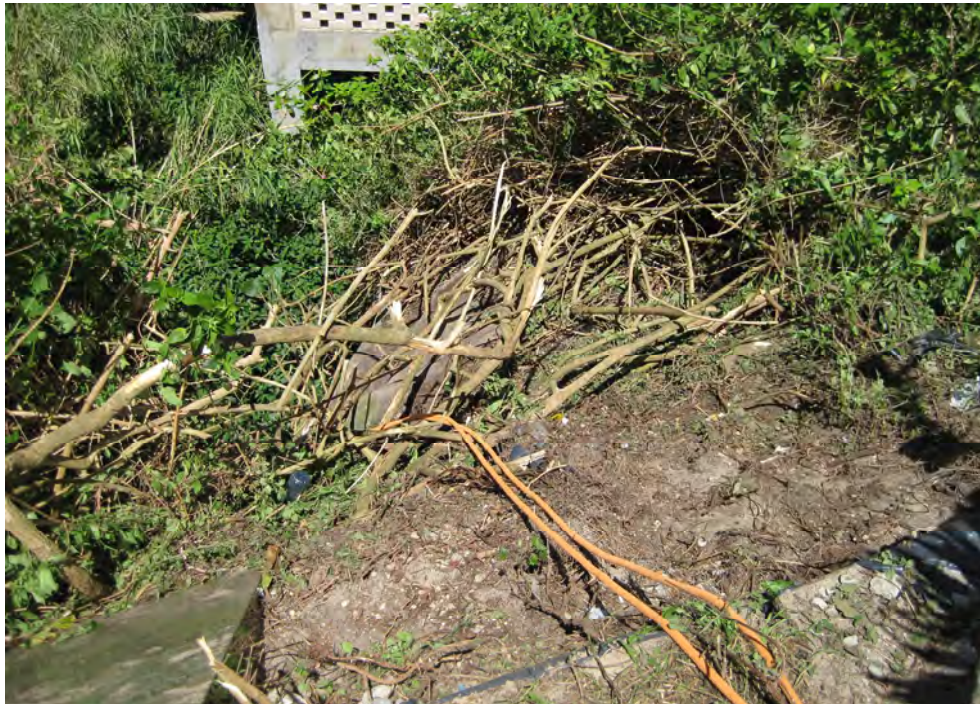
Mapping Traverse 107, Photo 2 – View down slope at the crest of traverse 107, with boulders and other debris on the slope surface.

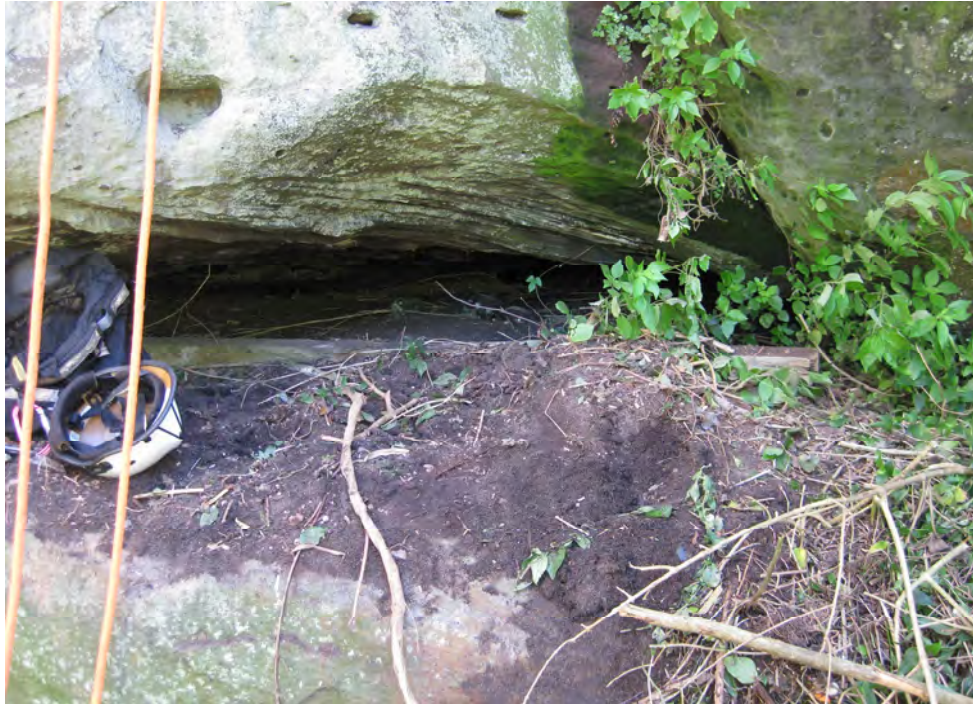
Mapping Traverse 107, Photo 5 – View of overhang and cave within cross-bedded sandstone, 0.5 m high and 2.5 m deep, developed on continuous bedding parting.

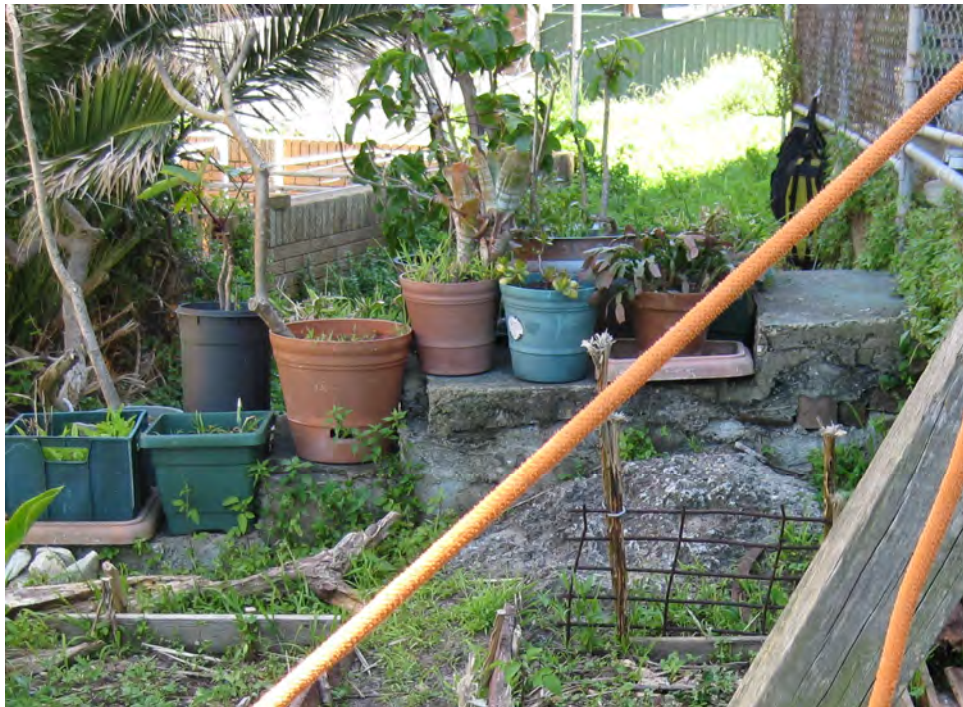
Mapping Traverse 108, Photo 1 – View south-west along crest of slope near the start of mapping traverse 108, showing a former set of concrete stairs leading towards the crest of the slope.

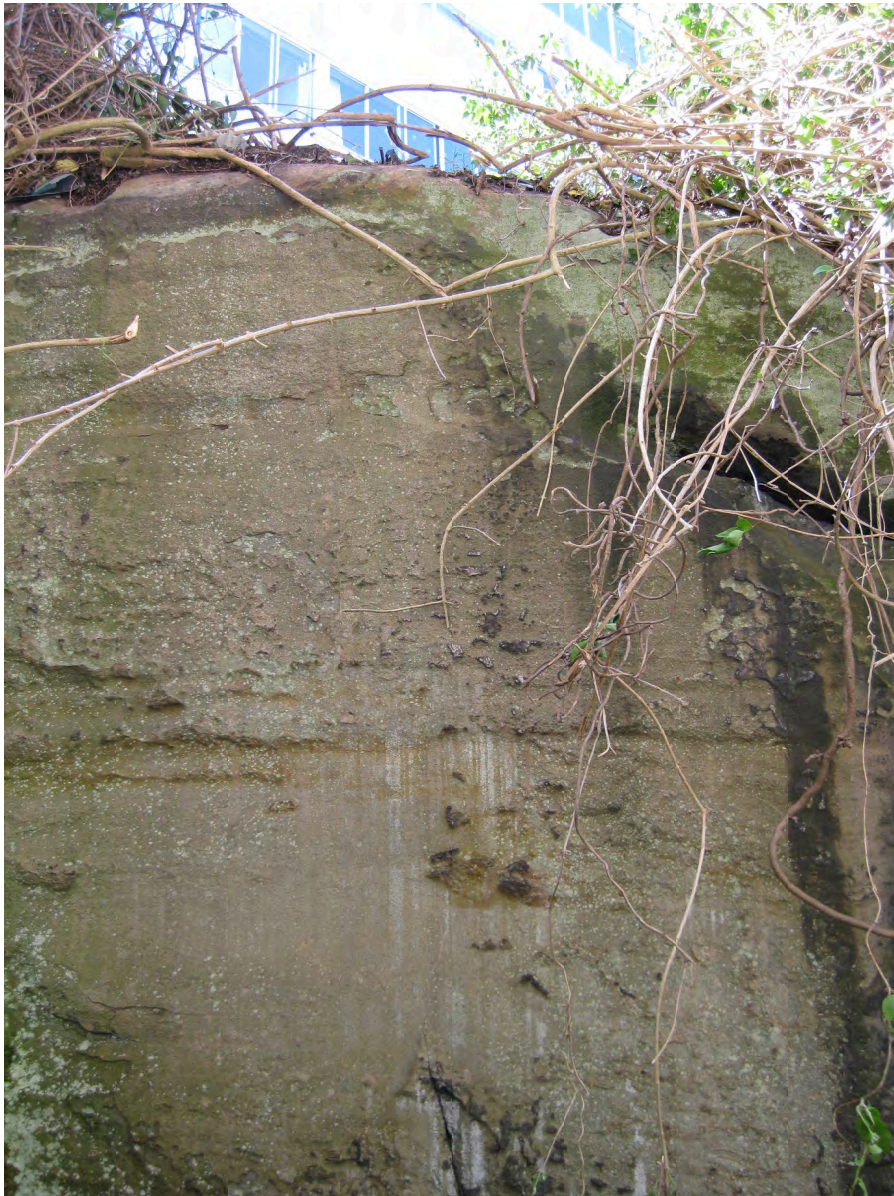
Mapping Traverse 108, Photo 2 – View upslope from base of traverse 108, of high strength sandstone.

Continuous  
bedding  
parting  
defect, with  
measured  
dip and dip  
direction  
23°/017°

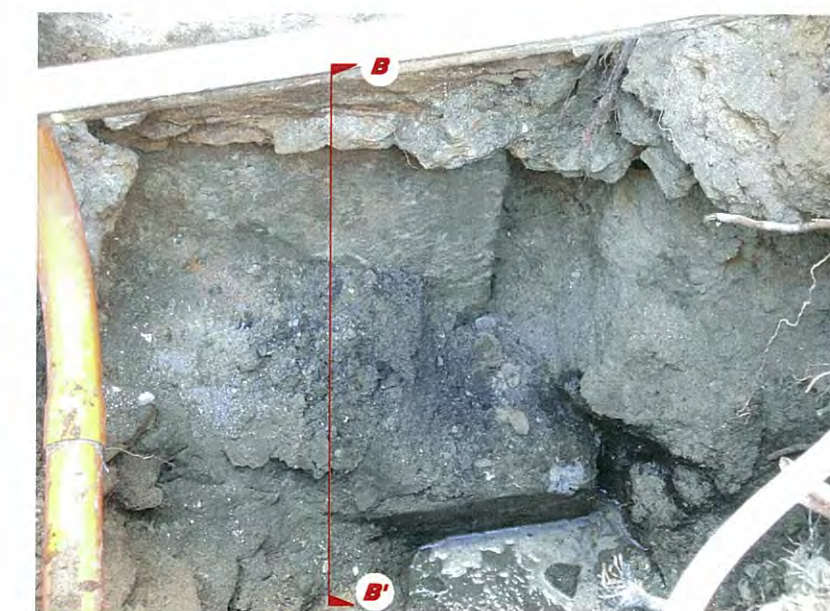
Photo 2: Showing corner of concrete footing

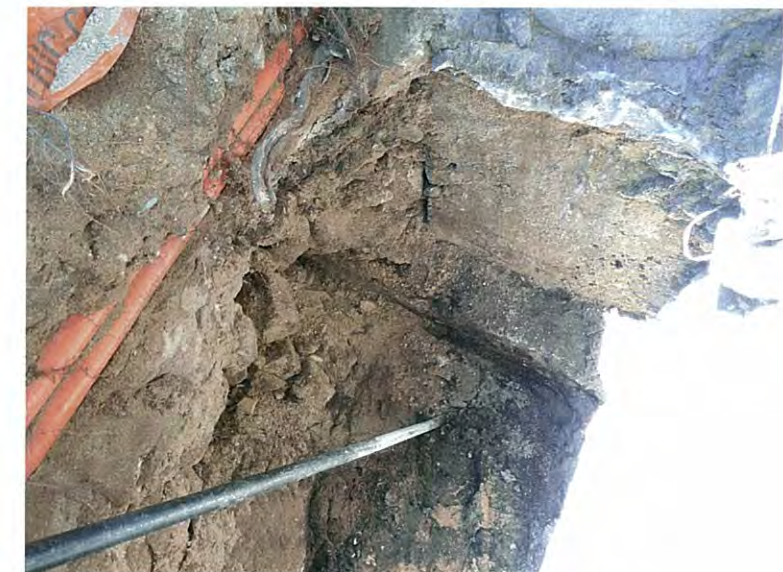
Photo 2: Northern edge of concrete footing

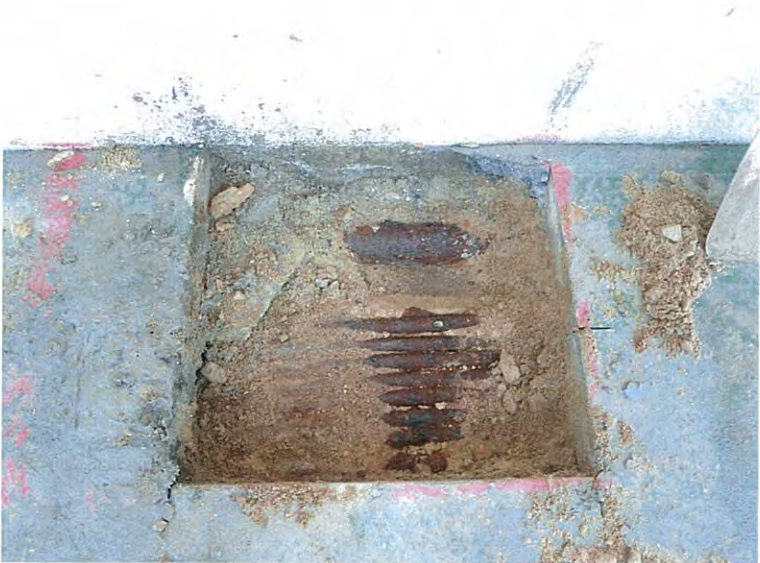
Photo 2: Services below slab
