Report on  
Geotechnical Investigation

Alterations and Additions  
20 Illawong Avenue, Tamarama

Prepared for  
Strata Plan 1731

Project 72261.06  
November 2018

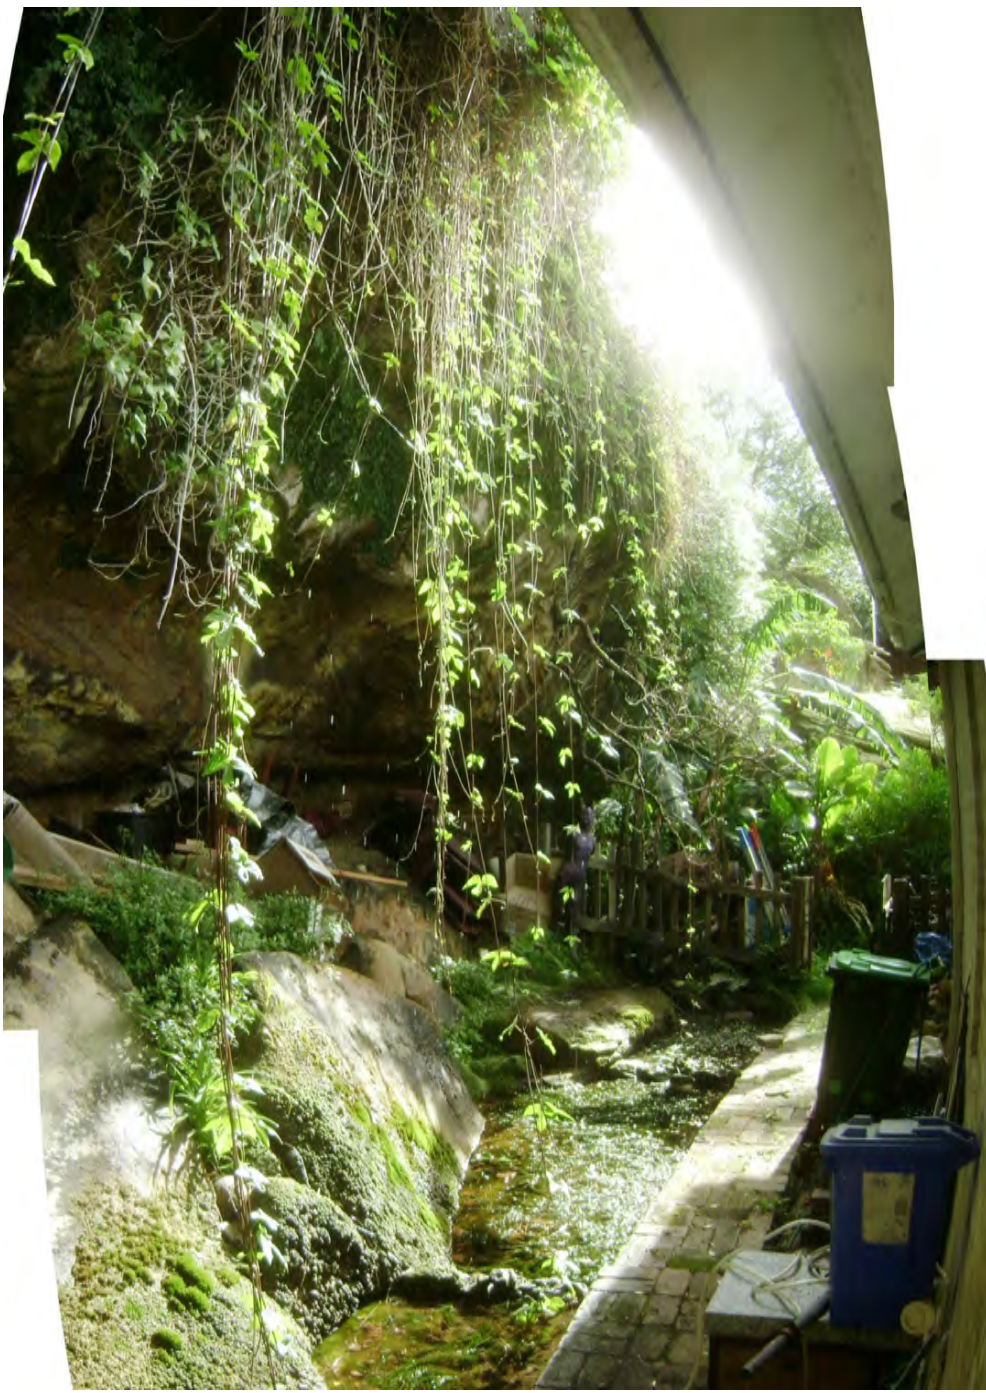
Section 1 viewed towards the north east  
(prior to clearing)

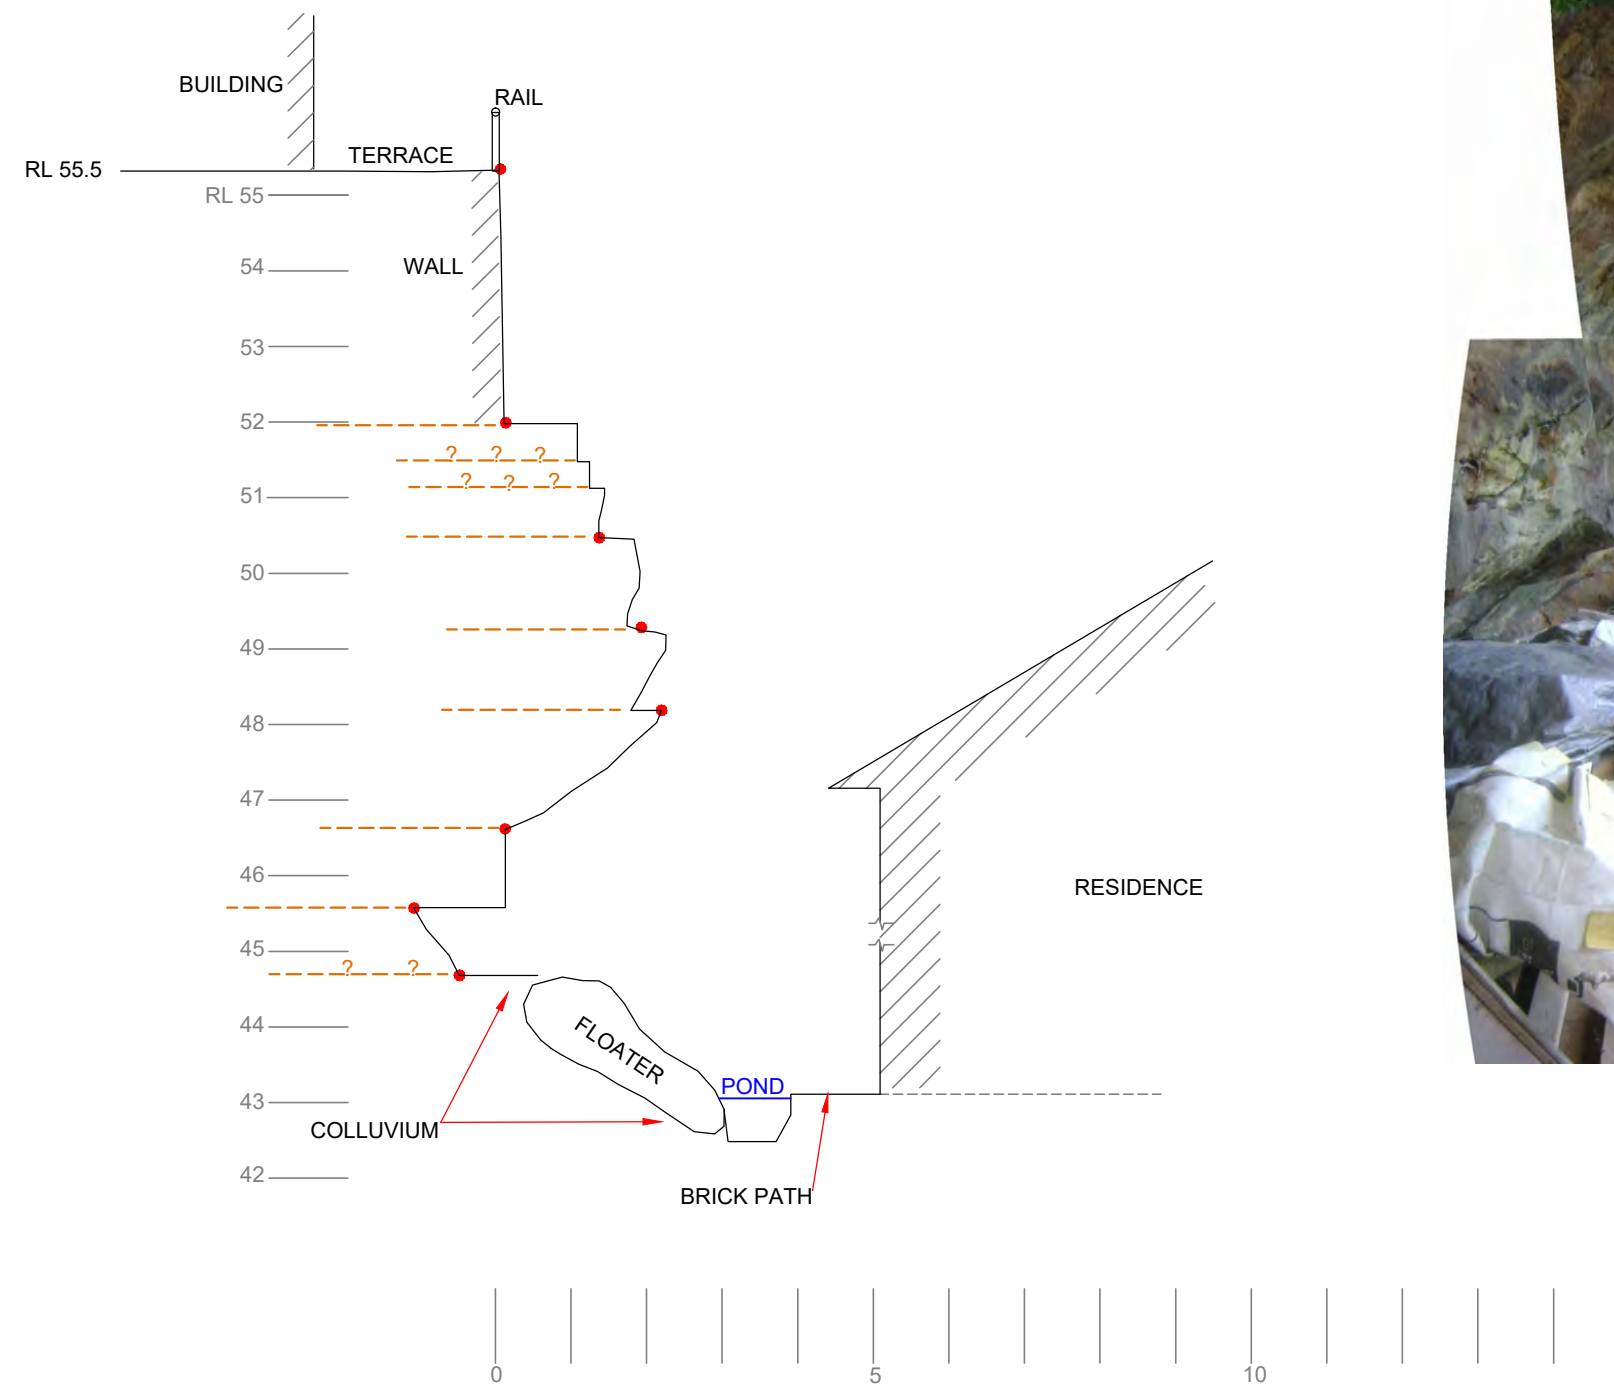
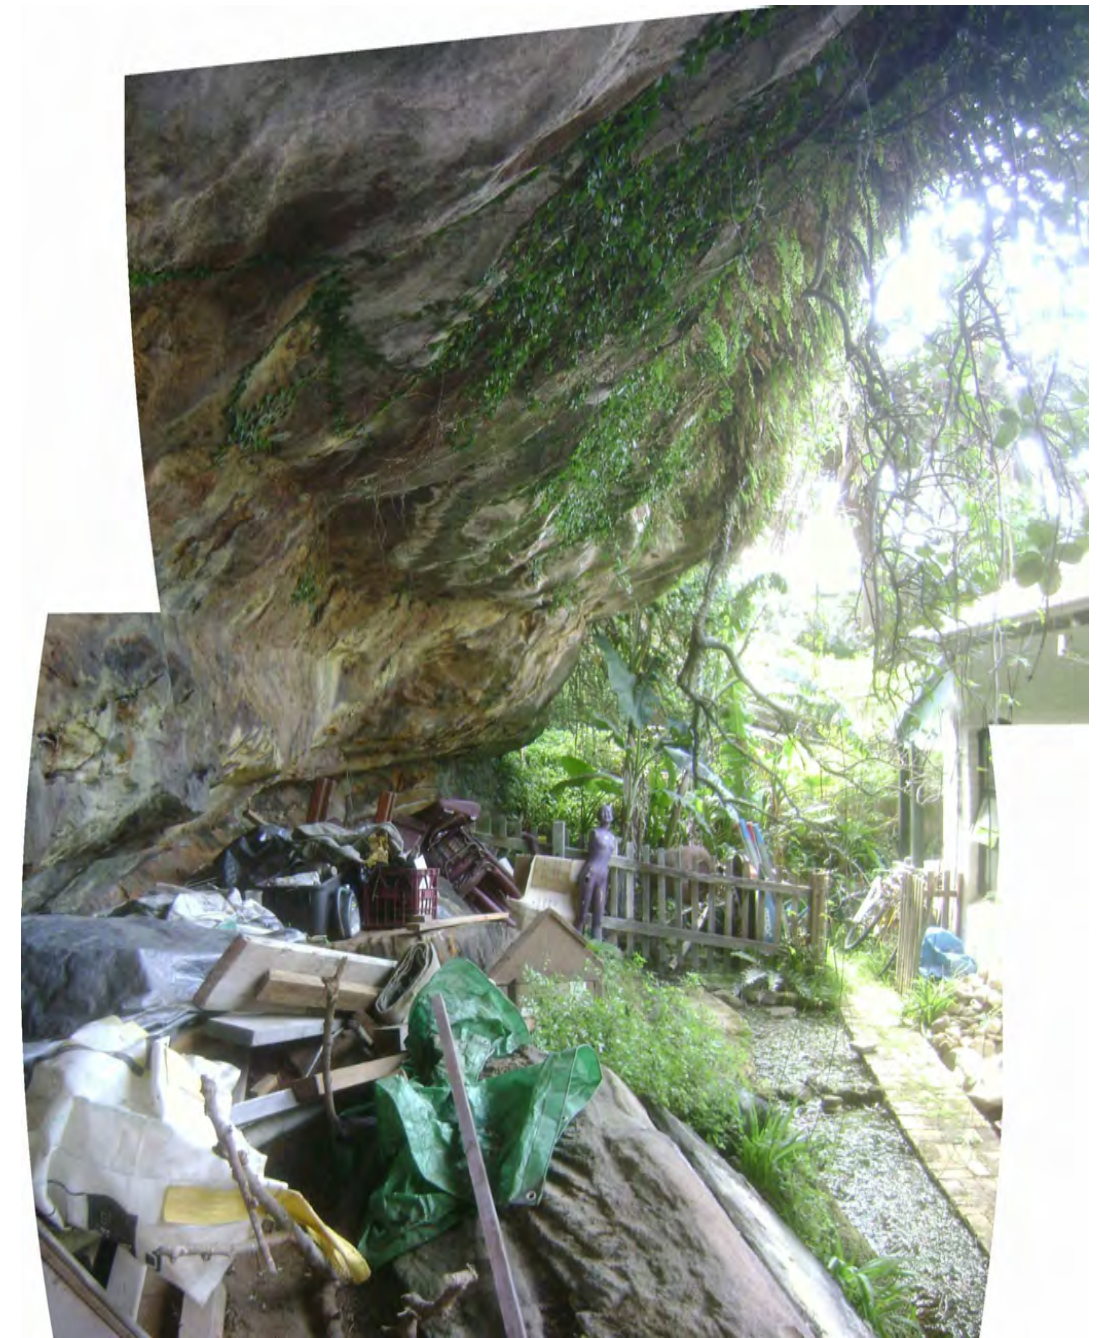
## CROSS SECTION 2

Section 2 viewed towards the north east

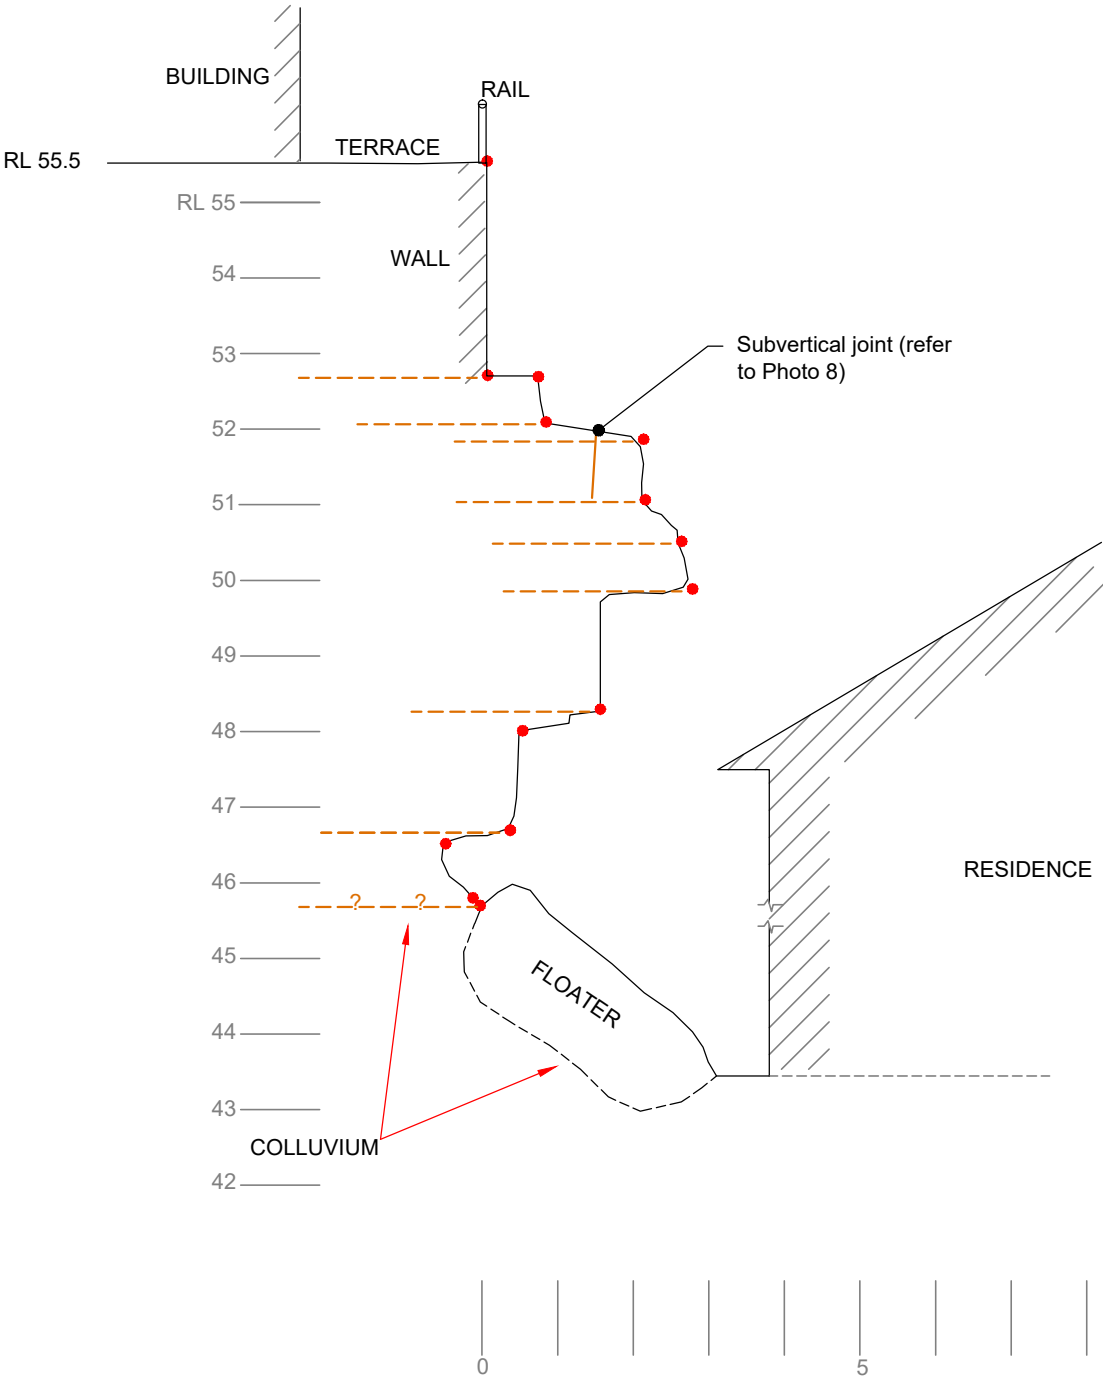
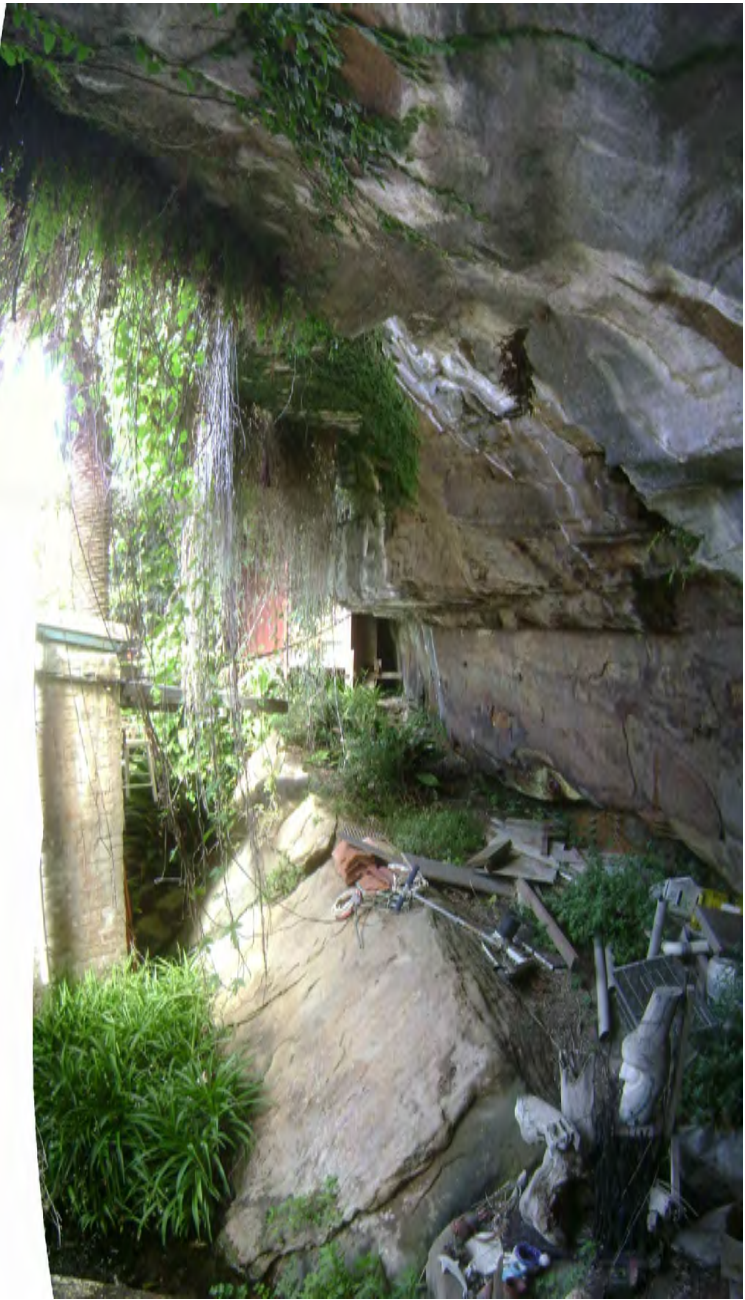
CROSS SECTION 3

Section 3 viewed towards the south west

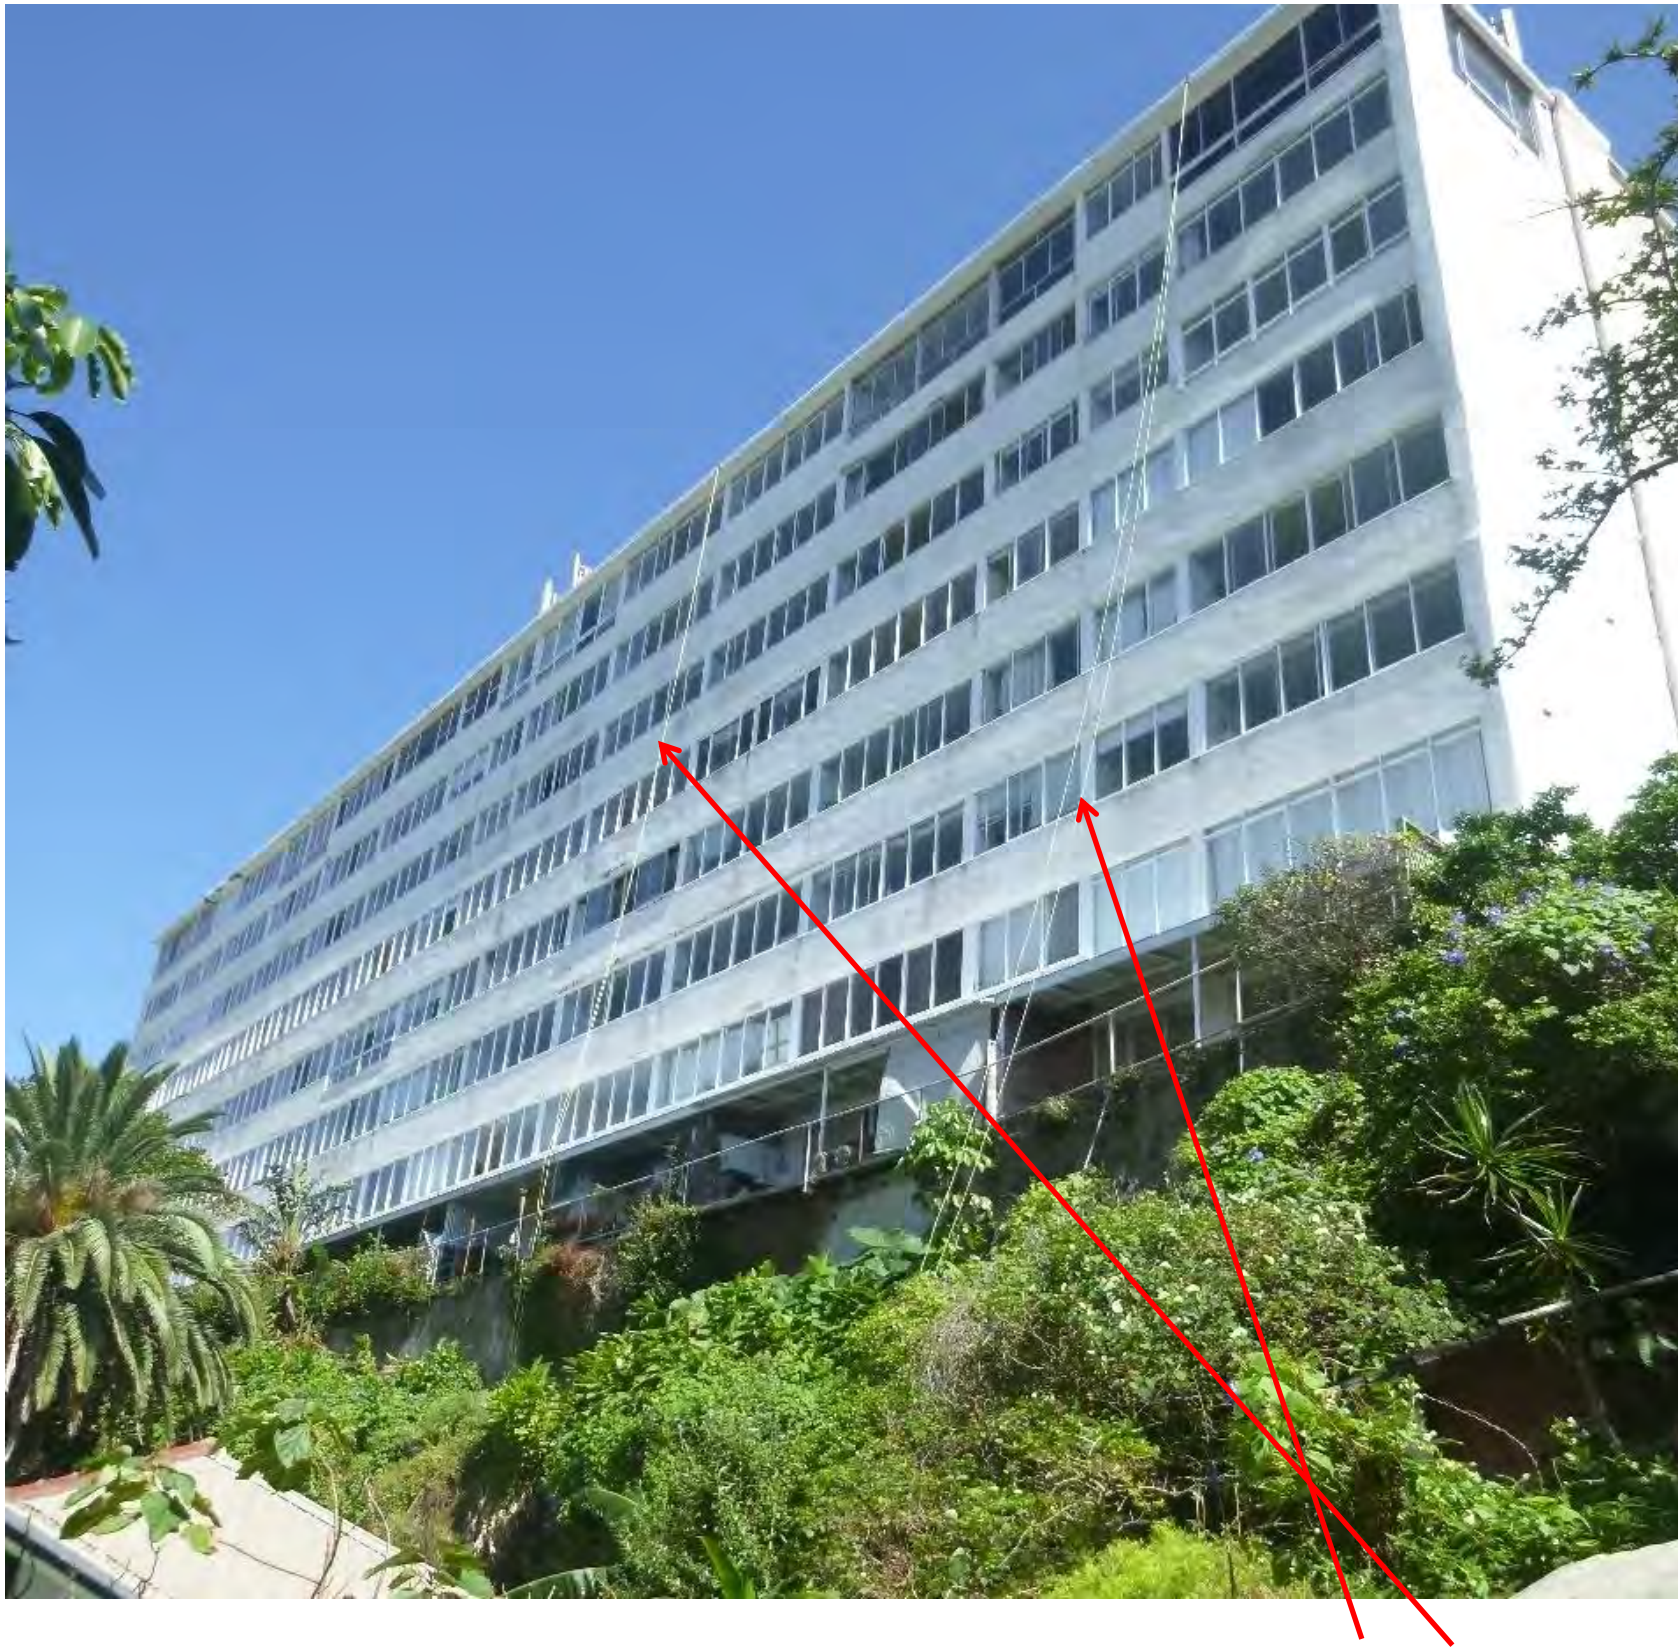
Photo 1. Southern side of building showing rope attachment locations to enable measurements for Cross Sections 1 and 2/3.

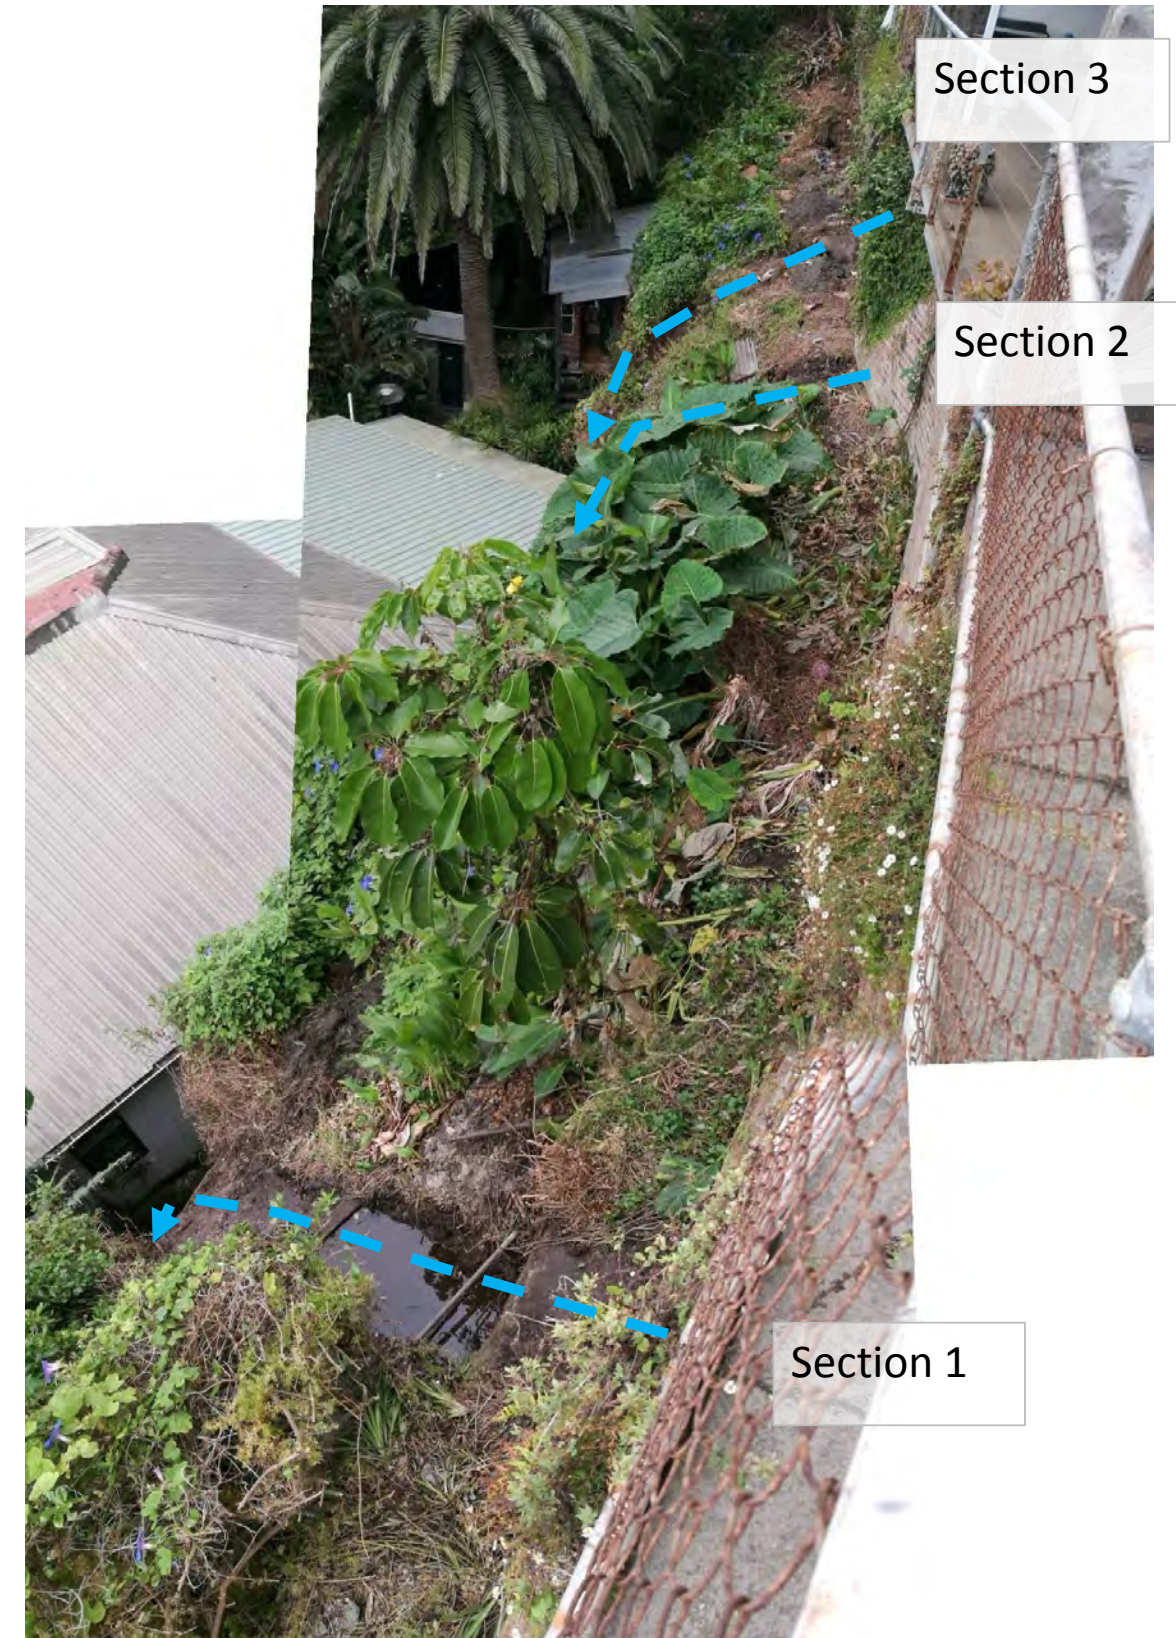
Photo 2. Top of the cliff, viewed towards the south-west at the time of vegetation clearing in 2016. Cross Section Numbers and locations indicated.

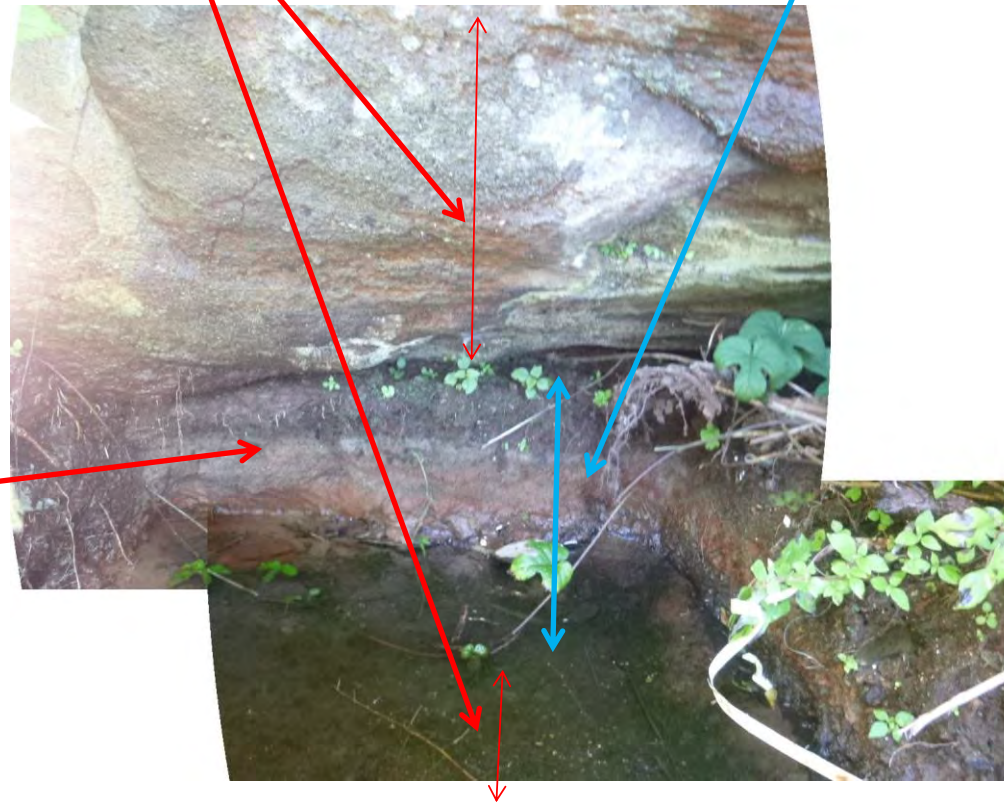
Photo 4.. Close up of Medium strength sandstone over very low strength, clayey sandstone then medium strength sandstone

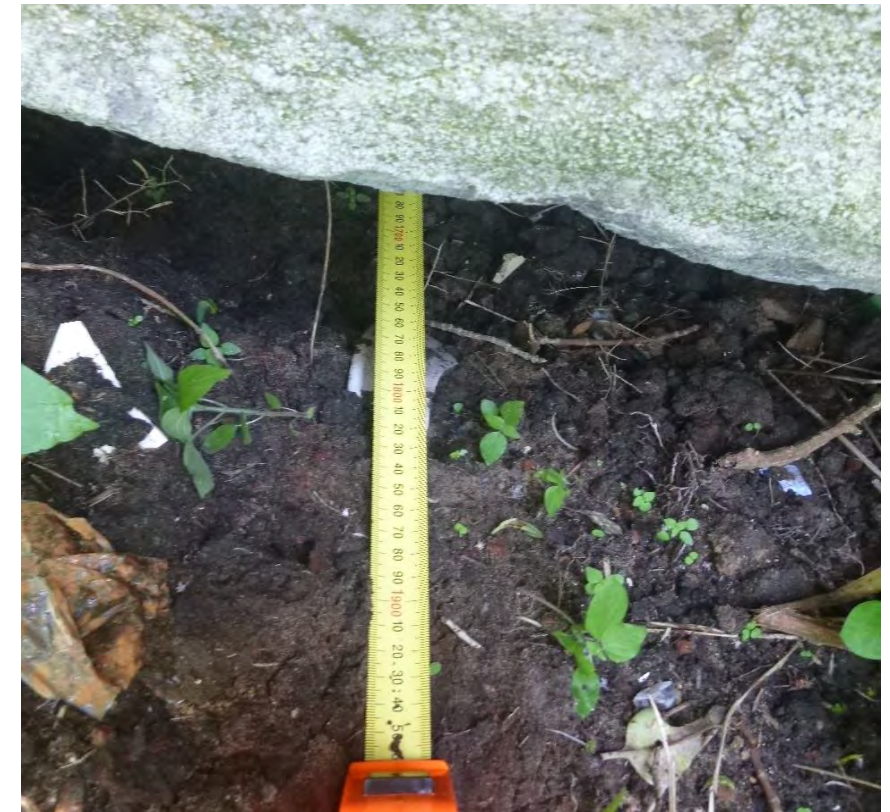
Photo 5. To north of Section 3 showing 1900mm penetration of tape measure into void/weathered seam.

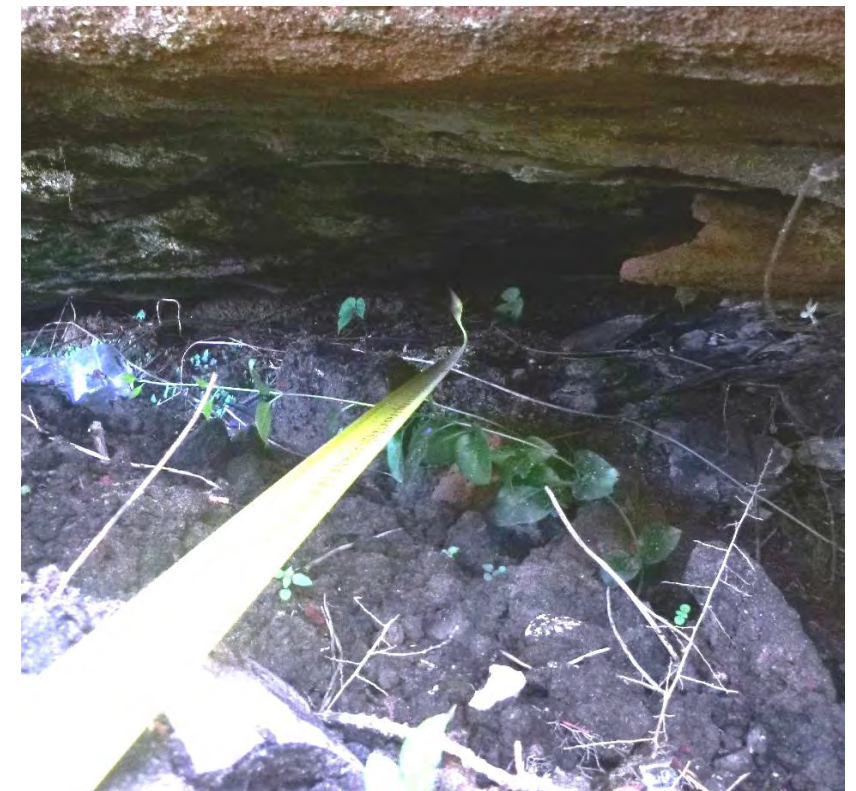
Photo 6. View into the weathered void.

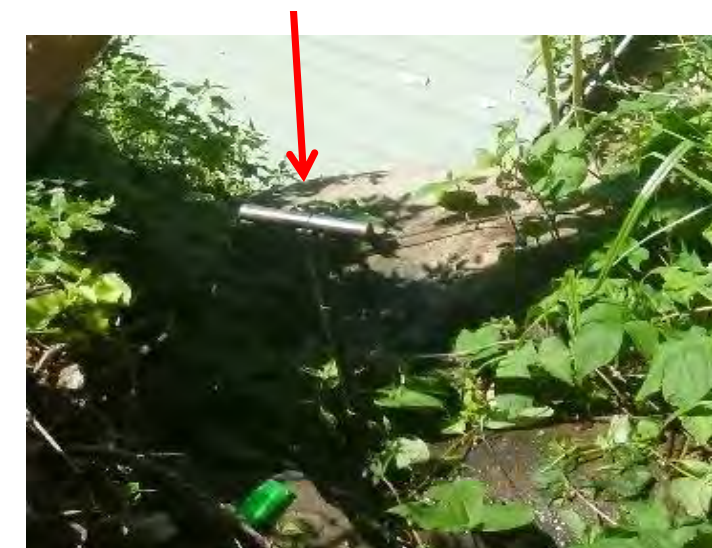
Photo 8a. Close up of test probe inserted into the open joint.

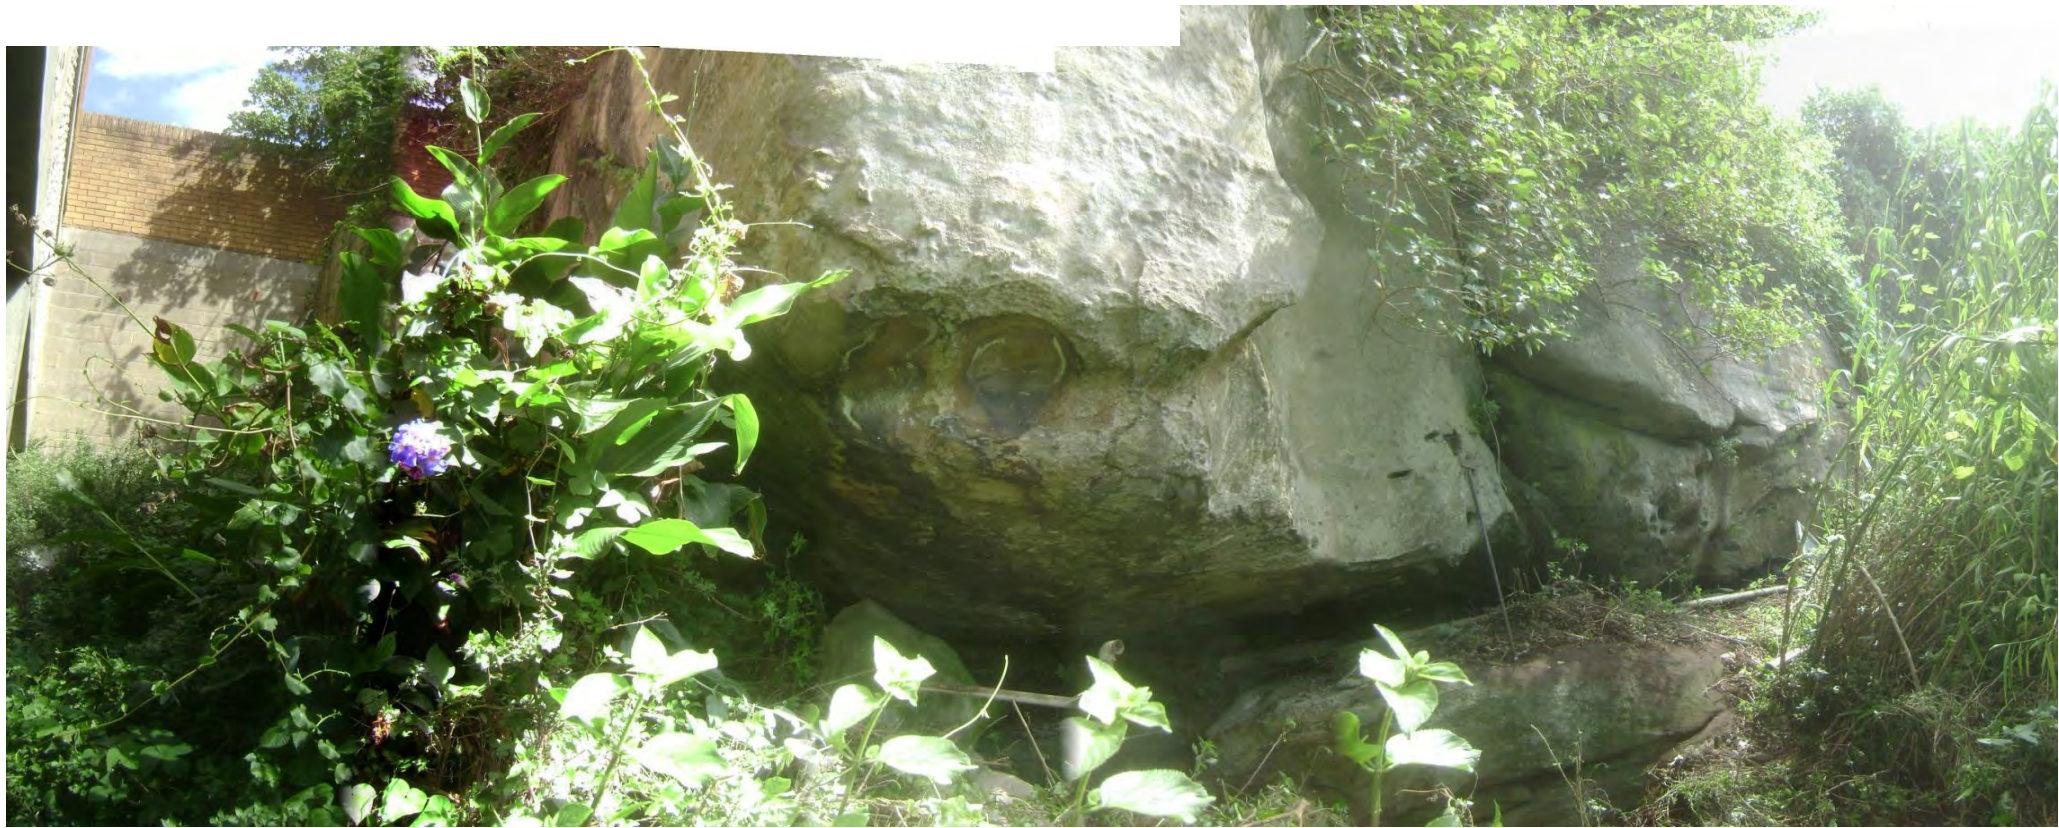
Photo 11. "Eastern end" of the southern most portion of the sandstone outcrop/cliff.

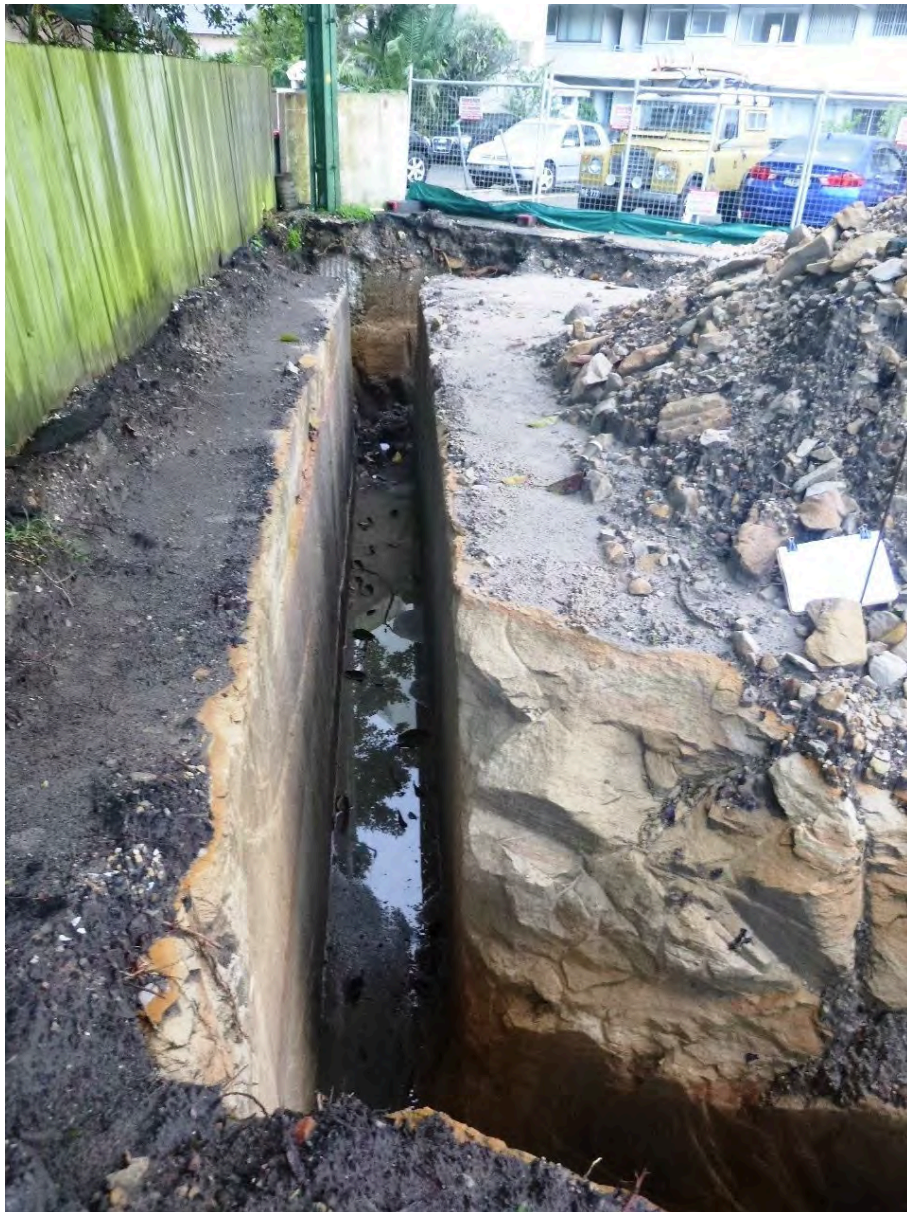
Historical Site Photograph of Sewer Diversion Trench, Photo 1 – View to east near Borehole BH3. Solid sandstone exposed at shallow depth along trench excavation.

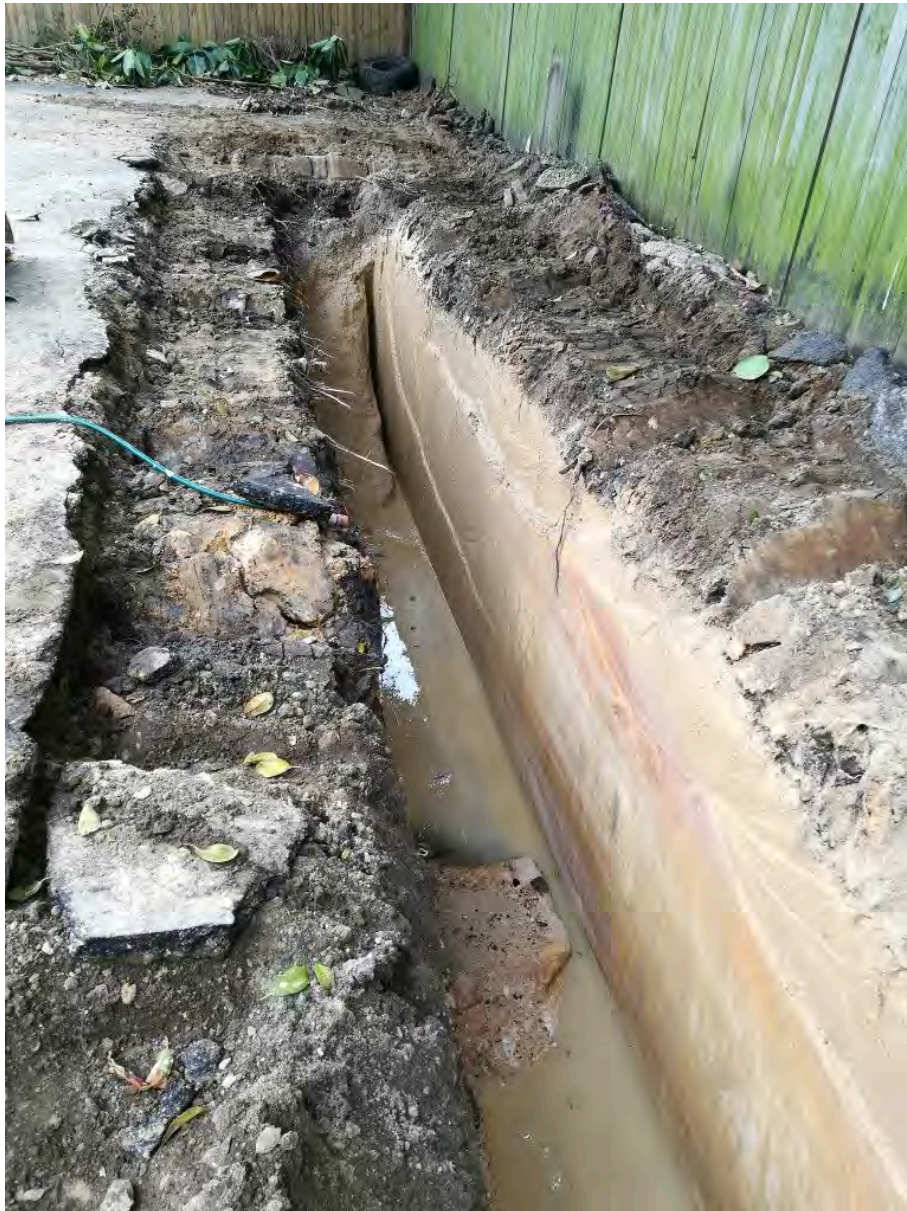
Historical Site Photograph of Sewer Diversion Trench, Photo 2 – View to west near Borehole BH3. Solid sandstone exposed at shallow depth along trench excavation.

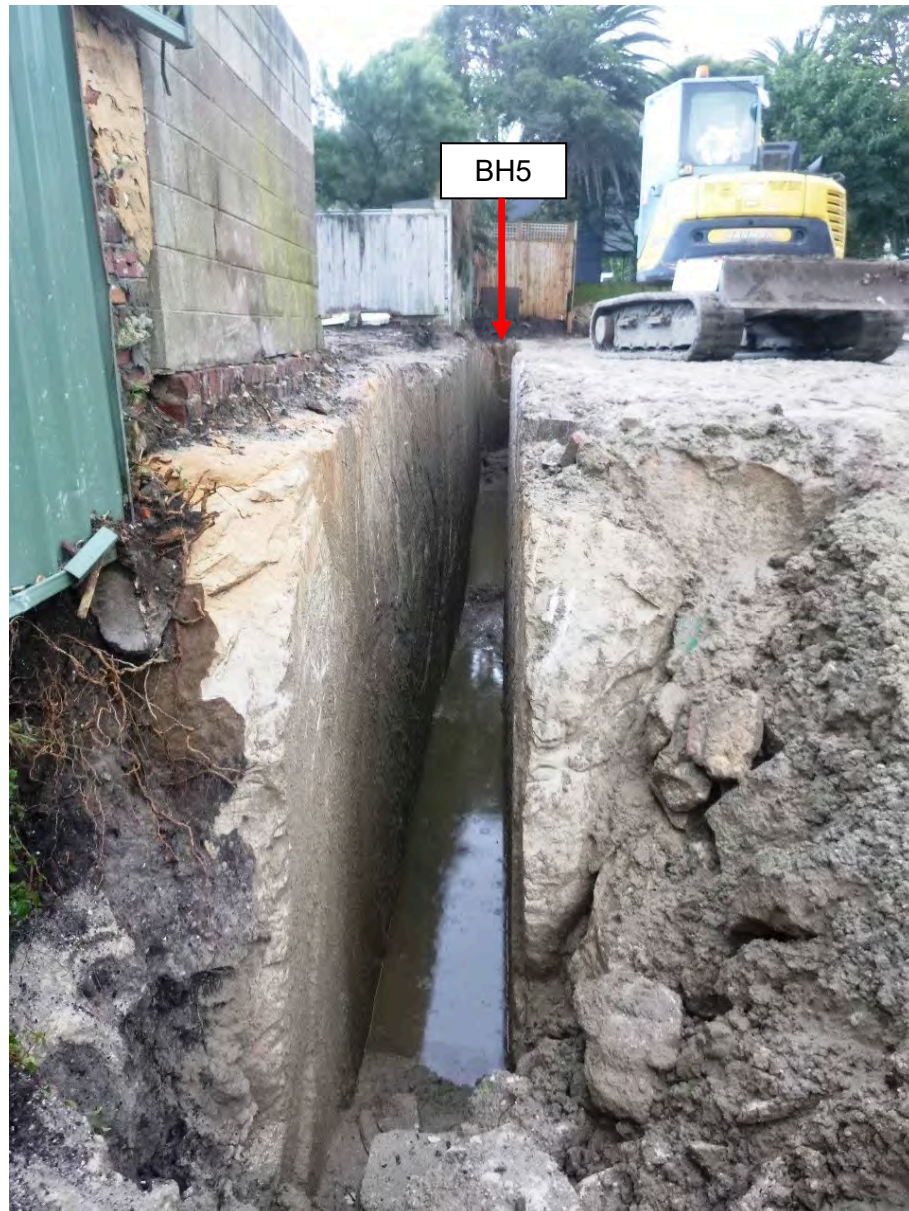
Historical Site Photograph of Sewer Diversion Trench, Photo 5 – View to north near Borehole BH101. Solid sandstone exposed at shallow depth along trench excavation. The approximate position of Borehole BH5 indicated as shown for reference.
