Arborist report

Impact assessment

DA 2019/00061

11 - 17 Mosbri Crescent, The Hill 2300
Arcadia Park and Mosbri Crescent Park

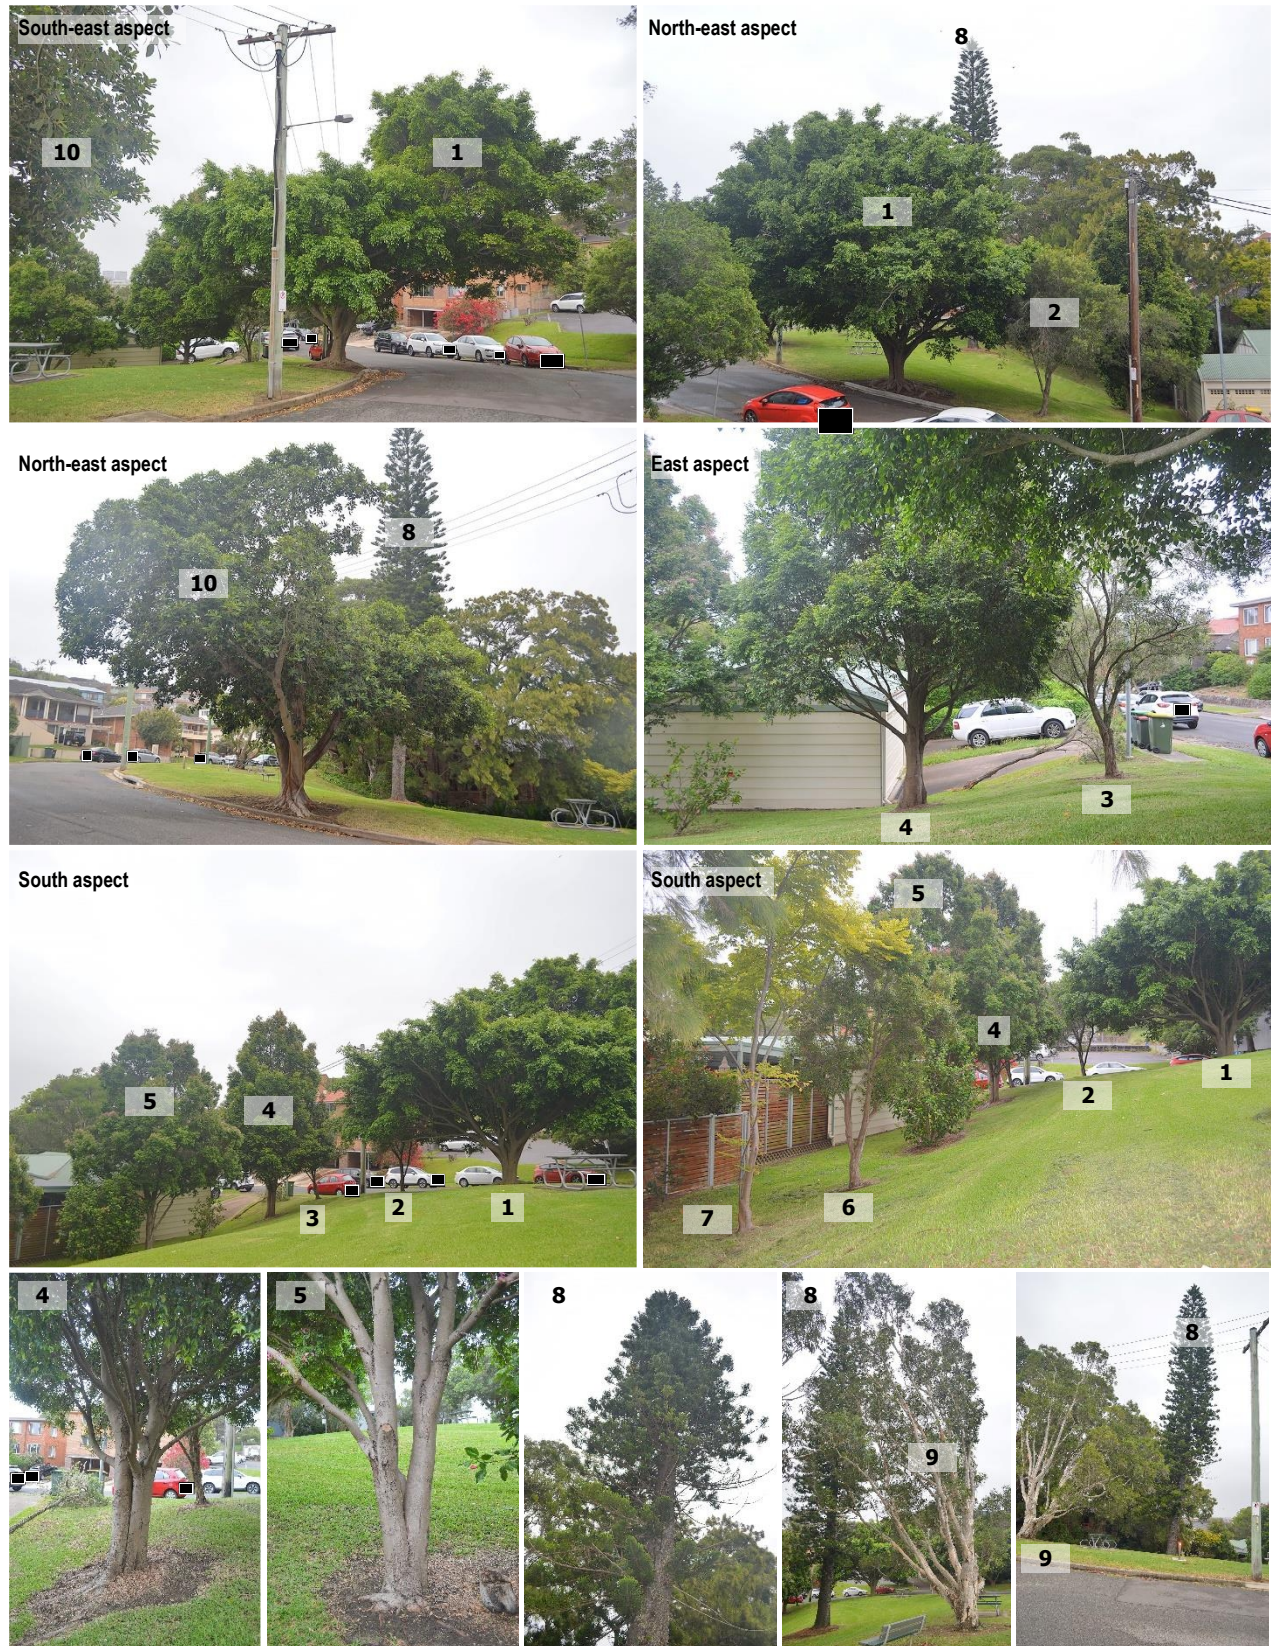
Photos

| # | Common / Botanical name | Age class | DBH in centimetres | TPZ in metres as a radius | DRB in centimetres | SRZ in metres as a radius | Height | Condition |
|---|--|---|---|---|---|---|---|---|
| 2 | Weeping bottlebrush <i>Callistemon viminalis</i> | Semi-mature | 22* | 2.6 | 29 | 2.0 | 7 | Co-dominant, 20cm and 10cm DBH. Mechanical damage to root crown. Pruning history. Suppressed canopy from adjoining tree 1, Fig. Trunk lisp northwards. Twig dieback and dead branches. Partial decline to east side. |
| 3 | Weeping bottlebrush <i>Callistemon viminalis</i> | Semi-mature | 20* | 2.4 | 27 | 1.9 | 5 | Multi-stemmed x 4; 14cm, 7cm, 6cm and 11cm DBH. Pruning history. Trunk and scaffold branch failure history. Poor foliage cover. Multiple fungal fruit bodies in multiple locations along trunk and pruning locations. |
| 4 | Small leaved lillypilly <i>Syzygium luehmannii</i> | Mature | 43* | 5.2 | 65 | 2.8 | 12 | Surface roots north-west, west and south-west, downslope, wounded. Basal flare. Multi-stemmed x 4; 26cm, 30cm, 13cm and 10cm DBH. Included bark to root crown of larger trunks, acutely convergent. Pruning history. Structurally deficient. Healthy. |
| 8 | Cook Pine <i>Araucaria columnaris</i> | Mature | 78 | 9.4 | 108 | 3.4 | 28 | Elevated root plate. Basal flare south side. Surface roots west-south-west. Slight bow to trunk at 4m with exudations, bulge. North side dead branches to approximately 10m. Latent bud growth. Suspected of being storm damaged at 4m. |
| 19 | Mountain grey gum <i>Eucalyptus cypellocarpa</i> | Mature | 84 | 10.1 | 85 | 3.1 | 14 | Stout. Congested undergrowth consisting of weed and undesirable species – Camphor laurel and Pittosporum. Vine incursion along trunk and branches. End weighted foliage distribution. Some epicormic growth along branch lengths. Branch failure history. Storm damaged. |

- 6.1. The revised stormwater plan connects to the existing infrastructure. This will have a major impact upon tree 2. Tree 2 cannot be retained and will require compensatory planting as an offset.
- 6.2. This revised stormwater plan has removed all potential excavation around any root systems to other trees of the park. No other TPZ or SRZ zones will receive impacts from this connection.
- 6.3. This is a most considered and compassionate effort for reducing impact to trees' of this park.
