Zhiva Living Dural Pty Ltd atf The Zhiva Living
C/- Mills Oakley

Drainage Line Classification: 4 Vineys Road, Dural, NSW.

P1806980JR01V03
July 2019

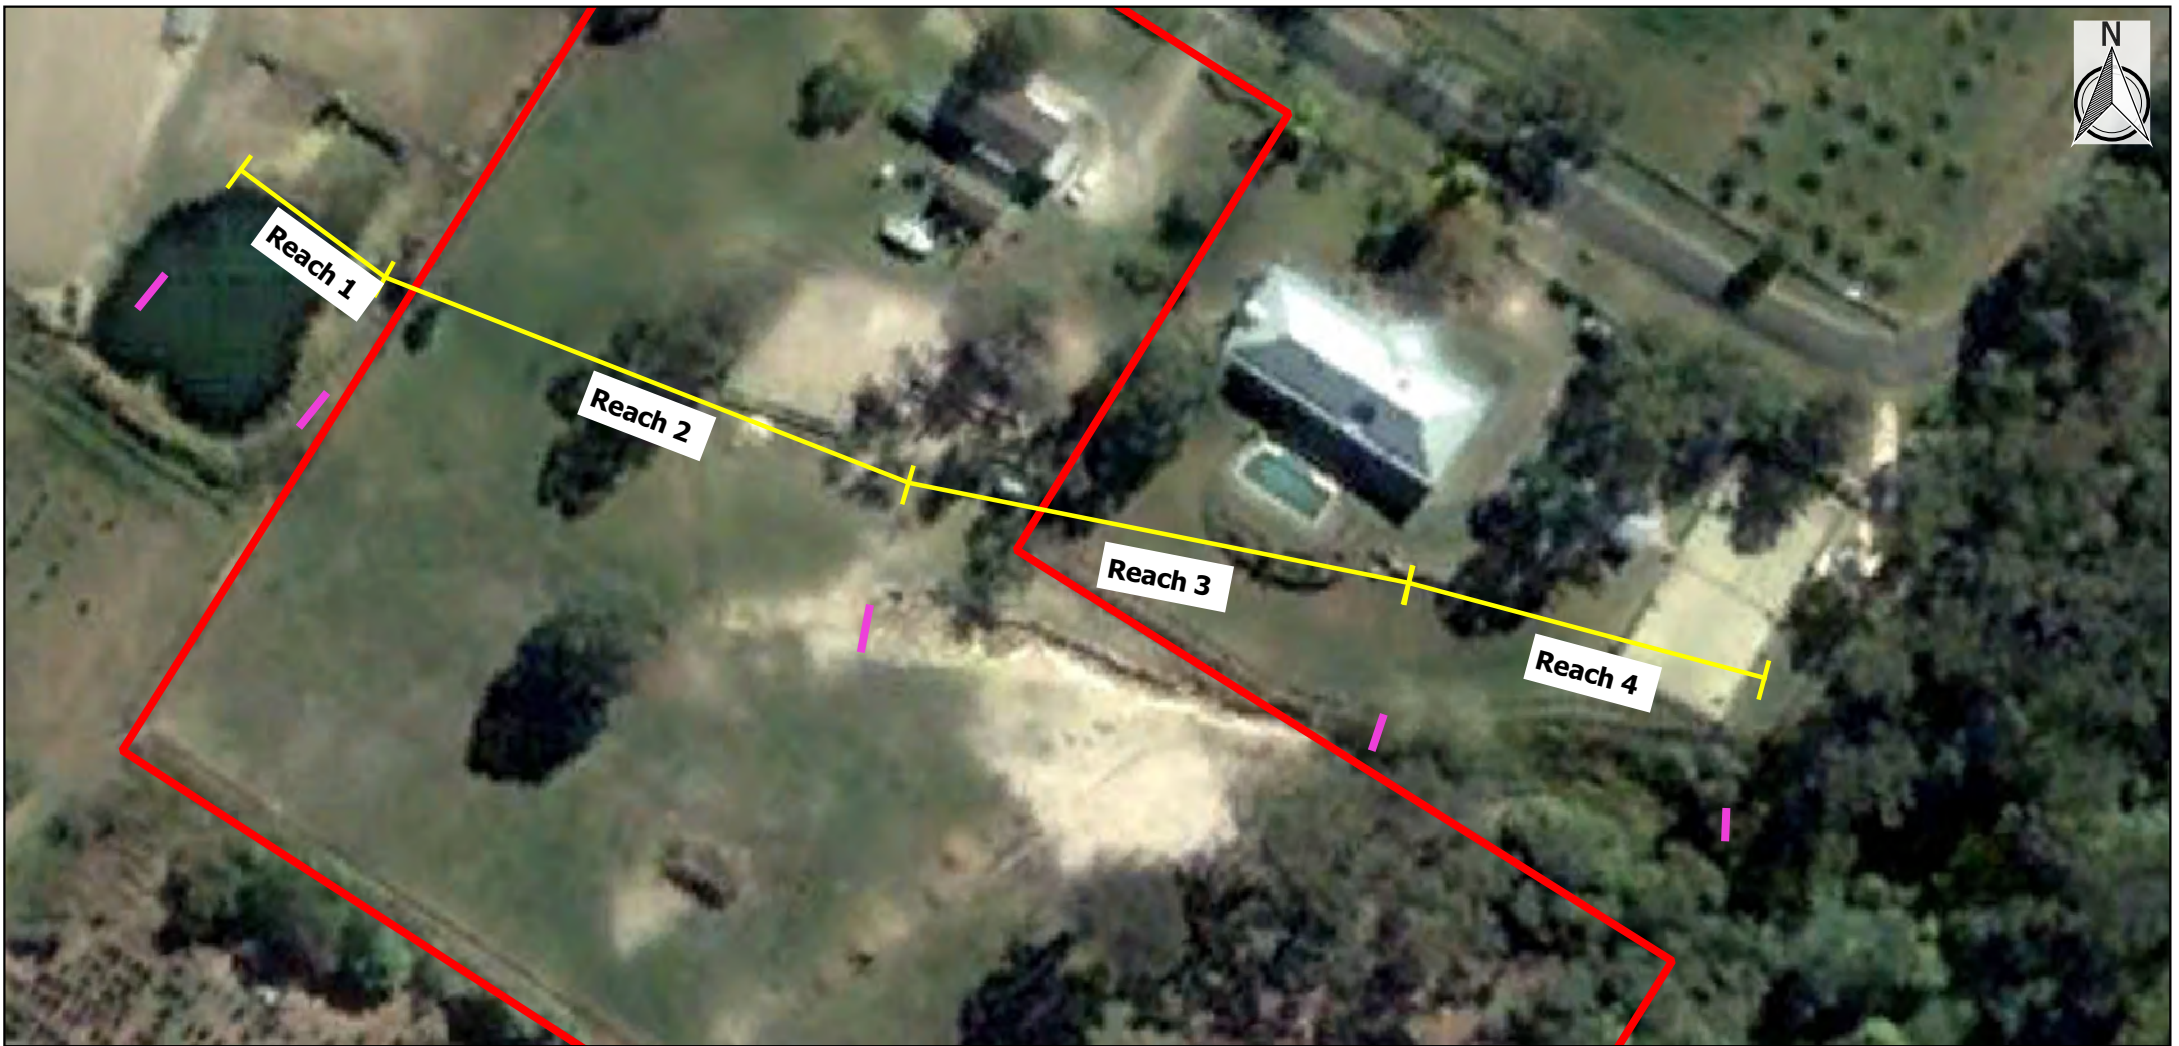
Figure 1 at Attachment B provides a copy of the 1:25,000 scale map for the site. This shows that a 'blue' line is drawn within the site, suggesting that a 1st order watercourse could possibly be present.

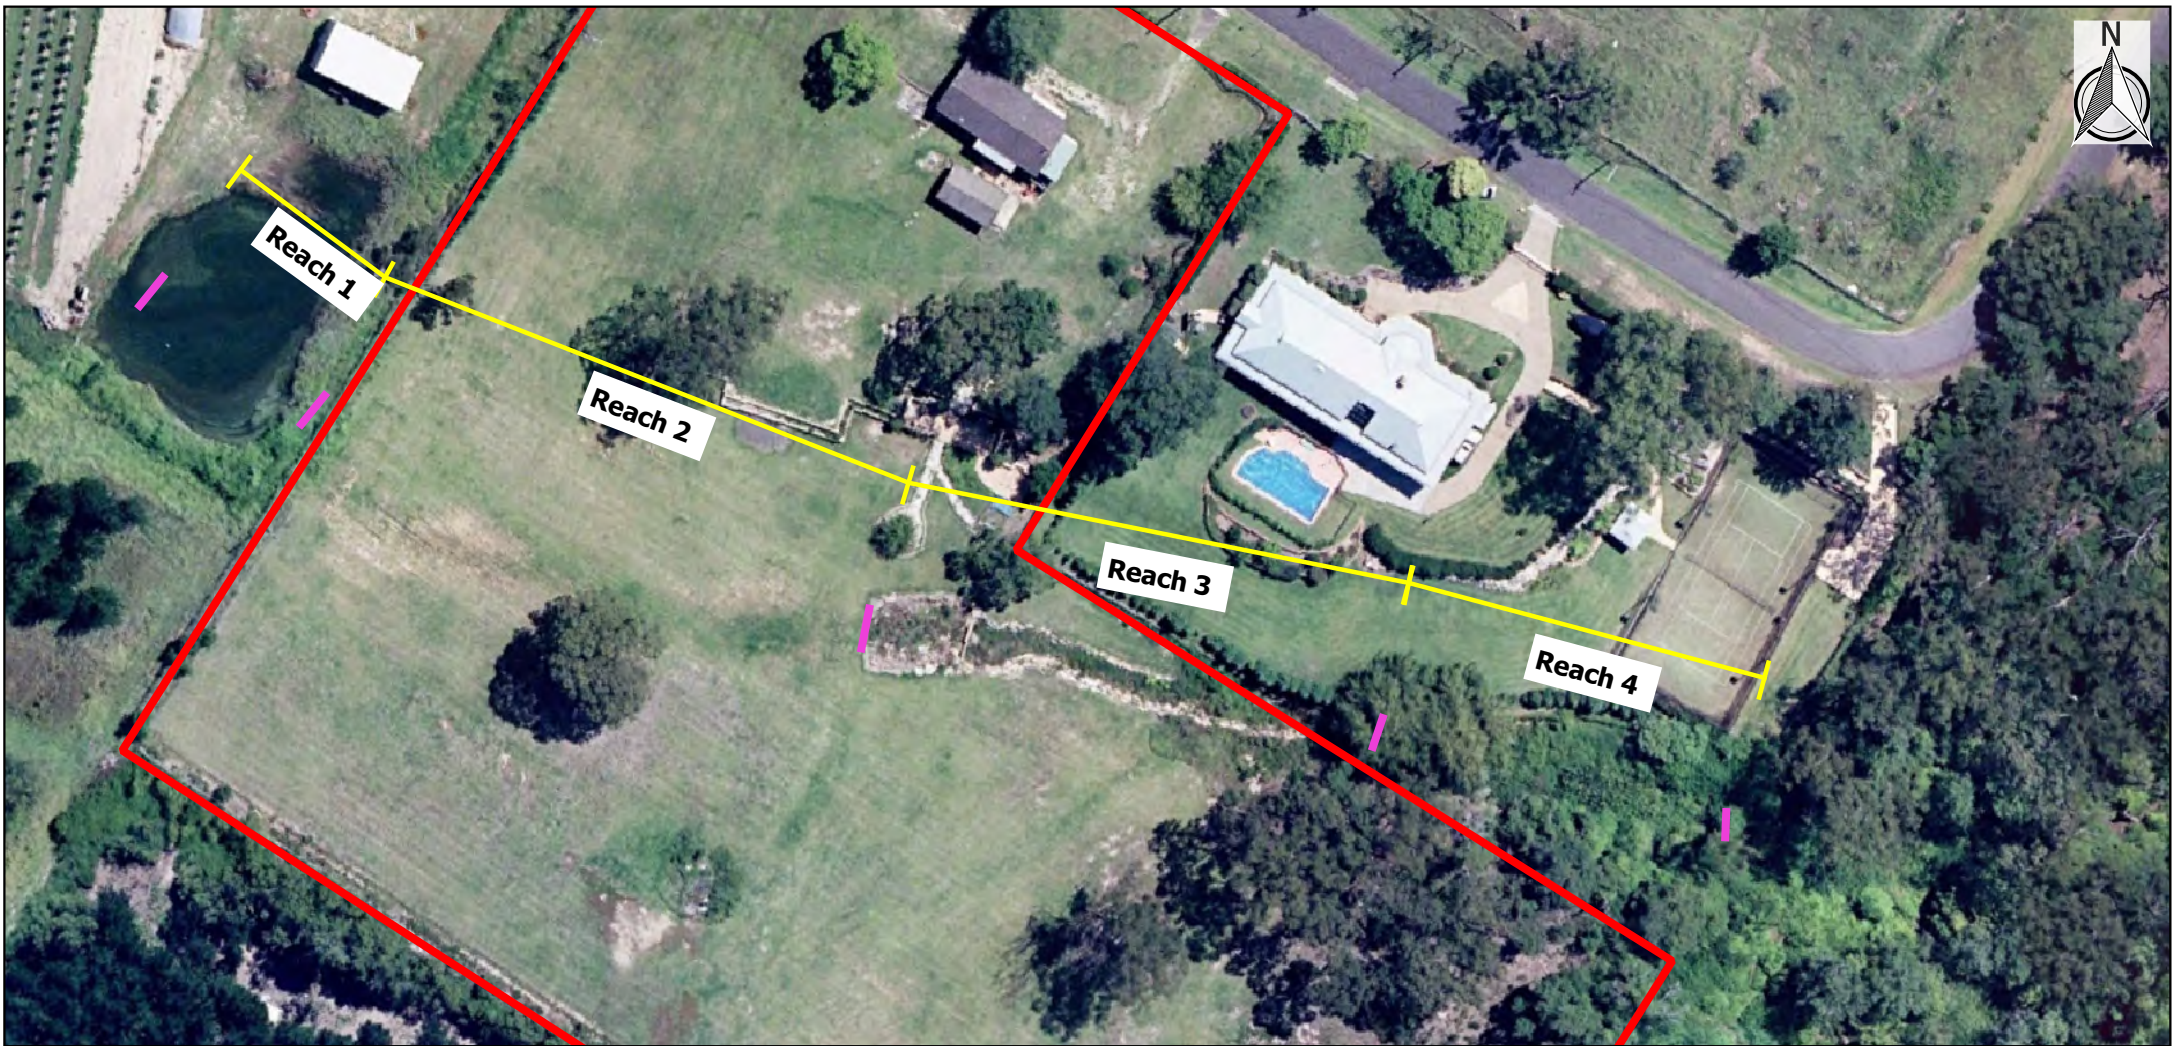
An analysis of historical photographs was undertaken to assist with classifying the drainage line within the site. Images included in the assessment were sourced from Google Earth and Nearmaps, and included images for 2003, 2007, 2014 and 2018. These images are provided at Figures 2, 3, 4 and 5 at Attachment B.

Martens & Associates Pty Ltd		ABN 85 070 240 890	
Environment Water Wastewater Geotechnical Civil Management			
Drawn:	PD	Site - Aerial 4 Vineys Road, Dural, NSW Source: Google Earth, 9/03/2003	Figure 2
Approved:	DM		
Date:	29/01/2019		
Scale:	1:1000 (A4)		Job No: P1806980

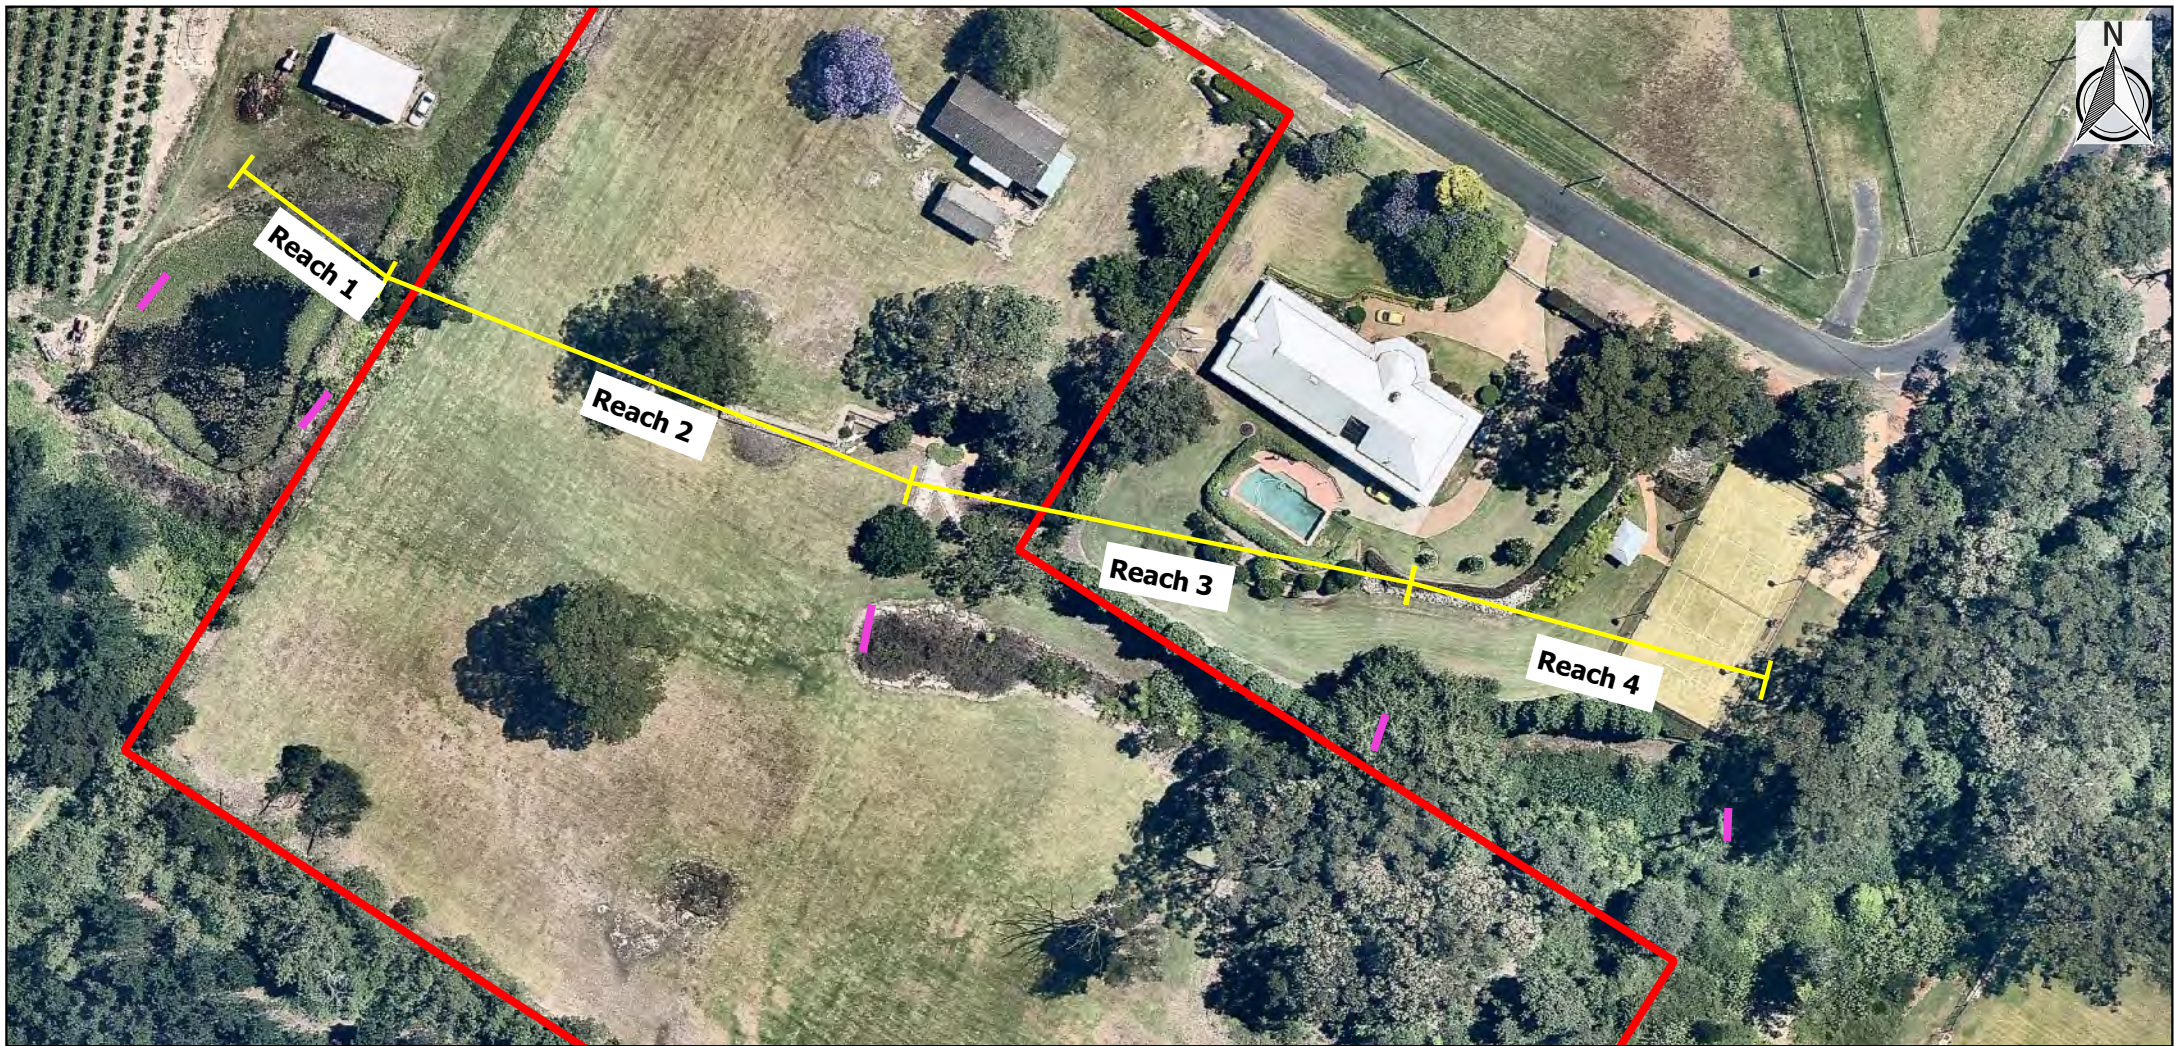
Martens & Associates Pty Ltd		ABN 85 070 240 890	
Environment Water Wastewater Geotechnical Civil Management			
Drawn:	PD	Site - Aerial 4 Vineys Road, Dural, NSW Source: Google Earth, 3/11/2007	Figure 3
Approved:	DM		
Date:	29/01/2019		
Scale:	1:1000 (A4)		Job No: P1806980
