Hazardous Material Survey

22-32 Queen Street, Campbelltown NSW

Report No: E24711.E10_Rev0

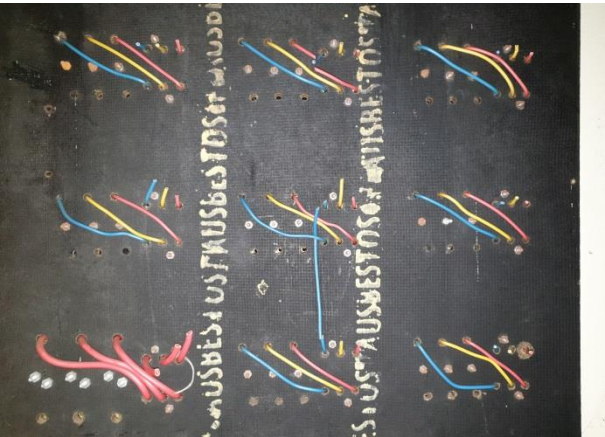
Location	Material Type	Friability	Sample	Analysis Result:	Quantity	Condition and Accessibility	Priority	Recommendations/ Comments	Photograph of material
24 Queen Street, Campbelltown									
Bowling alley, mezzanine office, AC control distribution board "Ausbestos"	Electrical backing board	Non-friable	A03	Chrysotile Asbestos Detected	1 unit	Good Maintenance only	Priority 4: Negligible Risk Level	Remove prior to demolition works

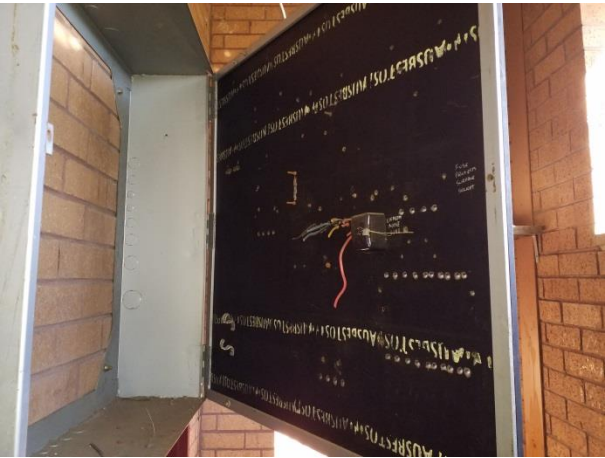
Location	Material Type	Friability	Sample	Analysis Result:	Quantity	Condition and Accessibility	Priority	Recommendations/ Comments	Photograph of material
24 Queen Street, Campbelltown									
Bowling alley, northern main switch room	Electrical backing board	Non-friable	Visual inspection Similar to a03	Assume Positive	1 unit	Good Maintenance only	Priority 4: Negligible Risk Level	Remove prior to demolition works

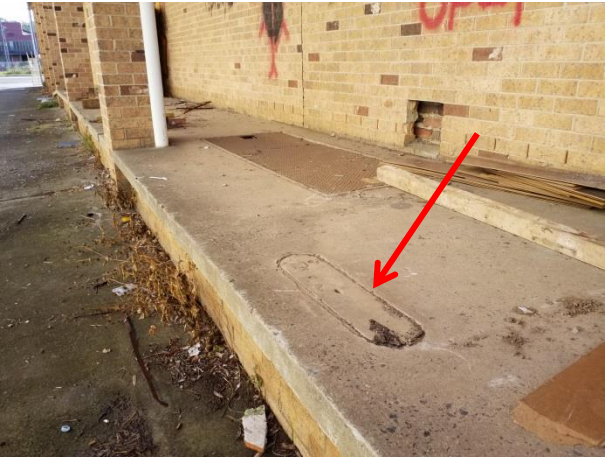
Location	Material Type	Friability	Sample	Analysis Result:	Quantity	Condition and Accessibility	Priority	Recommendations/ Comments	Photograph of material
24 Queen Street, Campbelltown									
Bowling alley, external, western elevated section in ground service pit	Asbestos cement service pit	Non-friable	A08	Chrysotile Asbestos Detected	1 unit	Fair Maintenance only	Priority 4: Negligible Risk Level	Remove prior to demolition works

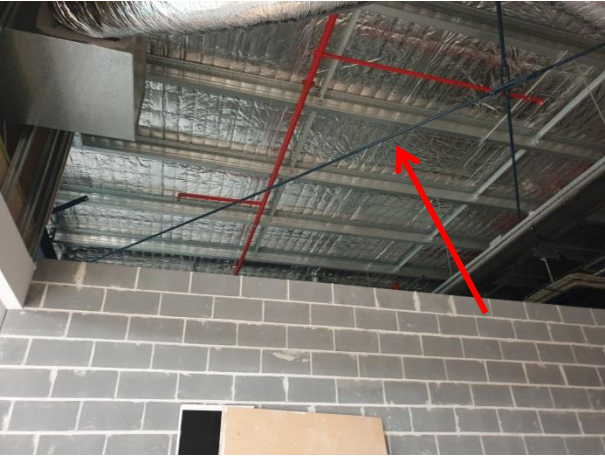
Location	Material Type	Friability	Sample	Analysis Result:	Quantity	Condition and Accessibility	Priority	Recommendations/ Comments	Photograph of material
32 Queen Street, Campbelltown									
Asbestos, lead based paints and PCBs									
Building constructed in 2009.									
SMF									
Underside of roof	Foil backed SMF	Non-friable	Visual inspection	Assume Positive	Not determined	Good Maintenance only	Priority 4: Negligible Risk Level	Remove during to demolition works
