Arborist Impact Assessment

Proposed Commercial Retail Development
Lot 14, DP 258848
42 Fullerton Cove Road, Fullerton Cove, NSW

21 June 2024

AEP Ref: 3063.03

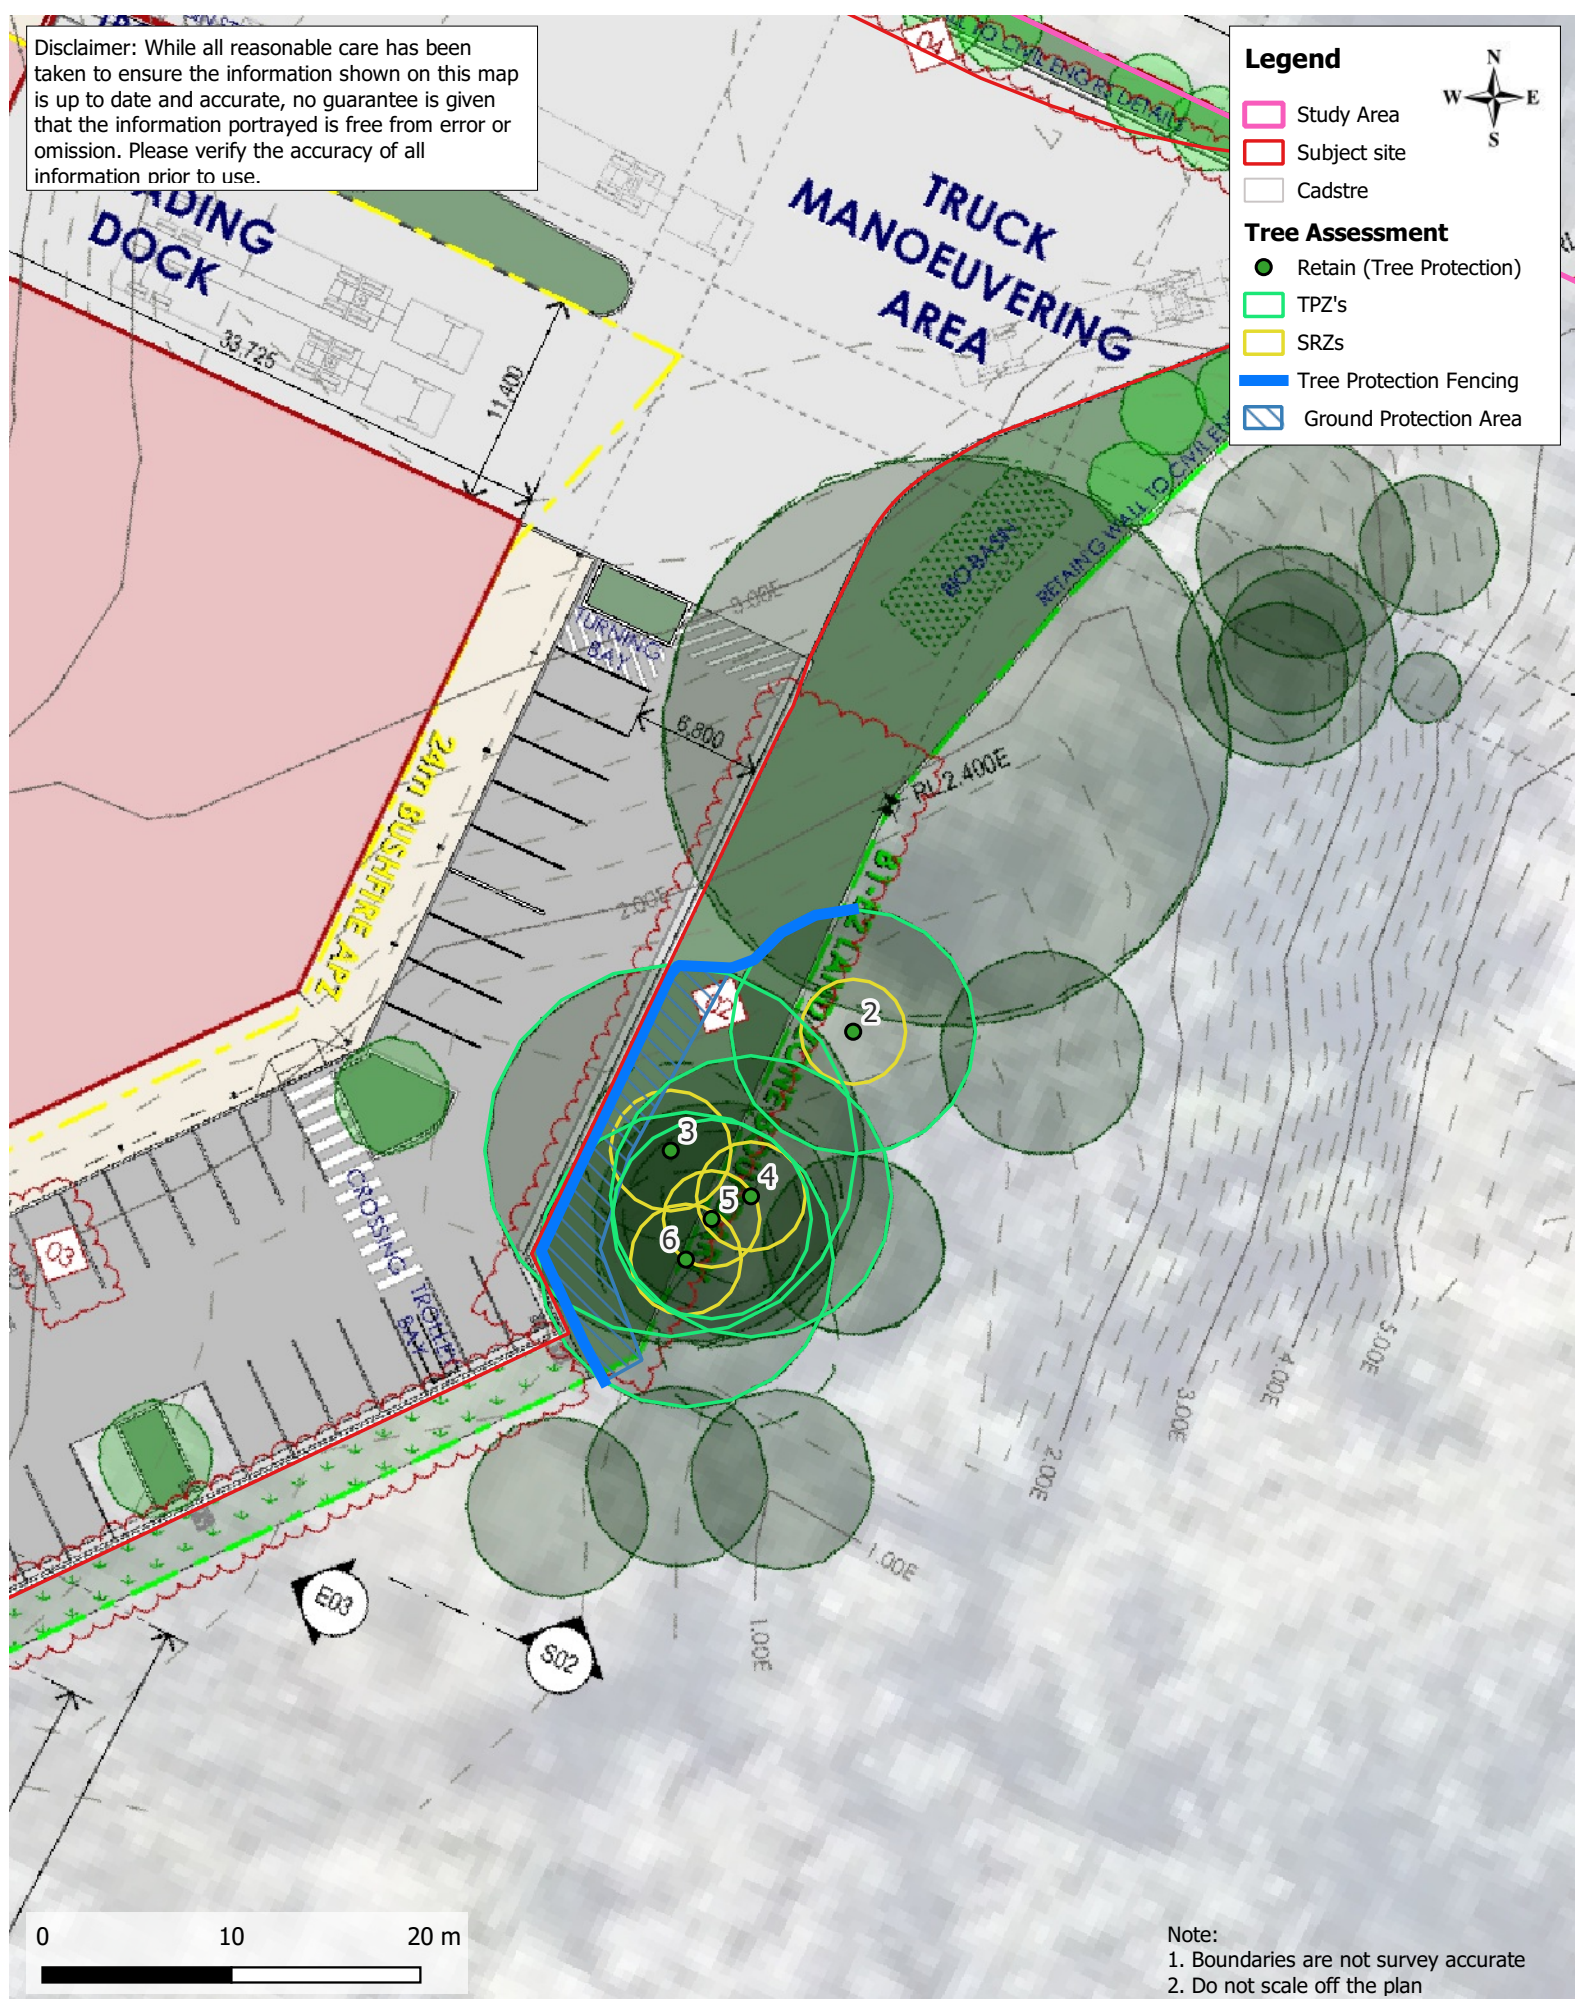
Figure 5 - Tree Protection

- Tree 3 has TPZ encroachment by the development footprint of approximately 20%, this area will require excavation and compacted fill during the construction phase, however this tree has potential to be retained with the establishment of a tree protection zone and critical care to be taken during excavation in the vicinity of the tree structure and SRZ area. TPZ fencing as displayed in **Figure 5** will be required for the duration of works. If a TPZ fence is impractical for construction, additional protection measures must be applied in lieu of fencing. These include trunk and low branch guards, and ground protection measures installed as displayed in **Figure 5** following guidance in Australian standard AS 4970 – 2009 Protection of trees on development Sites (**Appendix D**). The use of “soft” construction methods including manual and vacuum removal of soils is recommended for ground works conducted within the TPZ of Trees to be retained.

- Trees 2 & 4-6 have minimal to no encroachment into the TPZ by the development footprint, and can be retained with minimal impacts to tree viability. These trees will require the establishment of a tree protection zone similar to the above points, with TPZ fencing as displayed in **Figure 5** will be required for the duration of works. If a TPZ fence is impractical for construction, additional protection measures must be applied in lieu of fencing. These include trunk and low branch guards, and ground protection measures installed as displayed in **Figure 5** following guidance in Australian standard AS 4970 – 2009 Protection of trees on development Sites (**Appendix D**). The use of “soft” construction methods including manual and vacuum removal of soils is recommended for ground works conducted within the TPZ of Trees to be retained.

- All tree maintenance and pruning works should be carried out by a qualified tree worker in accordance with AS4373 –2007 Pruning of Amenity Trees.
- A continuous TPZ fence should be installed for retained trees as displayed in **Figure 5**. The TPZ shall be delineated by a 1.8m interlocking chain wire fence located around trees designated to be retained within close proximity to the Works, in accordance with AS 4687. **Appendix D** details tree protection fencing that should be implemented.
