# Preliminary Arborist Assessment

Proposed Update of Fire trails on land  
Lot 2 DP 791551  
8 Fleet Street, Salamander Bay, NSW

**AEP Ref: 5466**

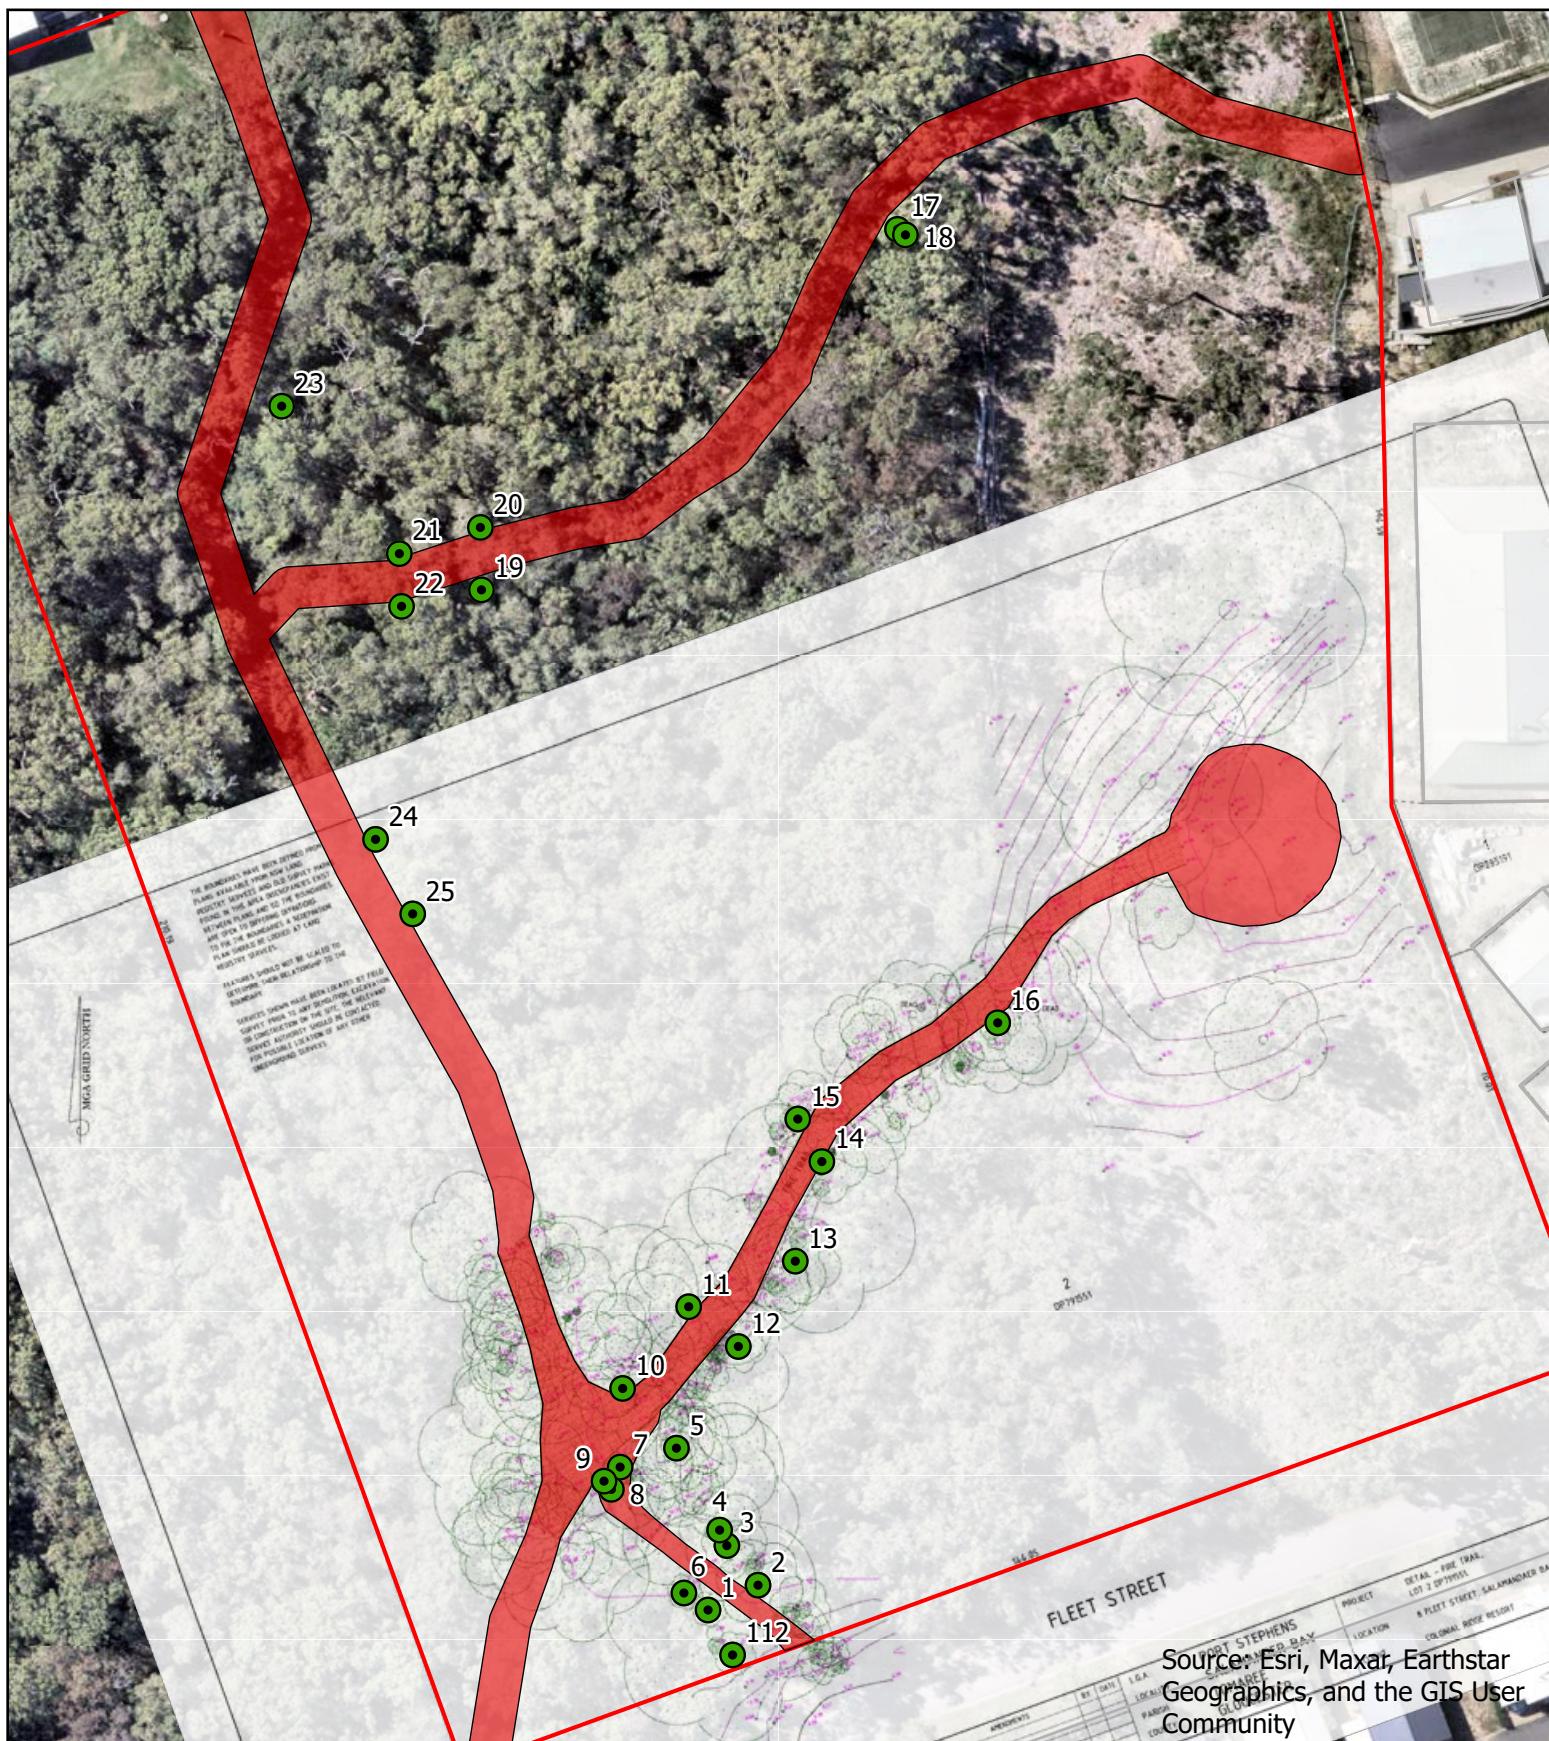
## Figure 2 - Tree Locations

Tree 1 has hollows present, indicating its potential as a habitat tree. Tree 112 exhibits multiple hollows and extensive scratch marks on its trunk, likely caused by possums. Tree 20 had Koala scats found beneath it, indicating Koala activity along the fire trail within the last 2 – 3 days.
