## **Dowe's Quarry**

### **Traffic Impact Assessment**

## **Traffic Impact Assessment**

## Stage 5 Road Safety Audit Dowe's Quarry Transportation Route

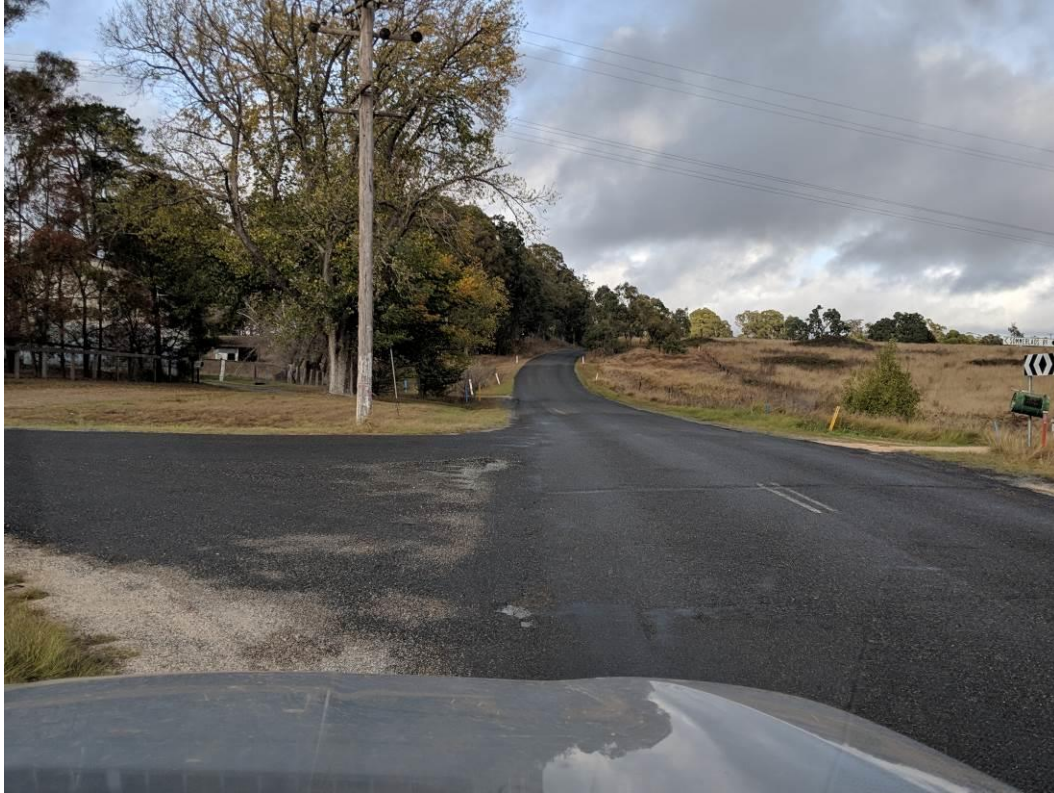
**Plate 1 - Mt Lindesay Road and Sommerlads Road Intersection**

Chainage <sup>#</sup>	Intersecting Road	Sight Distance North (m)	Sight Distance South (m)	Speed Zone (km/h)	SISD* (m)	Plate Ref.
CH1.8	Old Ballandean Road	260	210	70	151	Plate 13
CH3.7	Leechs Gully Road	220	240	100	248	
CH4.6	Sommerlads Road	450	265	100	248	Plate 1
CH6.2	Bryans Gap Road	260	110	100	248	
CH6.8	Quarry Access Road	250	250	100	248	
# Chainage commencing at New England Highway						
* Safe Intersection Sight Distance based on reaction time of 2.0 seconds (Austroads 2017)

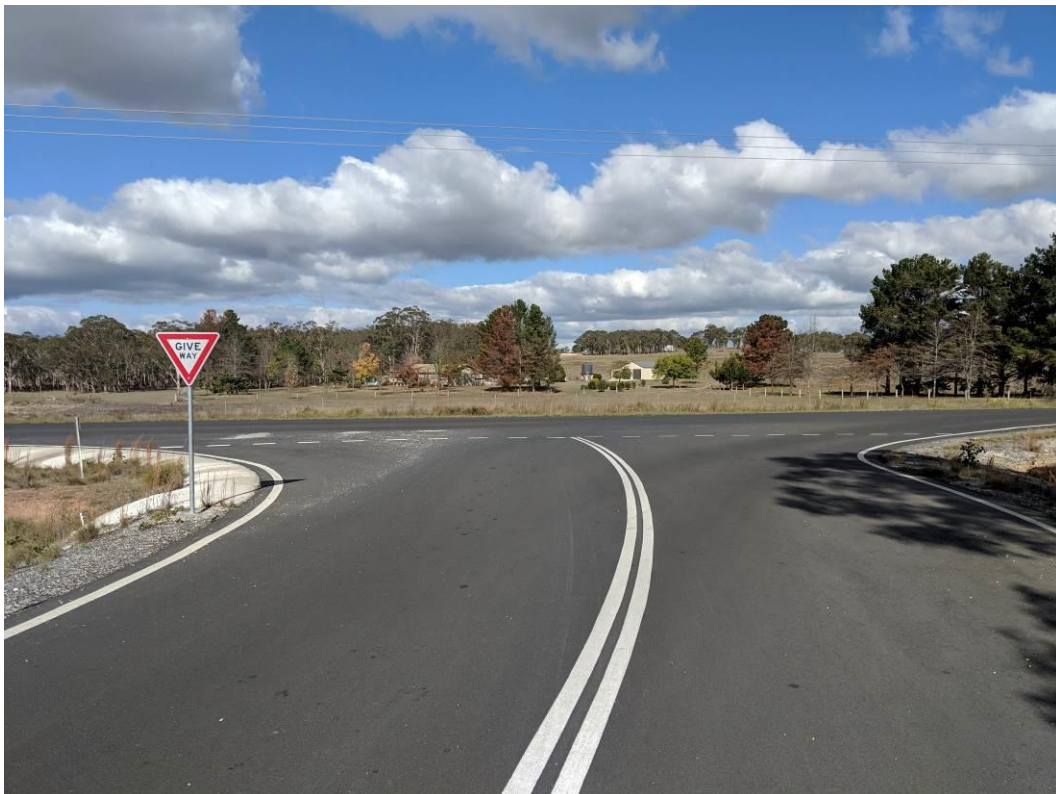
**Plate 8 - Dowe's Quarry Access Road looking east towards Mt Lindesay Road**

There is edge line and centre line marking on approach to the intersection on the quarry access road and lane continuity marking on Mt Lindesay Road. There are truck warning signs along Mt Lindesay Road in both directions on approach to the quarry access road intersection.

The sight distance in either direction along Mt Lindesay Road is reasonable to the north and south at approximately 250m in either direction. Safe intersection sight distance (SISD) for 100km/hr speed zone as per the Austroad Guides is 248m and as a result, the available sight distance is considered to be adequate.

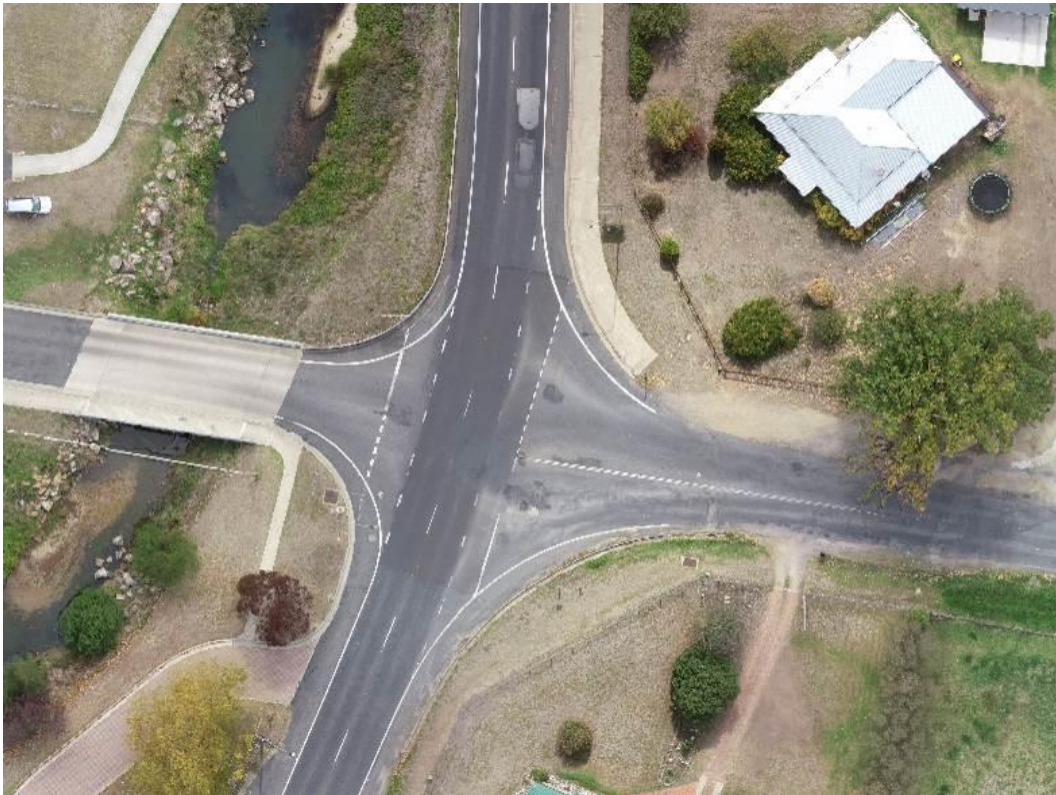
**Plate 10 - New England Highway and Naas Street Intersection**

The pavement condition is reasonable, and the line marking is in good condition along the highway with some centre line fading in proximity of the intersection. There is street lighting provided down the eastern side of the highway to the north and the western side of the highway to the south.

A safety barrier is provided along the western side of the highway to the north extending around the corner into Naas Street heading west. The sight distance in either direction along the New England Highway is approximately 350m to the north 190m to the south. Safe intersection sight distance (SISD) for a 50km/h speed zone is as per the Austroad Guides is 97m and as a result, the available sight distance is considered to be adequate.

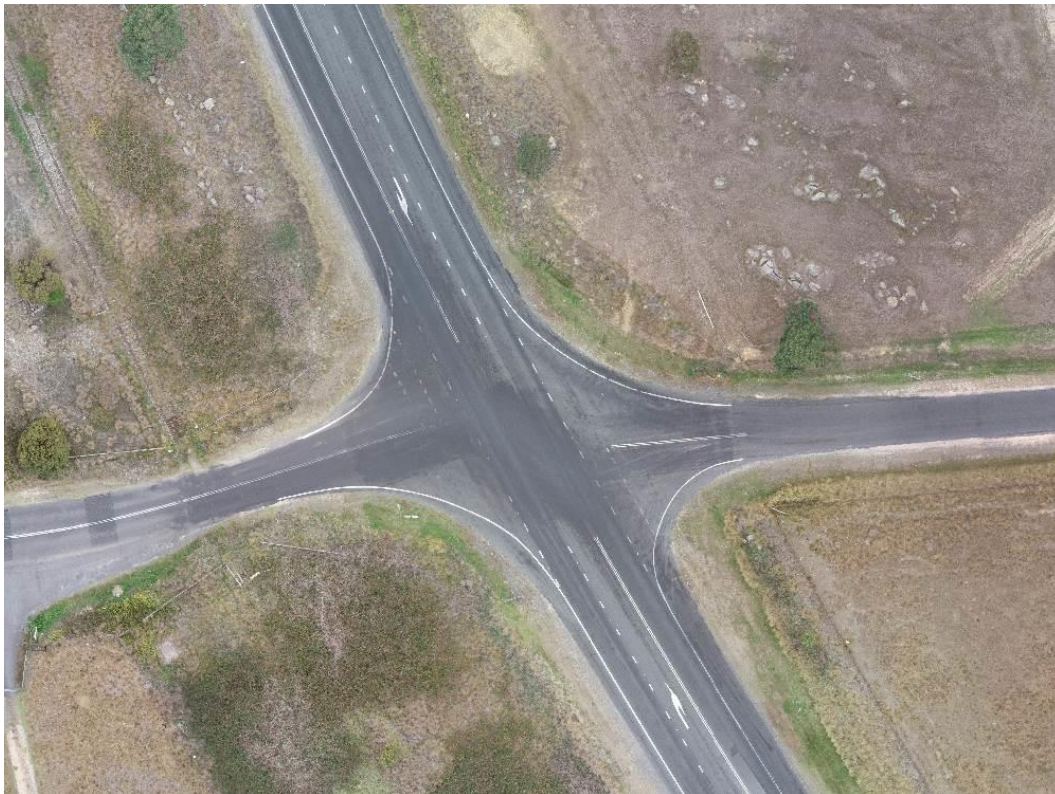
**Plate 11 - New England Highway and Old Ballandean Road Intersection**

The intersections are controlled by duplicated give way signs on the Old Ballandean Road approach although they are set well back from the intersection. There are faded holding lines for the Bruxner Highway and Old Ballandean Road as well as faded continuity lines for the through lanes on the highway. The pavement and line marking along the highway is considered to be in good condition and there is adequate dimensional capacity for all turning manoeuvres.

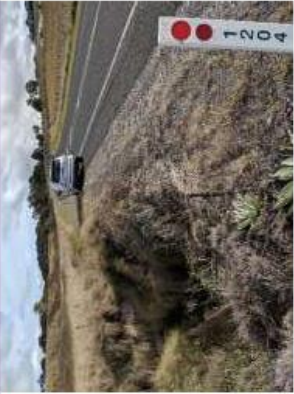
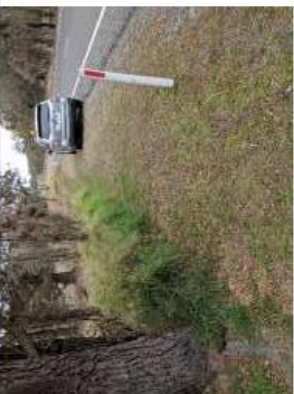
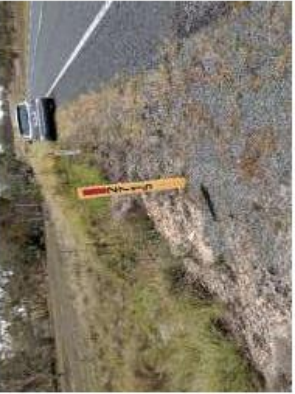
CAR No.	Audit Findings	Photographs
009	<p><b>Road Safety Category - Road Alignment and Cross Section</b></p> <p><u>Steep Batters</u></p> <p>There are a number of unprotected steep batters:</p> <p>There is a risk that an errant driver may leave the road, have insufficient shoulder width to recover and lose control down a steep batter as there is no safety barrier in place. This has the potential to cause serious injuries to the occupants of the vehicle.</p> <p>There is also an increased risk potential for vehicle rollover type crashes, particularly heavy vehicles, on the verge/batter as the road has batter slopes in numerous locations which are less than the minimum standard of 4:1 and less than the desirable minimum batter of 6:1 for heavy vehicles as per Austroads Guide to Road Design.</p>
