Geobag walls at Clarkes Beach, Byron Bay

WRL TR 2021/12, September 2021

By J T Carley and F Flocard

UNSW
Water Research
Laboratory

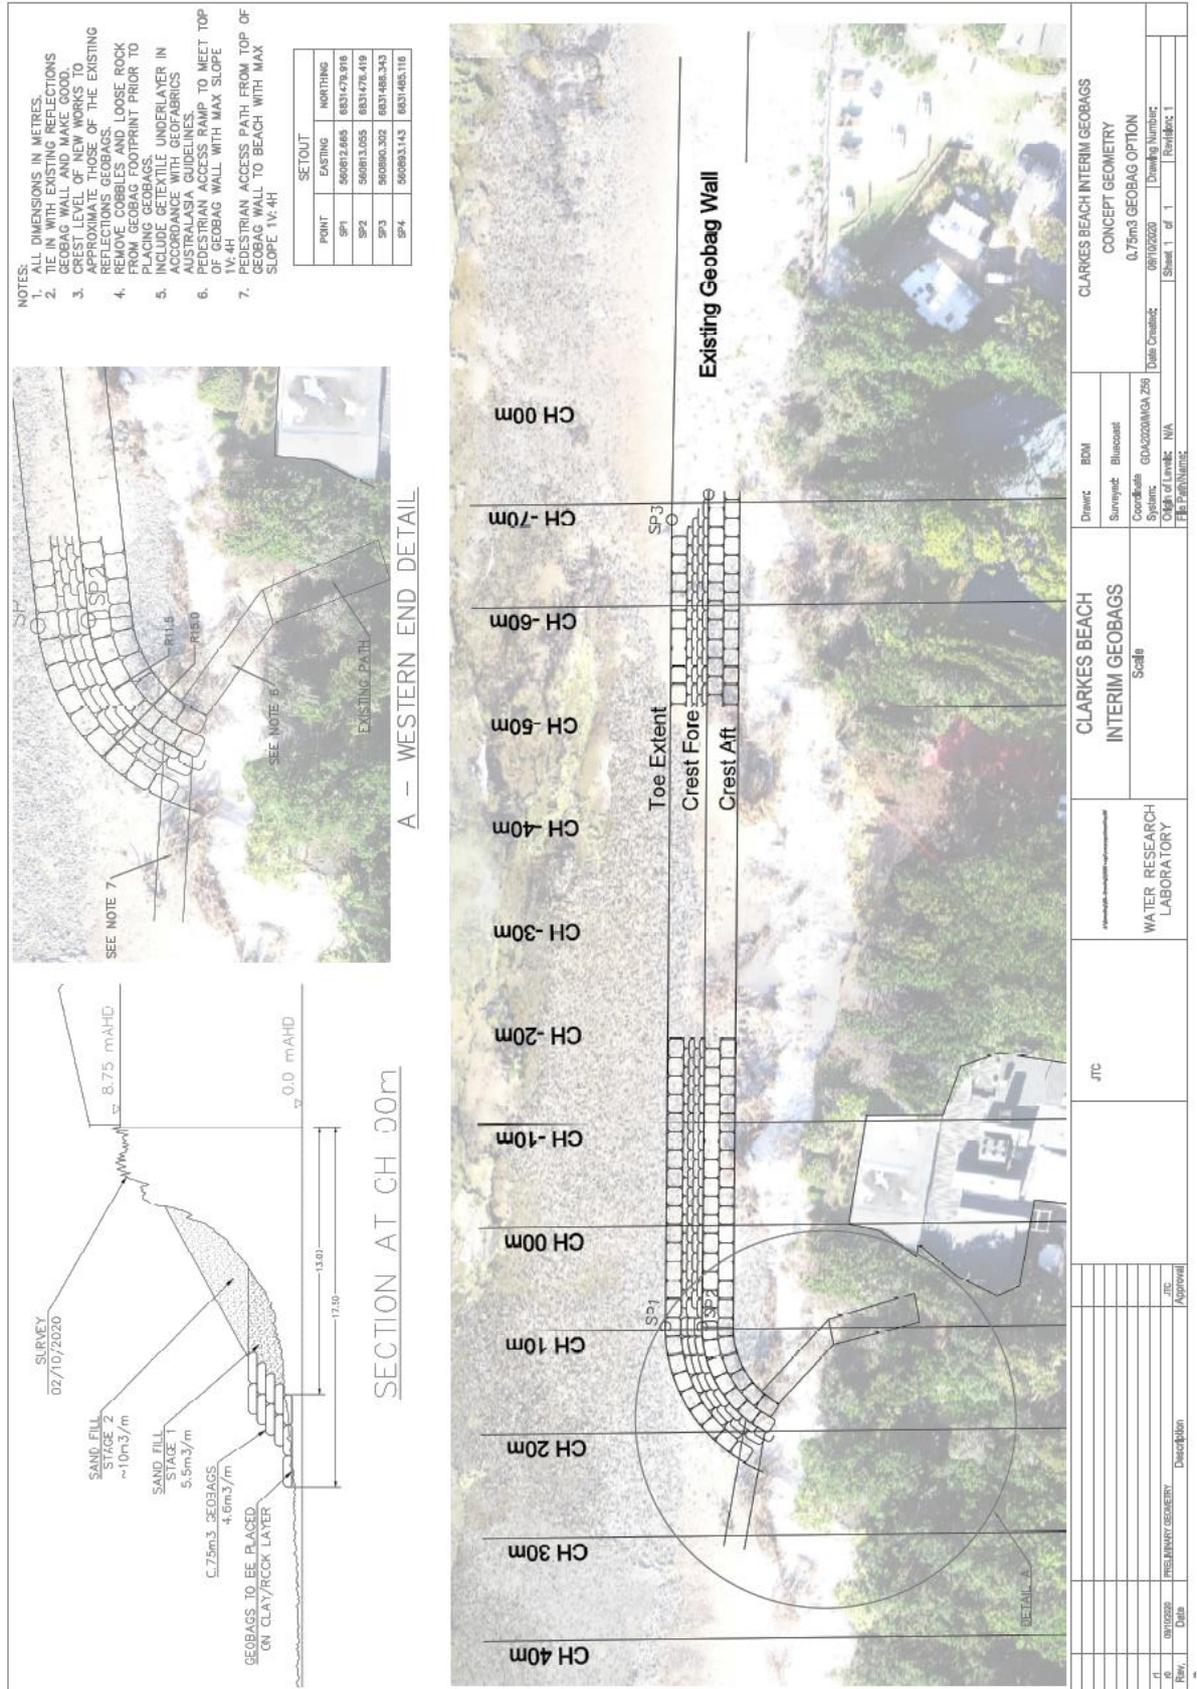
Figure 2.5 Plan and cross section of Cafe geobags – initial design

The cross shore geometry of the geobags was determined through collaboration between coastal engineers (WRL) and structural-geotechnical engineers (Ardill Payne). Plans and cross sections of the Cafe geobags are shown in Figure 2.5, noting that due to wave overtopping during large waves and elevated water levels, a significant portion of the crest was raised by one course of geobags in December 2020 (Figure 2.6).

Due to the urgency of the works and the initial 90 day design life, detailed coastal engineering calculations were not undertaken at the time of initial design/construction, but have subsequently been undertaken (Section 6). The geobag size (0.75 m³) and crest elevation (2.0 to 2.5 m AHD) were based primarily on engineering experience/judgement, including consideration of nearby comparable functional geobag structures throughout the Byron Bay embayment. The cross shore position of the geobags was set seaward from the base of the dune to provide acceptable geotechnical stability to the Cafe building, as determined by Ardill Payne.

Note: One single width course was added to a significant portion of the crest in December 2020

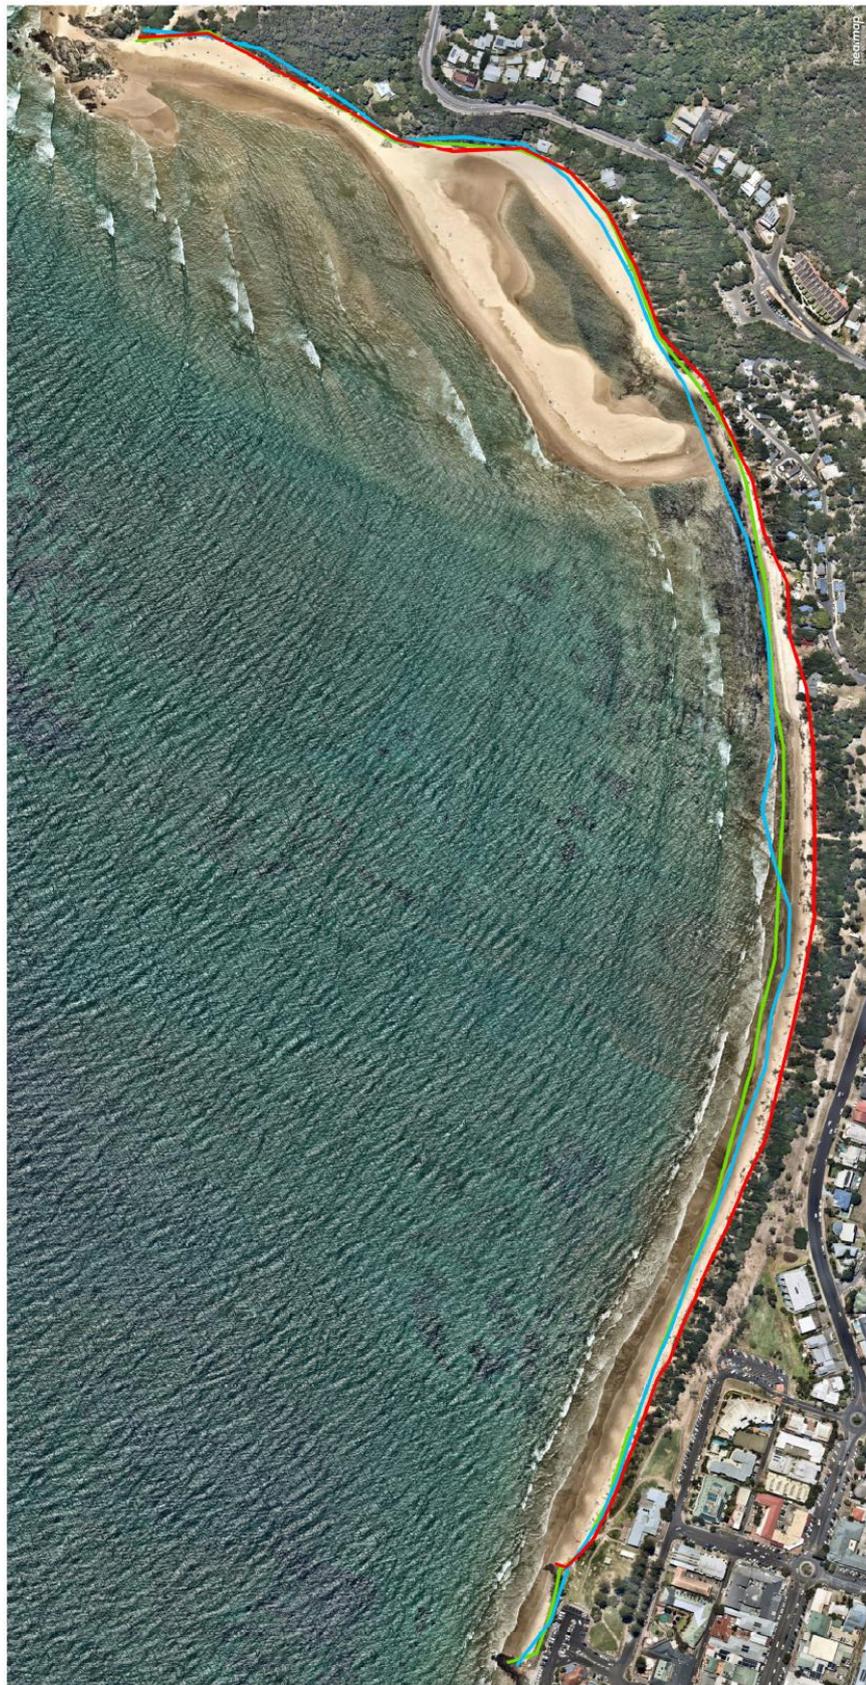
Figure 5.1 3 m AHD contour 2007 and 4 December 2020 – The Pass to Jonson Street

- Minimal erosion of the 3 m AHD contour from The Pass to the Captain Cook car park/ Thompsons Rock, just east of Reflections, due to the predominance of rock outcrops (including Thompsons Rock, Figure 2.2) backing the beach
- Horizontal erosion of 13 to 26 m between the Captain Cook / Thompsons Rock car park and Jonson Street

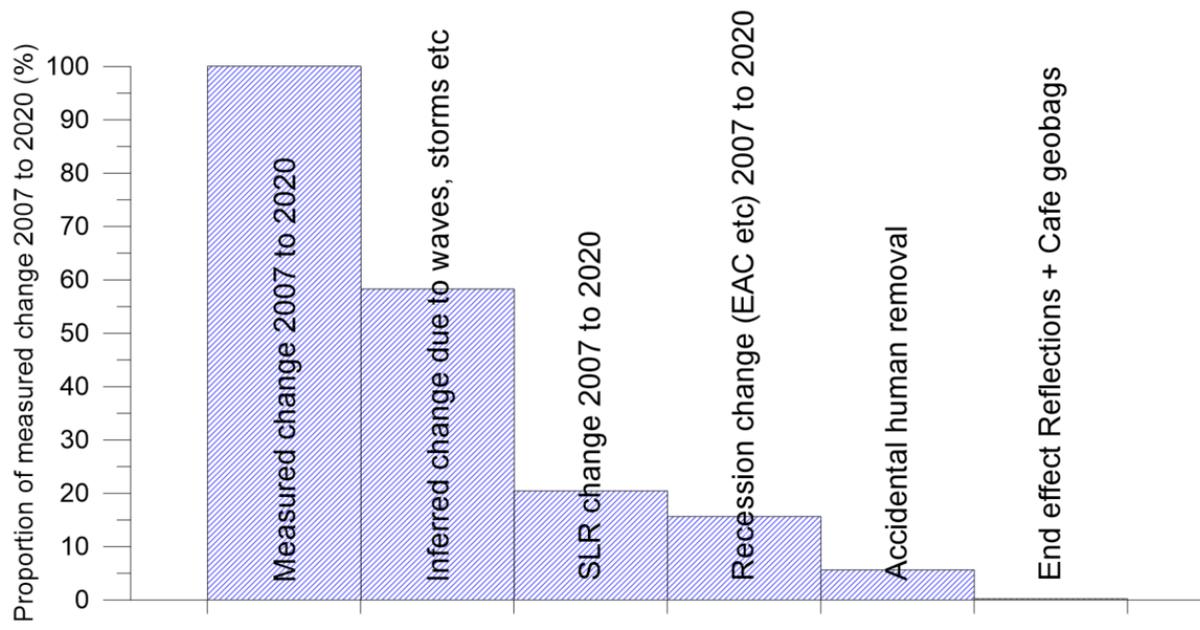
Figure 5.3 Indicative contributions to measured sand change above AHD (2007 to 2020)

As per Section 7, Table 5.3 and Figure 5.3, the direct impact of the Reflections and Cafe geobag works is almost imperceptible compared with embayment-wide sand quantities, and is less than accidental/incidental removal by people. Nevertheless, the Reflections and Cafe geobag works have localised end effects as detailed in Section 7. The largest change component (inferred change due to waves, storms etc.) would generally be expected to reverse in the near future, with beach recovery evident through 2021, though this trajectory is not certain over the next 5 years. However, the two recession components are not presently reversible.

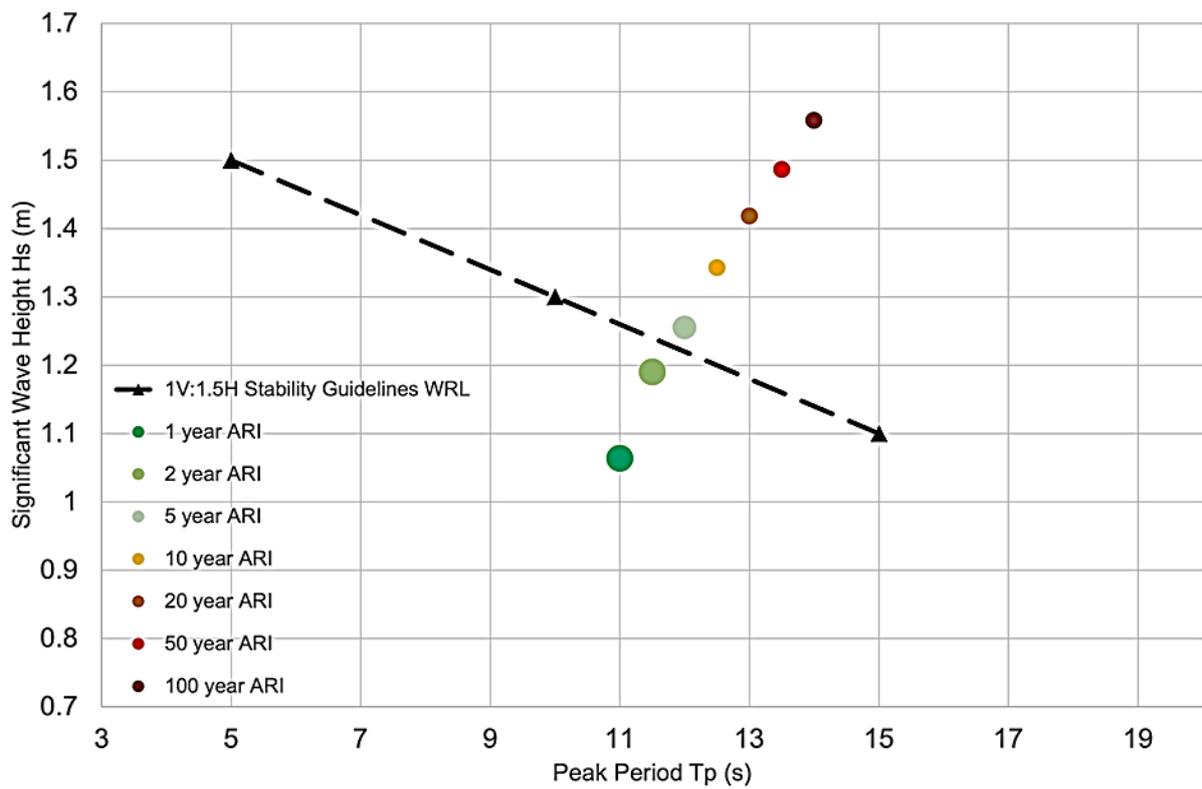
Figure 6.9 Geobag stability estimate

Design guidelines for geobag stability under wave attack was published in Coghlan et al. (2009) and Hornsey et al. (2011). The design curve for 0.75 m³ geobags is shown in Figure 6.9. This curve is for “initial damage”, defined as less than 2% of the geobags moving, noting that this is not “zero damage”.

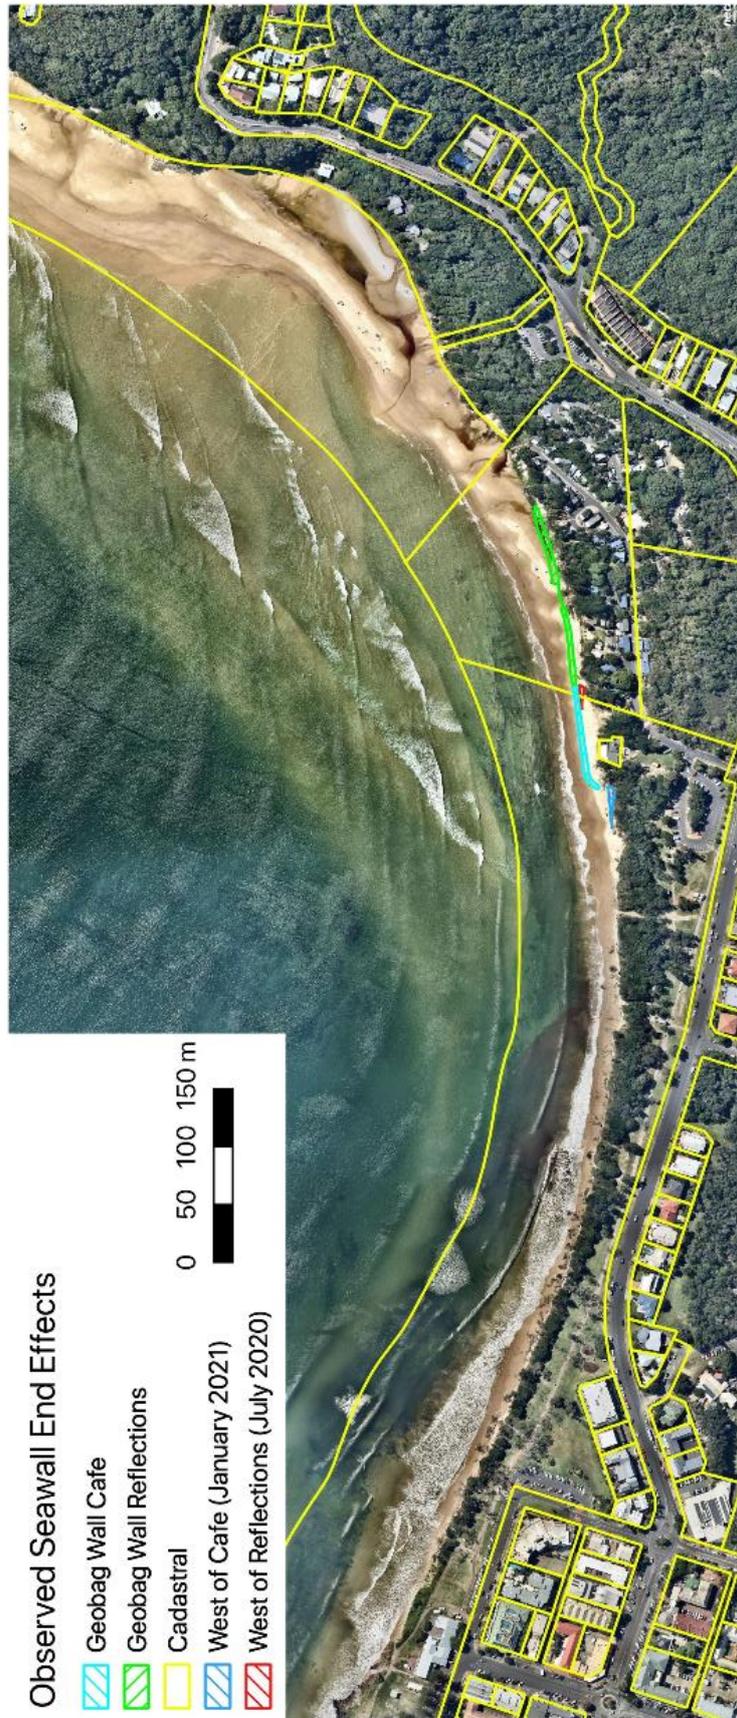
Figure 7.5 Observed end effect – embayment view

Observed end effects were estimated in the manner shown in Figure 7.3, that is by mapping the vegetation line, the embayment wide erosion and the local erosion associated with the seawall. End effects observed to date are summarised in Table 7.1. With Clarkes Beach generally appearing to be accreting during 2021, the recent observations may be the maximum extent of end effects, however, this trend cannot be extrapolated for the next 5 years.

Geobag wall	Embayment Zoom	Close up	r (m)	S (m)
Reflections only	Figure 7.5	Figure 7.6	4	20
Reflections plus Cafe	Figure 7.5	Figure 7.7	5	35

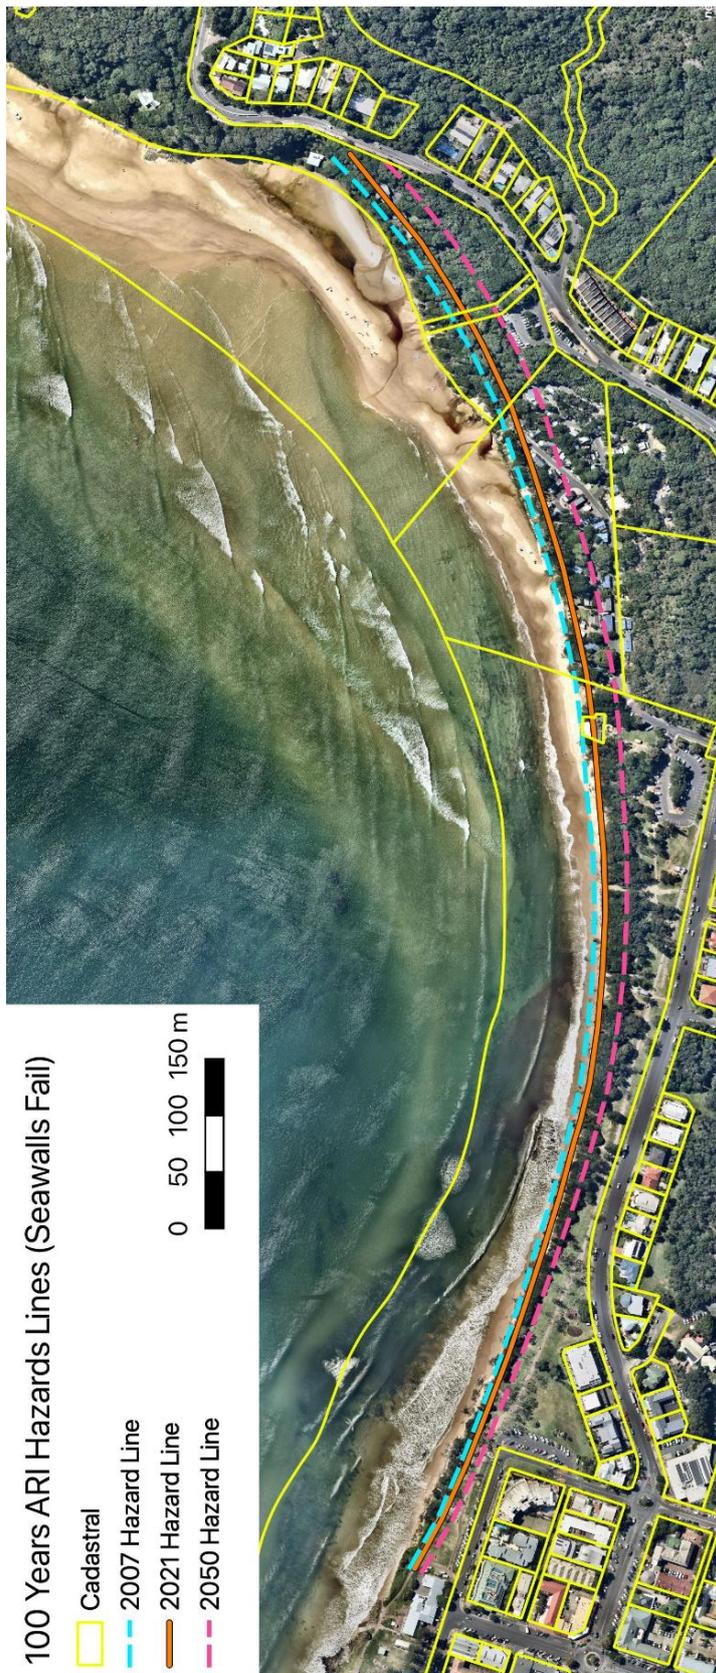
Figure 7.8 Erosion-recession hazard lines – embayment view

Geobag wall	Method	Erosion ARI (years)	Embayment zoom Figure	Close up Figure	Ls (m)	S (m)	r (m)
No geobags	-		Figure 7.8	Figure 7.9	-	-	-
Reflections	McDougal	5, 10, 20		Figure 7.10	160	110	16
	Carley	5		Figure 7.11		196	3
		10		Figure 7.11		196	6
		20		Figure 7.11		196	10
Cafe	McDougal	5, 10, 20		Figure 7.12	90	62	9
	Carley	5		Figure 7.13		154	3
		10		Figure 7.13		154	6
		20		Figure 7.13		154	10
Reflections + Cafe	McDougal	5, 10, 20		Figure 7.14	250	172	25
	Carley	5		Figure 7.15		250	3
		10		Figure 7.15		250	6
		20		Figure 7.15		250	10

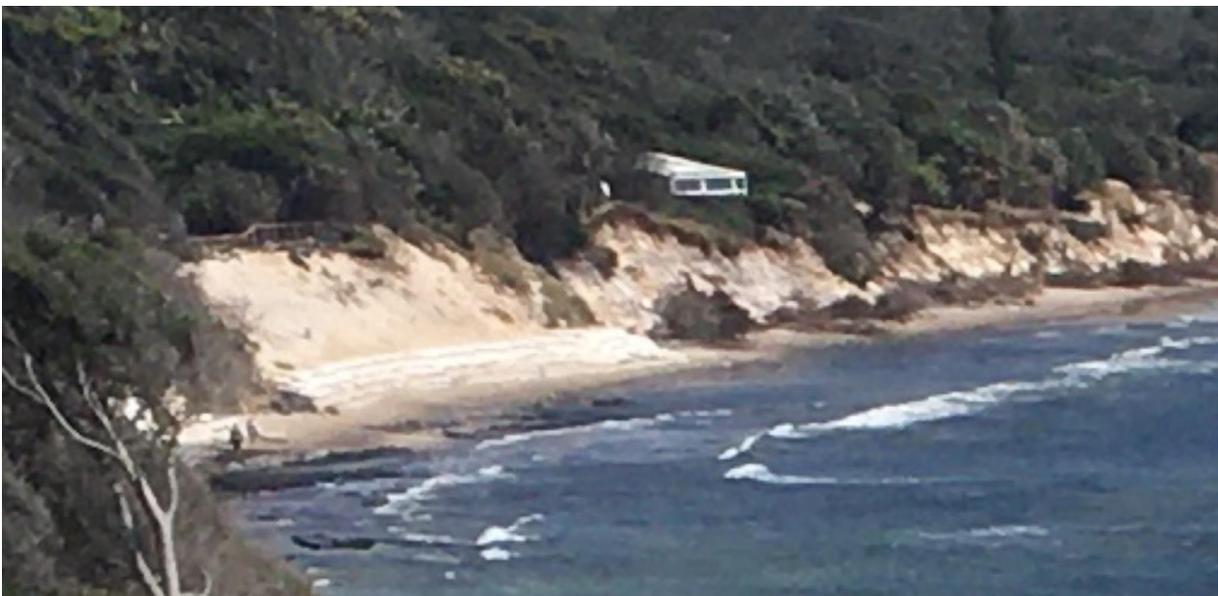
Figure 8.3 Zoomed image from proposed CoastSnap station

Note: Image was taken prior to construction of Cafe geobags. Reflections geobags are visible. Due to distance, geobags are not highly visible, but exposure can be observed, and can be detected by automated routines

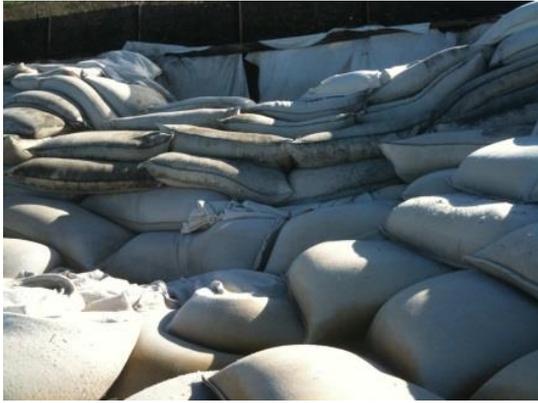
1. Undermining

Figure 2: Examples of sandbag seawall damage

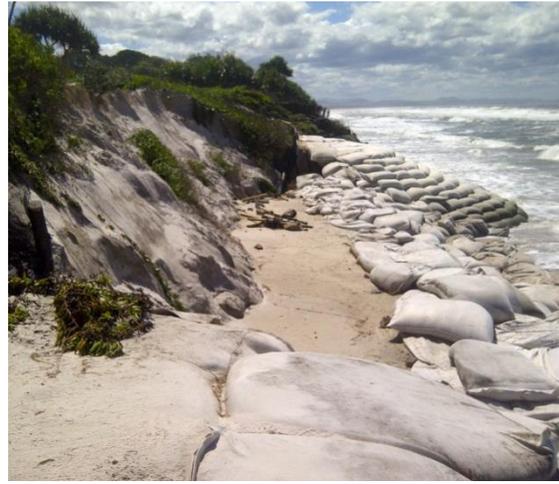
**6. Erosion of crest backfill (from overtopping) and
5. Sandbag displacement**
