**Arboricultural Impact Assessment**  
**On:Tree Specimens**  
**Location: 9 to 11 Fig tree Ave,**  
**TelopeaNSW2117**

For: 888 Pty Ltd.  
On. 24/7/2016

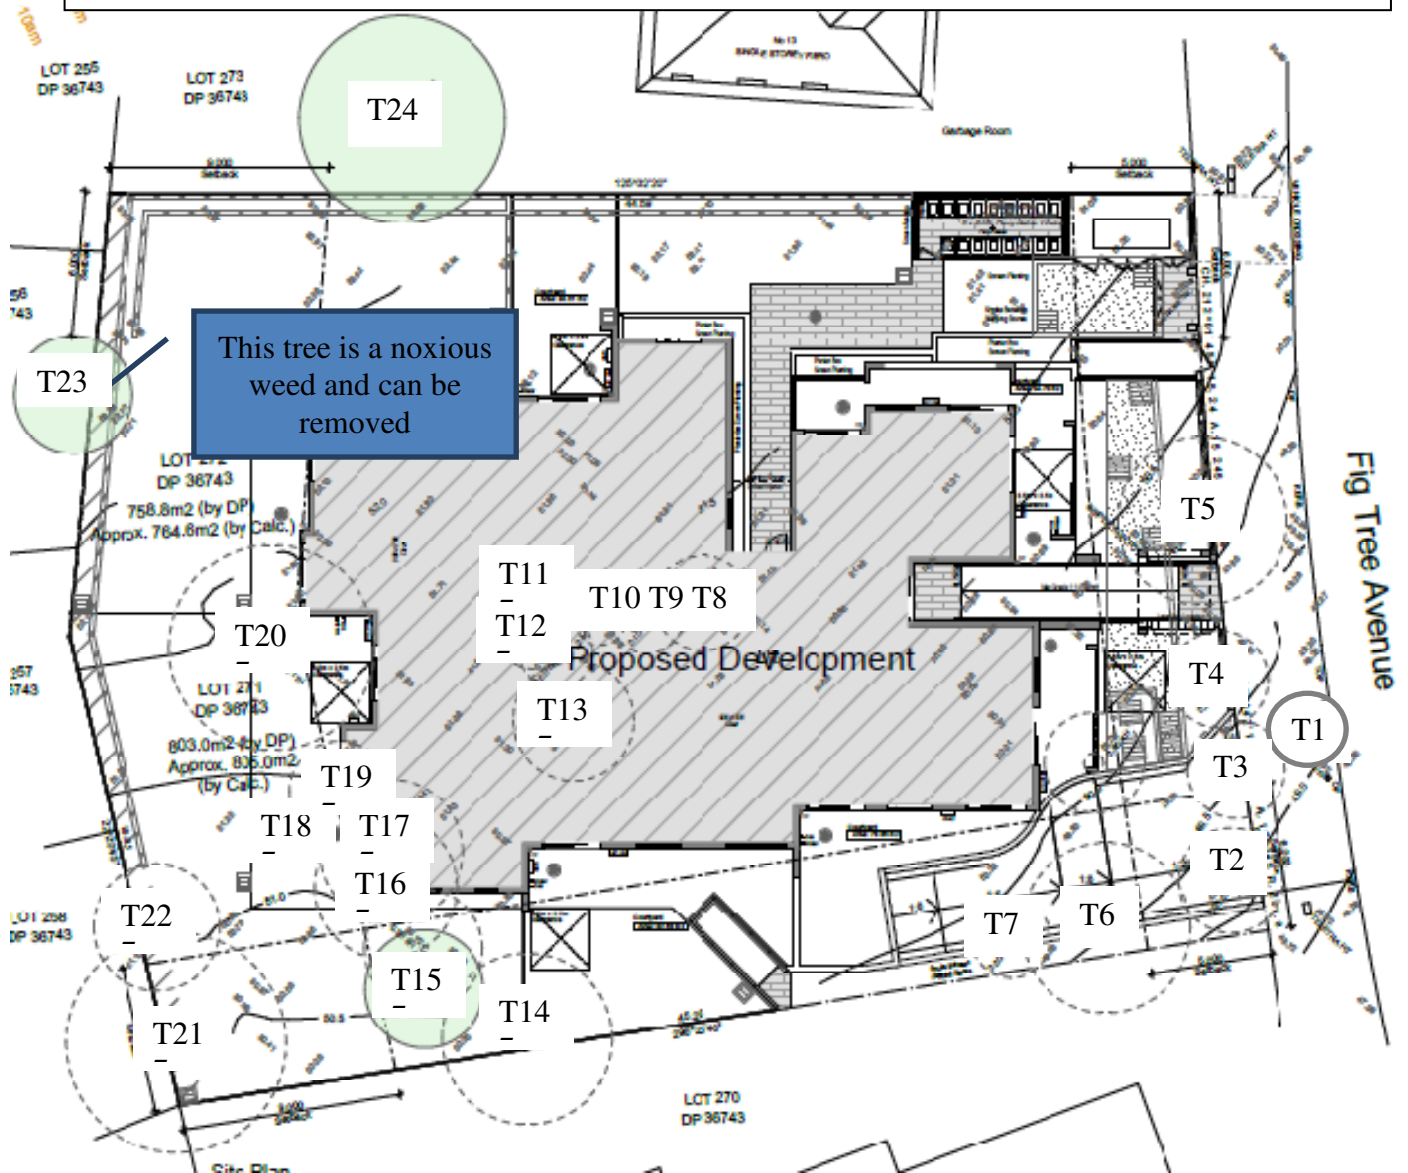
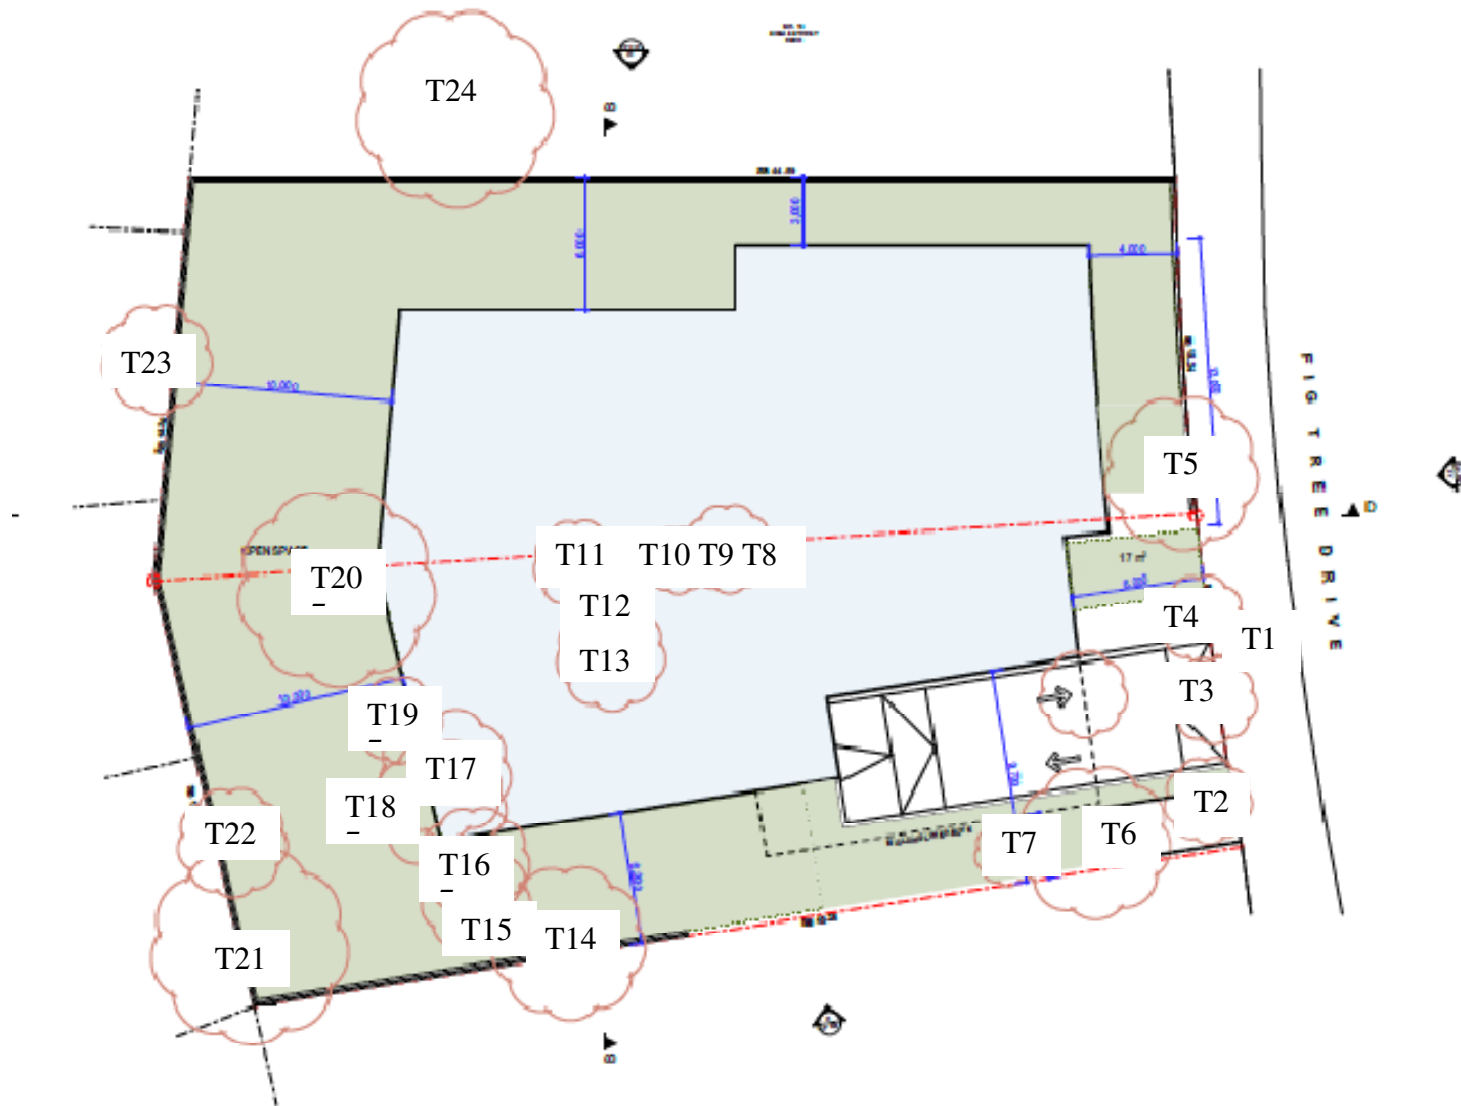
APPENDIX 2 Excerpt from site plan showing trees in relation to the proposed building works.

**4.14** Tree **T24** is an exotic deciduous tree growing in the neighbouring land to the East of the Site (see Fig. 21). The specimen is well away from the building footprint and associated construction works and will not be encroached by Site works (See Appendix 2).

T24 <i>Deciduous</i> Age class 50 years See Fig. 21.	8m	1 x 30cm 1 x 33cm 51cm at the base	N 4m E 4m S 4m W 4m	An exotic deciduous specimen growing in the neighbouring land to the North that is obviously well away from the building Site. the tree has co dominant stems meeting in a 'V' shaped stem junction at 0.4m from the ground. At the time of inspection there were no significant pathogens or signs of mechanical damage.	A1	5.35m	2.49m
--	----	---	------------------------------	---	----	-------	-------
