ARBORICULTURAL IMPACT ASSESSMENT REPORT

BOTANY AQUATIC CENTRE

STURT NOBLE ARBORICULTURE
CONSULTING ARBORISTS
Suite 91, 330 Wattle Street, ULTIMO NSW 2007

26th MARCH 2021

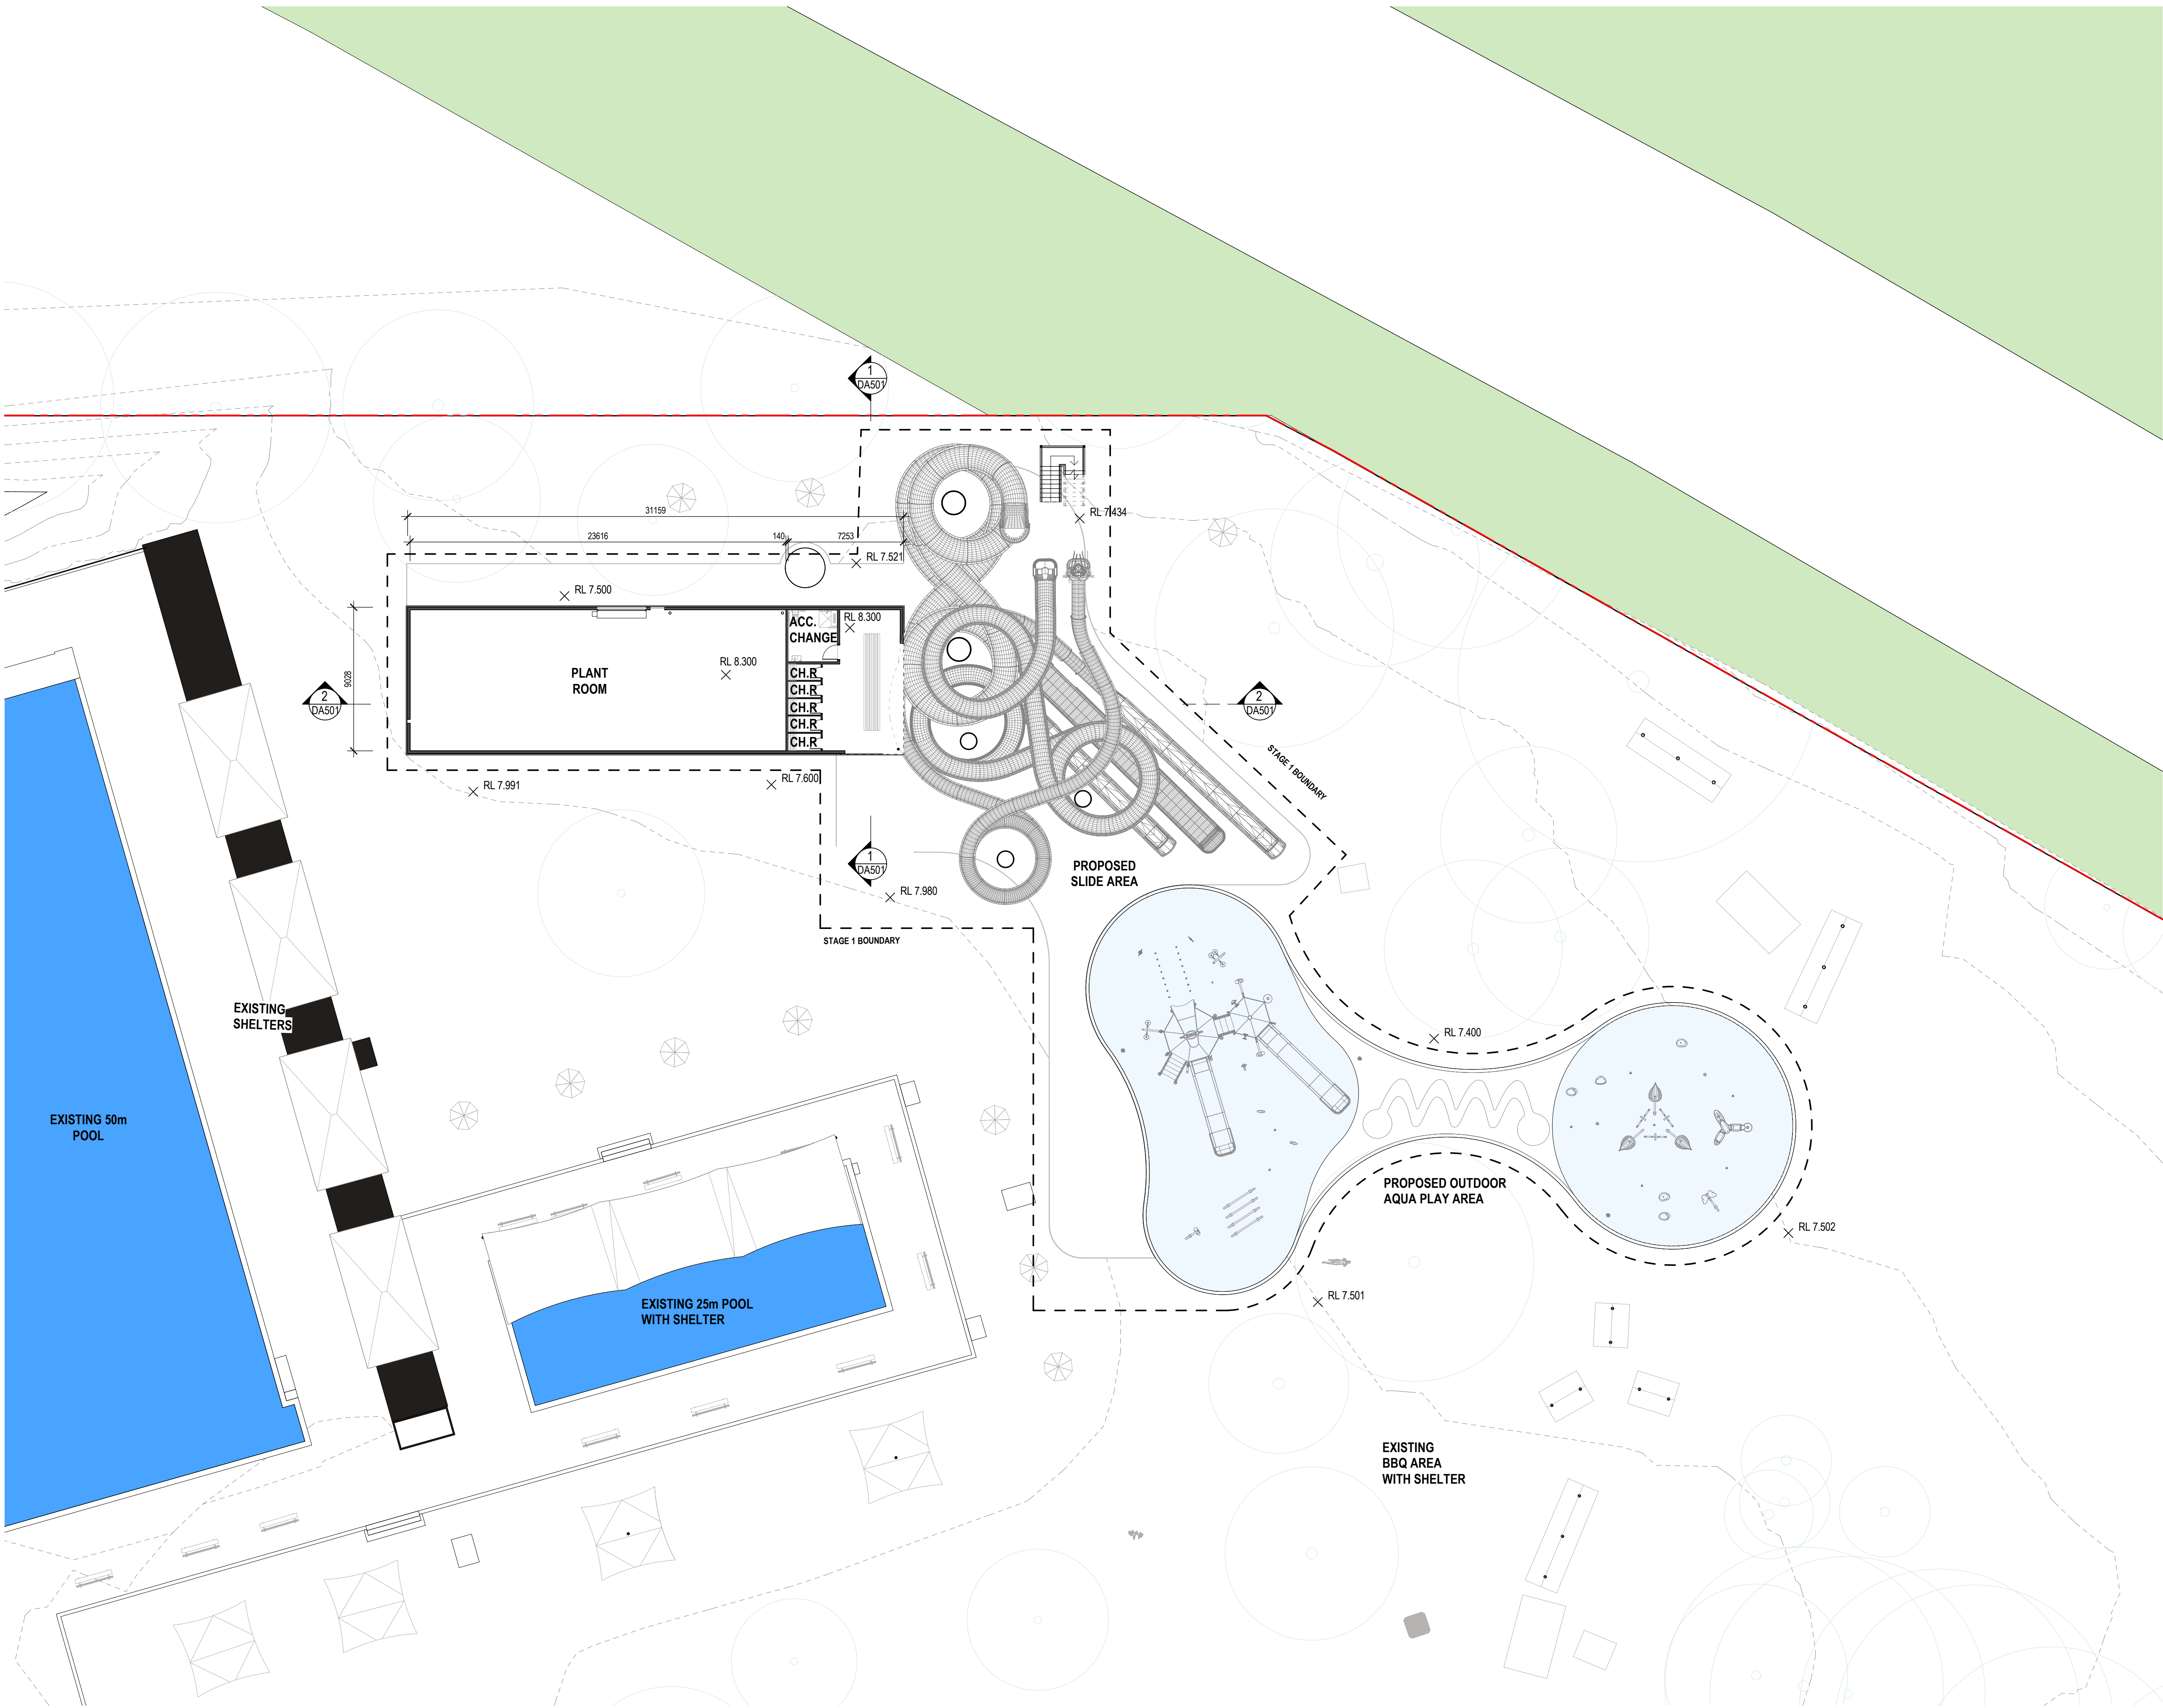
9.2 ***Appendix 2 General Arrangement Plan***

Seven (7) of the existing trees on site will require removal (Tree numbers 36, 41, 48, 49, 50, 60 & 65) as they are affected by the new works or are in poor condition.

Trees 38 and 51 will suffer 19% and 21% encroachment respectively and it is therefore recommended that further investigation and root mapping is used to determine possible retention.
