ARBORICULTURAL IMPACT ASSESSMENT  
&  
TREE PROTECTION SPECIFICATION

REF: L&Co192028 | 22 April 2021 | v3  
SITE ADDRESS | Bondi Surf Bathers' Life Saving Club  
PREPARED FOR | Lockhart-Krause Architects  
PREPARED BY | Dr Matthew Laurence

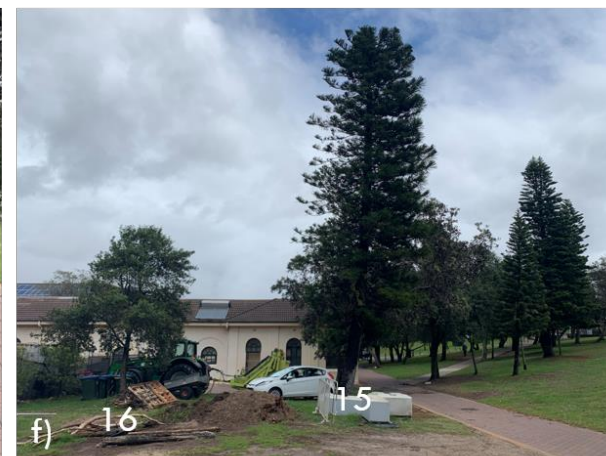
a) Showing current building at site and Tree 1. b) Showing Tree 1 and raised bed. c) Showing Trees 2, 4 & 5. d) Showing Trees 2, 4, 5, 6, 7 & 8 e) Showing Trees 11, 12 & 14. f) Showing Trees 15 & 16.

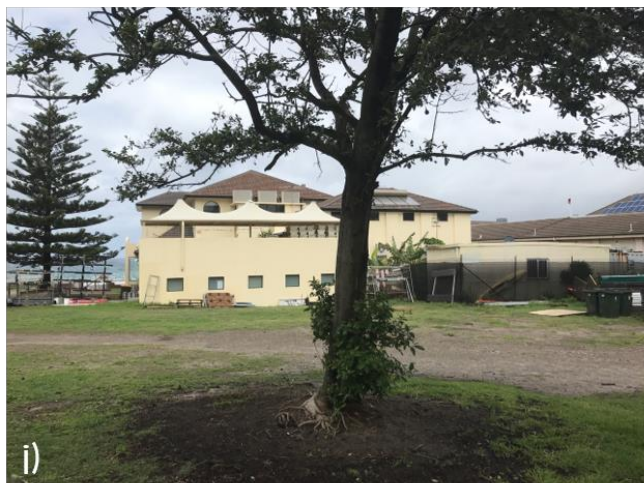
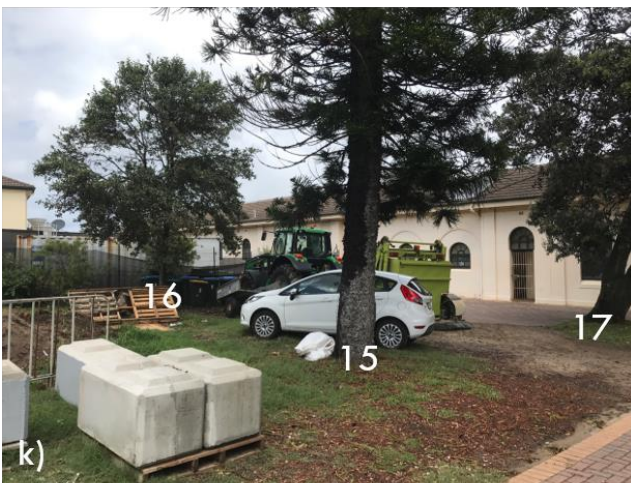
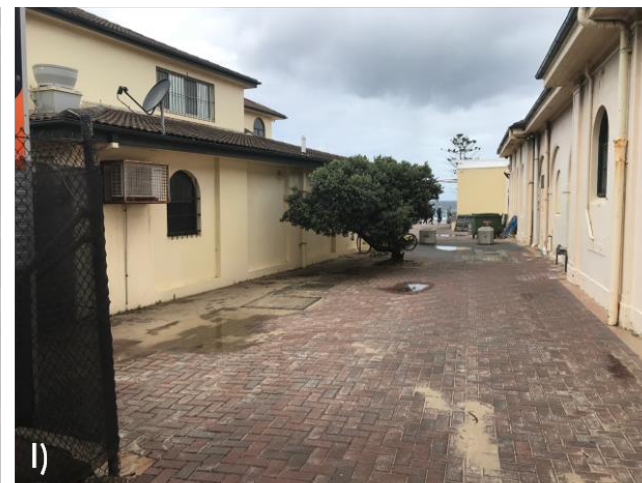
g-i) Showing Trees displaying poor physiological health and poor form that will need to be removed to accommodate the proposed works. (k) Showing trees 15, 16 & 17. Showing Tree 18. According to Lockhart-Krause Architects, Trees 15, 16, 17 & 18 have been removed as part of a separate Development Application since the site inspection conducted for the current report (16.03.2020)
