# **Arboricultural Impact Assessment**

**Christ Church Bexley**

**Prepared by Alex Austin  
For  
Sustainable Development Group Ltd  
June 2022  
V5**

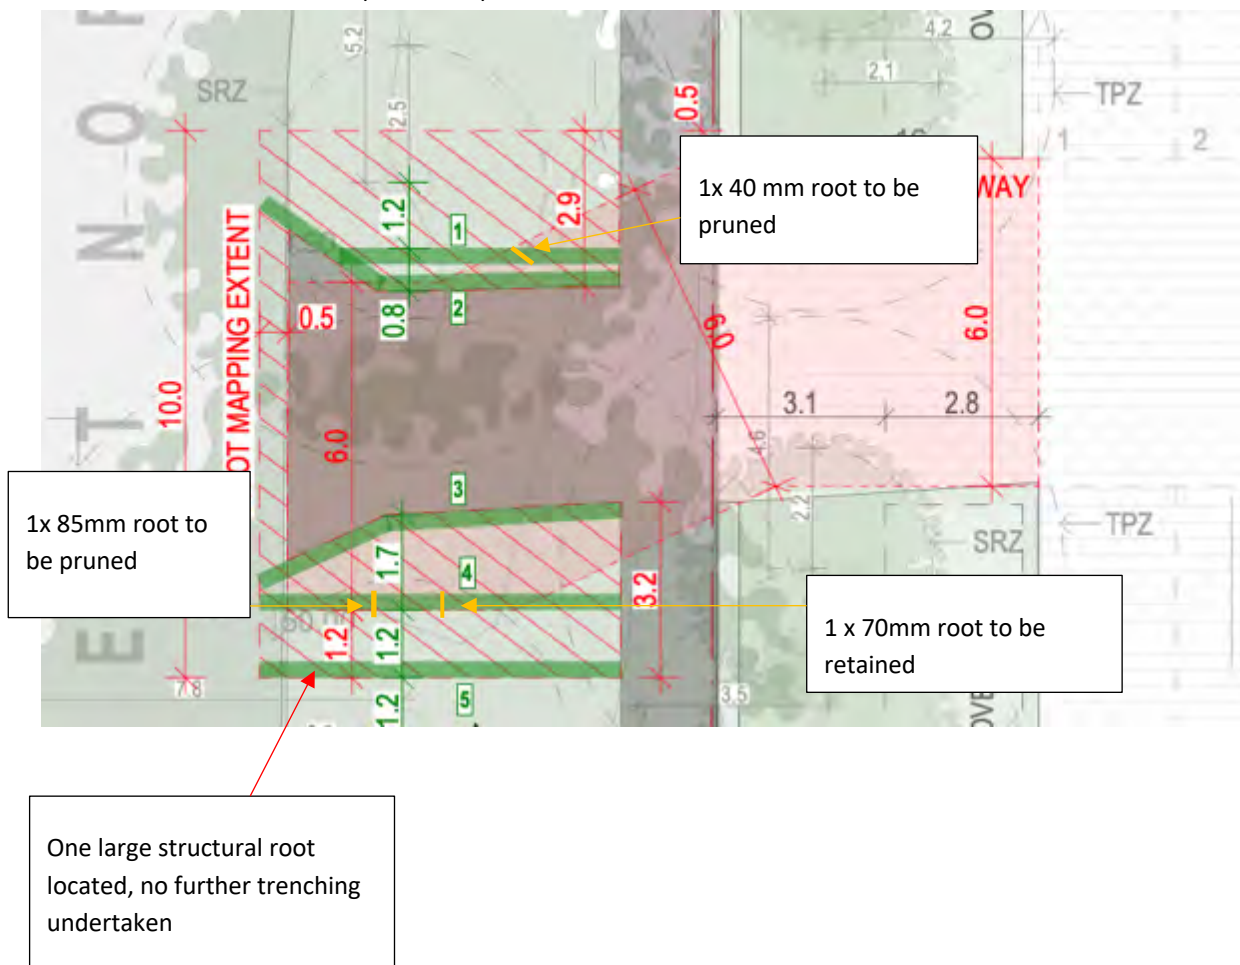
Exploratory root investigation for T24 revealed one 40mm root located at 150mm that would require to be pruned.

Exploratory root investigation for T25 revealed one 70mm root at 300mm depth to be retained and on 85mm root at 200mm that would require to be pruned.

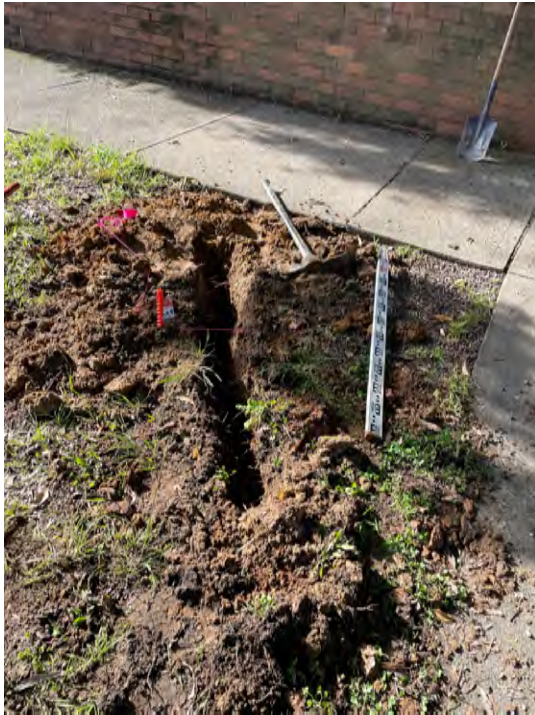
#### 4.6.1 PHOTOGRAPHS T24

Image of root to be pruned
