ARBORICULTURAL IMPACT ASSESSMENT (AIA) REPORT

Leichhardt Park Community Boatshed

An AIA report prepared for the Community Rowing Club Inc. for a proposed development at Part Lot 120 DP 1279860 – 66-68 Mary Street LILYFIELD

DATE: 13/02/2024

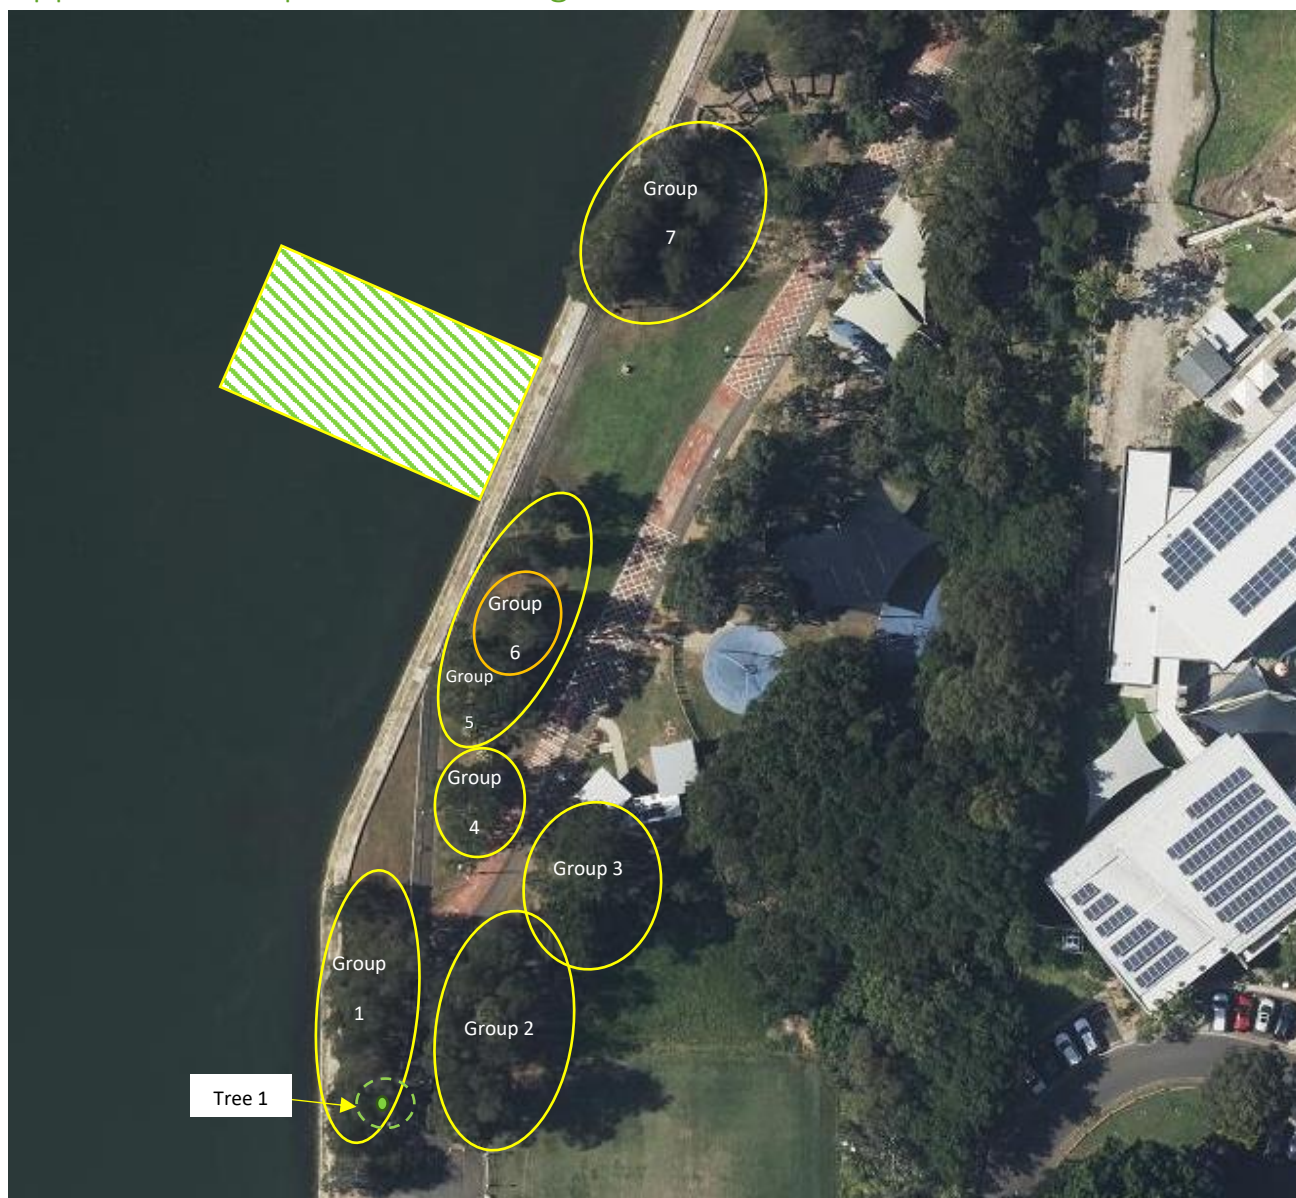
- 5.3.** There was one (1) x Tree: *Ficus rubiginosa* (Port Jackson Fig) and seven (7) x groups of trees comprising of mostly *Casuarina spp.* (She Oak) and one *eucalyptus sp.* (Eucalyptus) (observed within Group 7) that have been assessed for potential impact from the proposed development. Their locations have been mapped, see Figure 3 and the tree data obtained from site can be seen in Table 3 Tree audit for prescribed trees.

Figure 3 Aerial photo showing the approximate location of the proposed new Community rowing boatshed and location of nearby trees and groups of trees.

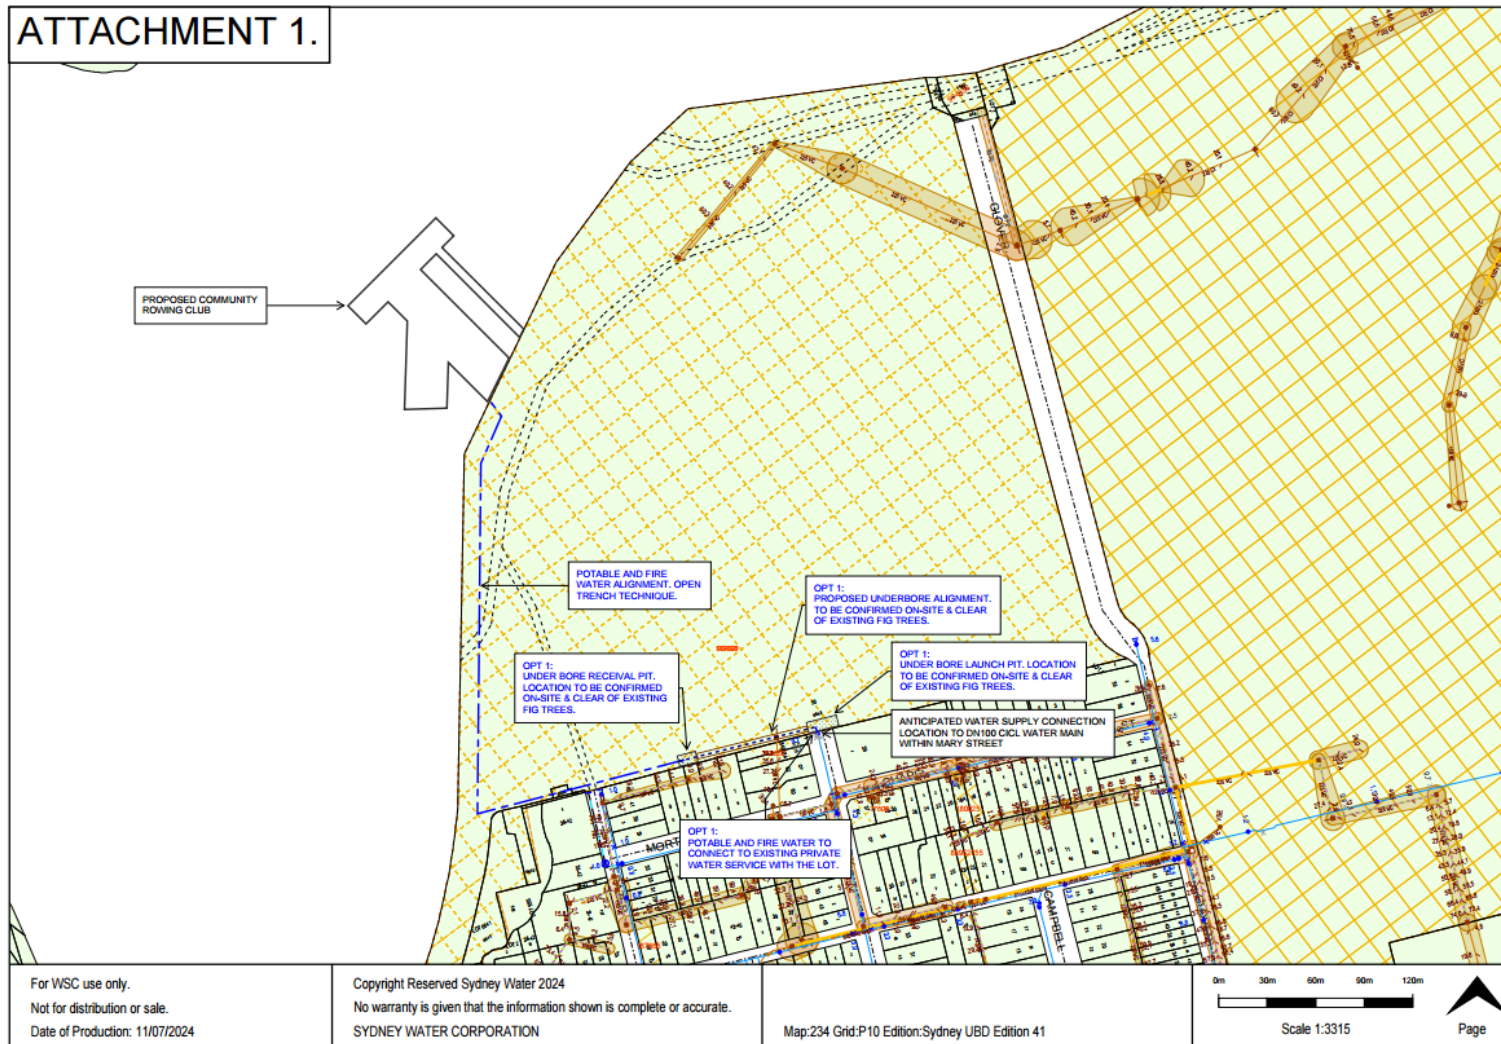
- 5.7.** As this site is a Greenfield site, there are no existing service connections. As such there are a number of proposed plans which show connections to existing services some distance away, see Figure 11, Figure 12 and Figure 13.

Figure 11 Proposed water connections provided by Client by email 13/2/2025
