Report on
Geotechnical Investigation

Alterations and Additions
20 Illawong Avenue, Tamarama

Prepared for
Strata Plan 1731

Project 72261.06
November 2018

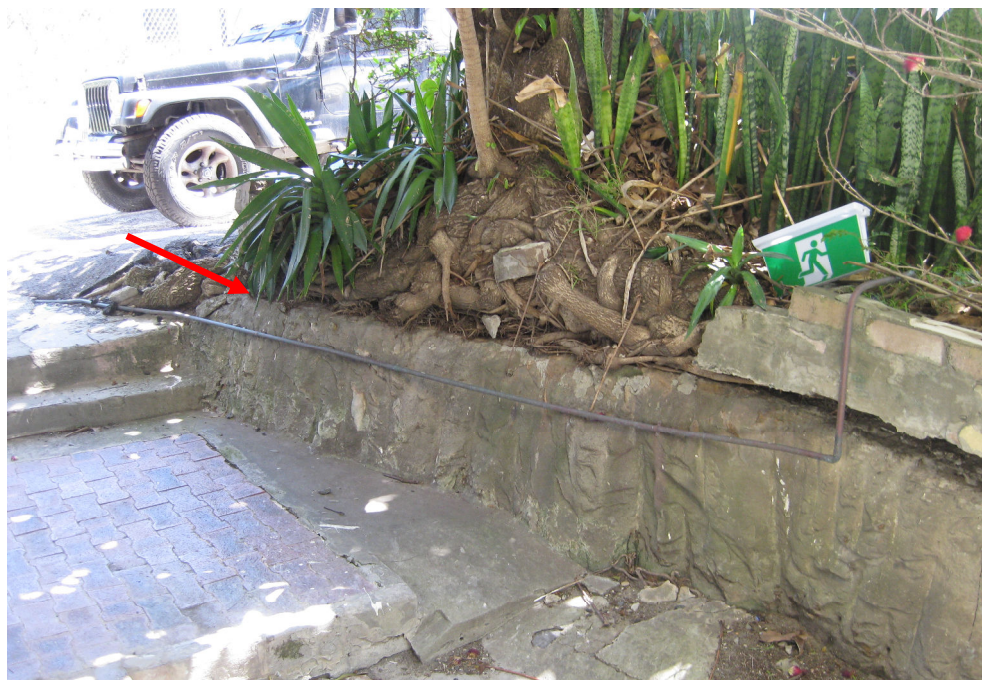
An exposure of massive, high strength sandstone was observed adjacent to the car park, near the south-western end of the unit block (refer Photo 12 in Appendix B). A sandstone cliff is present along most of the south-western boundary (i.e. on the side furthest from the proposed basement excavation and closest to the gully above Tamarama Park), having a height between 4 - 8 m and being mostly obscured by vegetation. The terraces of the building are supported by a brick retaining wall up to about 3.4 m high, curved in places, which has been constructed adjacent to and set-back from the cliff crest by between 0 - 5 m.

Photo 12 – View north-west towards existing car park. Rock exposure indicated as shown

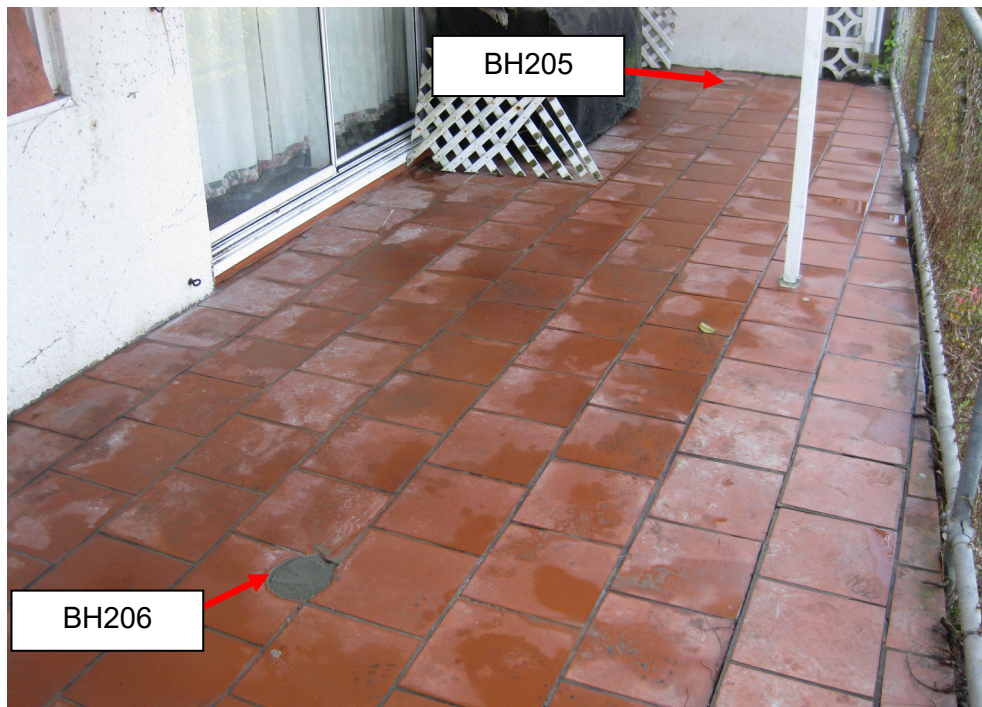
The width of the terraces between Unit 1 and Unit 5 (i.e. the distance between the building and the brick retaining wall at the northern end of the building) is between 2.5 - 3 m, widening to 8 m at Unit 8 and Unit 9, then narrowing again to 4 m at Unit 10. It is noted that the terraces of Units 2 and 3, which are surfaced with timber decking, have been constructed to overhang the brick retaining wall by between 0.5 - 1 m (refer Photo 13 in Appendix B). Some of the other terraces were also partially or entirely surfaced with timber decking or tiles, over concrete slabs (e.g. Photos 17 and 18 in Appendix B).

Photo 17 – View north-east along balcony of Units 5 and 6. Borehole positions are indicated as shown.

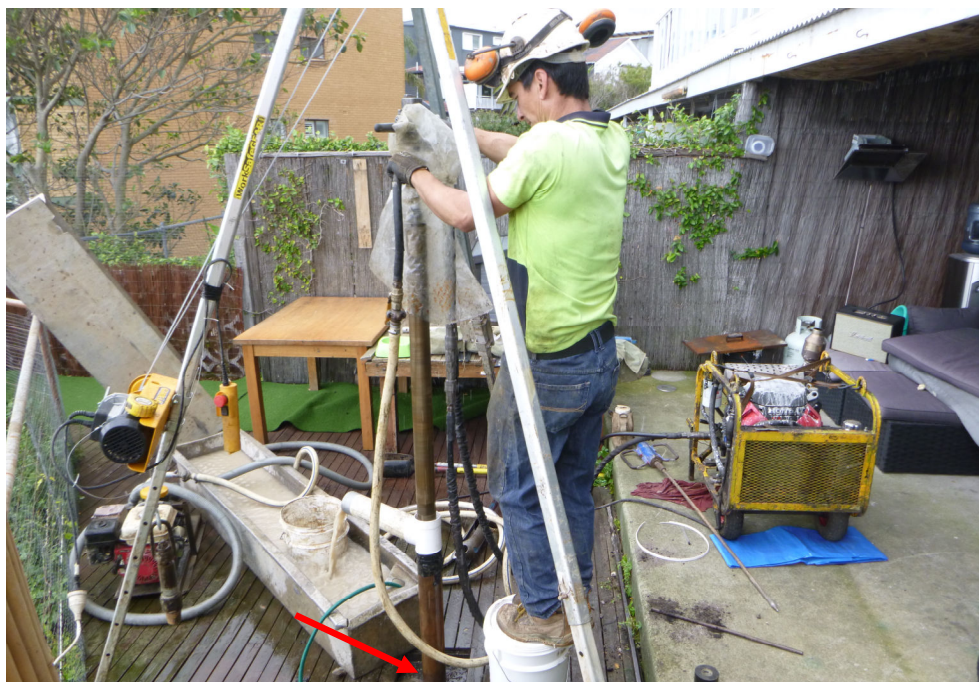
Photo 18 – View south-west along balcony of Unit 7. The position of BH208 is indicated as shown, below a timber deck.

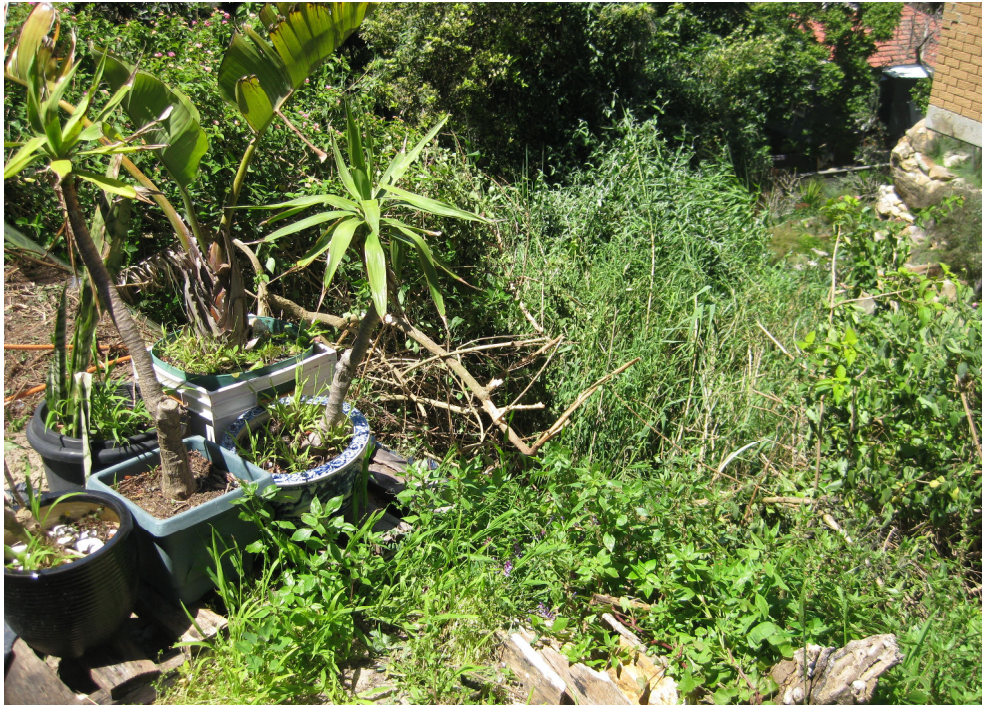
Photo 21 – View east at southern end of balcony / terrace of Unit 10, adjacent to cliff edge.

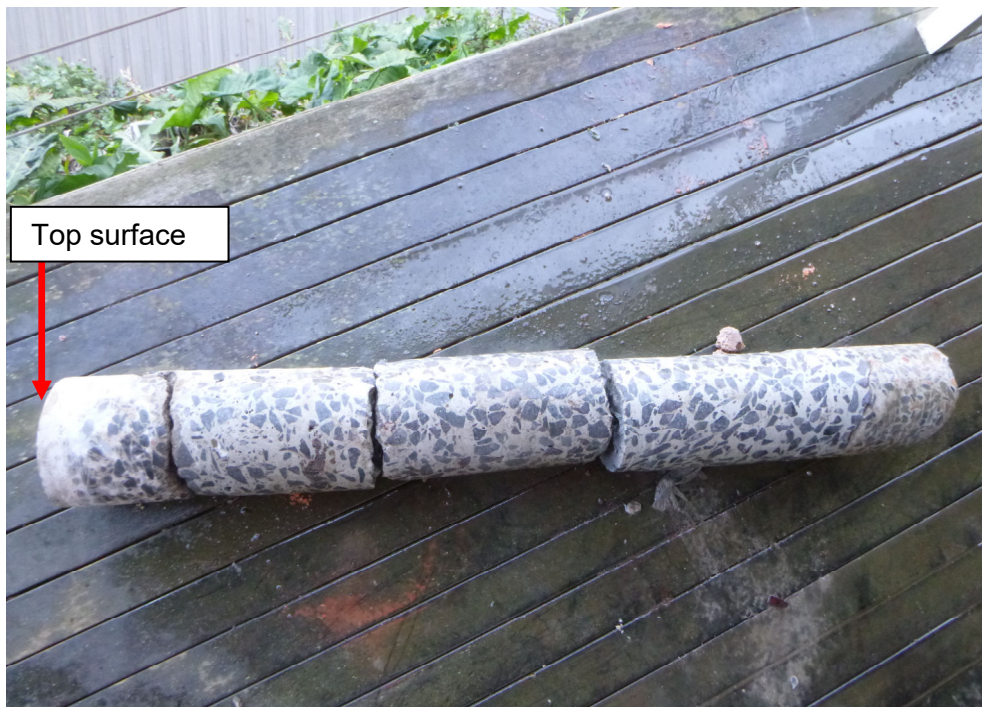
Photo D1 – View of concrete cored from beneath the balcony of Unit 2 (Borehole BH202). The start / top of the core is indicated as shown.

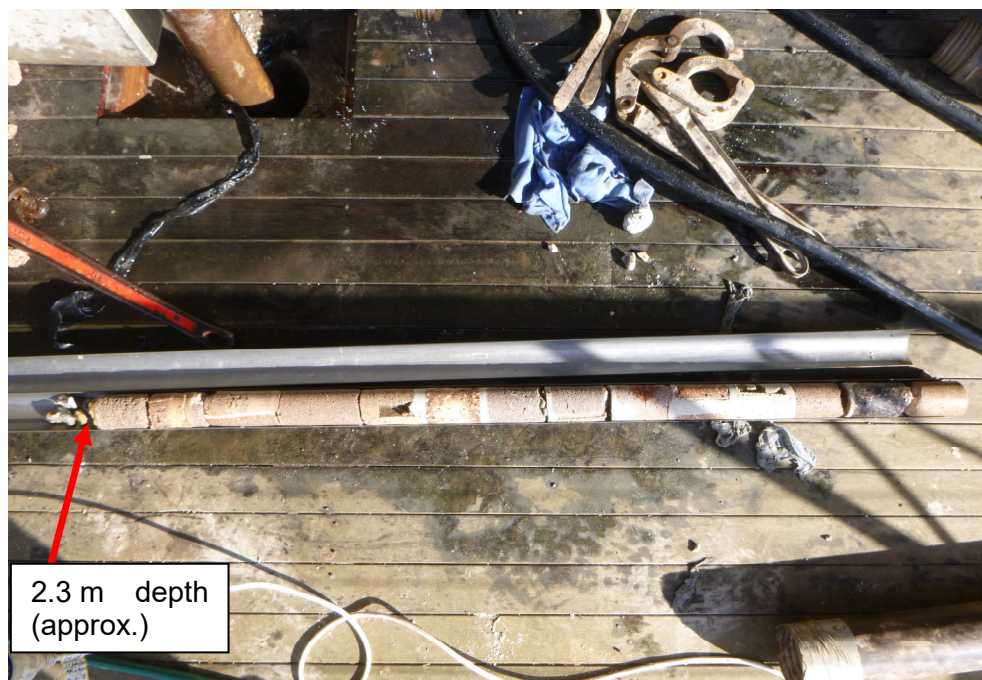
Photo D2 – View of mortared bricks within Borehole BH202. The start / top of the bricks is indicated as shown (approximate start / top depth of 2.3 m).

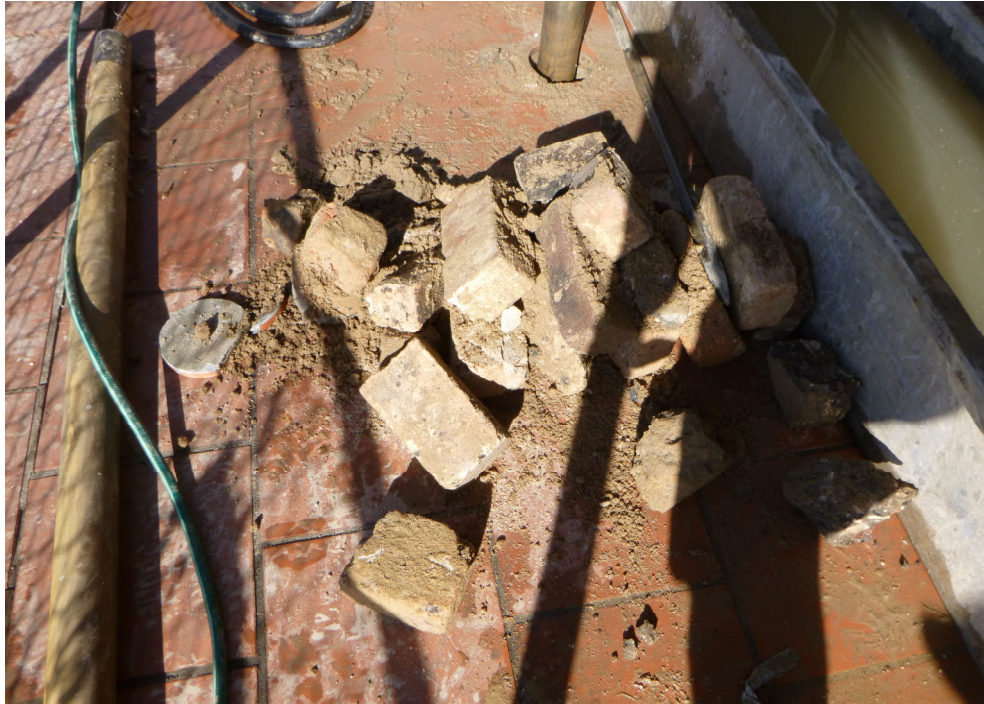
Photo D3 – View of rubble filling removed from Borehole BH206, drilled within the balcony of Unit 6.

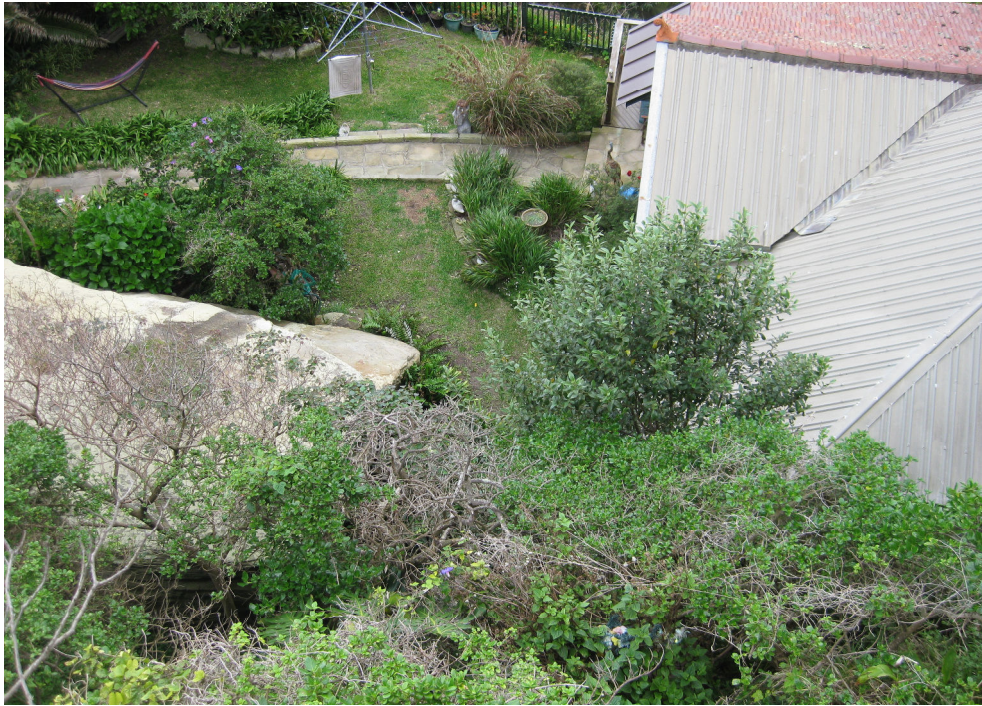
Mapping Traverse 101, Photo 1 – View south-east from Unit 1 (ground floor), down towards No. 14 Illawong Avenue below. The upper part of the mapping traverse is in the foreground.

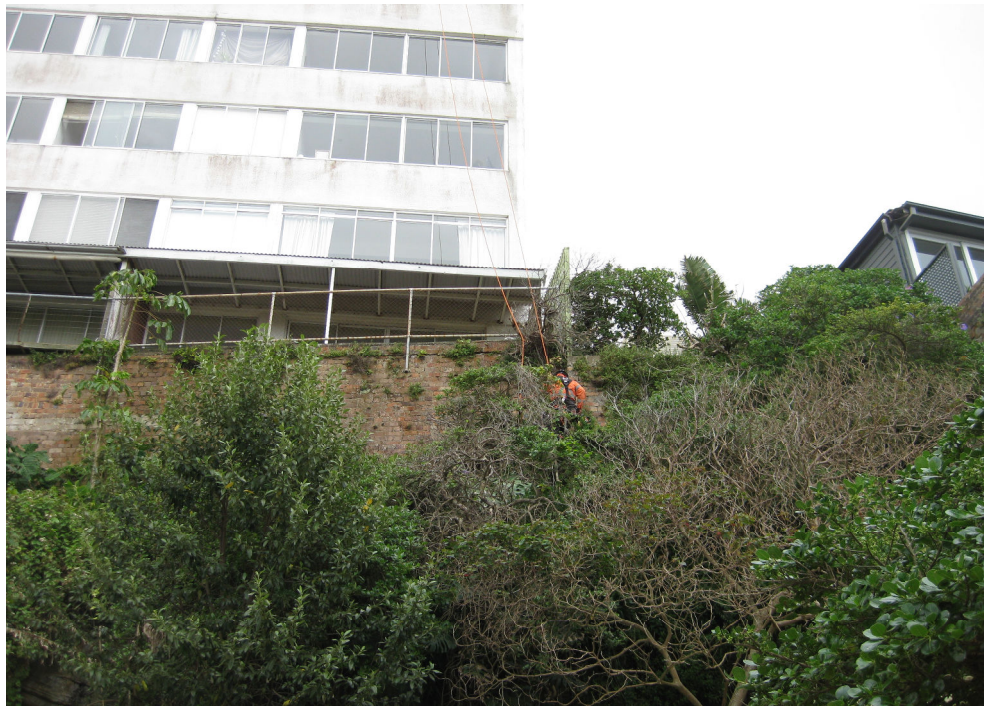
Mapping Traverse 101, Photo 4 – View north-west towards Unit 1 from the base of the cliff, at cliff mapping traverse 101.

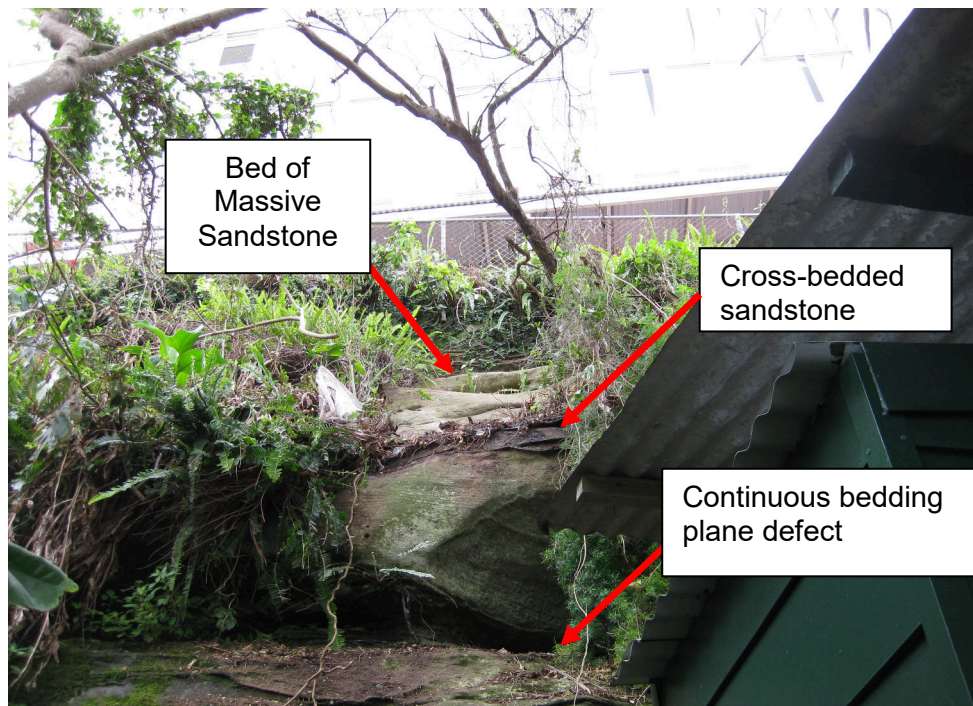
Mapping Traverse 103, Photo 1 – View of upper part of mapping traverse 103 from below, with a bed of massive sandstone forming the upper part of the cliff, over cross-bedded sandstone, as shown.

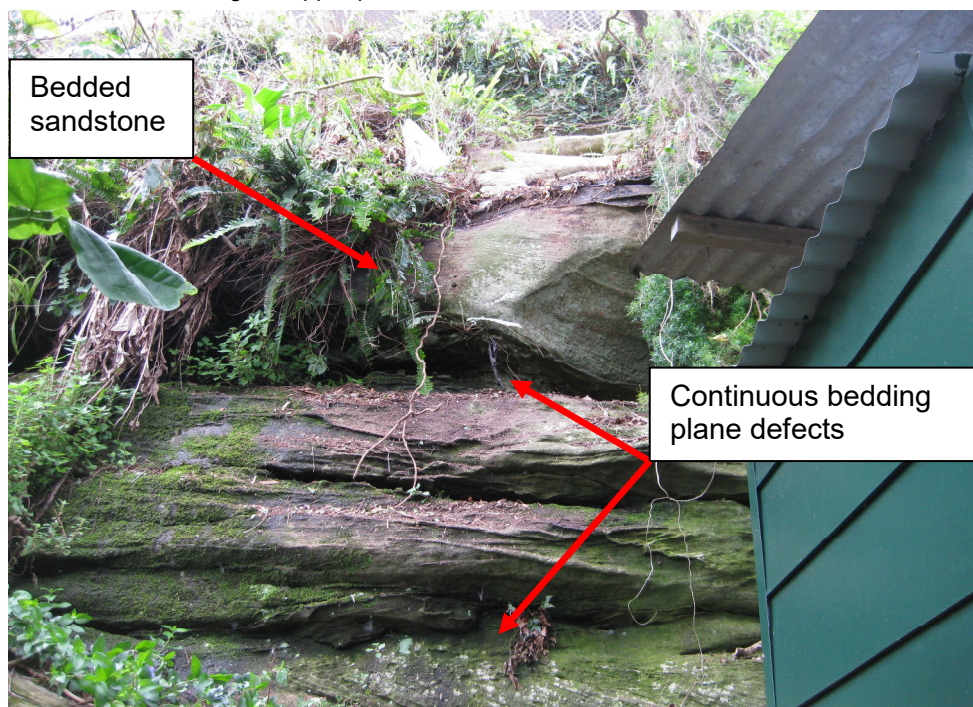
Mapping Traverse 103, Photo 2 – View of cross-bedded sandstone at mapping traverse 103..

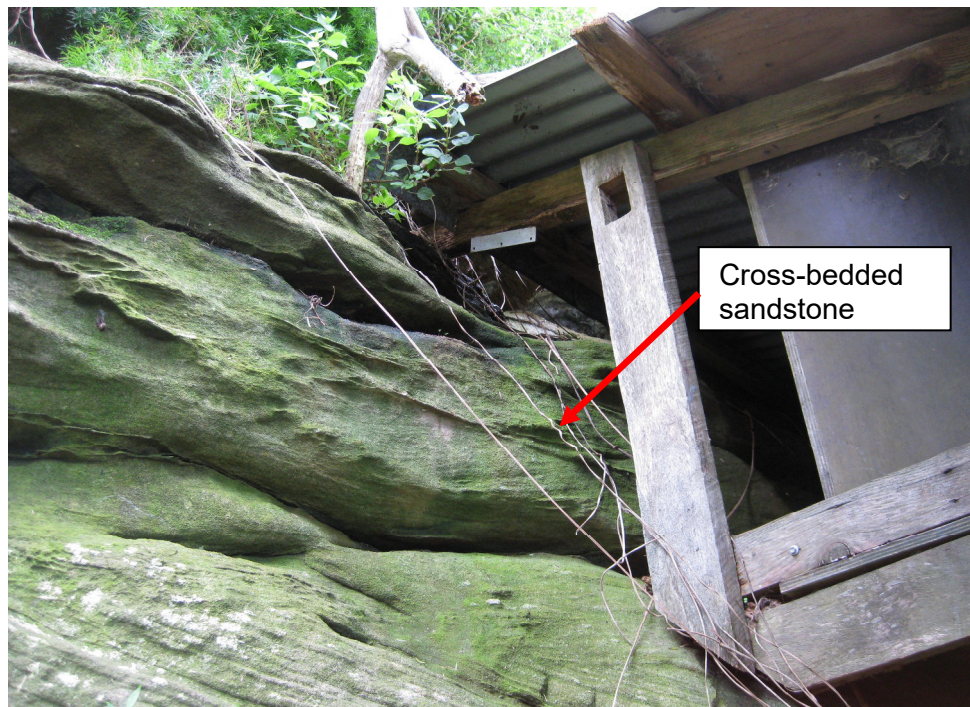
Mapping Traverse 103, Photo 3 – Oblique view of mapping traverse 103 from below, with cross--bedded sandstone exposed, as shown.

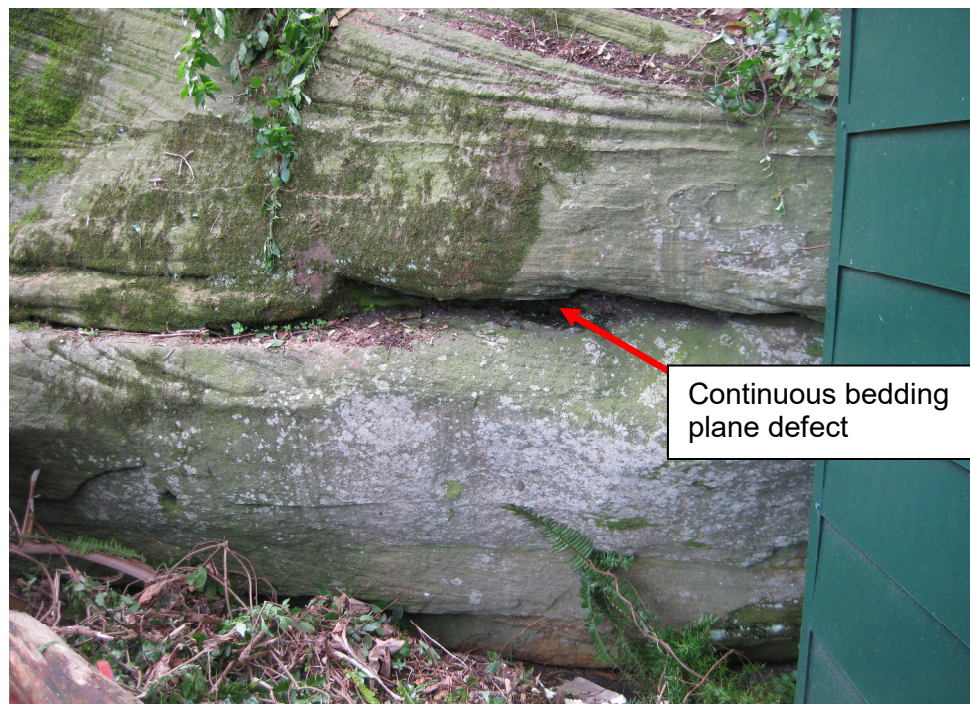
Mapping Traverse 103, Photo 4 – View of lower part of cliff at traverse 103.

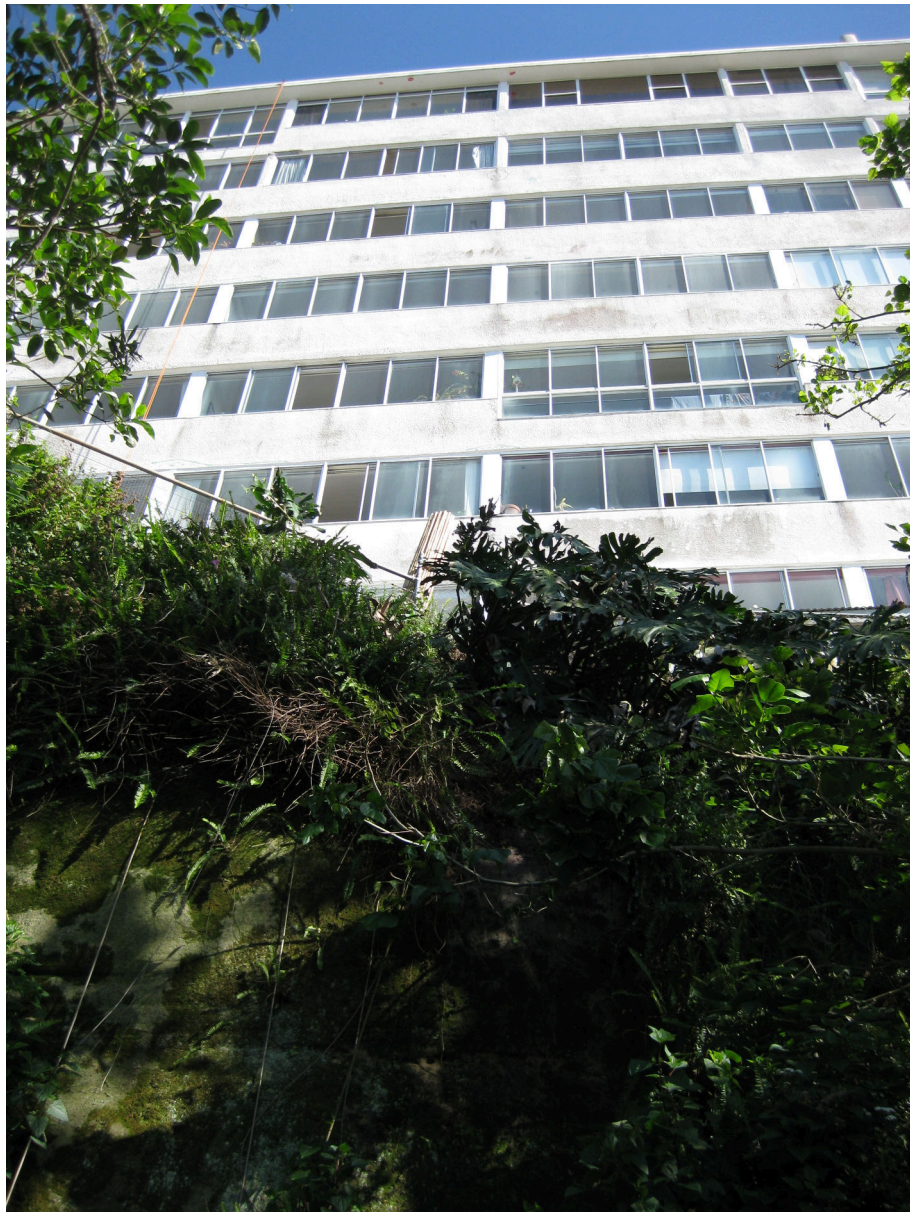
Mapping Traverse 104, Photo 1 – View towards the existing unit building at mapping traverse 104. Solid sandstone exposed for most of the lower part of the slope.

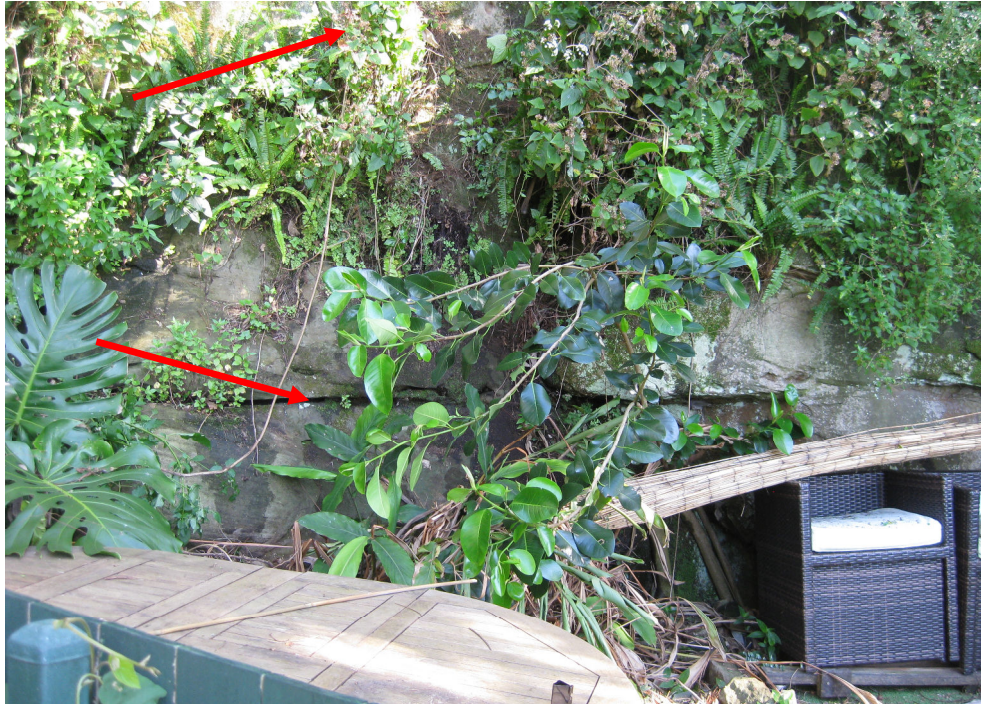
Mapping Traverse 104, Photo 2 – View of the lower part of the traverse, exposing thin, continuous seams / bedding partings, which are indicated as shown.

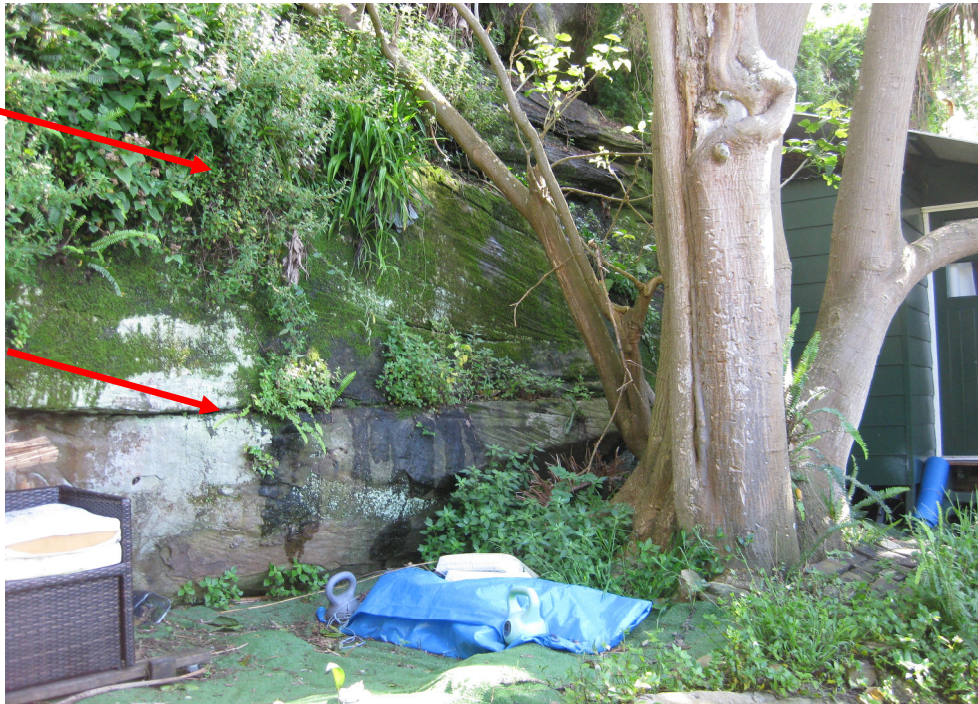
Mapping Traverse 104, Photo 3 – View north of mapping traverse 104. Continuous bedding planes within cross-bedded sandstone are indicated as shown.

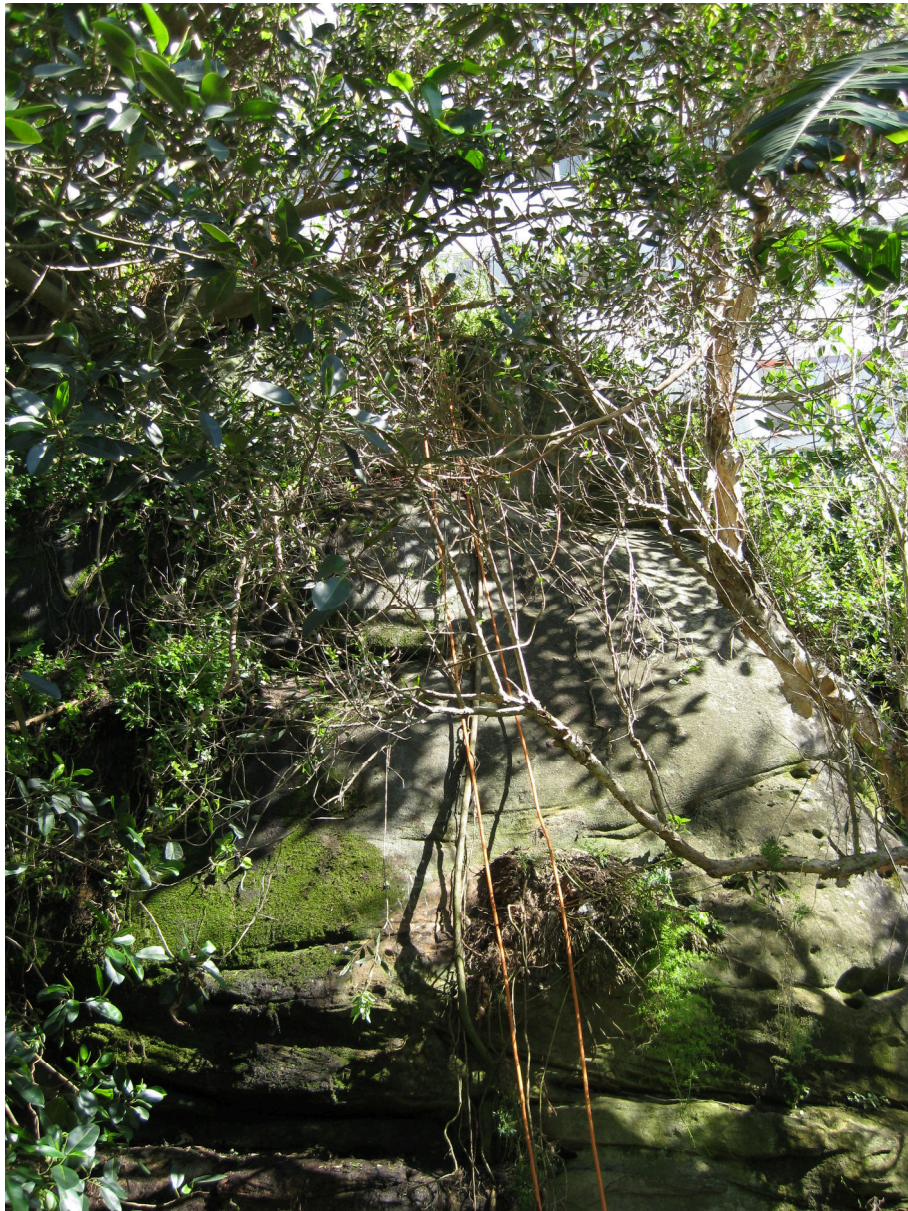
Mapping Traverse 105, Photo 2 – View towards the existing unit building at mapping traverse 105. Interbedded massive and laminated sandstone exposed for most of the lower part of the slope, with some discontinuous siltstone lenses and discontinuous bedding parting defects.

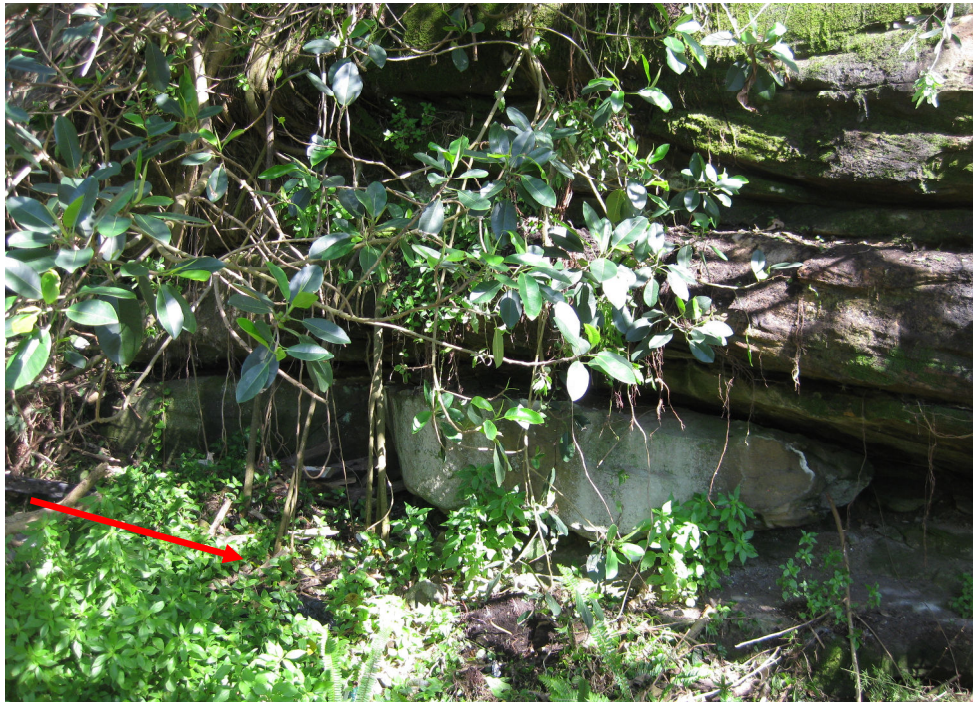
Mapping Traverse 105, Photo 5 – View towards mapping traverse 106 from traverse 105. Tabular boulder on sub-horizontal bedding plane within cave, with debris and colluvium forming a bush path indicated as shown.

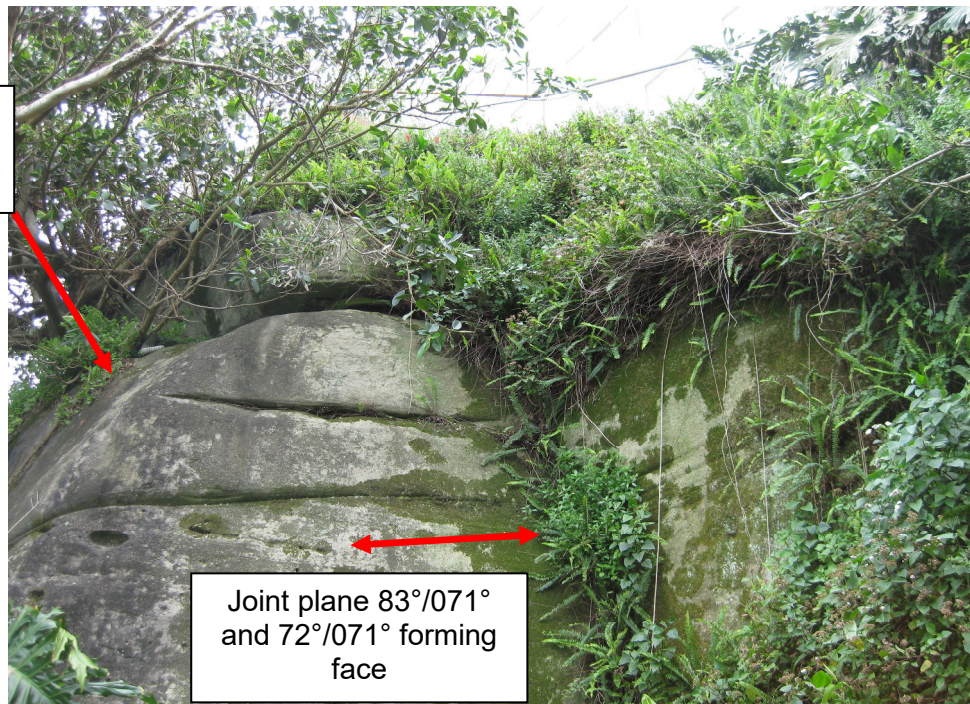
Mapping Traverse 105, Photo 6 – Side view of mapping traverse 105 (indicated). Persistent sub-vertical joint, forming a face, is indicated as shown.

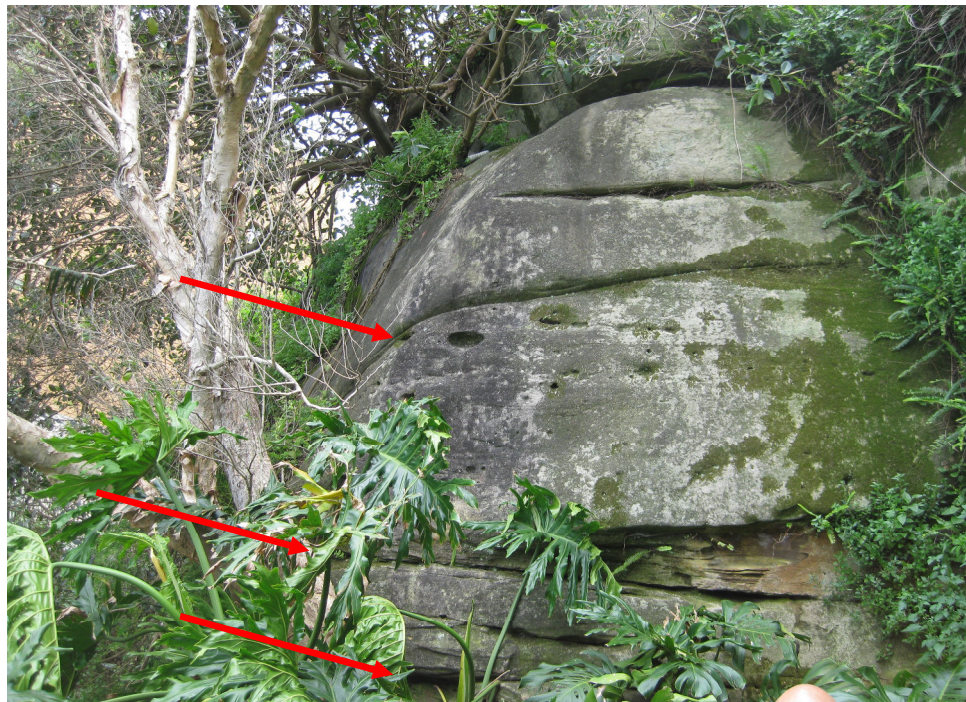
Mapping Traverse 105, Photo 7 – View towards mapping traverse 105. Continuous bedding partings within cross-bedded sandstone are indicated as shown.

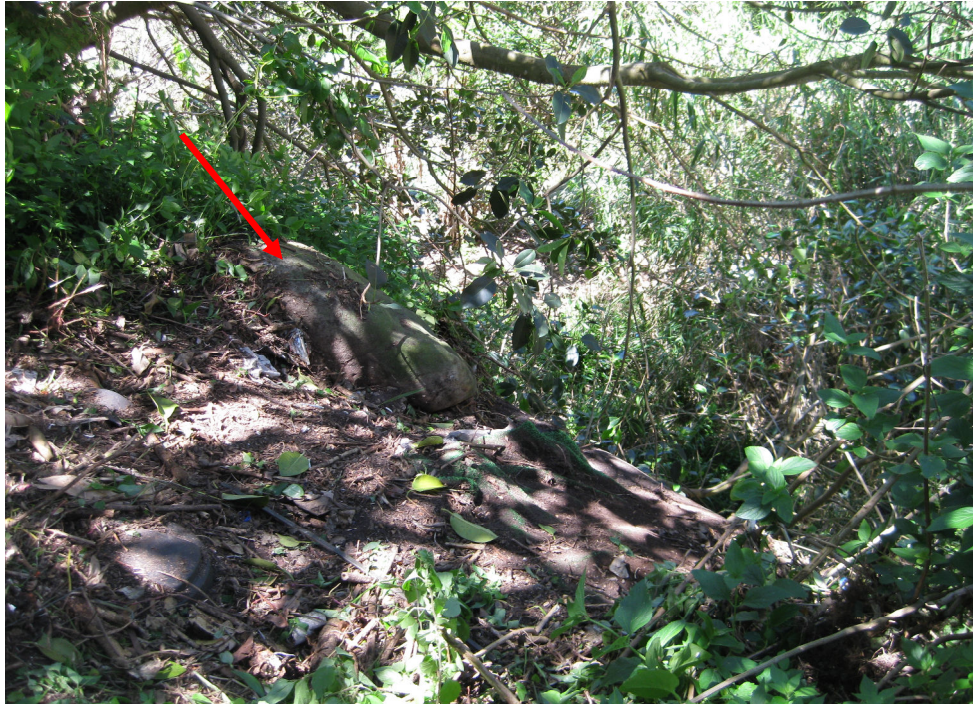
Mapping Traverse 106, Photo 1 – View downslope from the crest of mapping traverse 106, showing some boulders at the slope crest, indicated as shown.

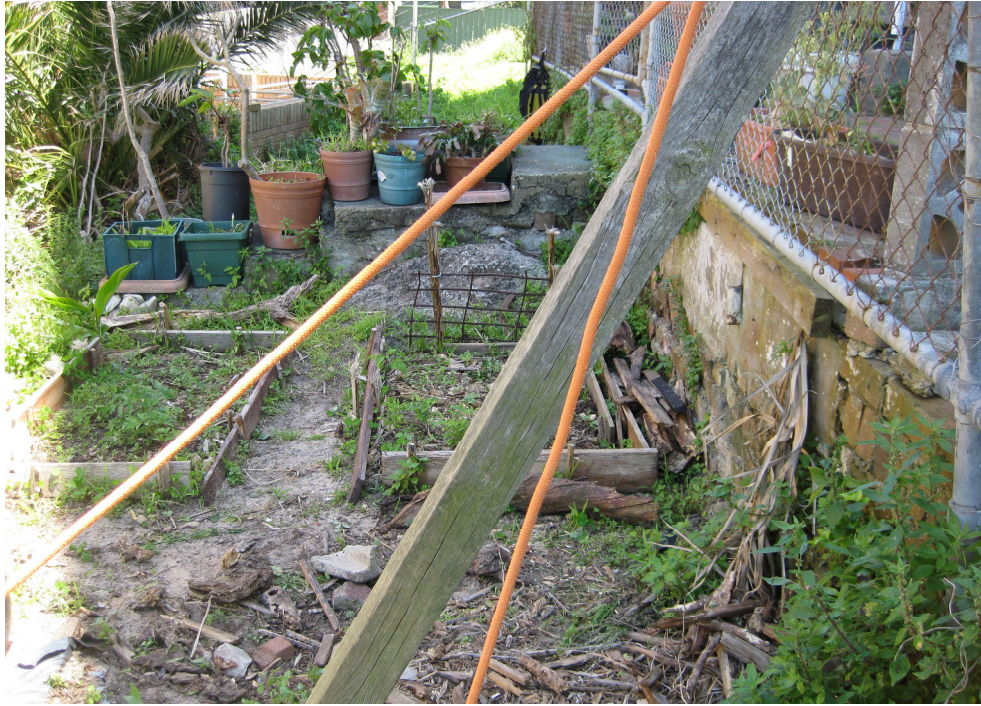
Mapping Traverse 107, Photo 1 – View south-west along crest of slope near the start of mapping traverse 107, showing an informal garden area.

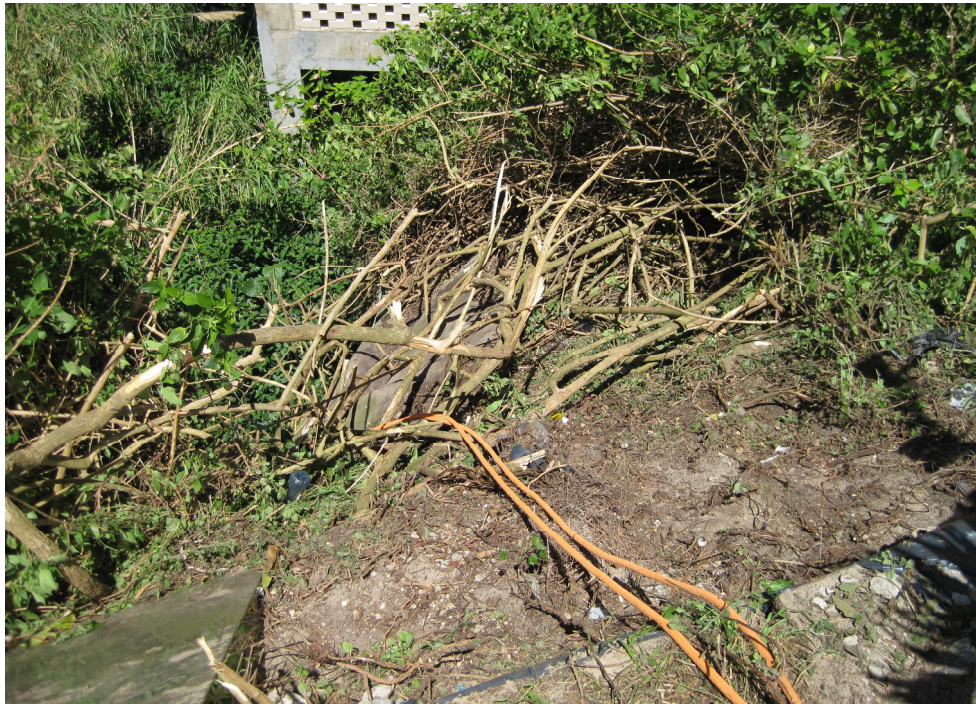
Mapping Traverse 107, Photo 2 – View down slope at the crest of traverse 107, with boulders and other debris on the slope surface.

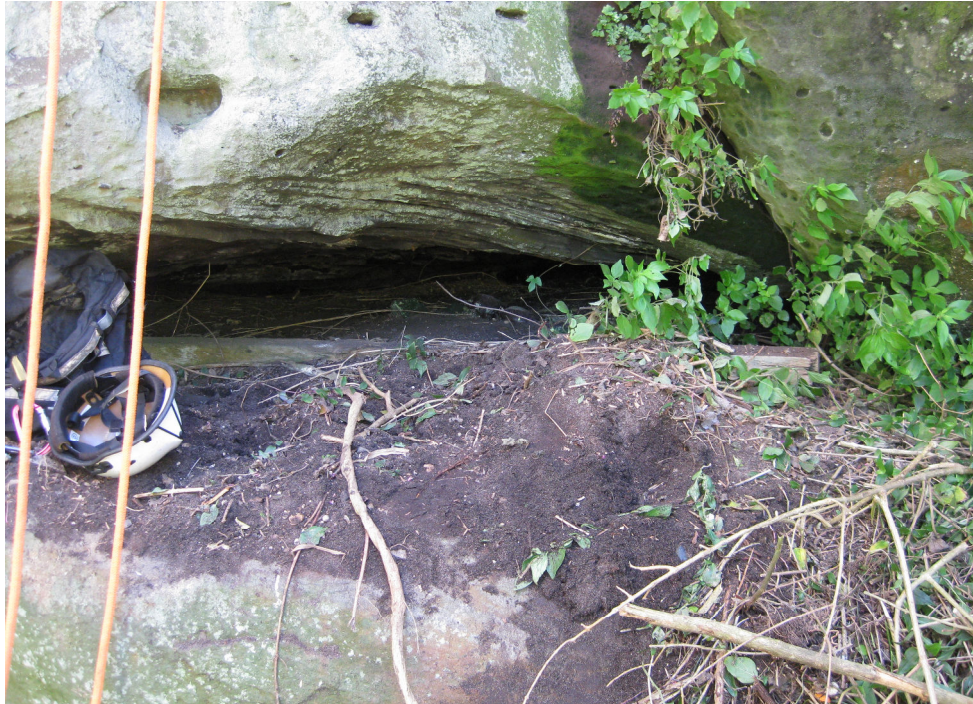
Mapping Traverse 107, Photo 5 – View of overhang and cave within cross-bedded sandstone, 0.5 m high and 2.5 m deep, developed on continuous bedding parting.

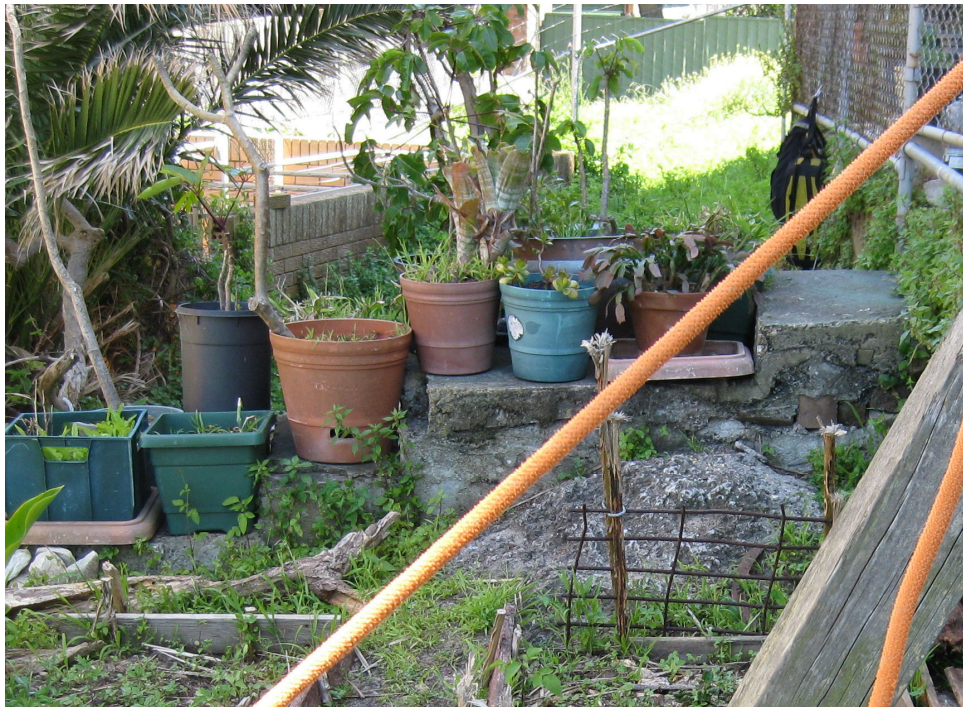
Mapping Traverse 108, Photo 1 – View south-west along crest of slope near the start of mapping traverse 108, showing a former set of concrete stairs leading towards the crest of the slope.

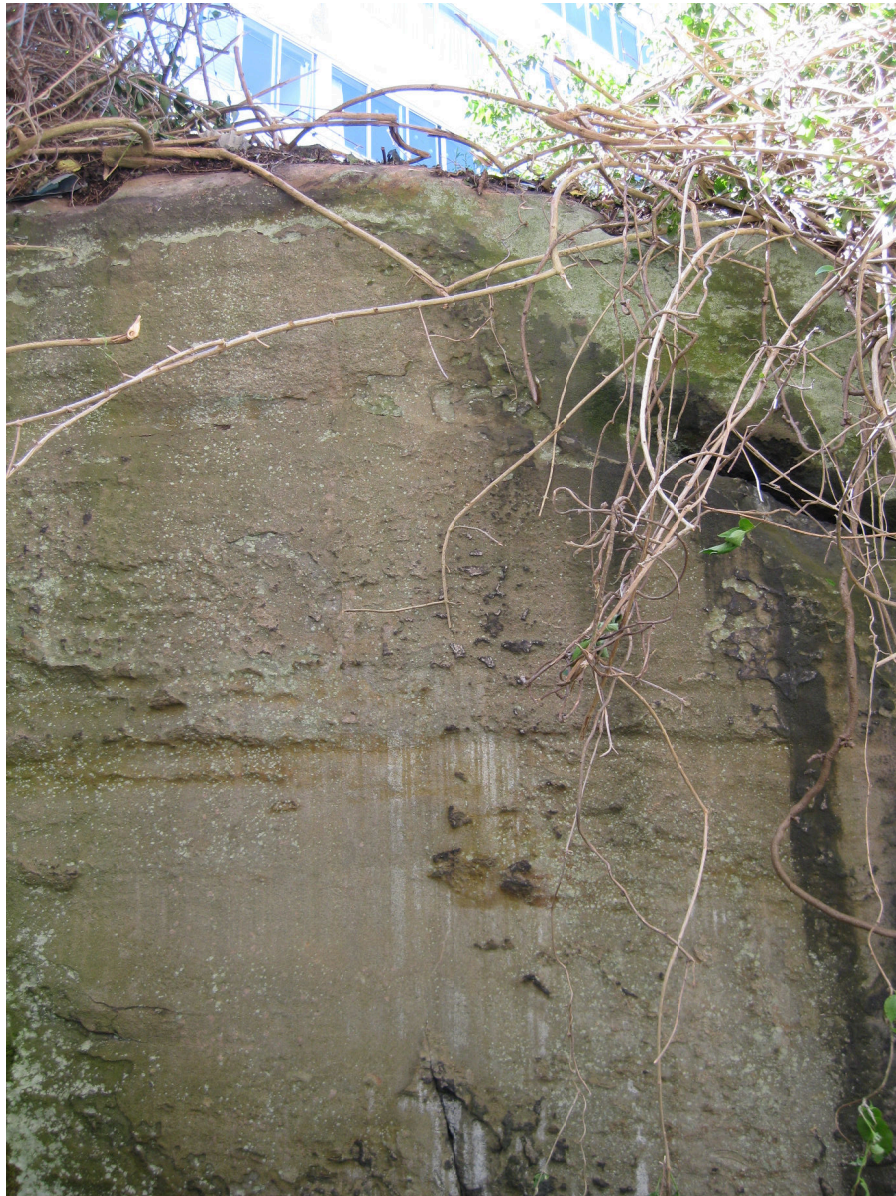
Mapping Traverse 108, Photo 2 – View upslope from base of traverse 108, of high strength sandstone.

Continuous bedding parting defect, with measured dip and dip direction 23°/017°

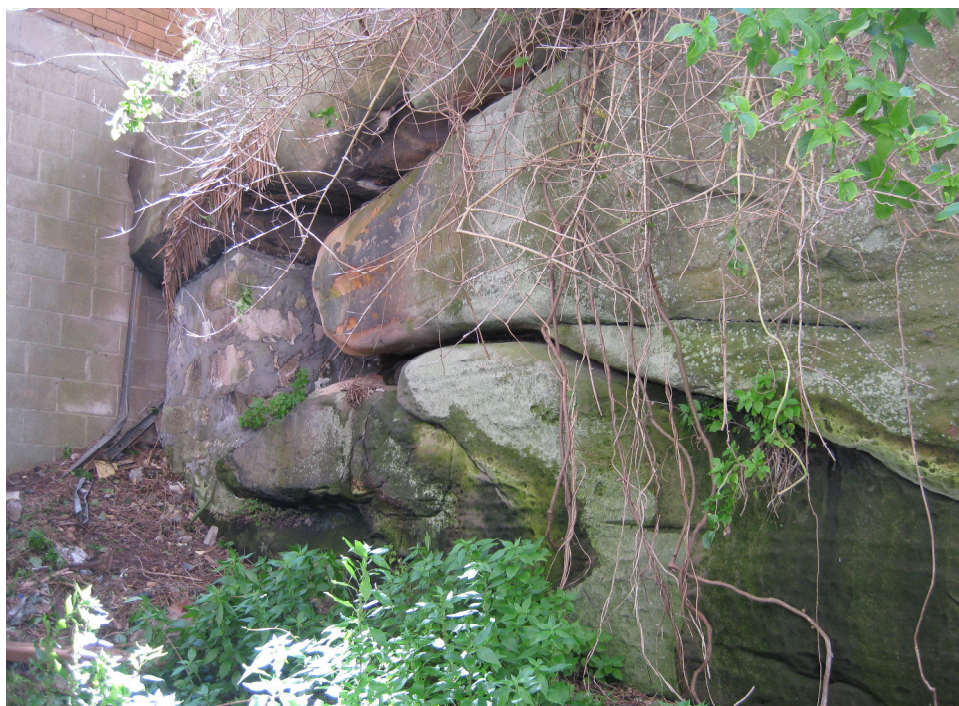
Mapping Traverse 109, Photo 2 – View north towards mapping traverse 109, showing sub-horizontal and dipping bedding plane defects.

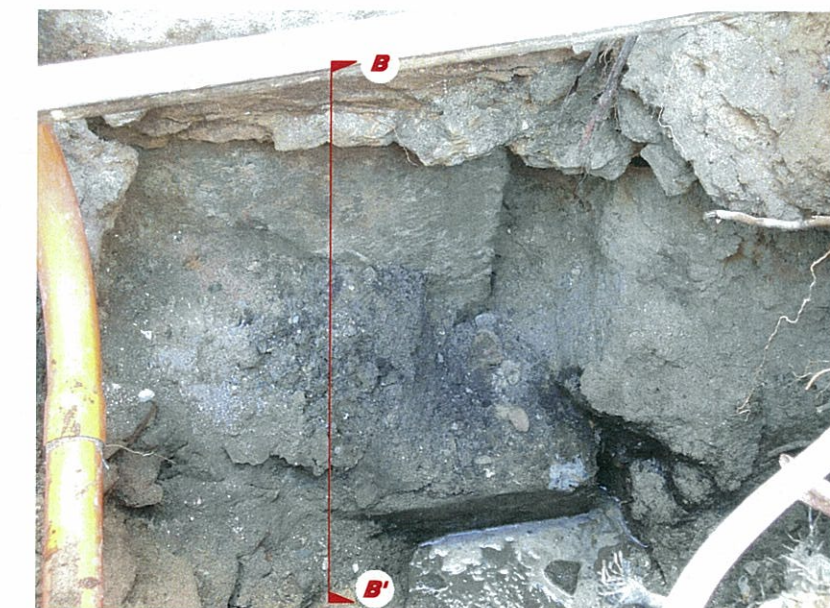
Photo 2: Showing corner of concrete footing

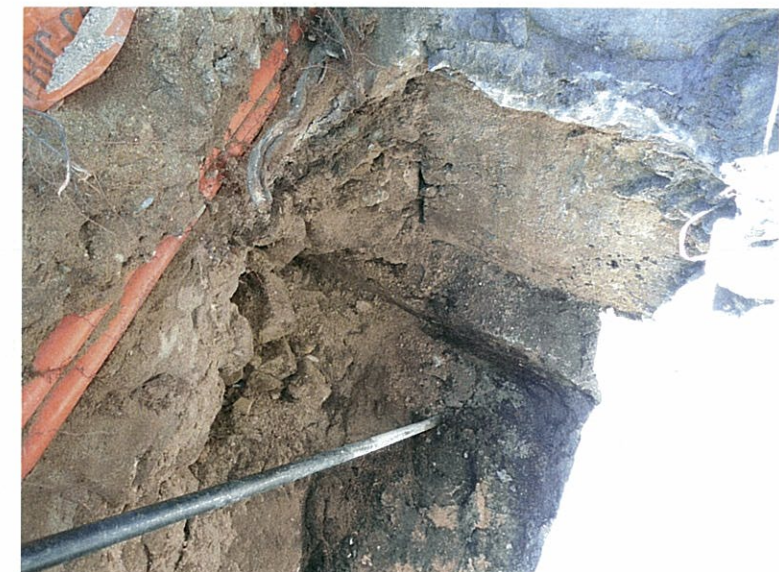
Photo 2: Northern edge of concrete footing

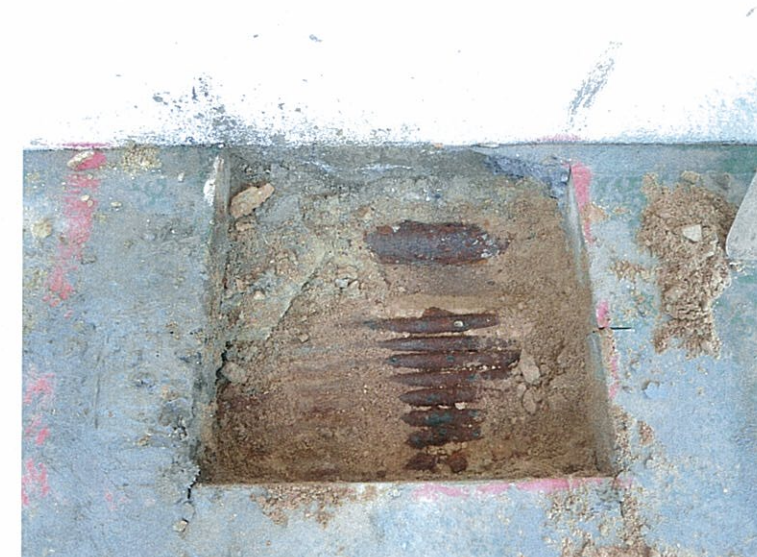
Photo 2: Services below slab
