Report on
Geotechnical Investigation

Alterations and Additions
20 Illawong Avenue, Tamarama

Prepared for
Strata Plan 1731

Project 72261.06
November 2018

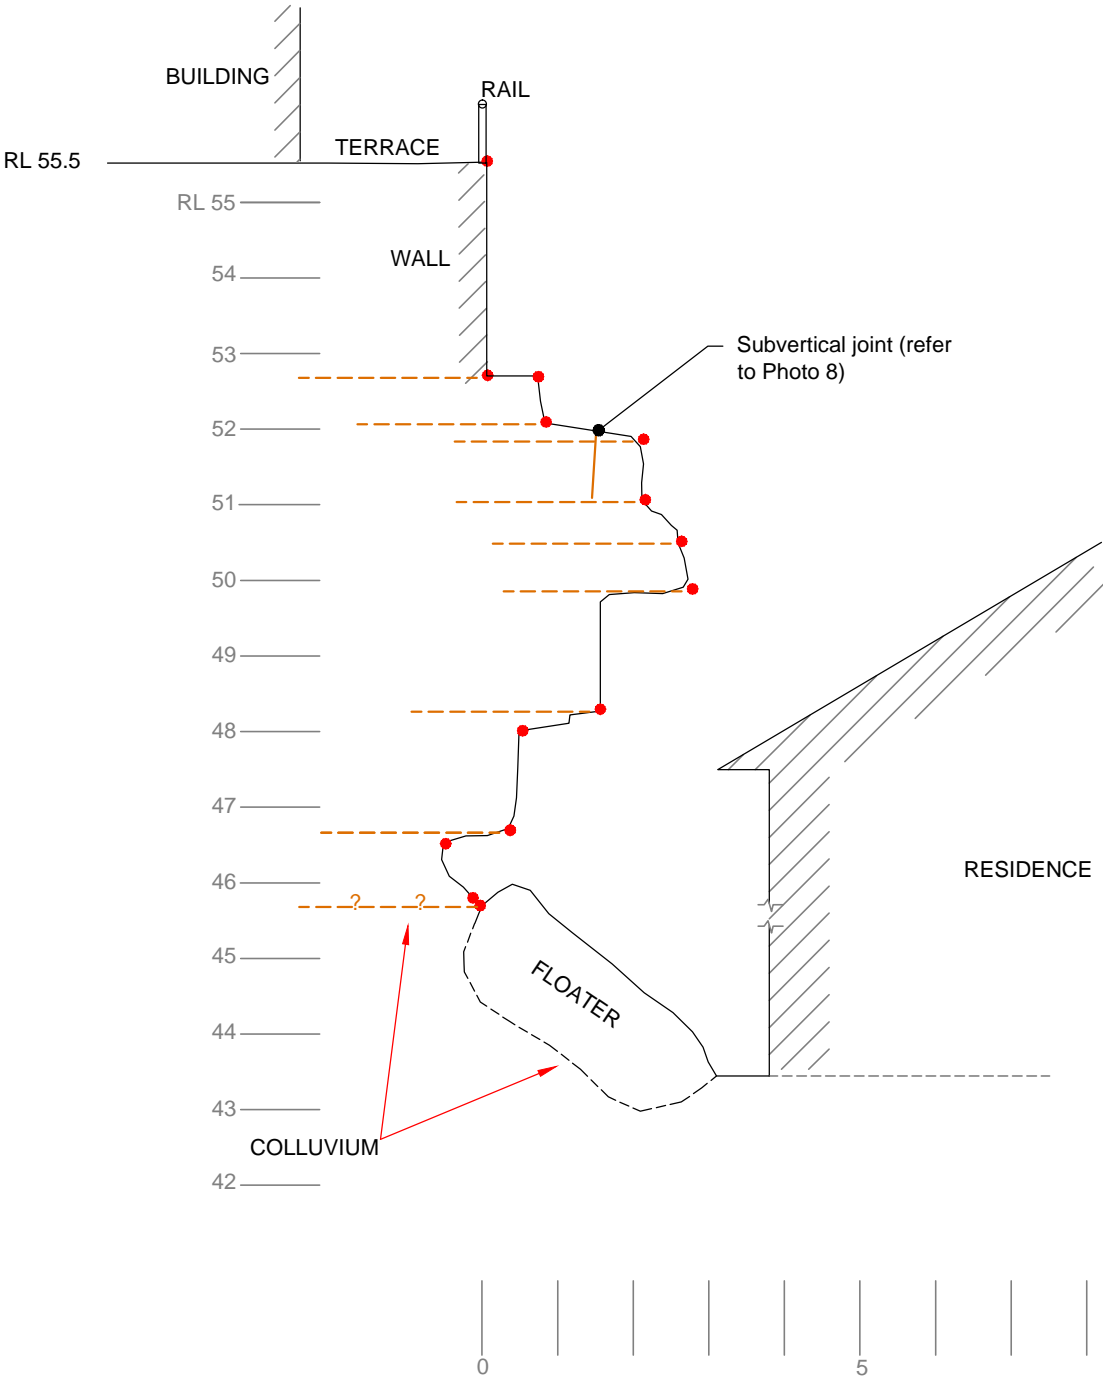
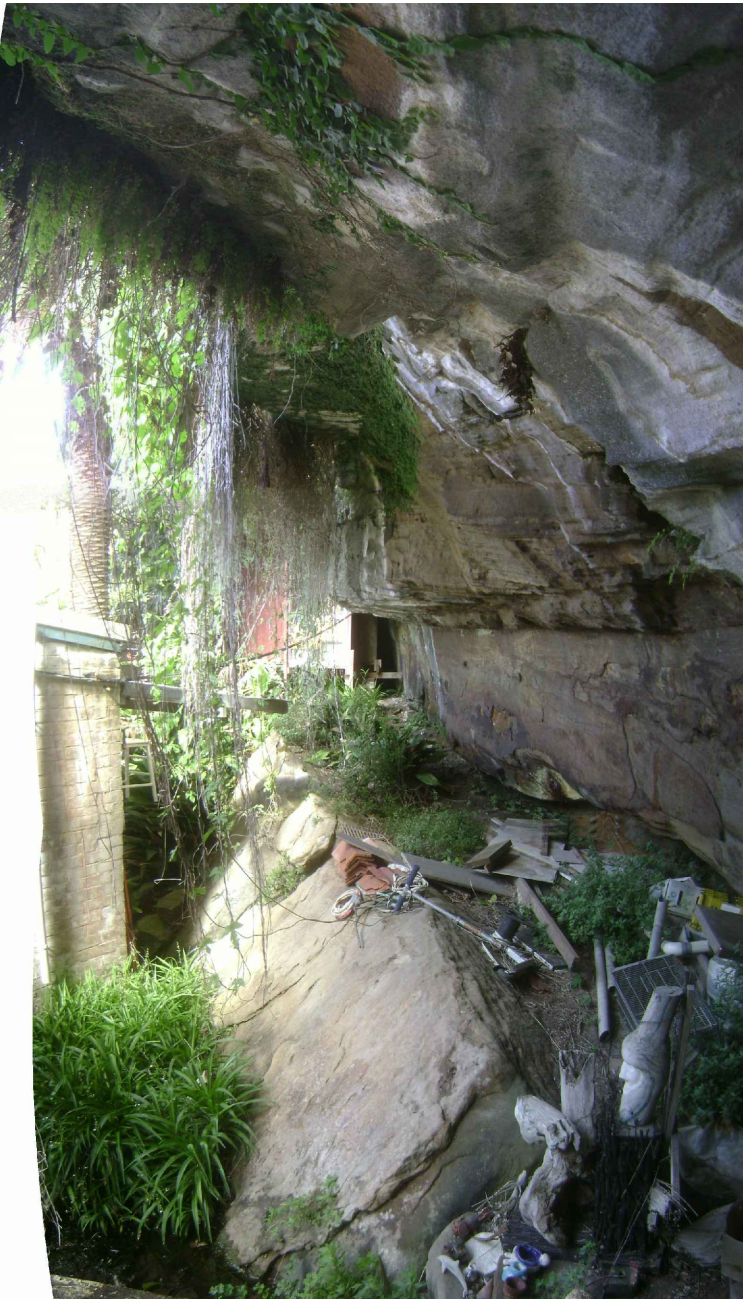
CROSS SECTION 3

Section 3 viewed towards the south west

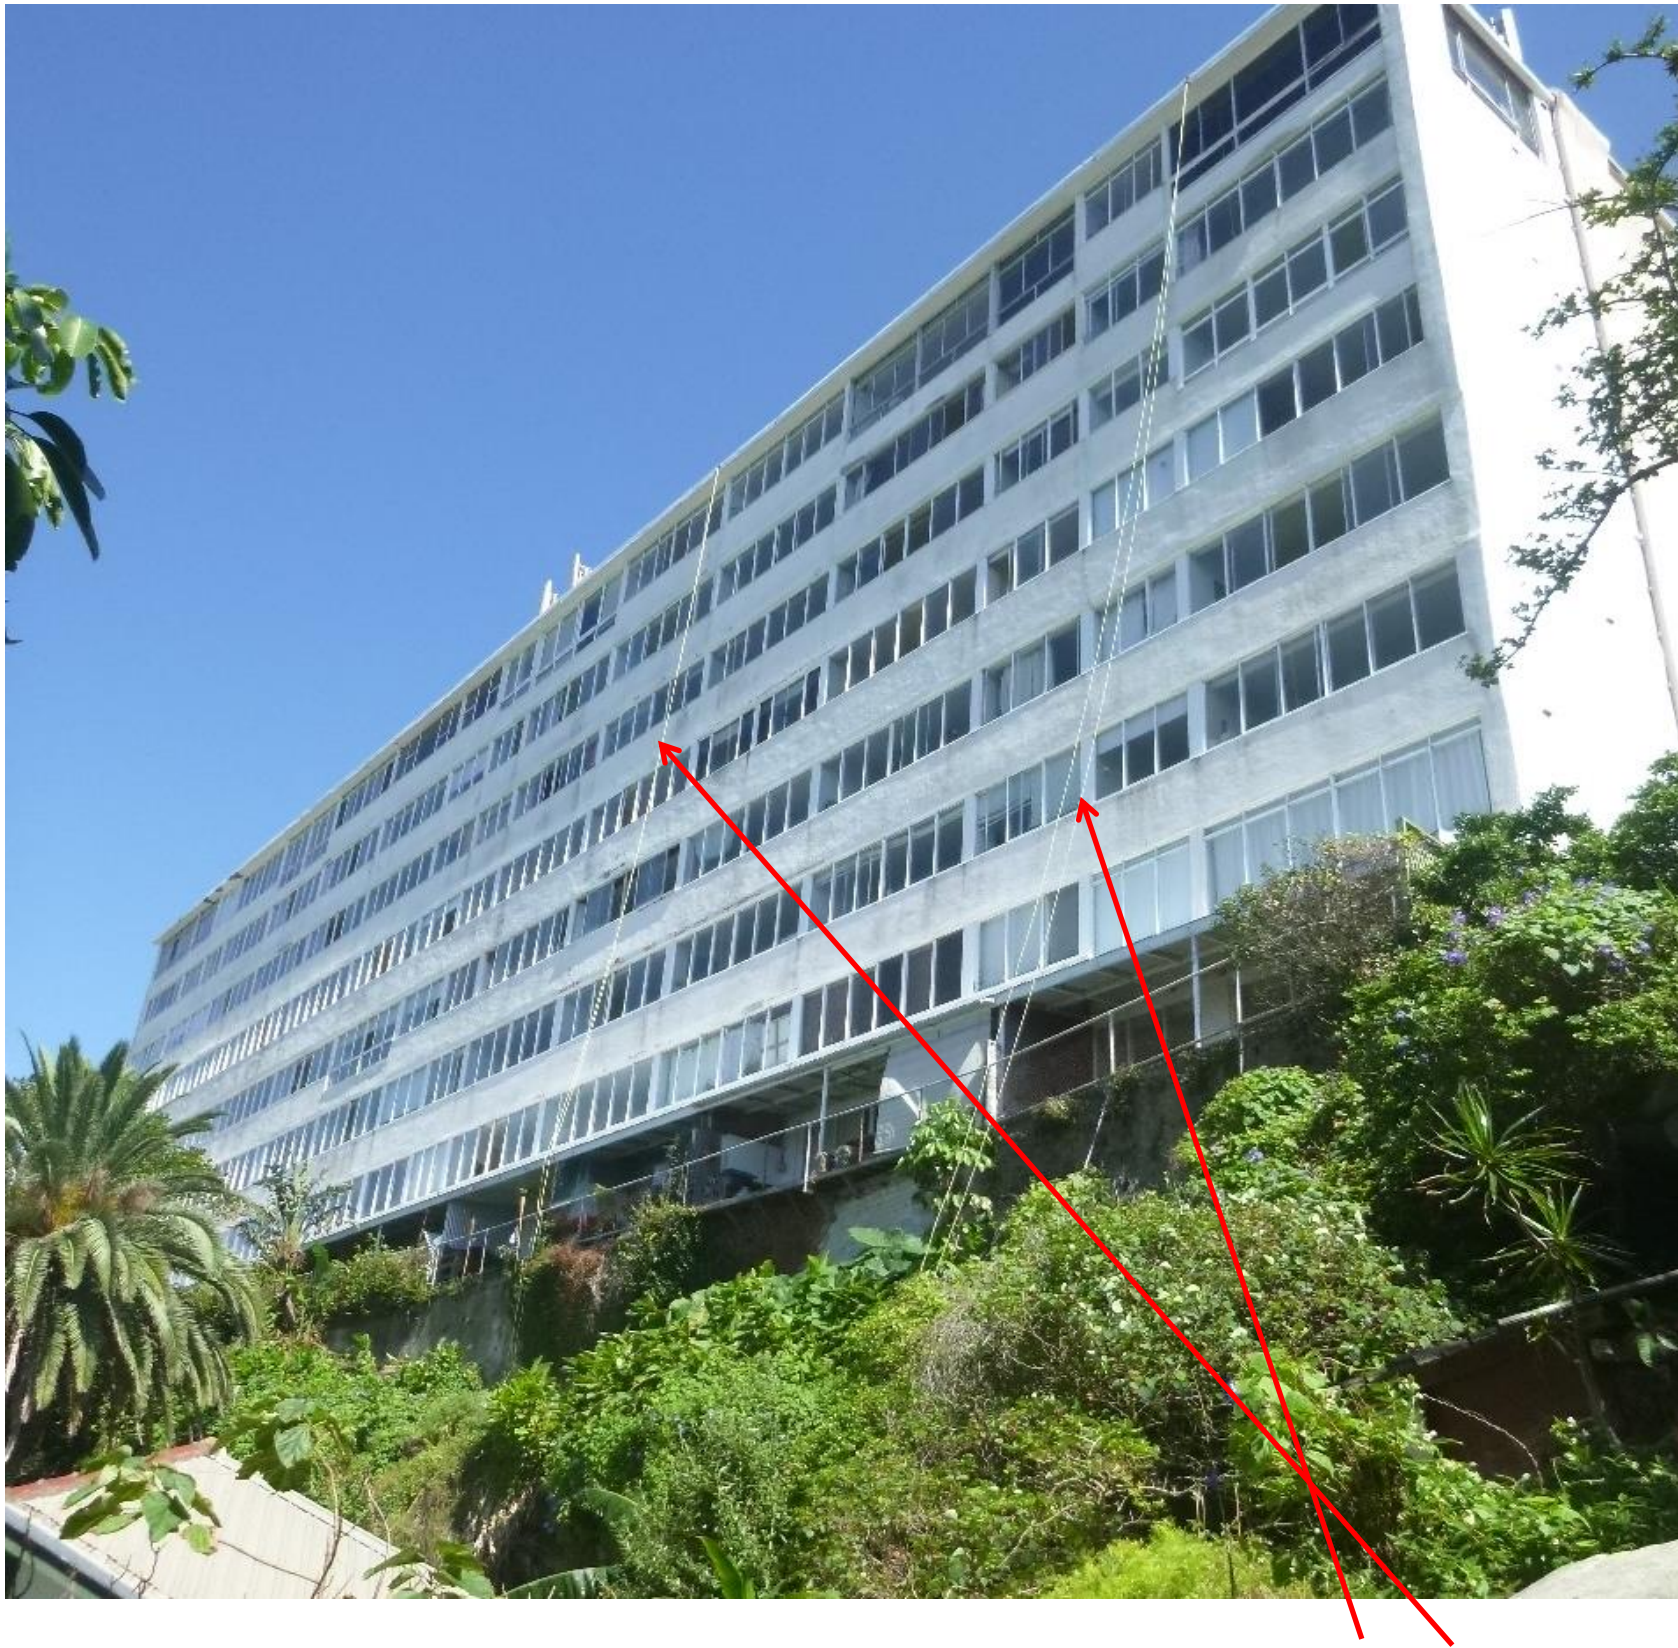
Photo 1. Southern side of building showing rope attachment locations to enable measurements for Cross Sections 1 and 2/3.

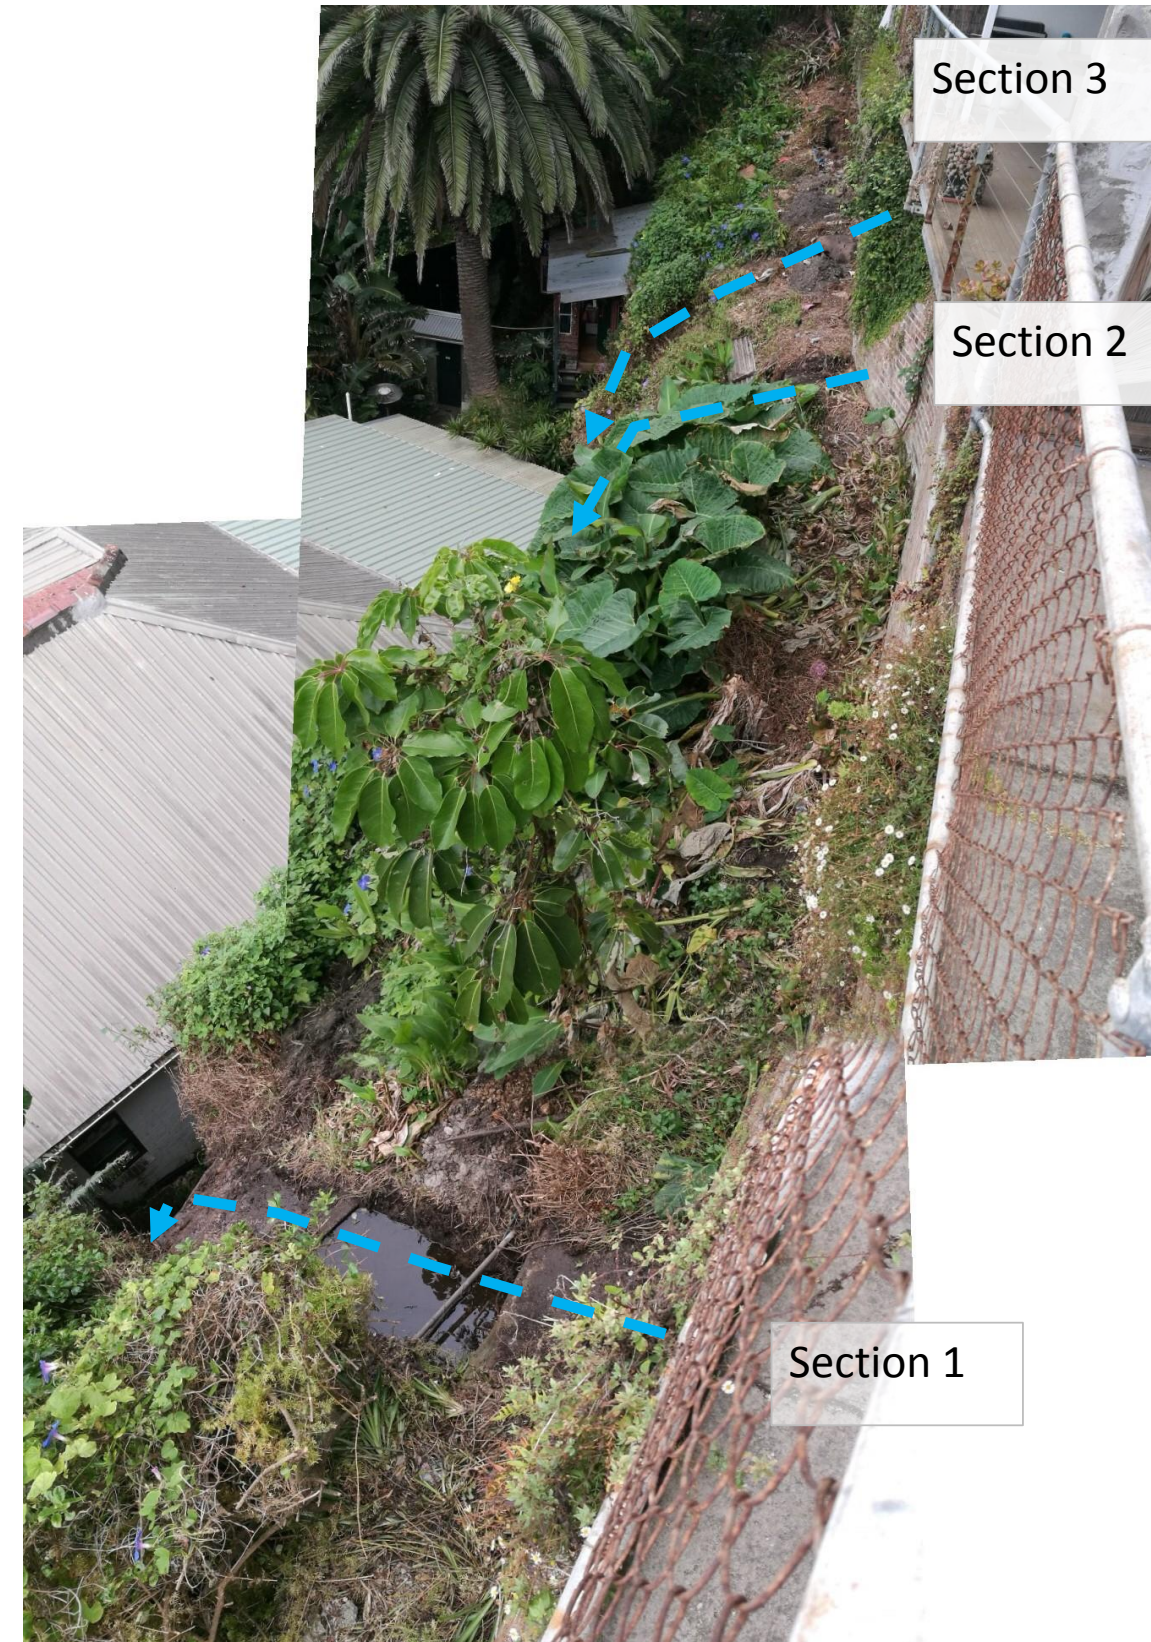
Photo 2. Top of the cliff, viewed towards the south-west at the time of vegetation clearing in 2016. Cross Section Numbers and locations indicated.

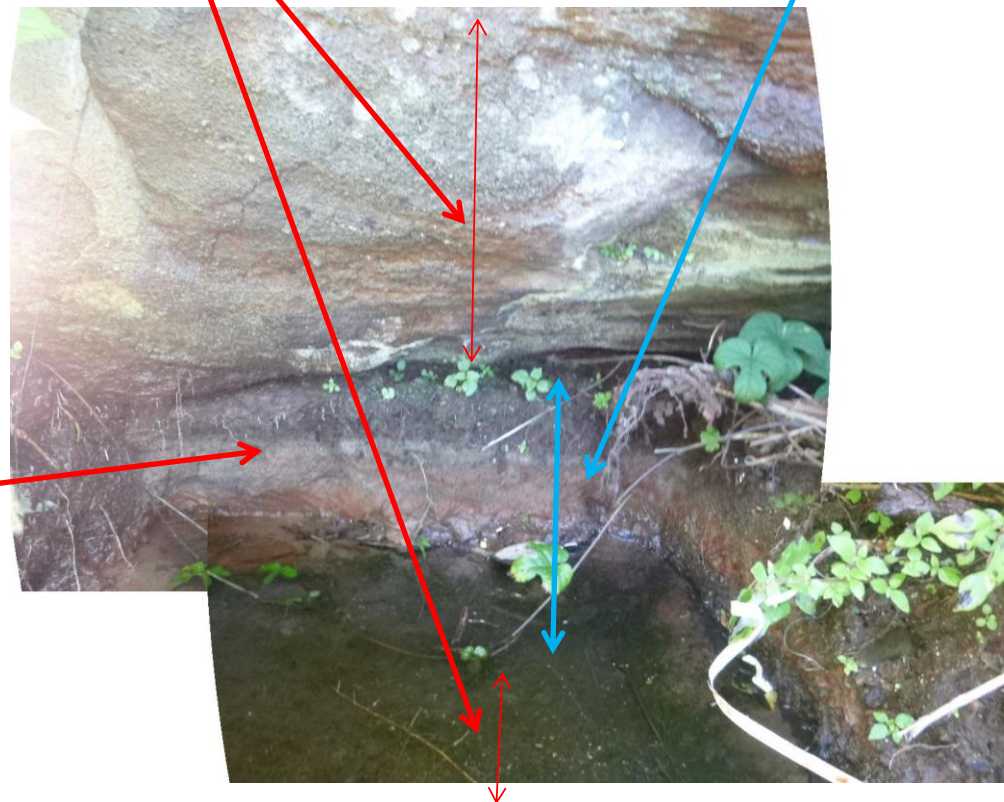
Photo 4.. Close up of Medium strength sandstone over very low strength, clayey sandstone then medium strength sandstone

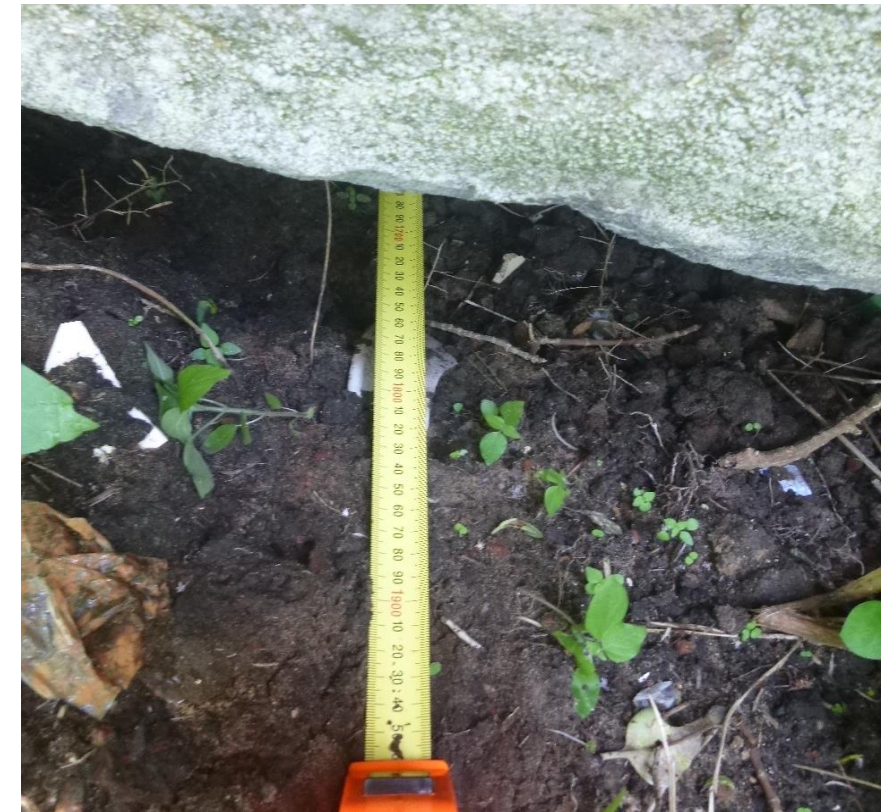
Photo 5. To north of Section 3 showing 1900mm penetration of tape measure into void/weathered seam.

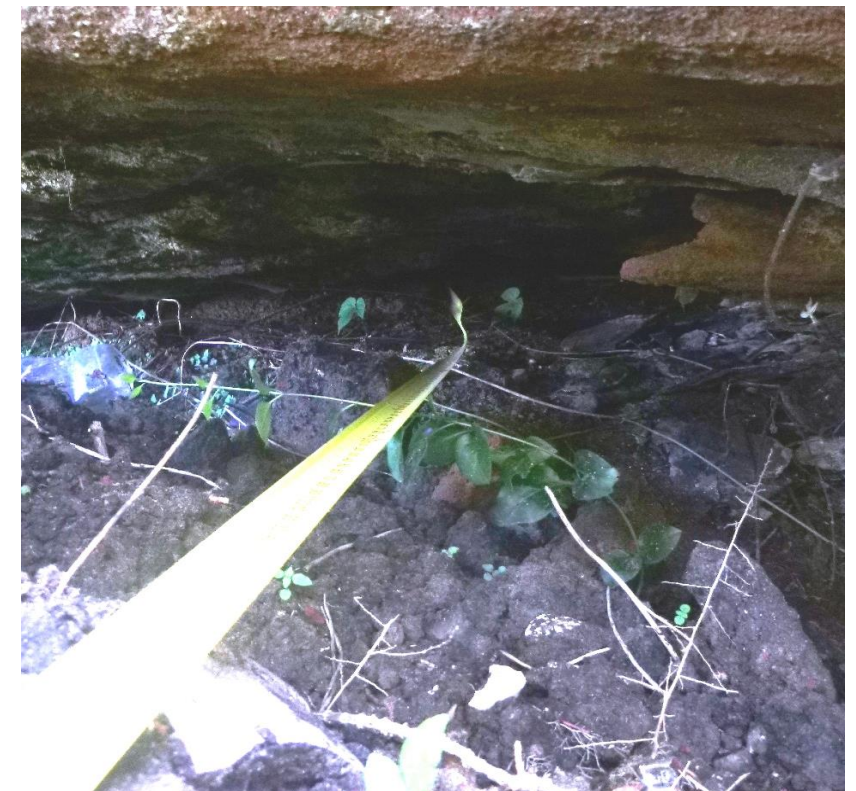
Photo 6. View into the weathered void.

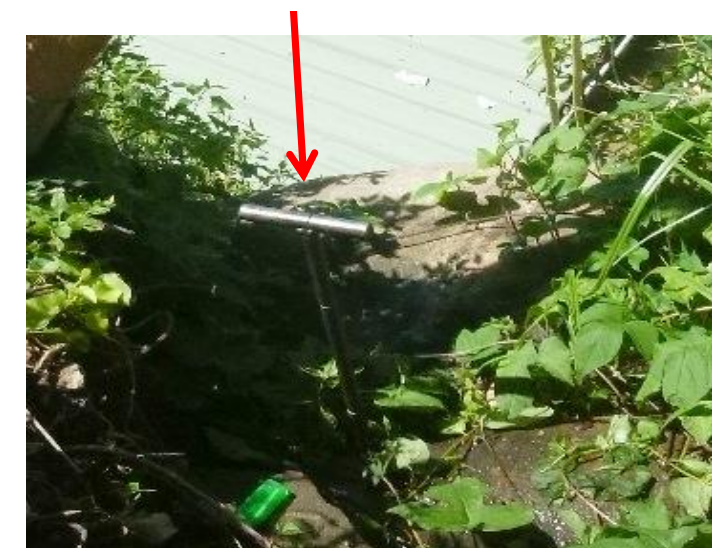
Photo 8. Outer edge of Section 3. Note 1m long steel test probe inserted 700mm into an open, though sand filled, joint, approximately 700mm back from the cliff crest.

Photo 8a. Close up of test probe inserted into the open joint.

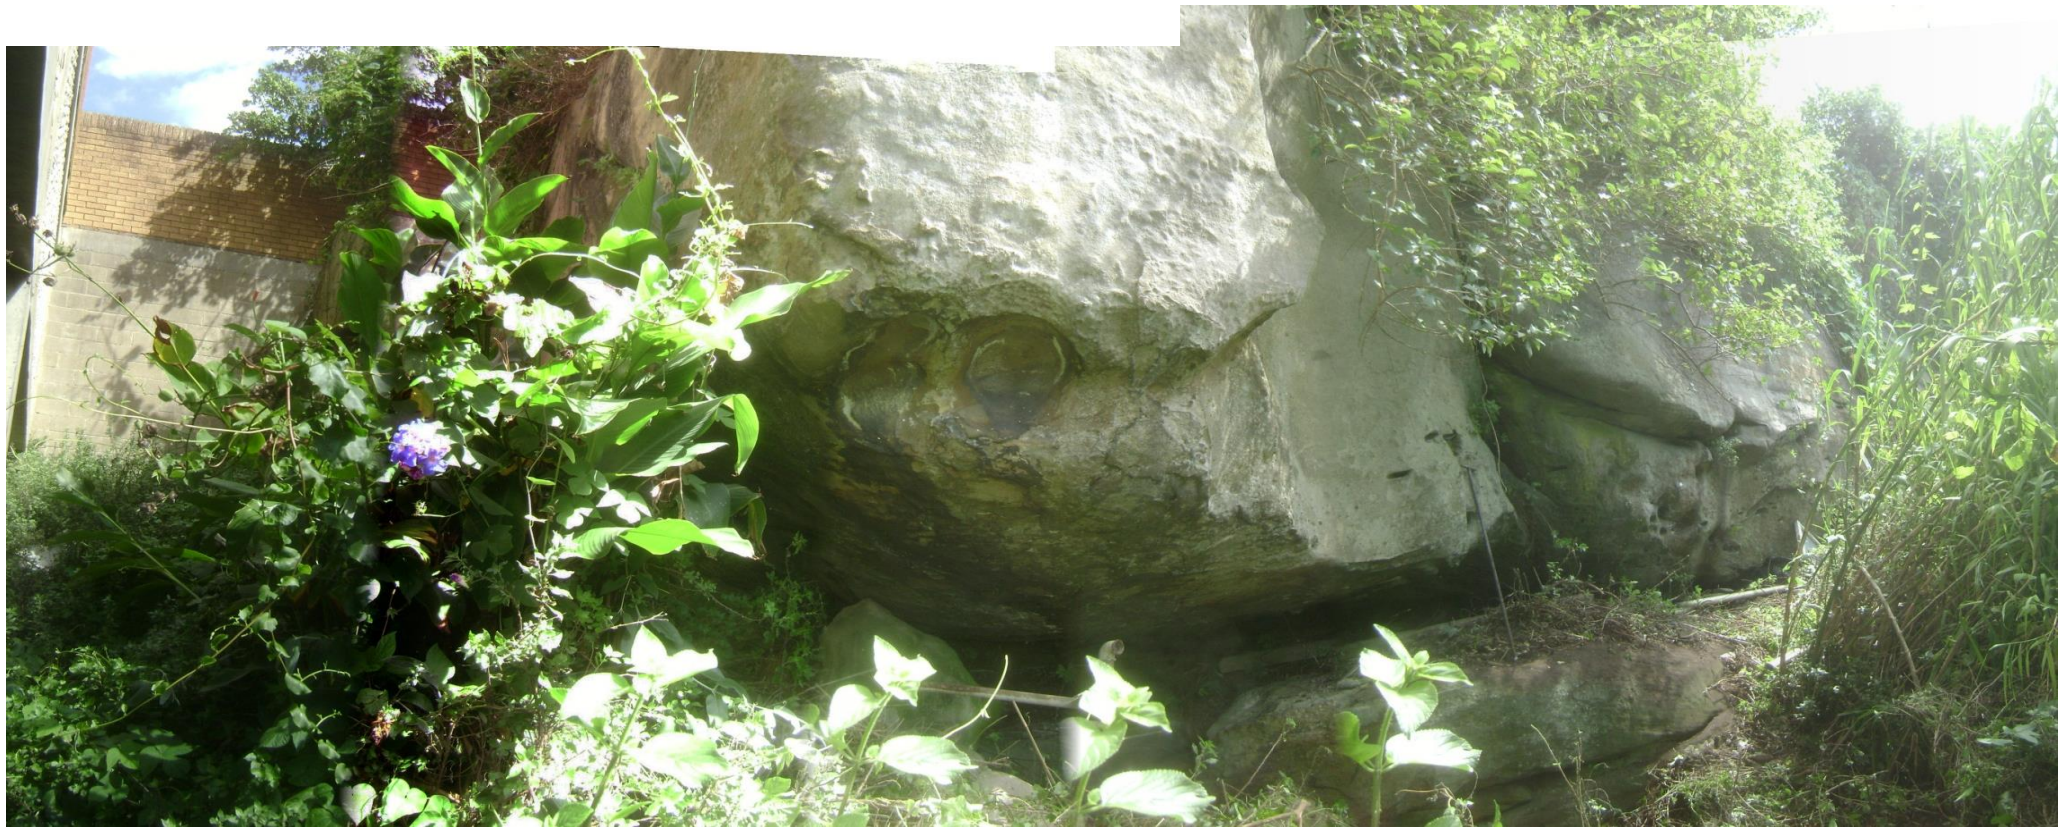
Photo 11. "Eastern end" of the southern most portion of the sandstone outcrop/cliff.

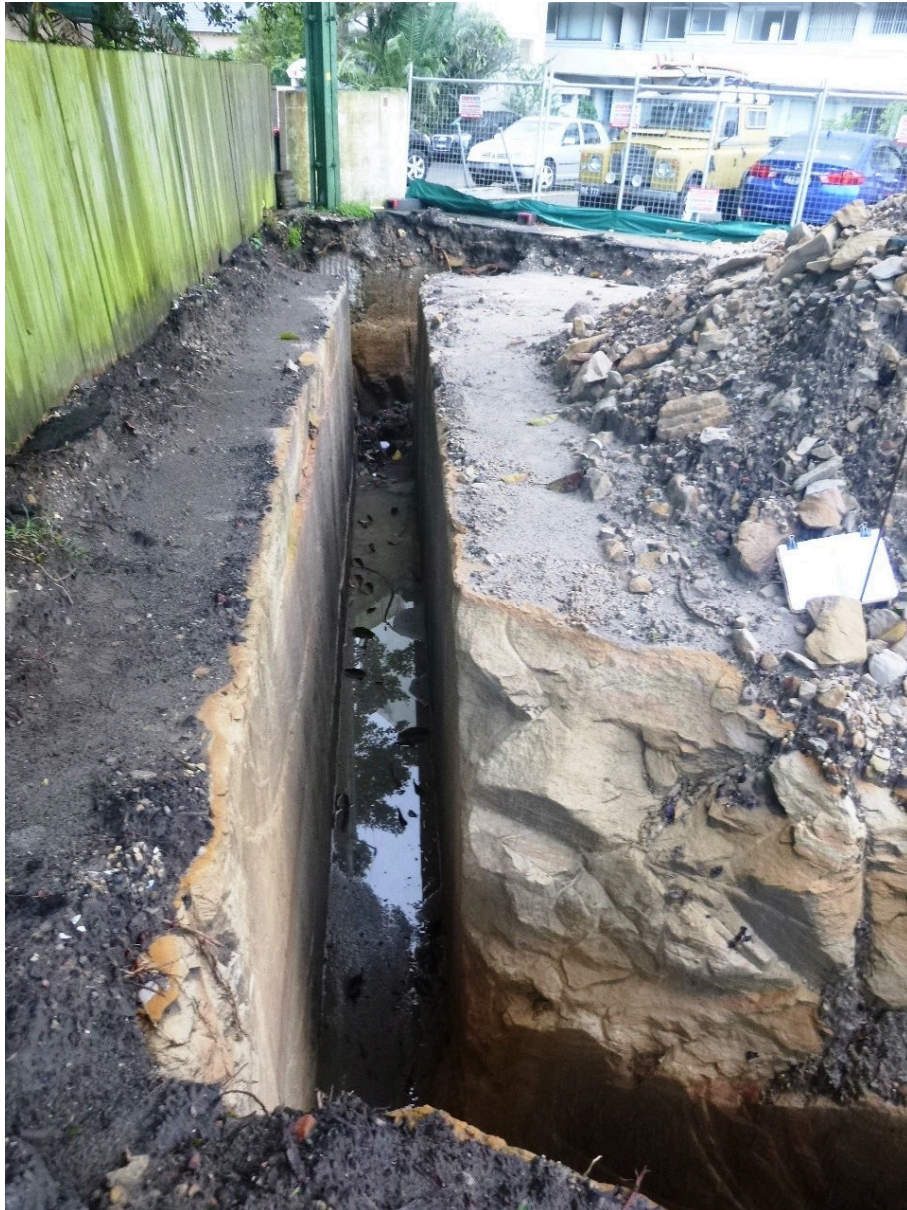
Historical Site Photograph of Sewer Diversion Trench, Photo 1 – View to east near Borehole BH3. Solid sandstone exposed at shallow depth along trench excavation.

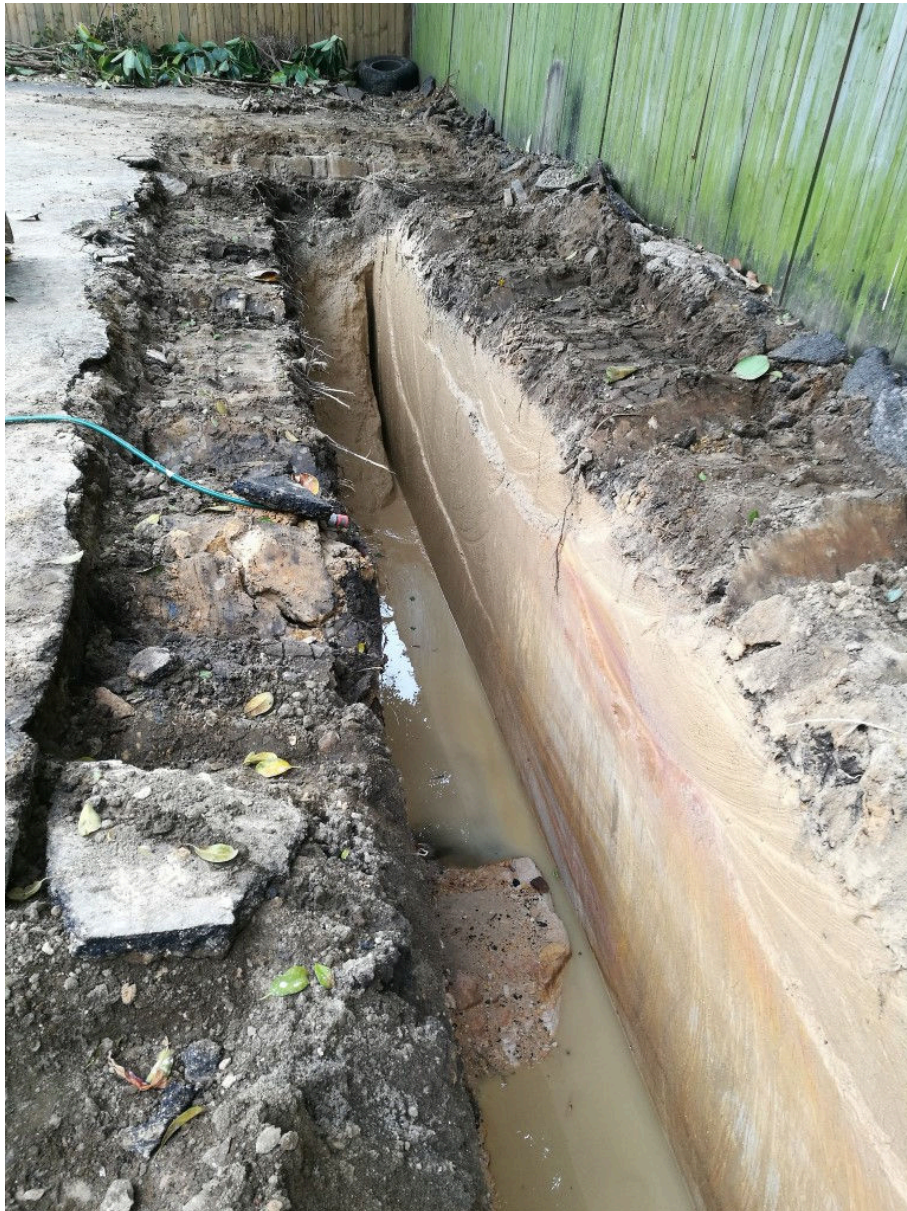
Historical Site Photograph of Sewer Diversion Trench, Photo 2 – View to west near Borehole BH3. Solid sandstone exposed at shallow depth along trench excavation.

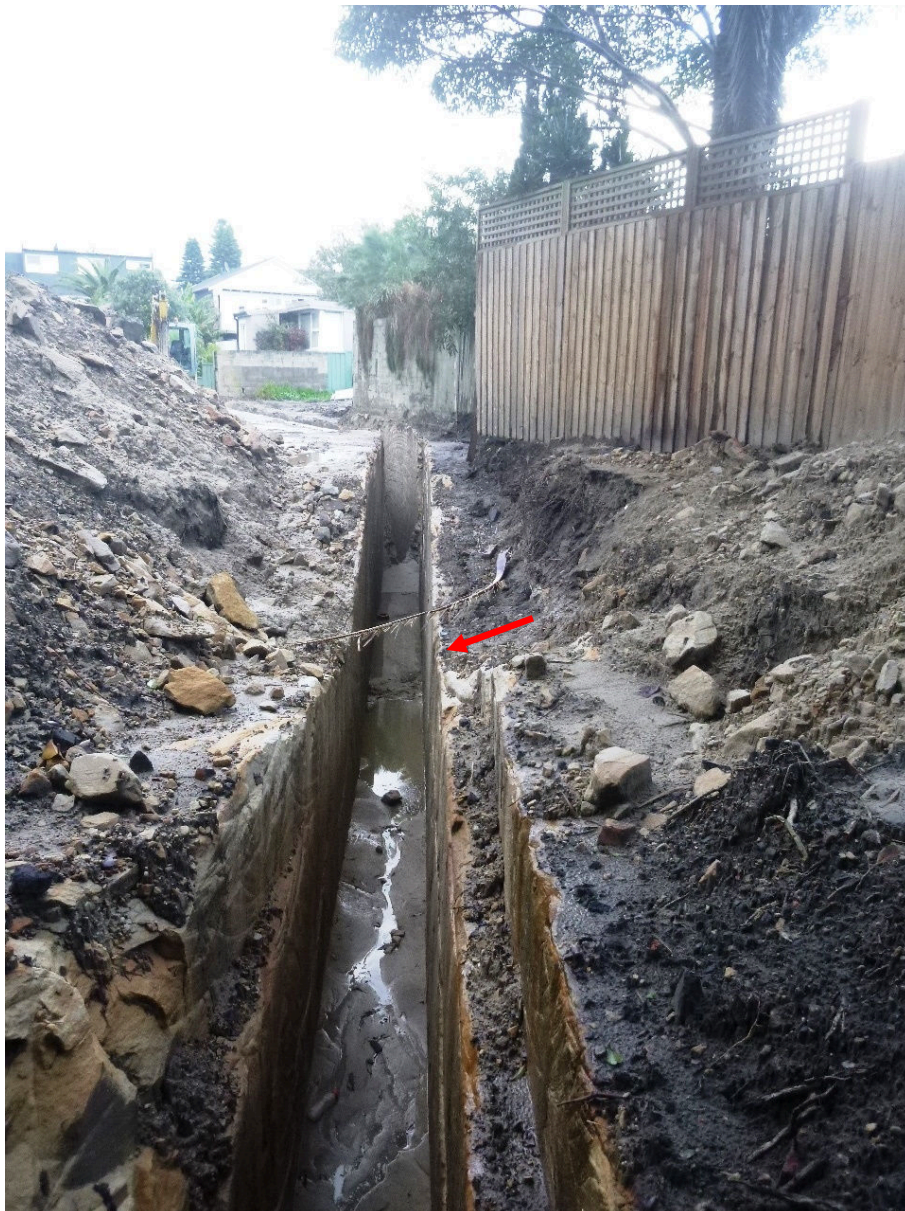
Historical Site Photograph of Sewer Diversion Trench, Photo 3 – View to south-west near Borehole BH5. Solid sandstone exposed at shallow depth along trench excavation. The approximate position of the clayey feature shown in Photo 4 is indicated as shown.

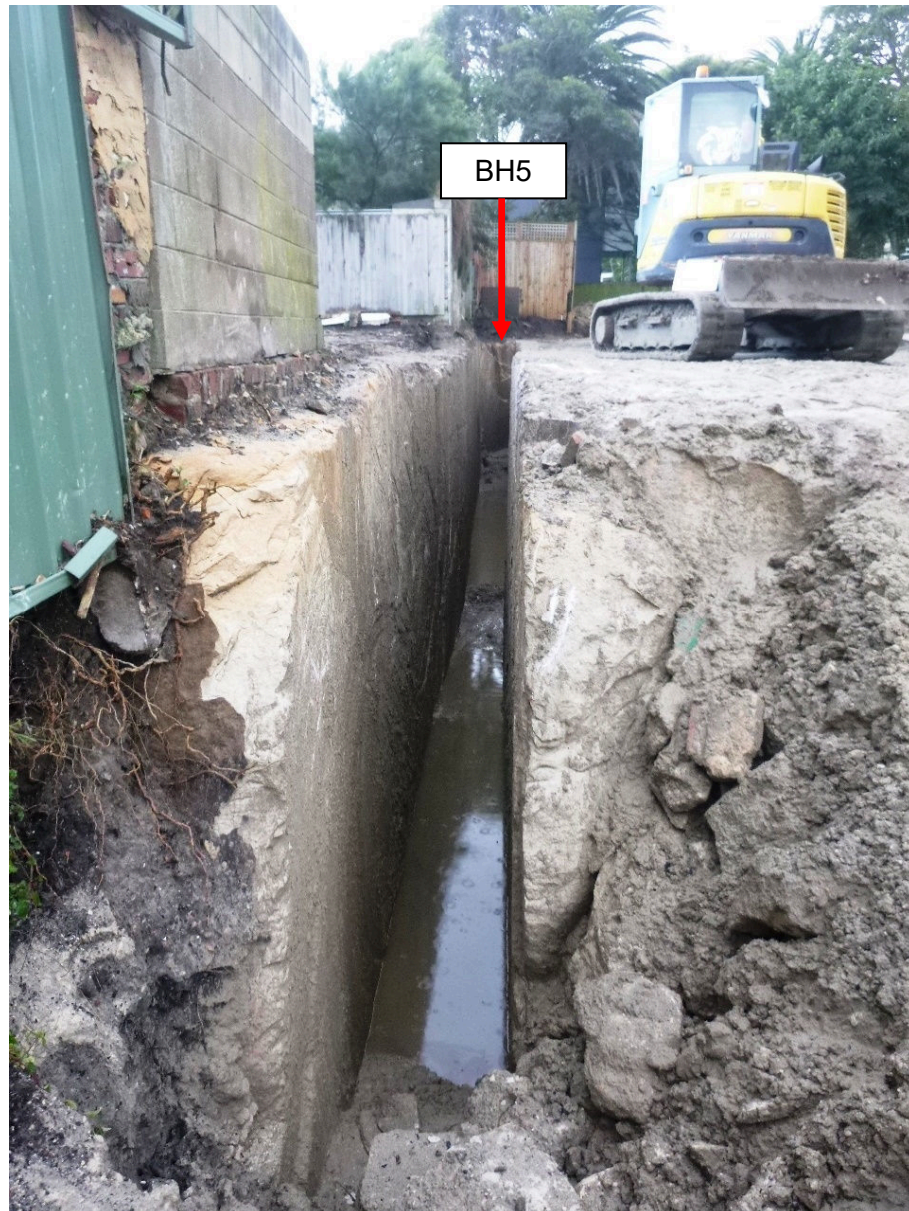
Historical Site Photograph of Sewer Diversion Trench, Photo 5 – View to north near Borehole BH101. Solid sandstone exposed at shallow depth along trench excavation. The approximate position of Borehole BH5 indicated as shown for reference.
