Hazardous Materials Survey

13-19 Canberra Avenue, St Leonards NSW

Report No: E25217.E10_Rev1

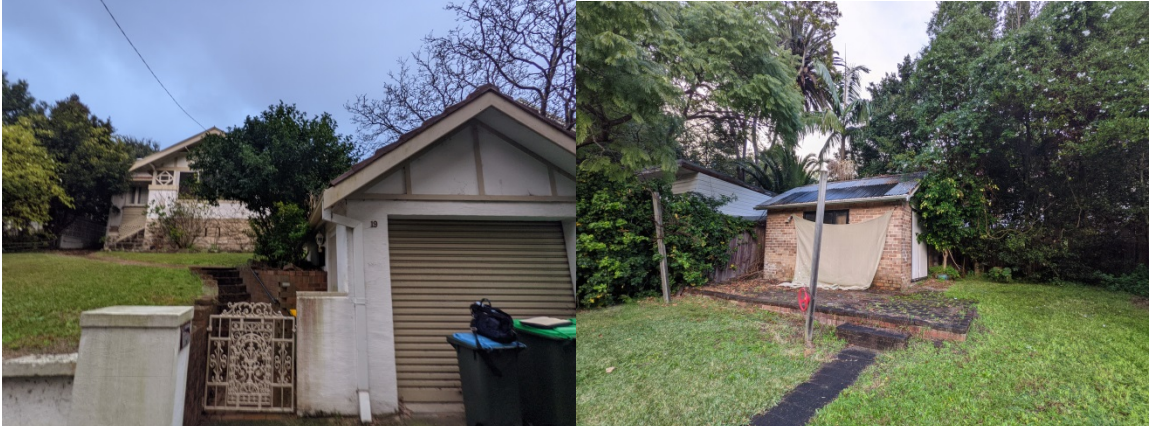
Description
<p>19 Canberra Avenue</p> <p>The property consists of a single story residential house.</p> <p>The building consists of brick external and internal walls, ceramic tiled roofing,, fibre cement sheeting (FSC) and Masonite ceiling. House includes 2 backyard sheds and a garage unit.</p> <p>Note: The ceiling, walls and/or subfloor cavity was inaccessible.</p>

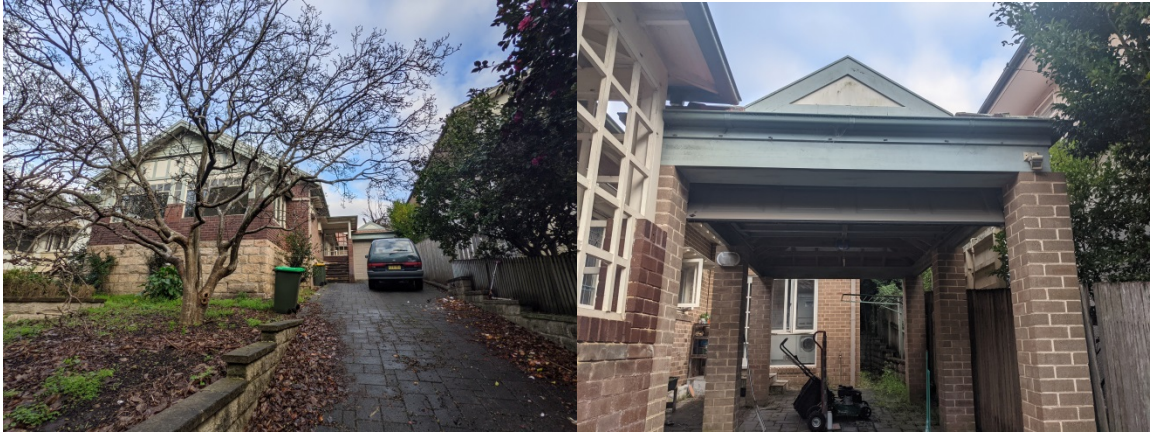
17 Canberra Avenue

The property consists of a single story residential house.

The building consists of brick external walls, brick and plasterboard internal walls, ceramic tiled roofing, fibre cement sheeting (FSC) and plasterboard ceiling. House includes a carport area.

Note: The ceiling, walls and/or subfloor cavity was inaccessible.

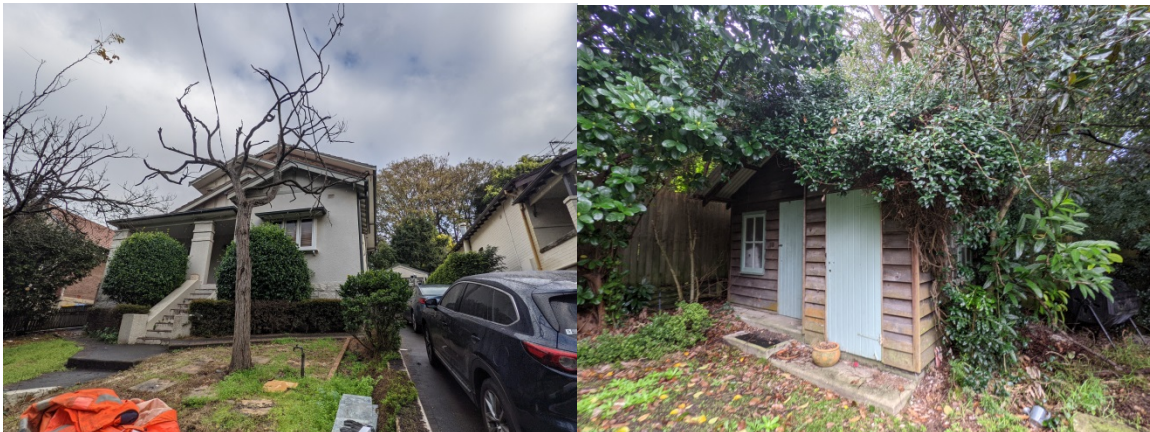
15 Canberra Avenue

The property consists of a double story residential house.

The building consists of brick external walls, brick and plasterboard internal walls, ceramic tiled roofing, plasterboard ceiling, fibre cement sheeting (FCS) awning boards and eaves. House includes a backyard shed and a carport area.

Note: The ceiling, walls and/or subfloor cavity was inaccessible.

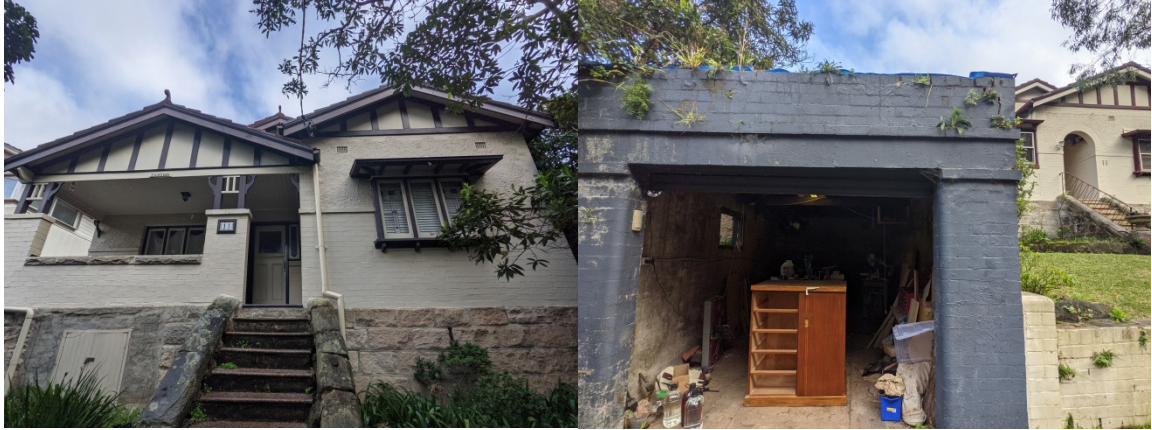
13 Canberra Avenue

The property consists of a single story residential house.

The building consists of brick external walls, brick and plasterboard internal walls, ceramic tiled roofing, timber and FCS ceiling, awning boards and eaves. House includes a backyard shed and a garage unit.

Note: The ceiling, walls and/or subfloor cavity was inaccessible.

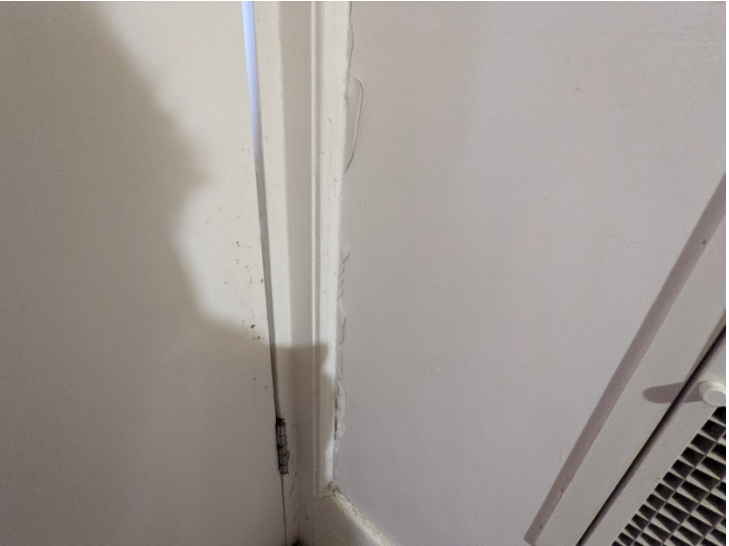
Main house, Internal, Walls	White Paint	NA	Pb-3	Negative for LBPs (0.009%w/w)	>100 m ²	Good (Maintenance only)	NA	NA
-----------------------------------	-------------	----	------	----------------------------------	---------------------	----------------------------	----	----

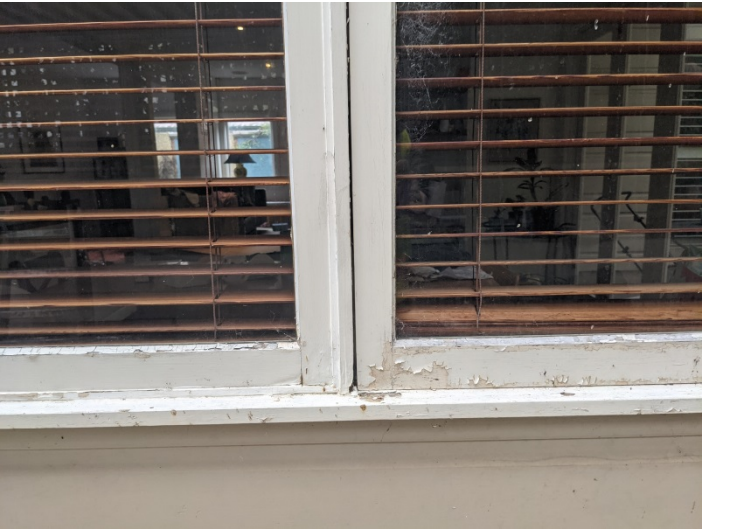
Main house, Internal, External Wall, window, door frame	White Paint	NA	Pb-4	Negative for LBPs (0.001%w/w)	30 m ²	Fair (Regularly)	NA	NA
--	-------------	----	------	----------------------------------	-------------------	---------------------	----	----

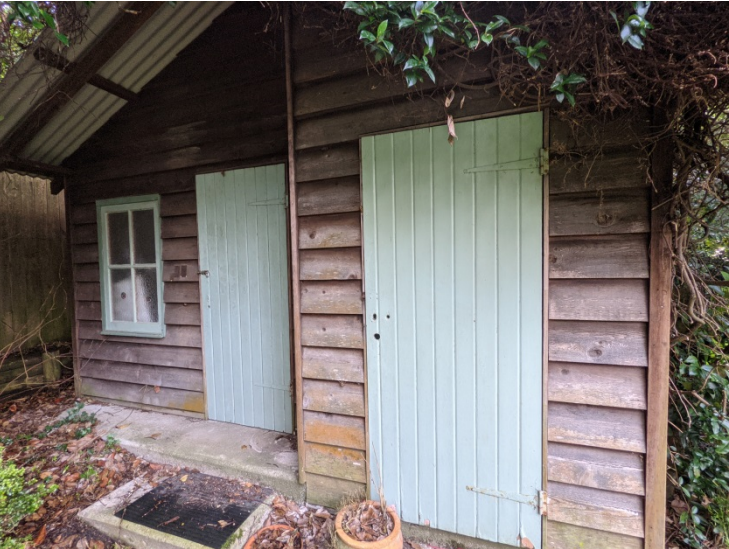
Outhouse, External, Door frame	Blue Paint	NA	Pb-5	Negative for LBPs (0.033%w/w)	<10 m ²	Good (Maintenance only)	NA	NA
--------------------------------------	------------	----	------	----------------------------------	--------------------	----------------------------	----	----

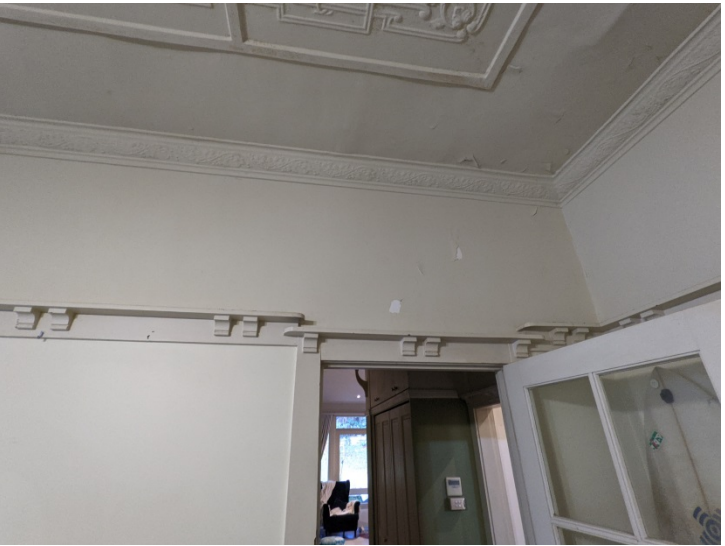
Main house, Internal, Walls and Ceiling	White Paint	NA	Pb-6	Negative for LBPs ($<0.001\%w/w$)	$>100\text{ m}^2$	Good (Maintenance only)	NA	NA

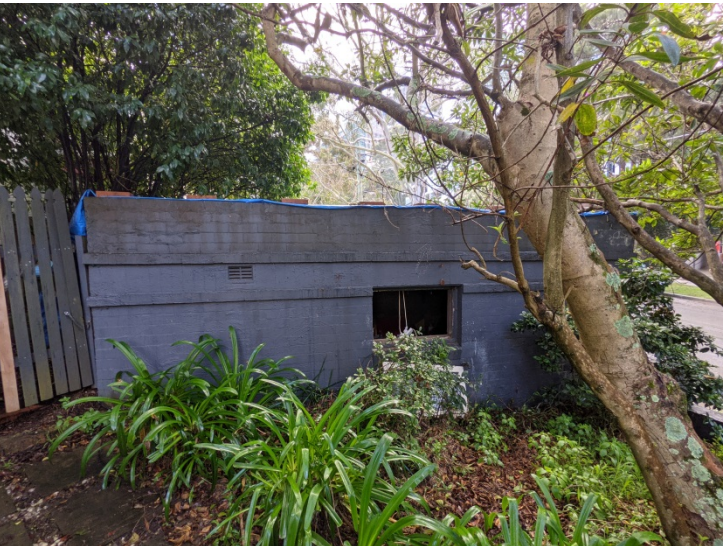
Garage, External, Walls, fence walls, residence deck, frame work	Blue Paint	NA	Pb-7	Negative for LBPs ($0.004\%w/w$)	$>100\text{ m}^2$	Good (Maintenance only)	NA	NA

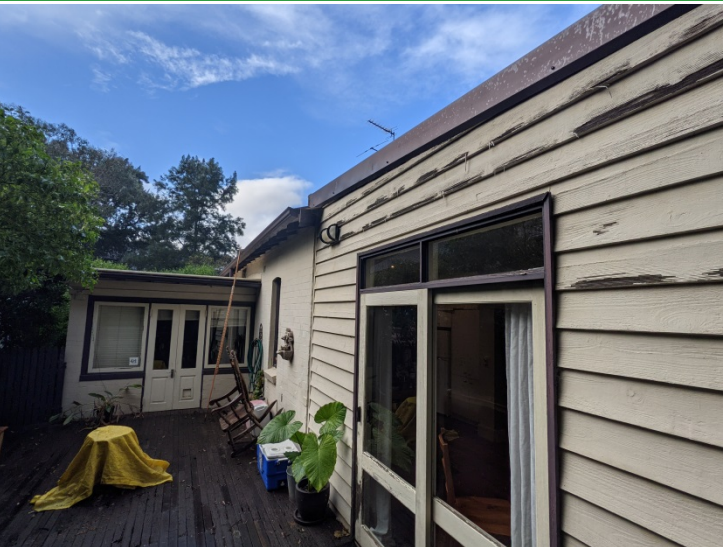
Main house, External, Rear timber walls	Cream Paint	NA	Pb-9	Negative for LBPs ($0.001\%w/w$)	40 m^2	Good to fair (Maintenance only)	NA	NA

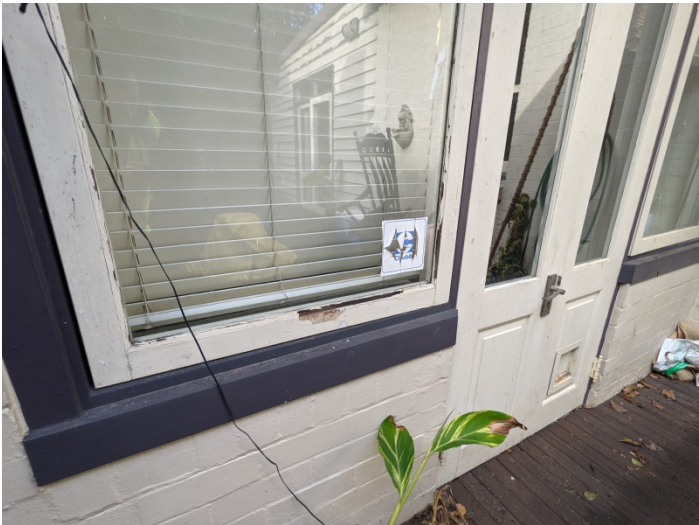
Main house, Internal, Walls, window and door frames	White Paint	NA	Pb-8	Negative for LBPs (<0.001%w/w)	>100 m ²	Good (Maintenance only)	NA	NA
